Inspection Photos

API: 071-07766

Operator: EVERGREEN NATURAL RESOURCES

Inspection Date: 9/16/2021

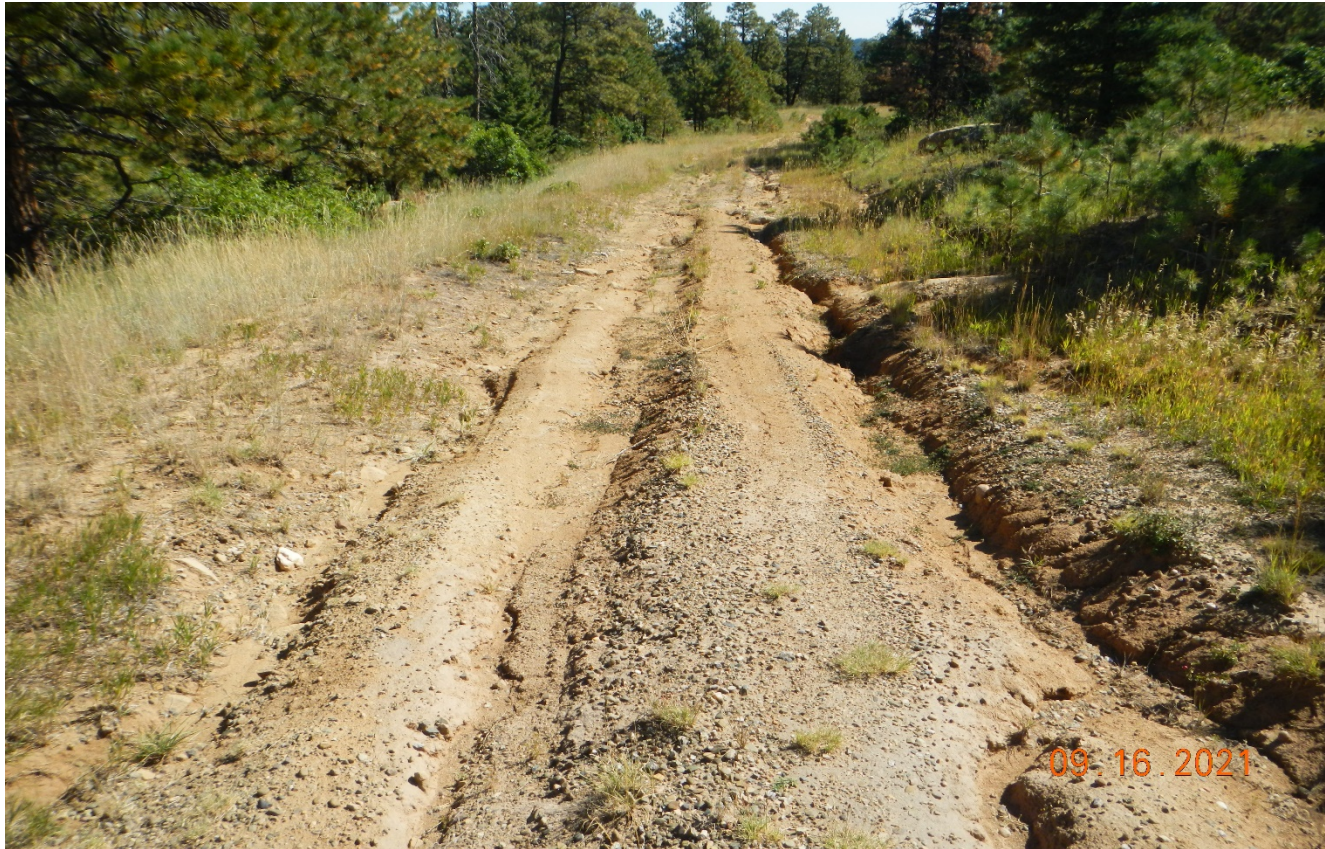
Photo 1. Facing northeast along the access road. The road is not stabilized and there is erosion channels along the road. Previous corrective action was not completed.

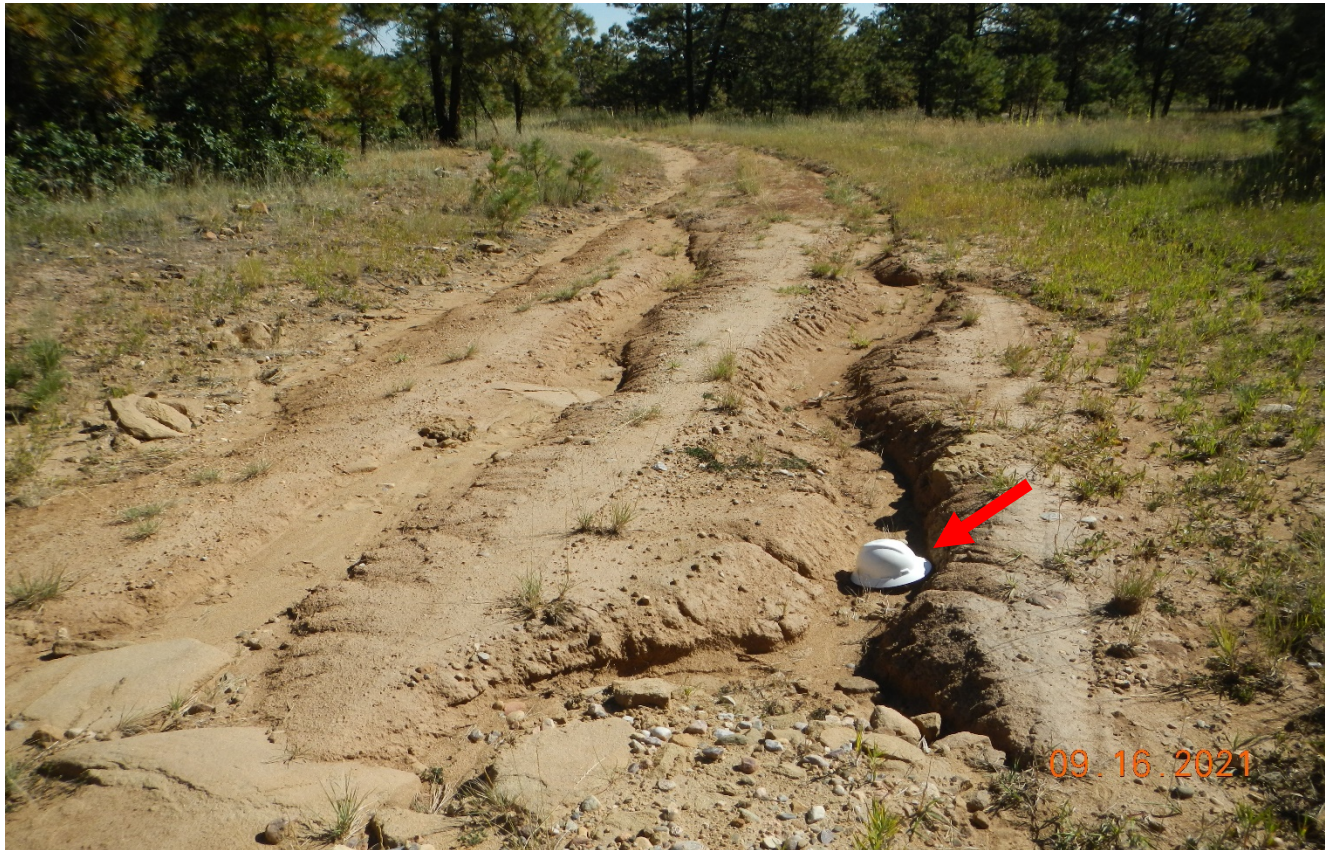
Photo 2. The road is not stabilized and there is erosion channels along the road. Red arrow points to hard hat for scale. Previous corrective action was not completed.

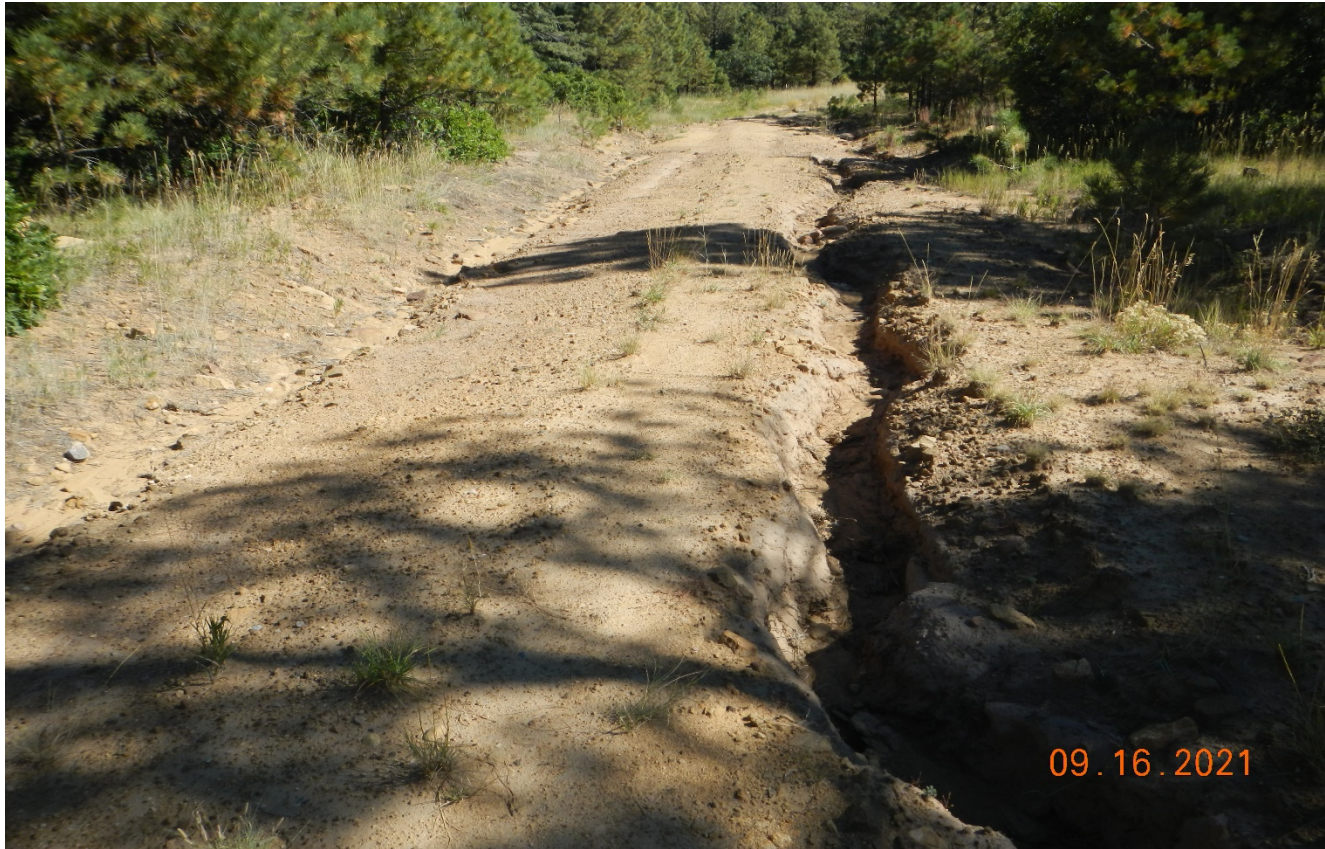
Photo 3. Facing northeast further along the access road. The road is not stabilized and there is erosion channels along the road.

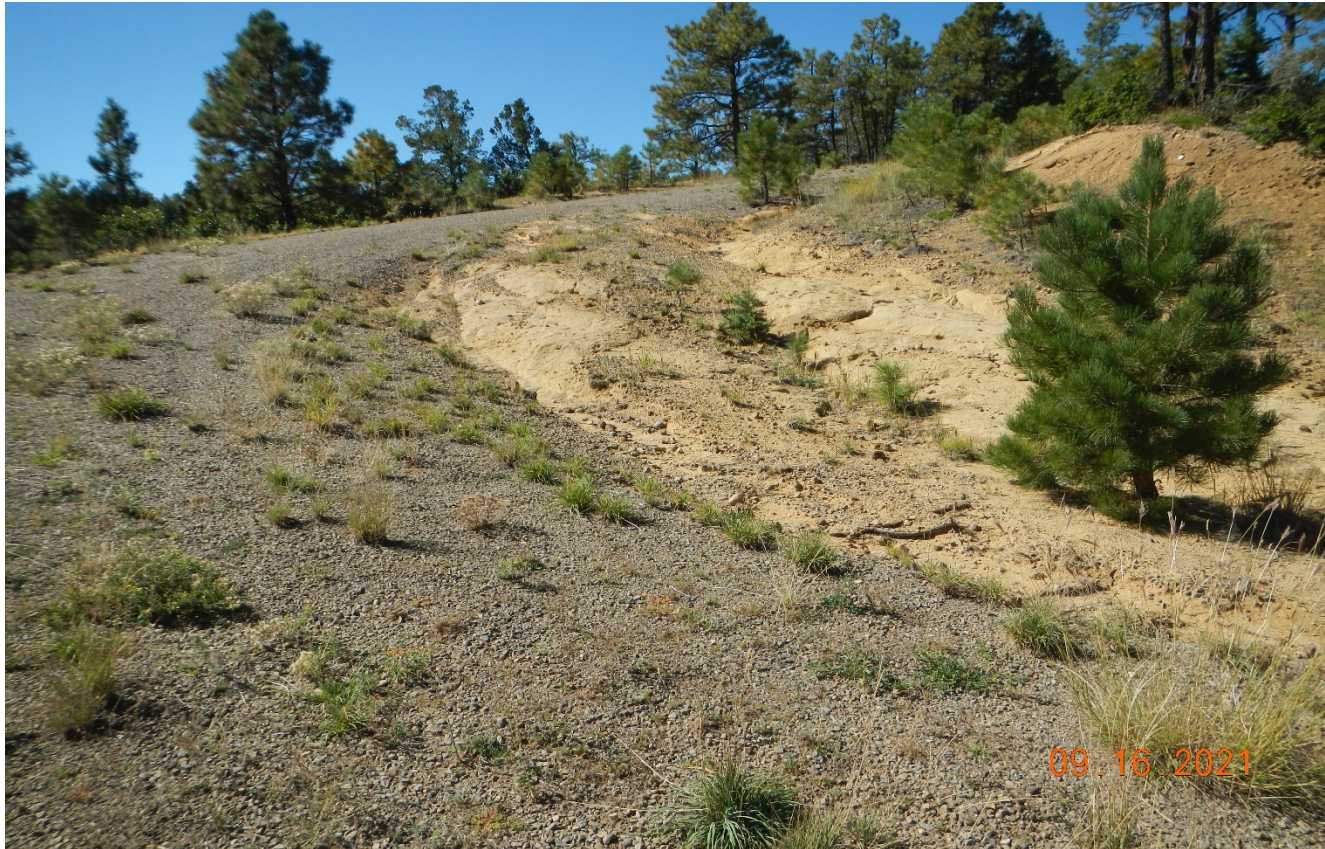
Photo 4. Facing back where the road turns down the hill side into the canyon. The side of the road is not stabilized in this area.

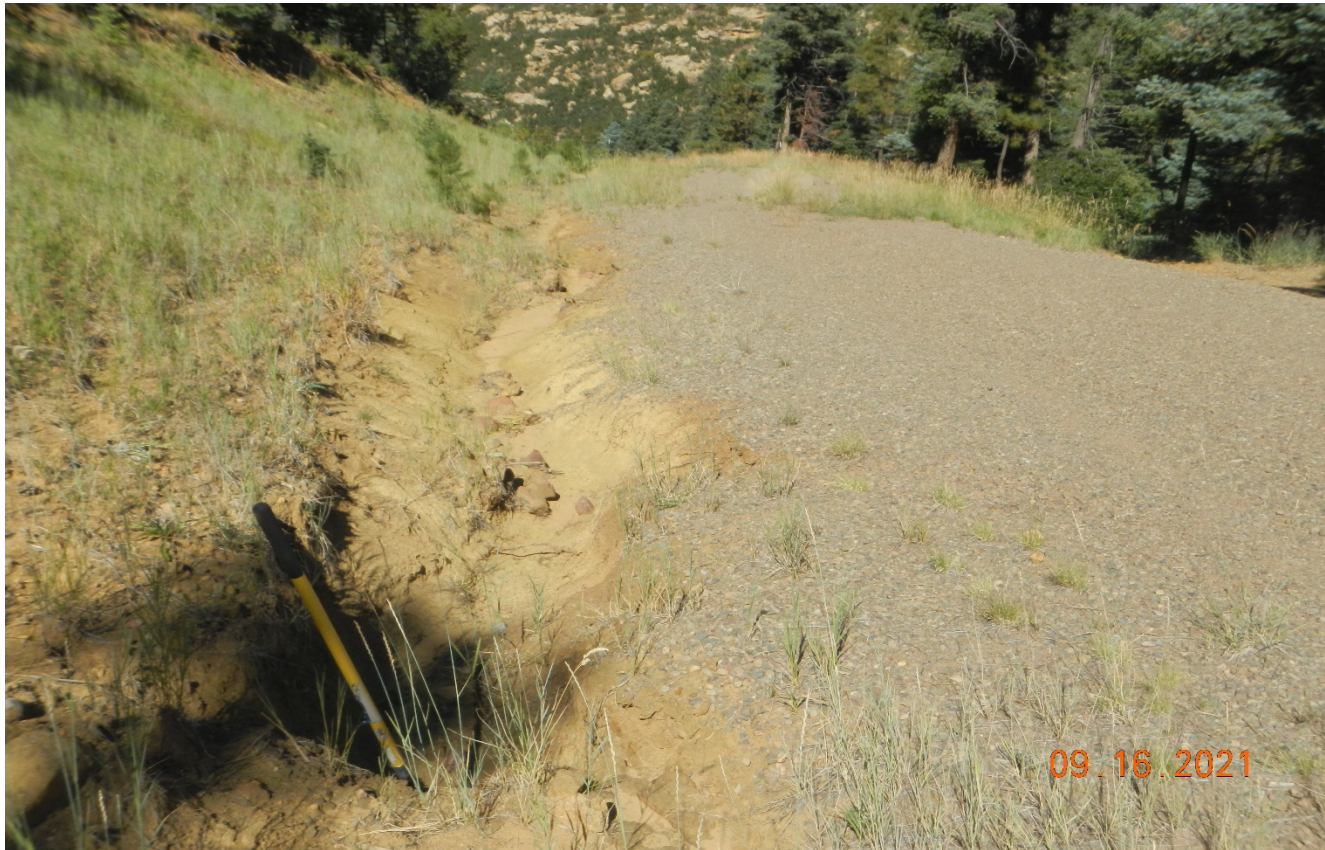
Photo 5. There is erosion occurring along the side of the road and culverts are filled in with sediment.

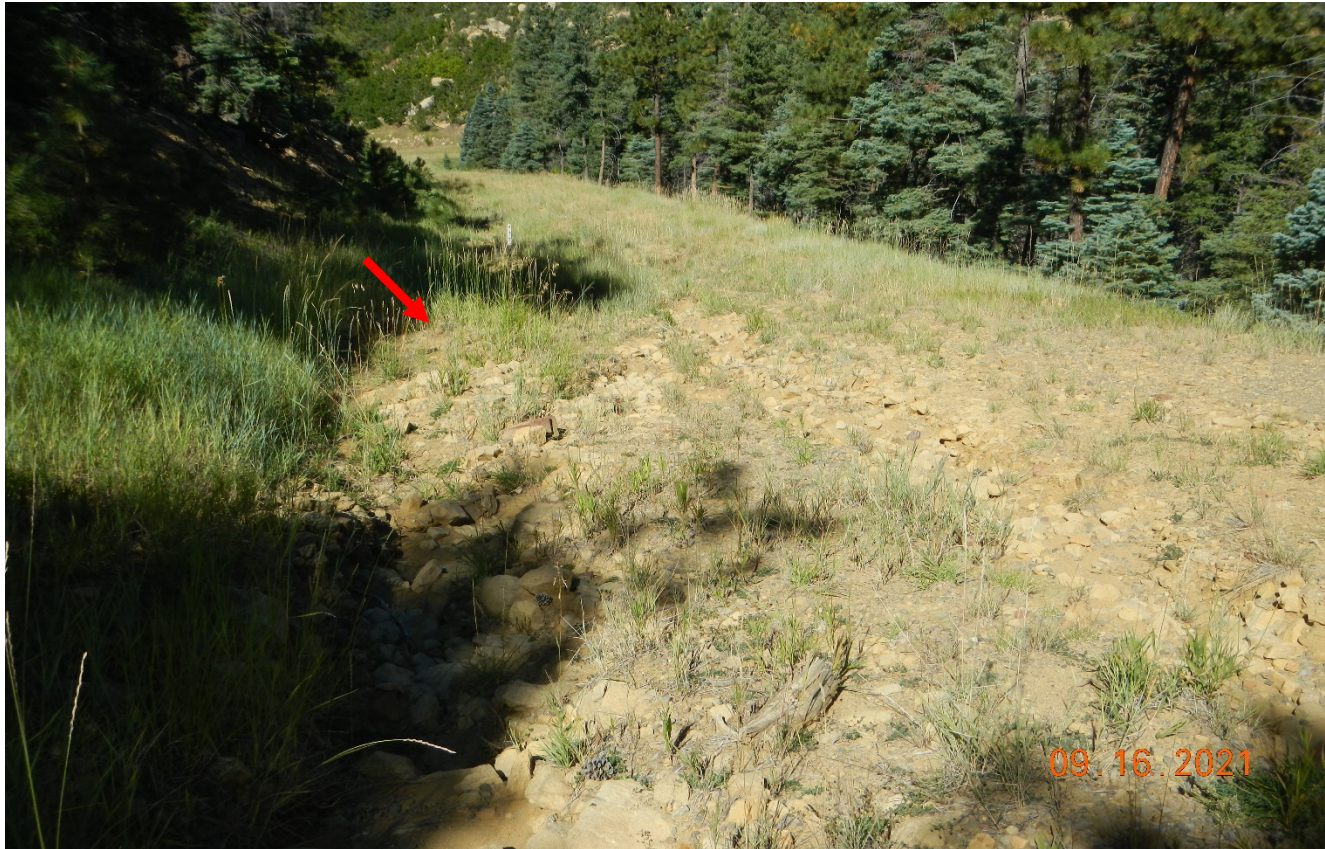
Photo 6. The arrow points to a culvert which is filled in with sediment.

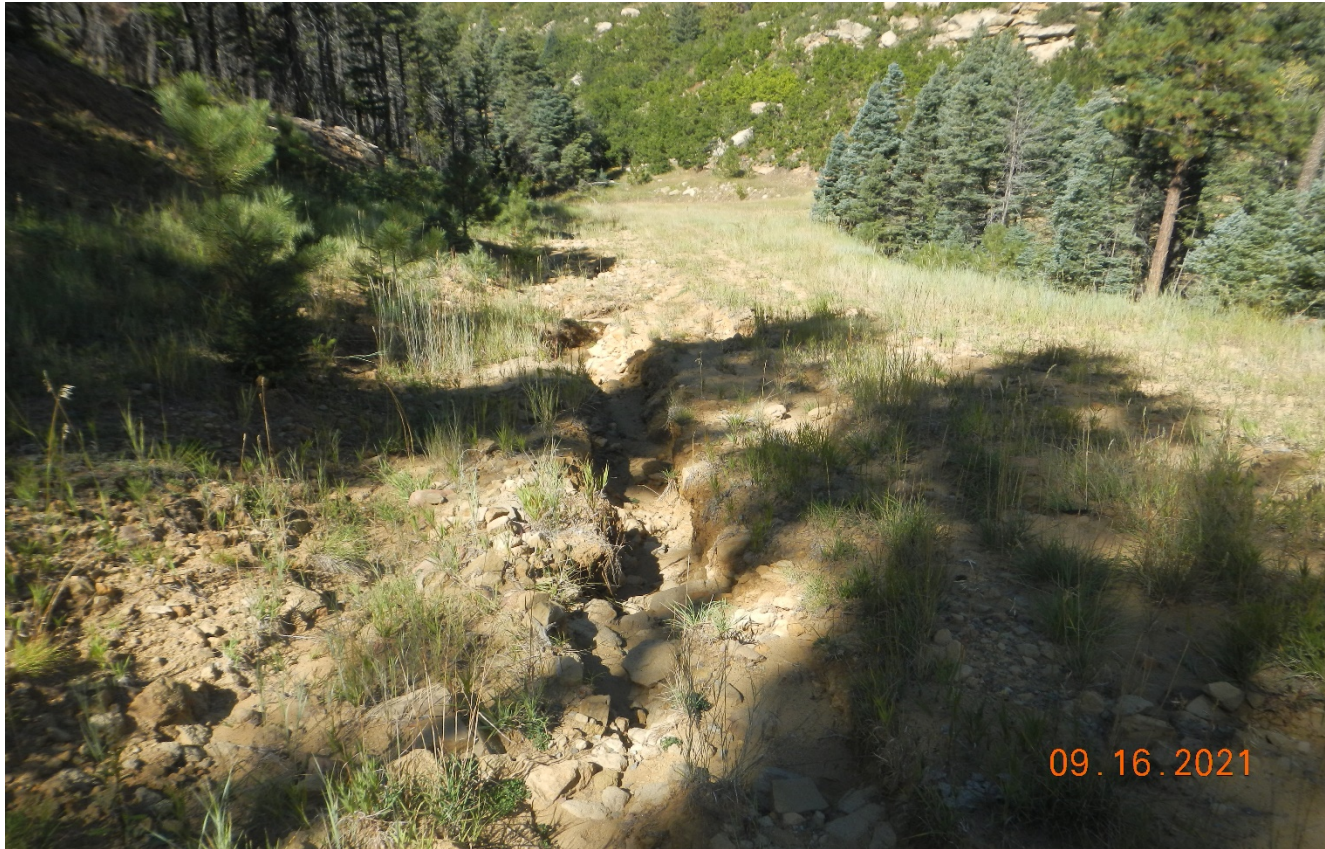
Photo 7. Facing northwest along the access road descending into the canyon. There is erosion along the road all the way down to the canyon bottom.

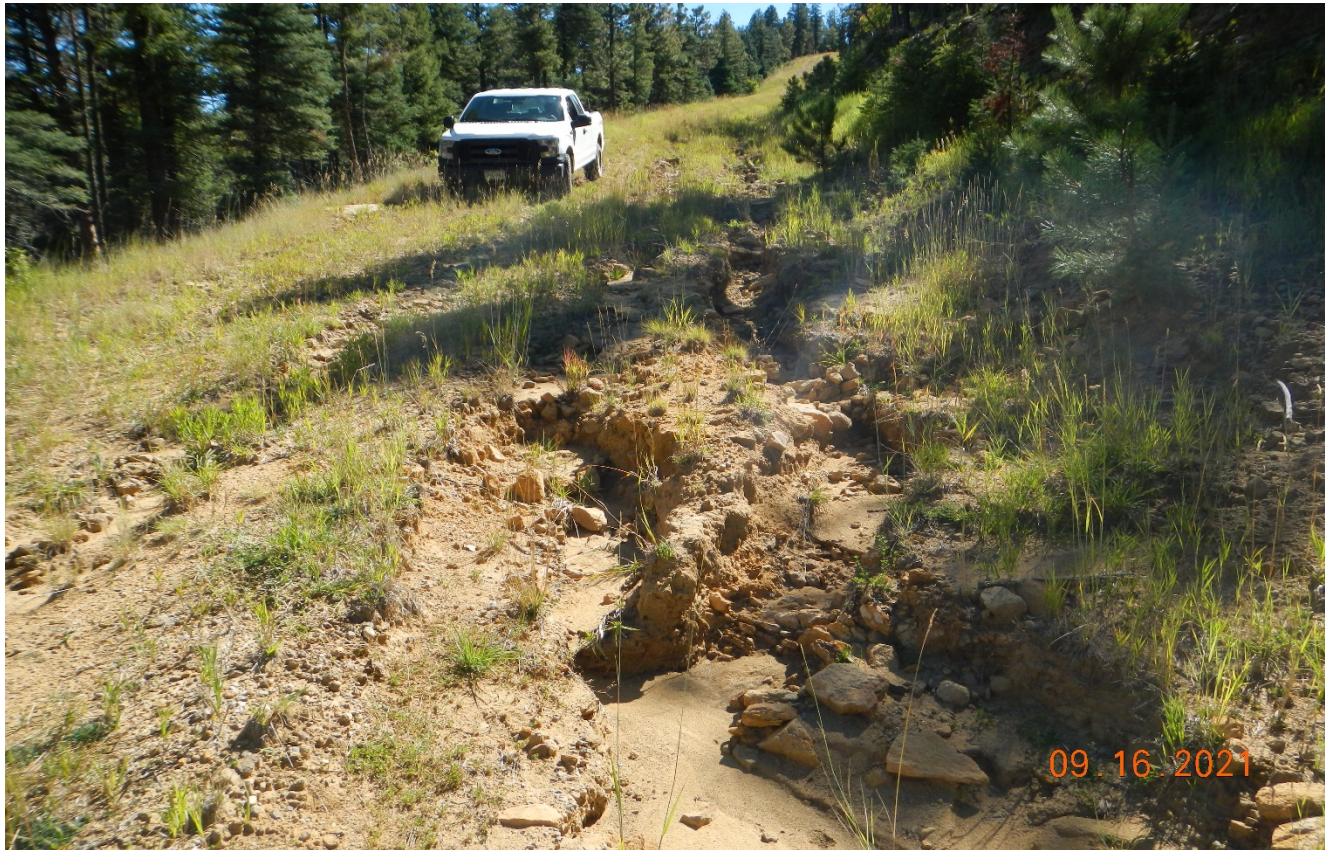
Photo 8. Facing northwest along the access road descending into the canyon. There is erosion along the road all the way down to the canyon bottom.

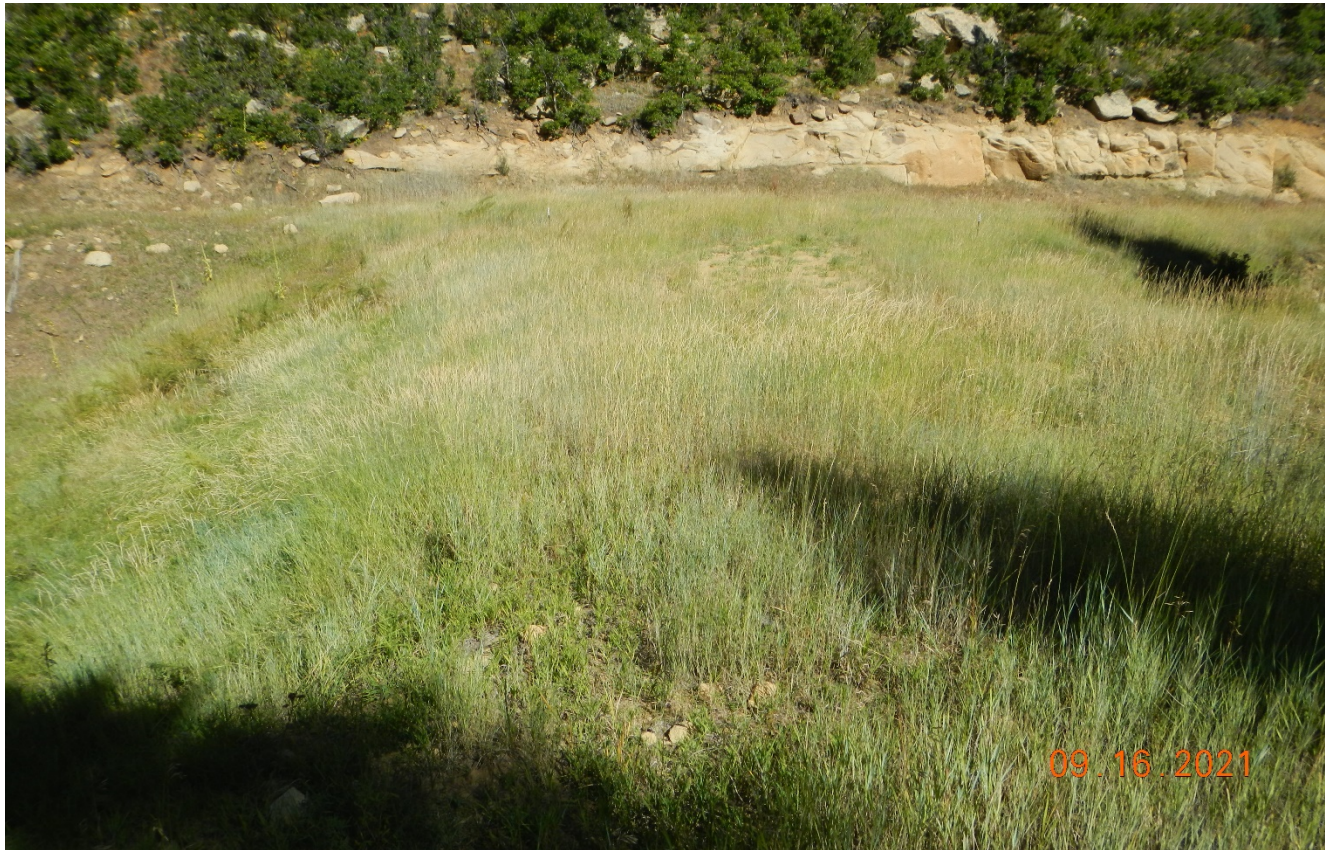
Photo 9. The road crosses the canyon bottom which creates a dam across the canyon.

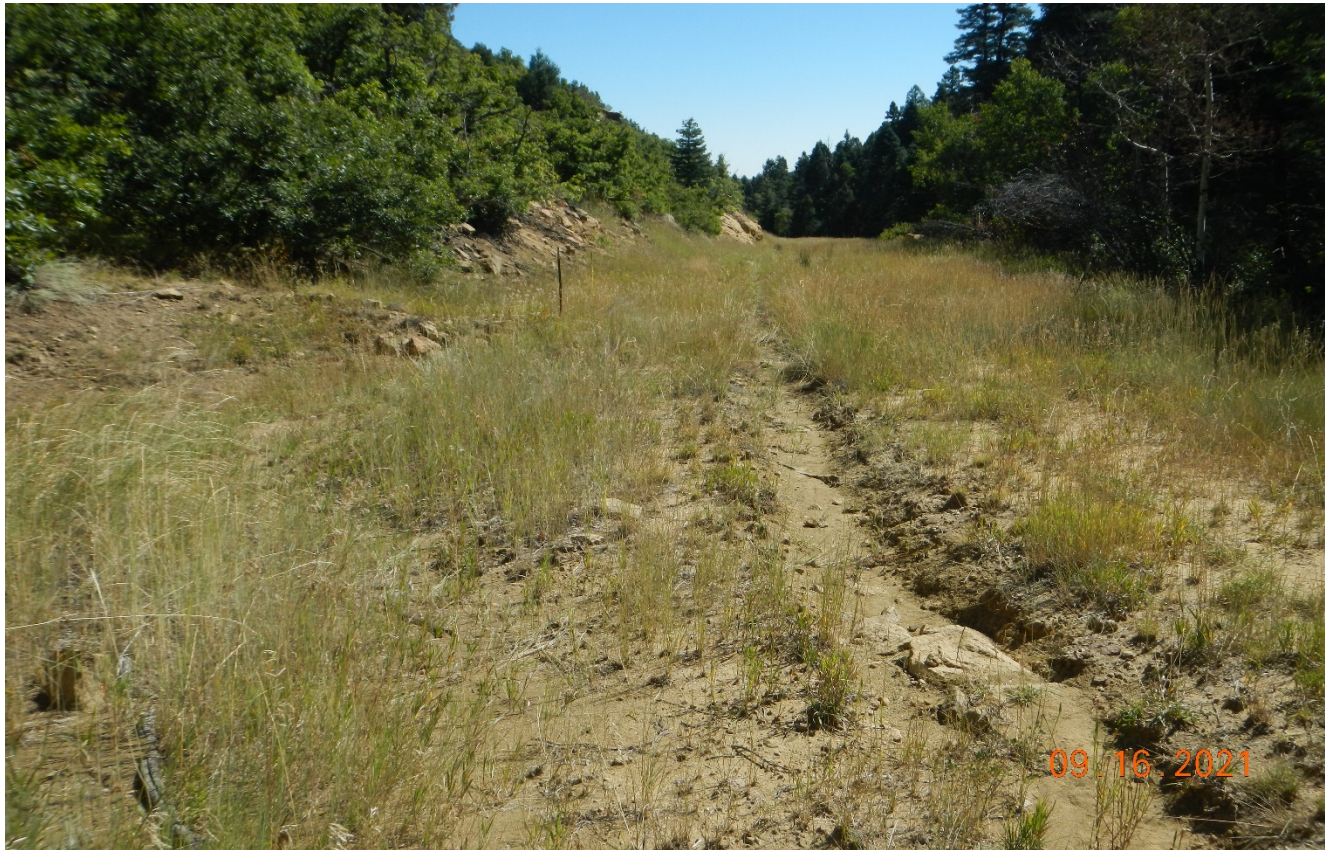
Photo 10. Facing east along the access road. It appears erosion has occurred along the road and stormwater is not diverted toward the culvert.

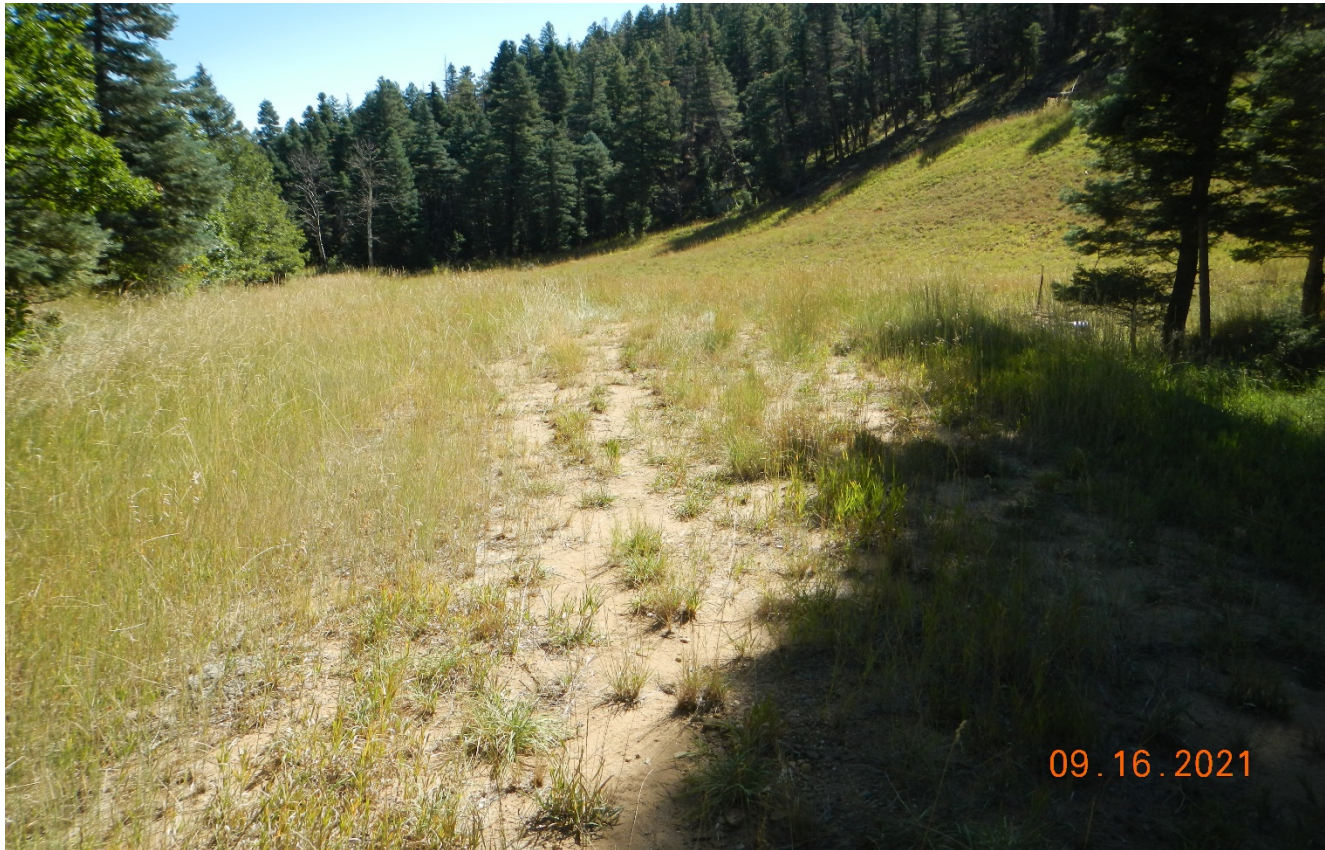
Photo 11. Facing southeast toward the location. There is a culvert that remains at red arrow. The location has been recontoured and reclaimed.
