Inspection Photos

API: 071-07791

Operator: EVERGREEN NATURAL RESOURCES

Inspection Date: 9/16/2021

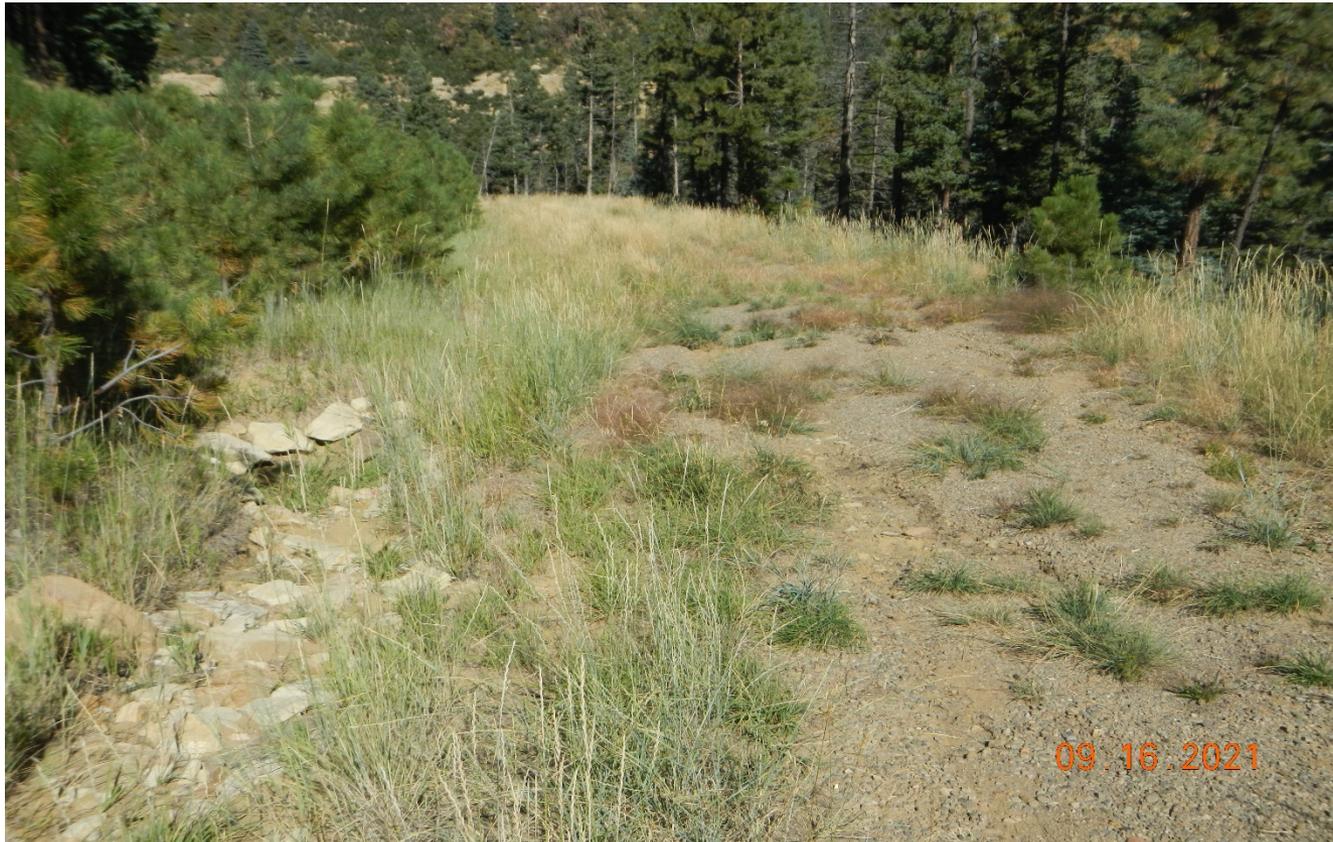
Photo 1. Facing northwest toward the beginning portion of the access road.

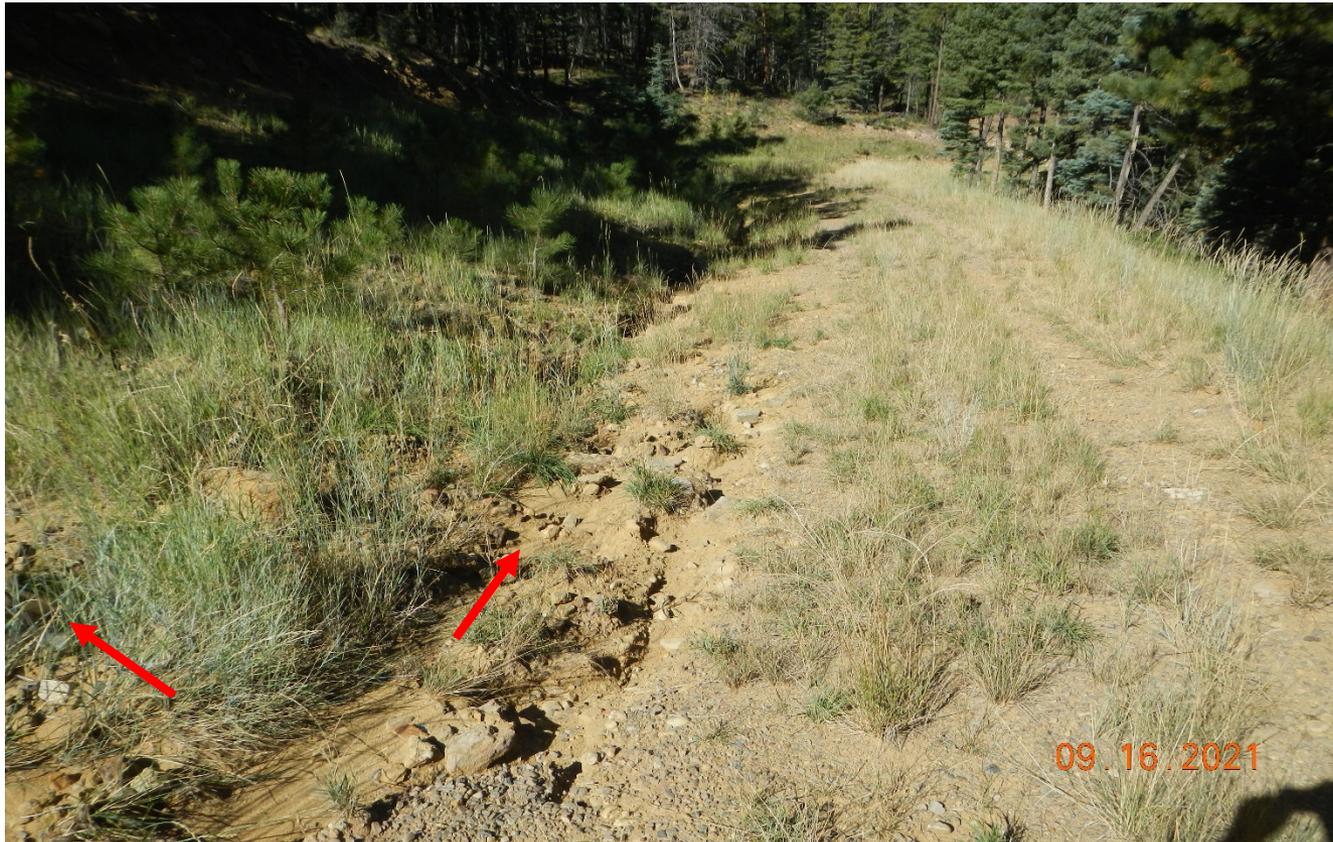
Photo 2. The culvert along the access road is filled in with sediment causing erosion down the road side.

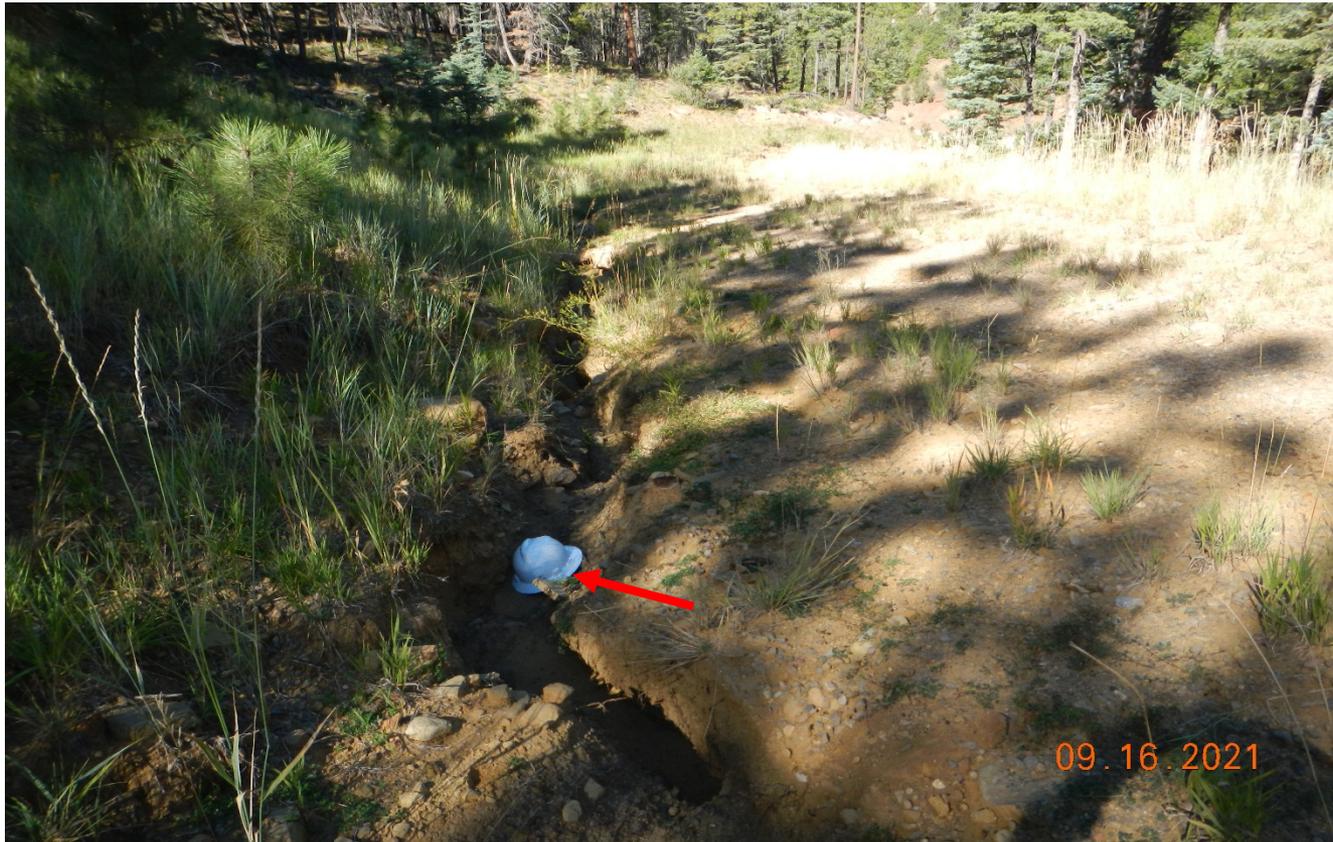
Photo 3. There is erosion along the road side. Red arrow points to a hard hat for scale.

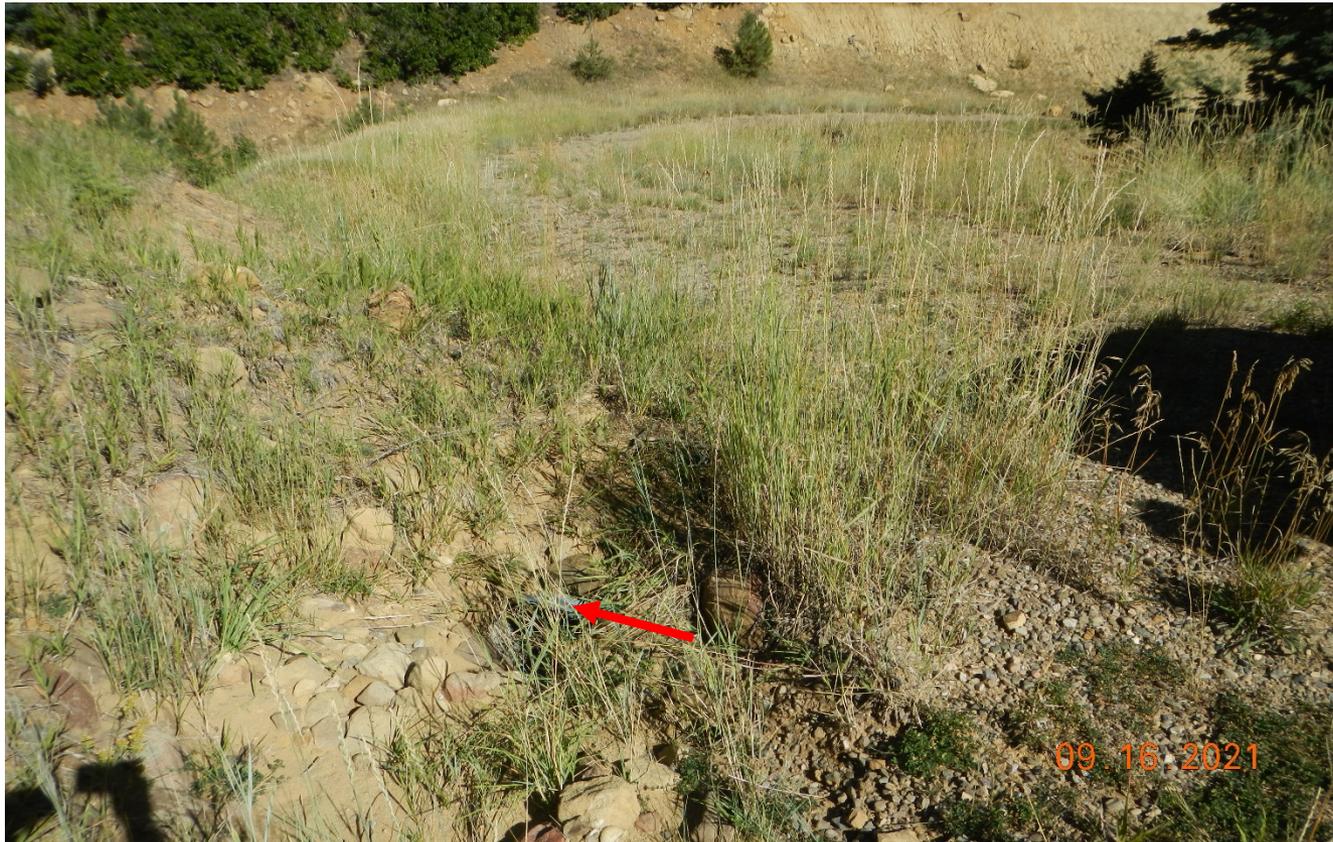
Photo 4. The road crosses the canyon bottom which creates a dam across the canyon. The culvert is filled in with sediment shown at red arrow.

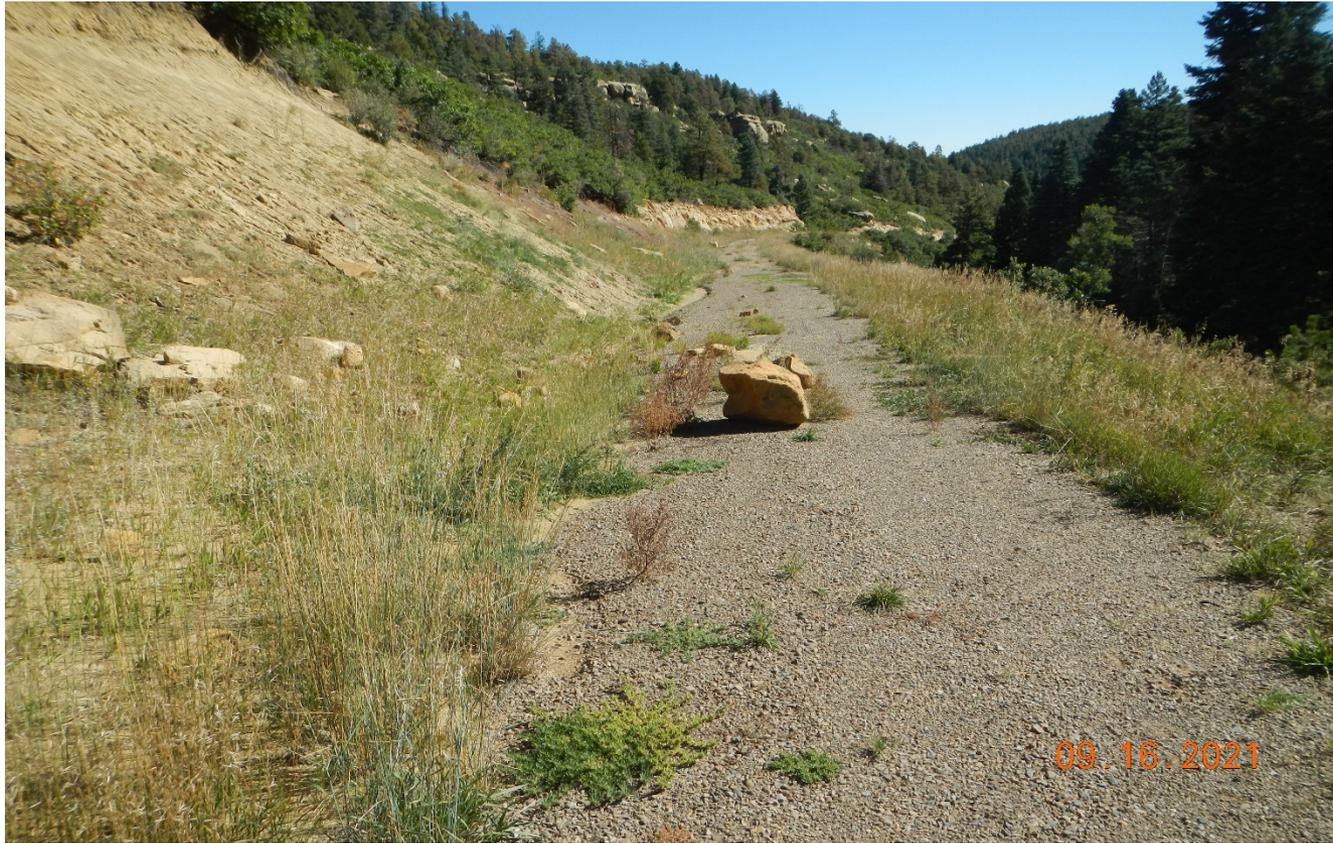
Photo 5. Facing northeast along the access road. The road is not recontoured and rocks have fallen onto the road.

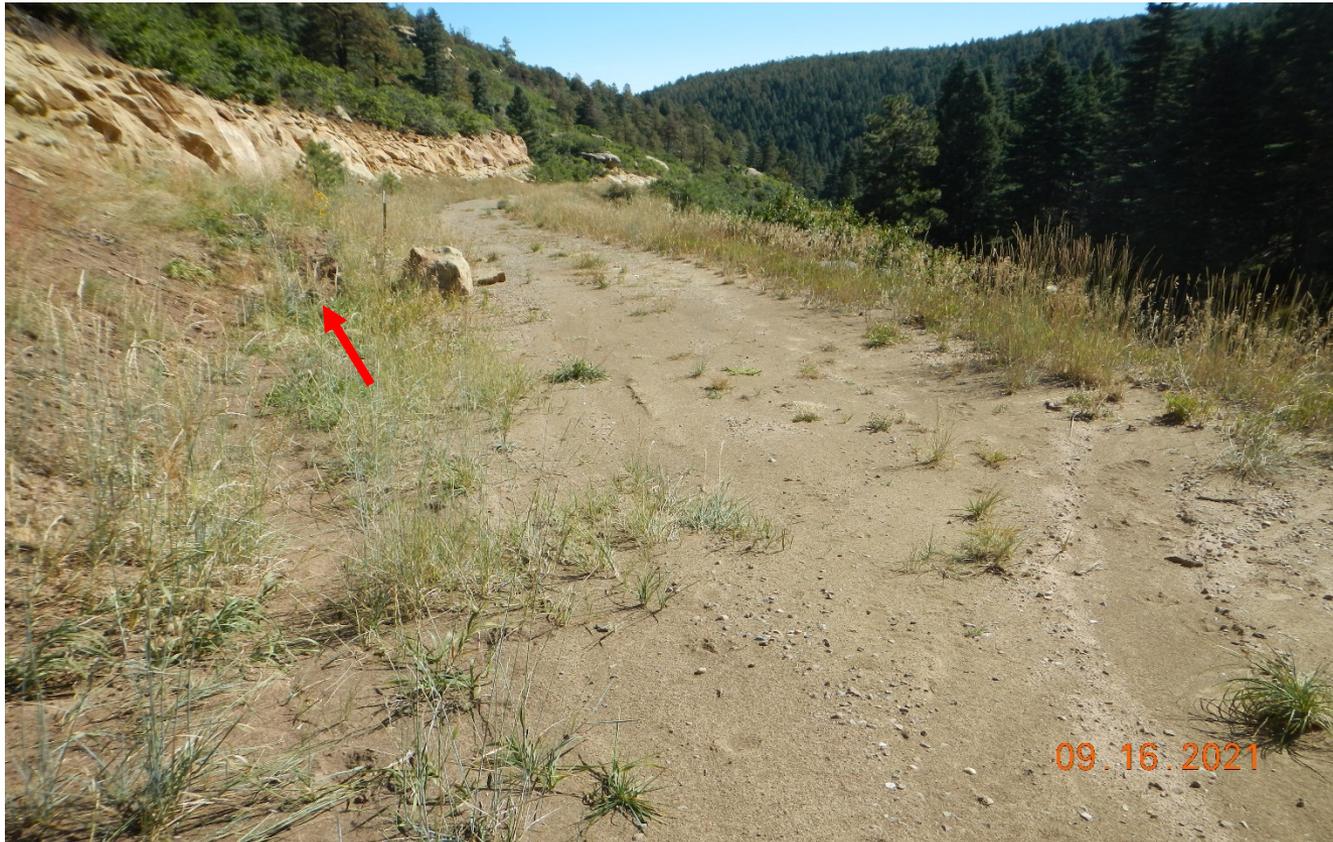
Photo 6. Facing northeast along the access road. The culvert is filled in with sediment shown at red arrow. Rocks have fallen on the road.

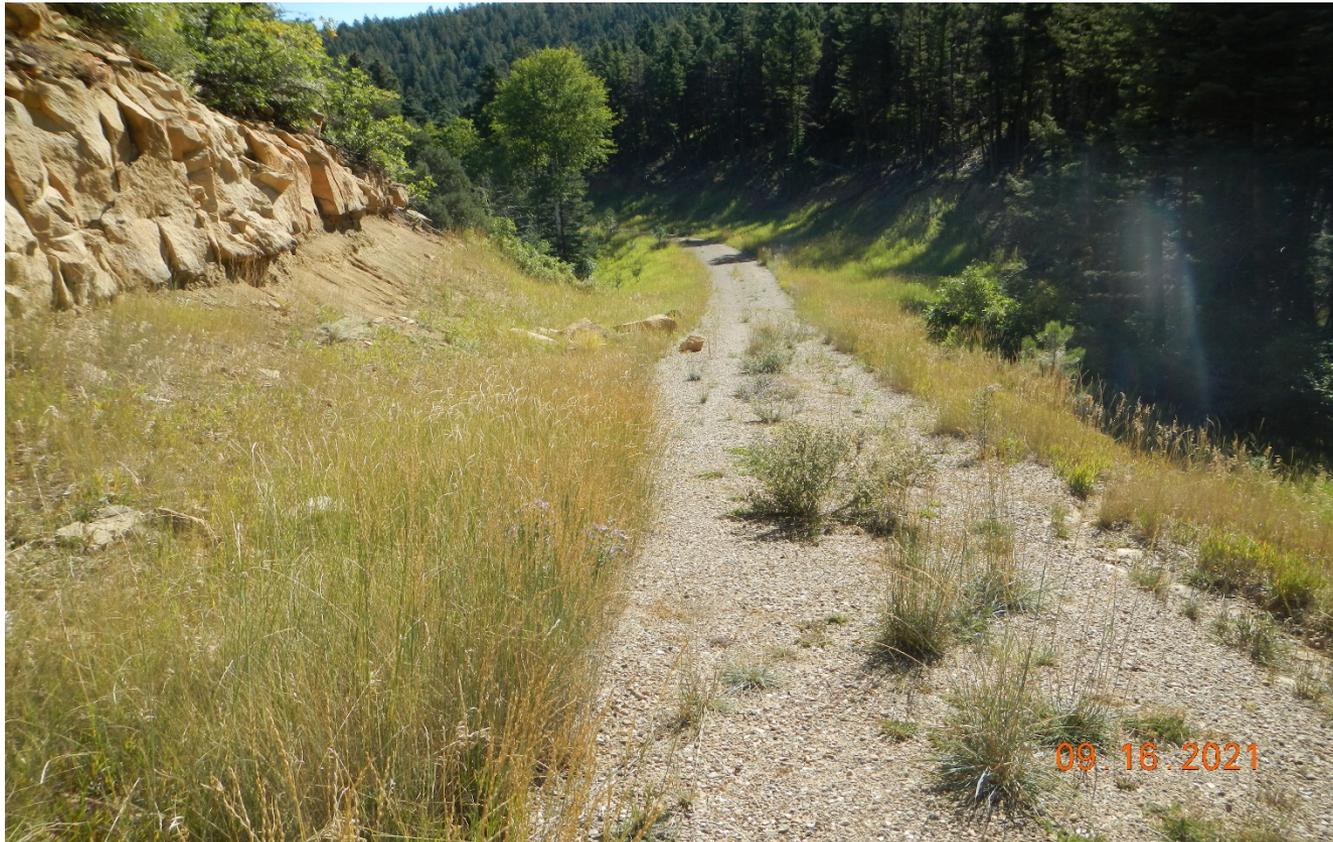
Photo 7. Facing east along the access road toward the location.

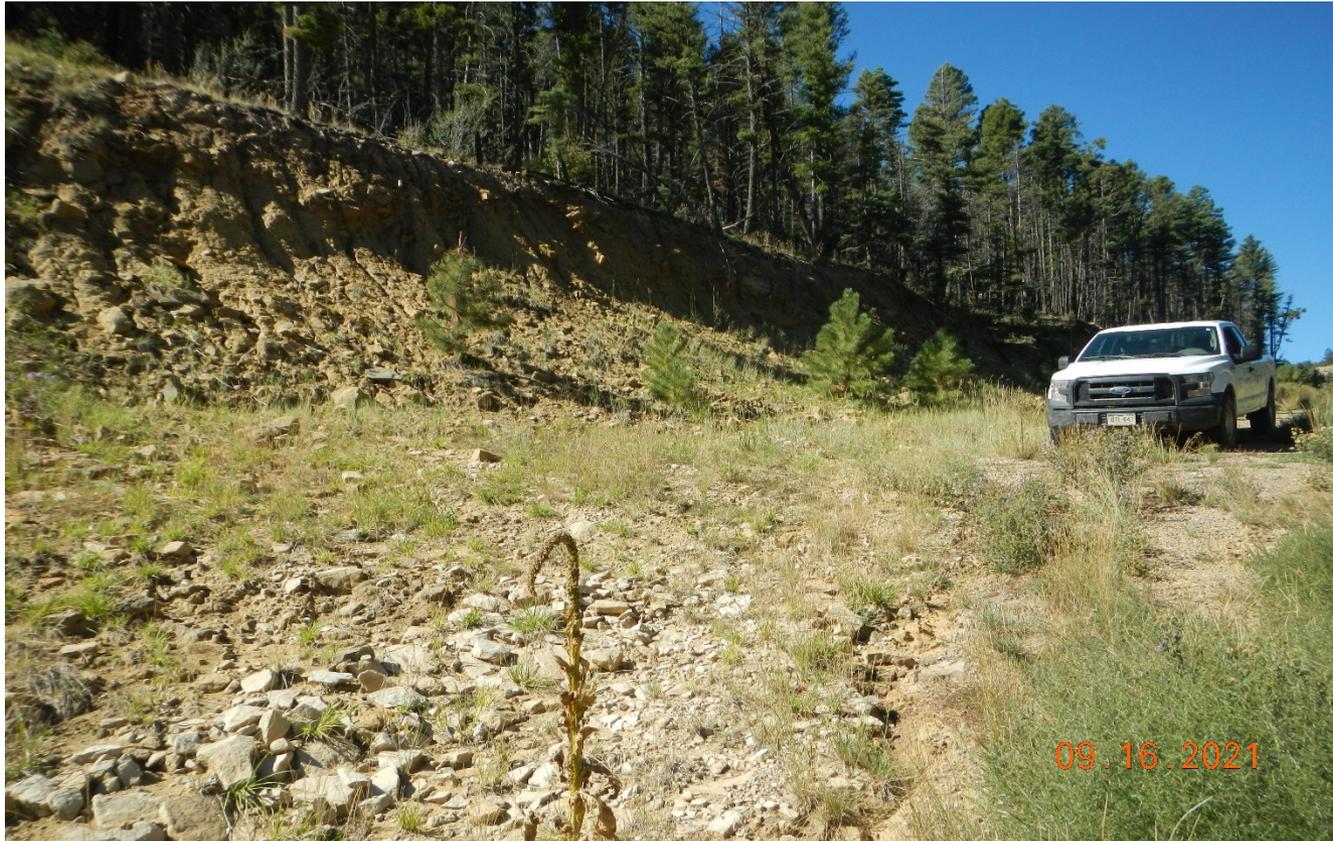
Photo 8. There is a steep cut slope at the end of the access road that is not stabilized.

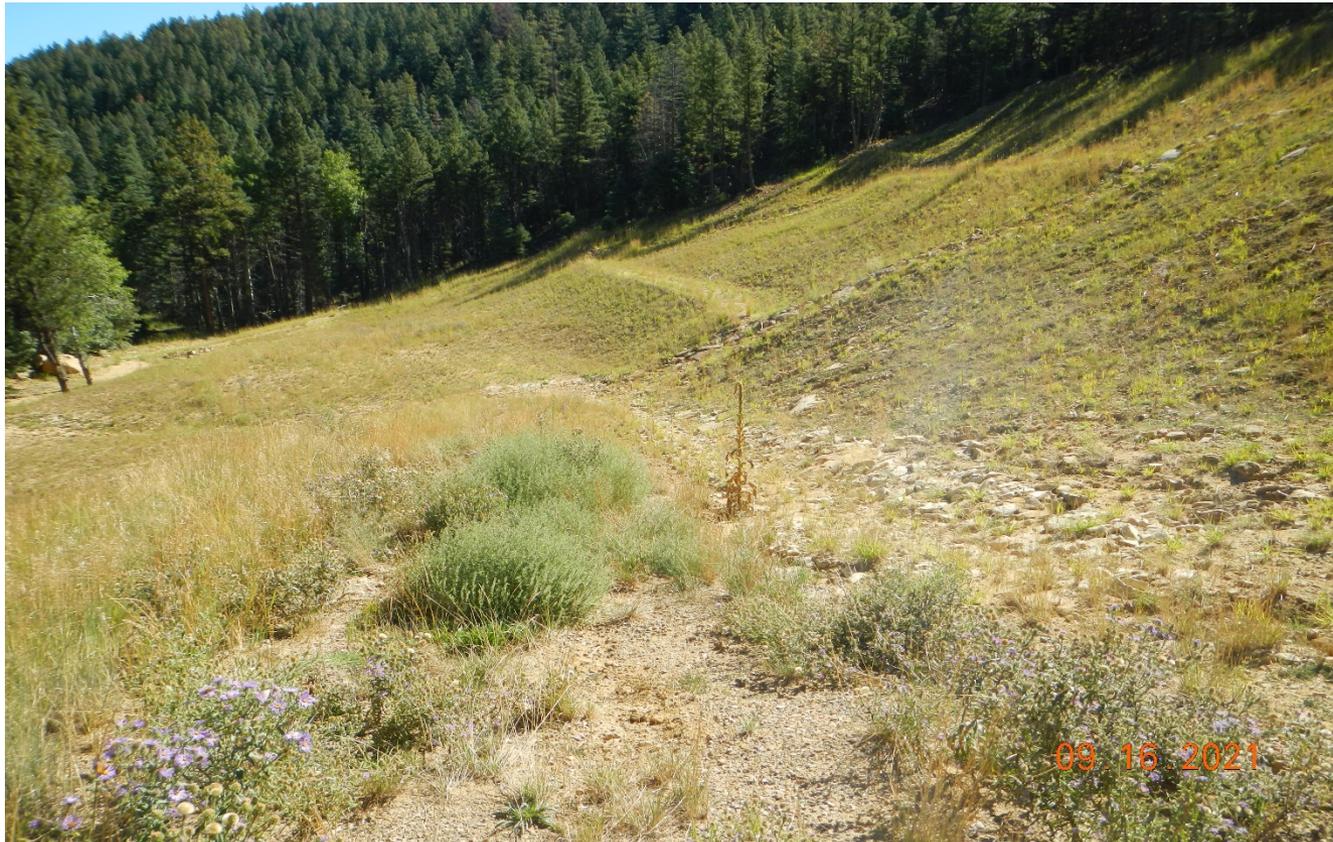
Photo 9. Facing east toward the location. The location has been recontoured and reclaimed.

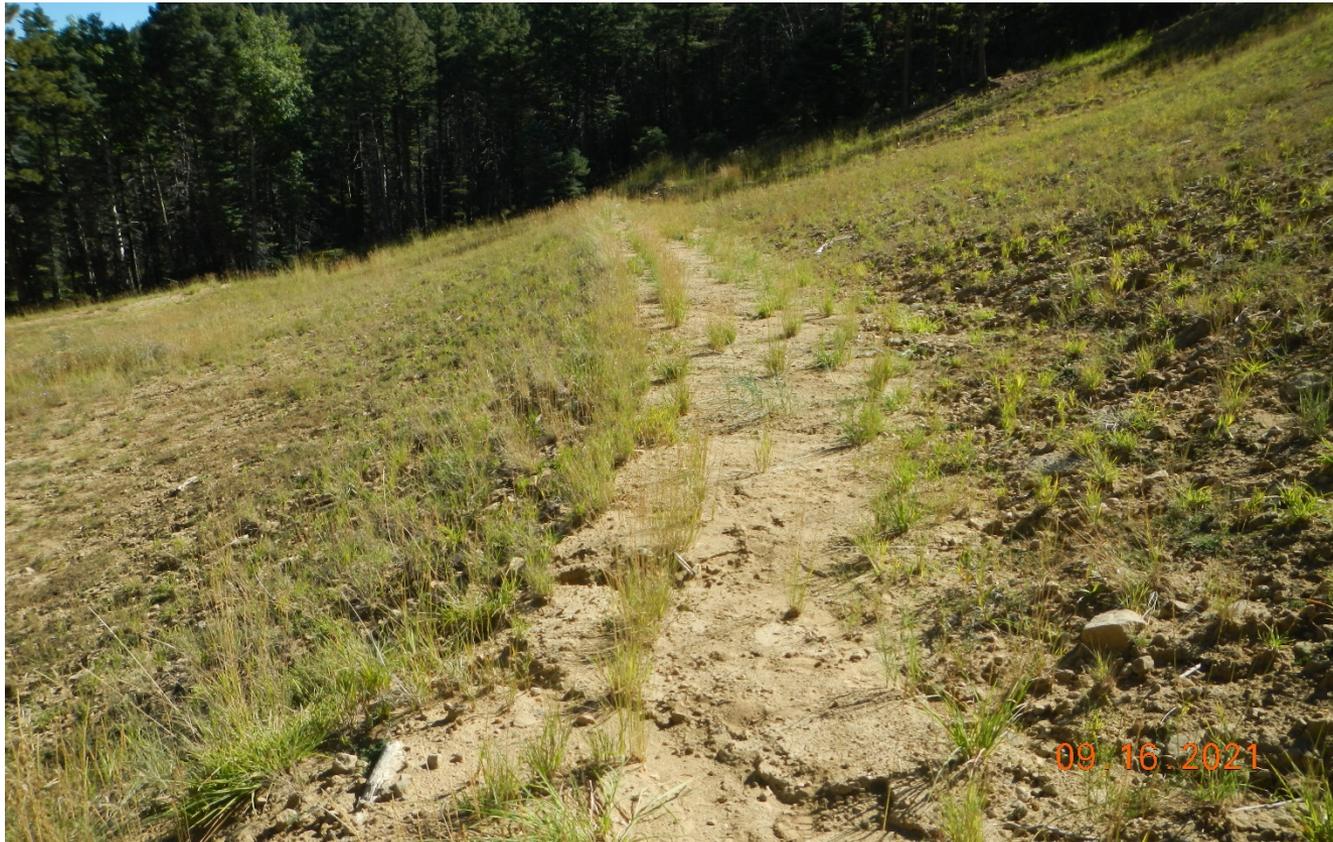
Photo 10. Facing east at the location.

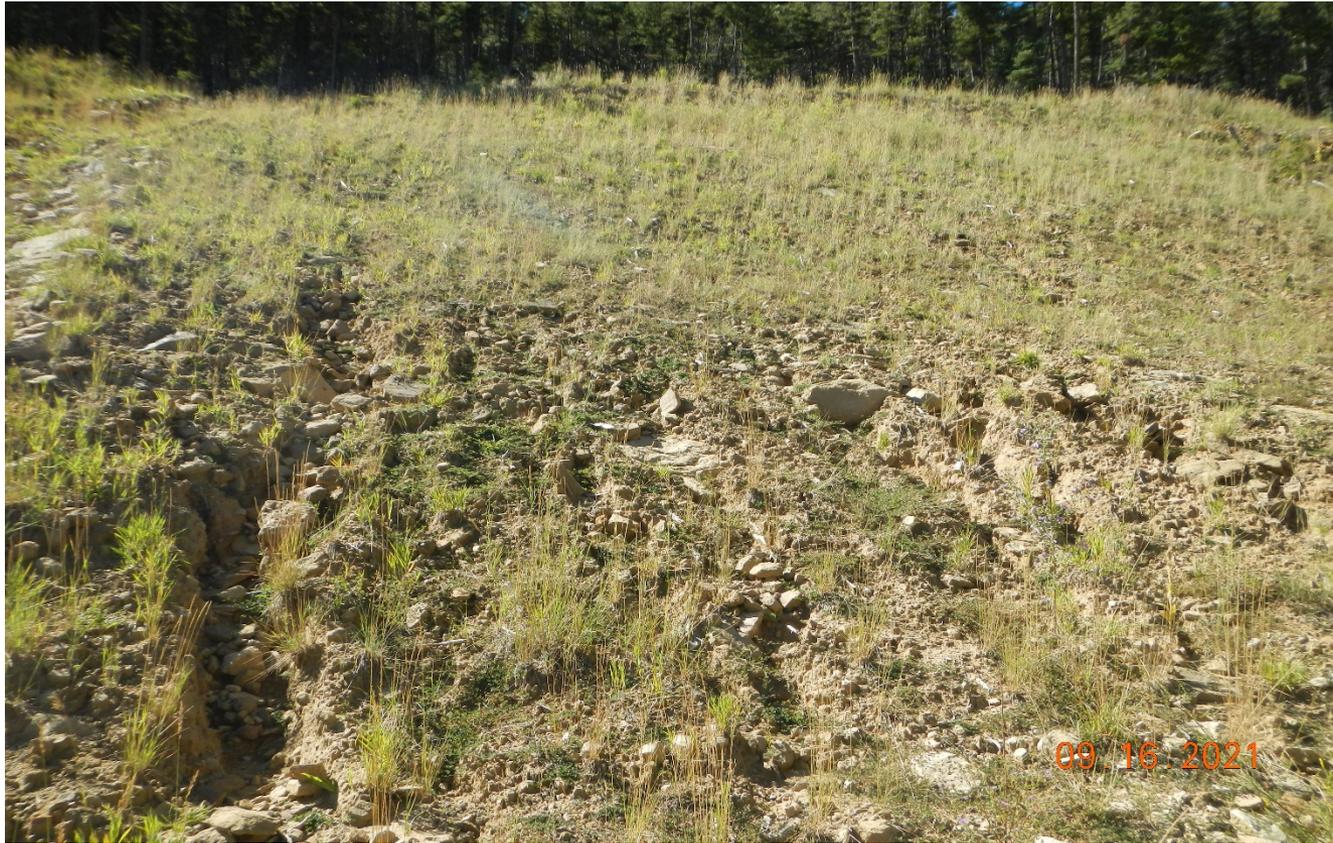
Photo 11. There are area of erosion along the reclaimed location that need to be repaired and stabilized.

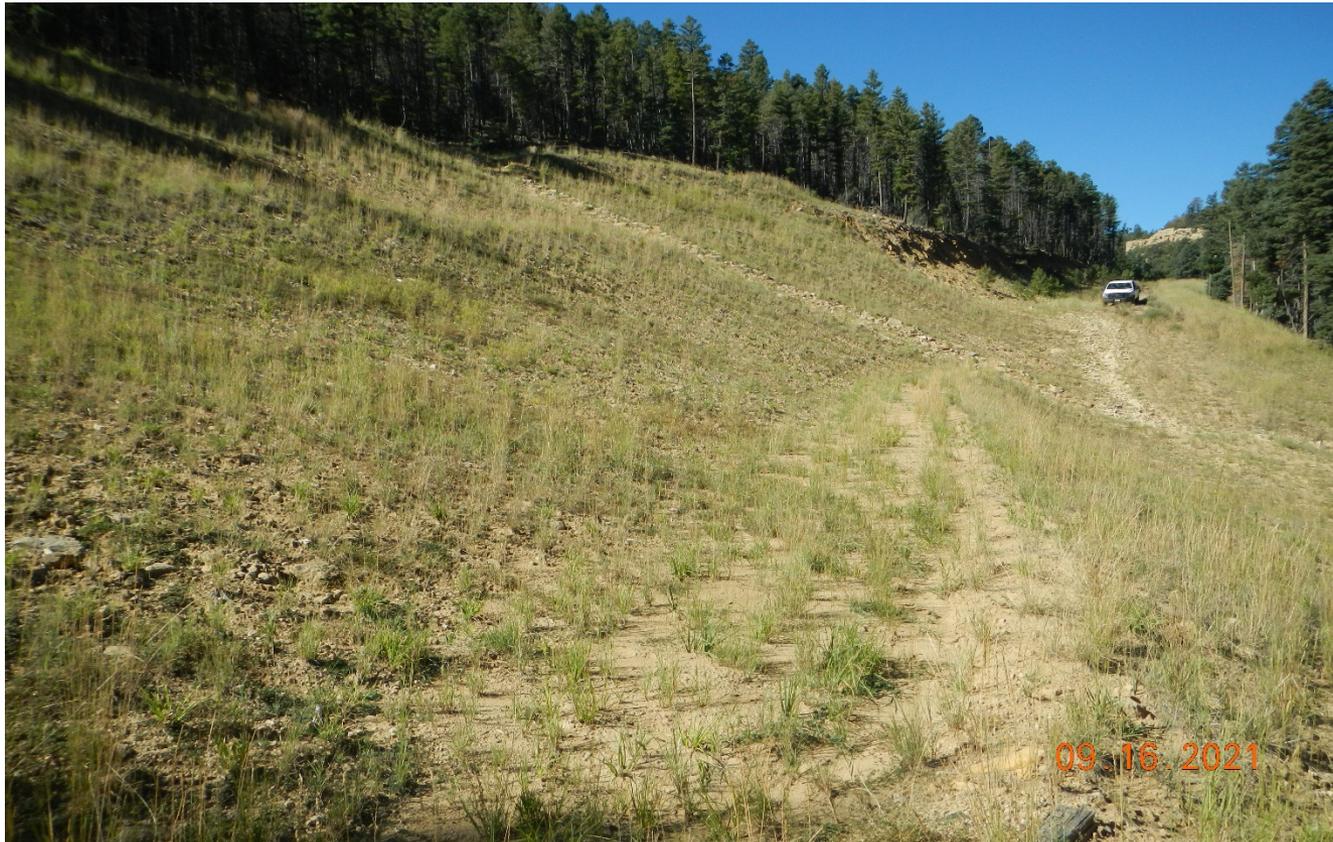
Photo 12. Facing southwest toward the location.
