Red Willow Provided as Courtesy

Reportable Release Photographic Documentation

Middle Pad 7F – 9/7/21 (2021-0025)

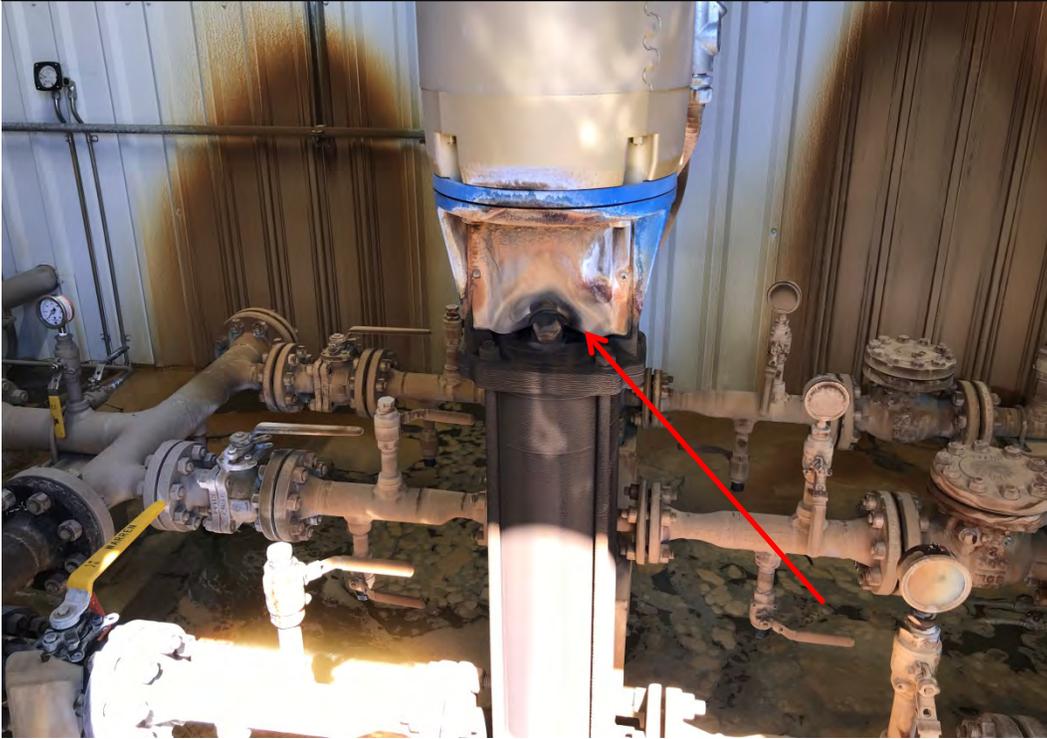
Looking North: Seal failed within the transfer pump allowing water out.

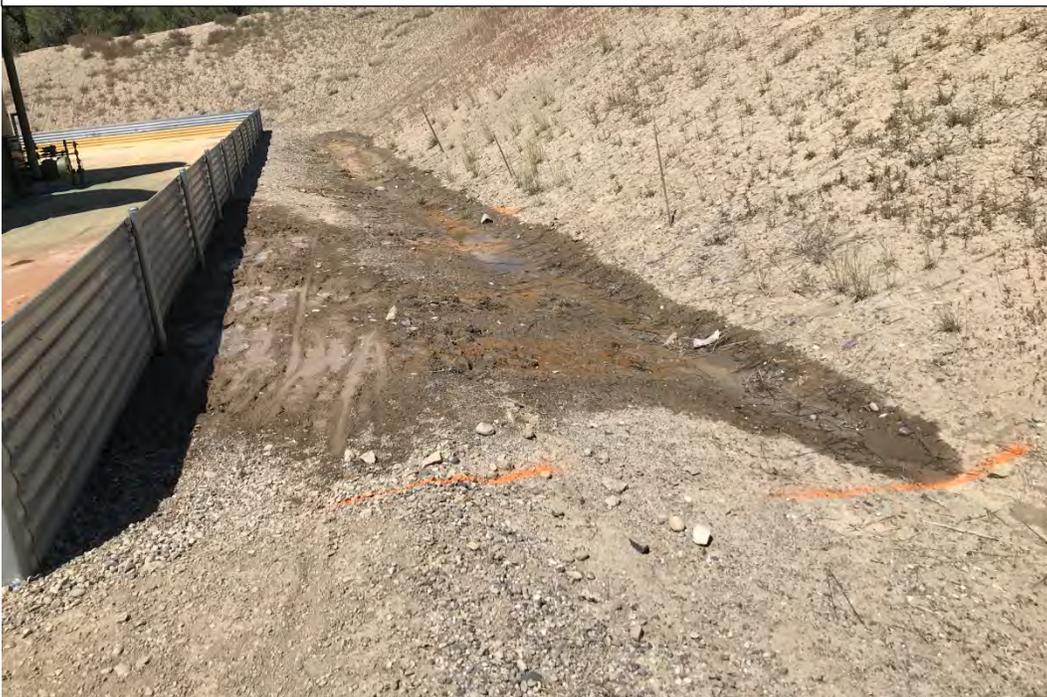
Looking North: Impacted area in diversion ditch after a water truck pulled the standing water.

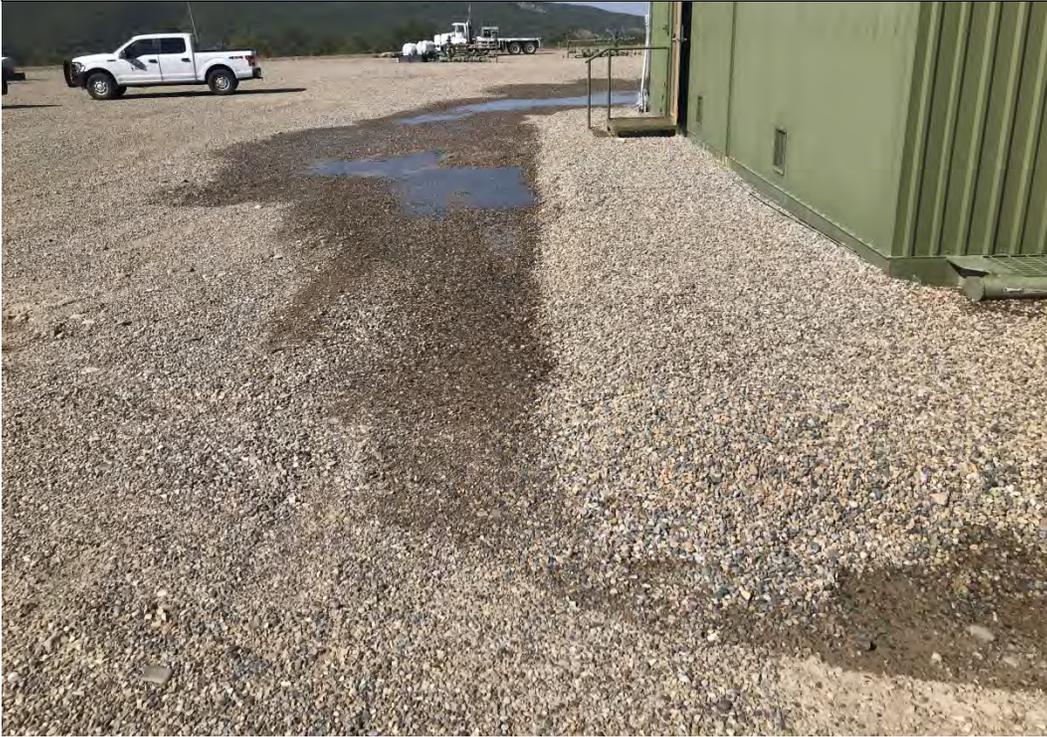
Looking West: Impacted area outside of the pump building.

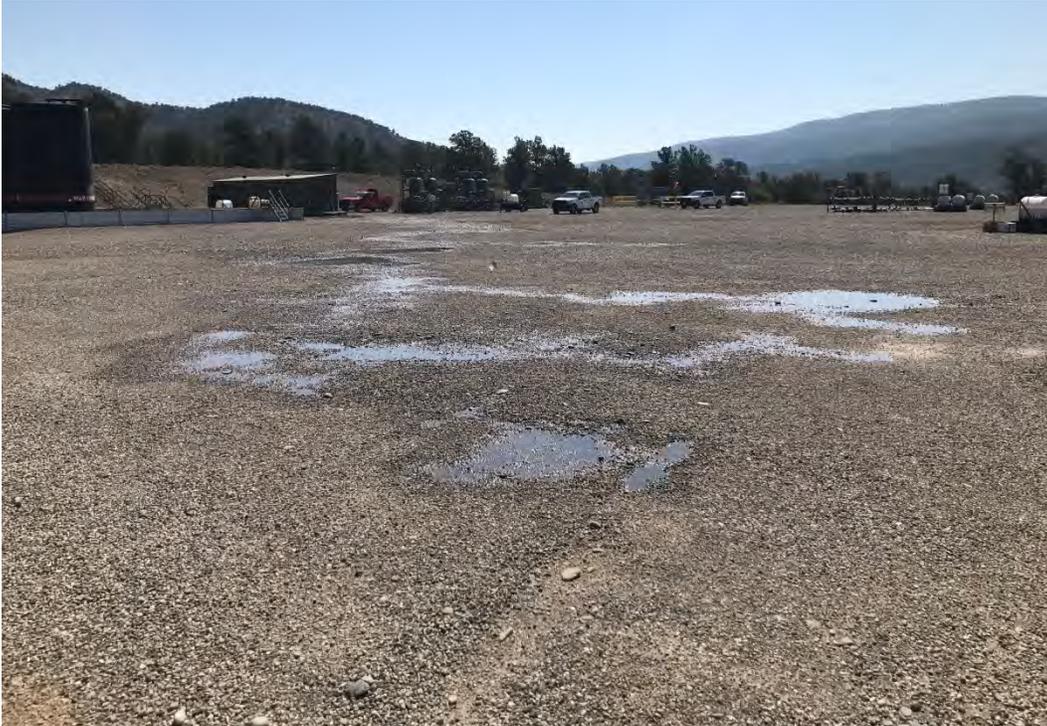
Looking South: Terminus of release looking back toward the pump building.

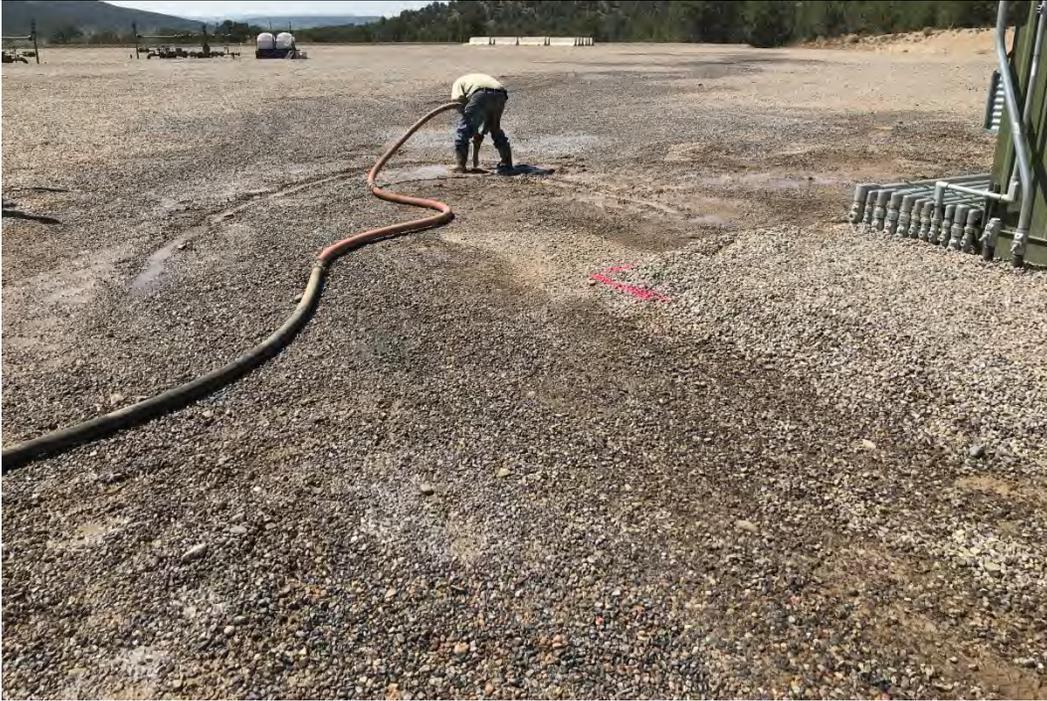
Looking Northwest: Impacted area outside of pump building looking towards the terminus. Water truck was pulling standing water where possible.
