Inspection Photos
Operator: Simcoe
Facility: 067-09938
Date: 9/16/2021

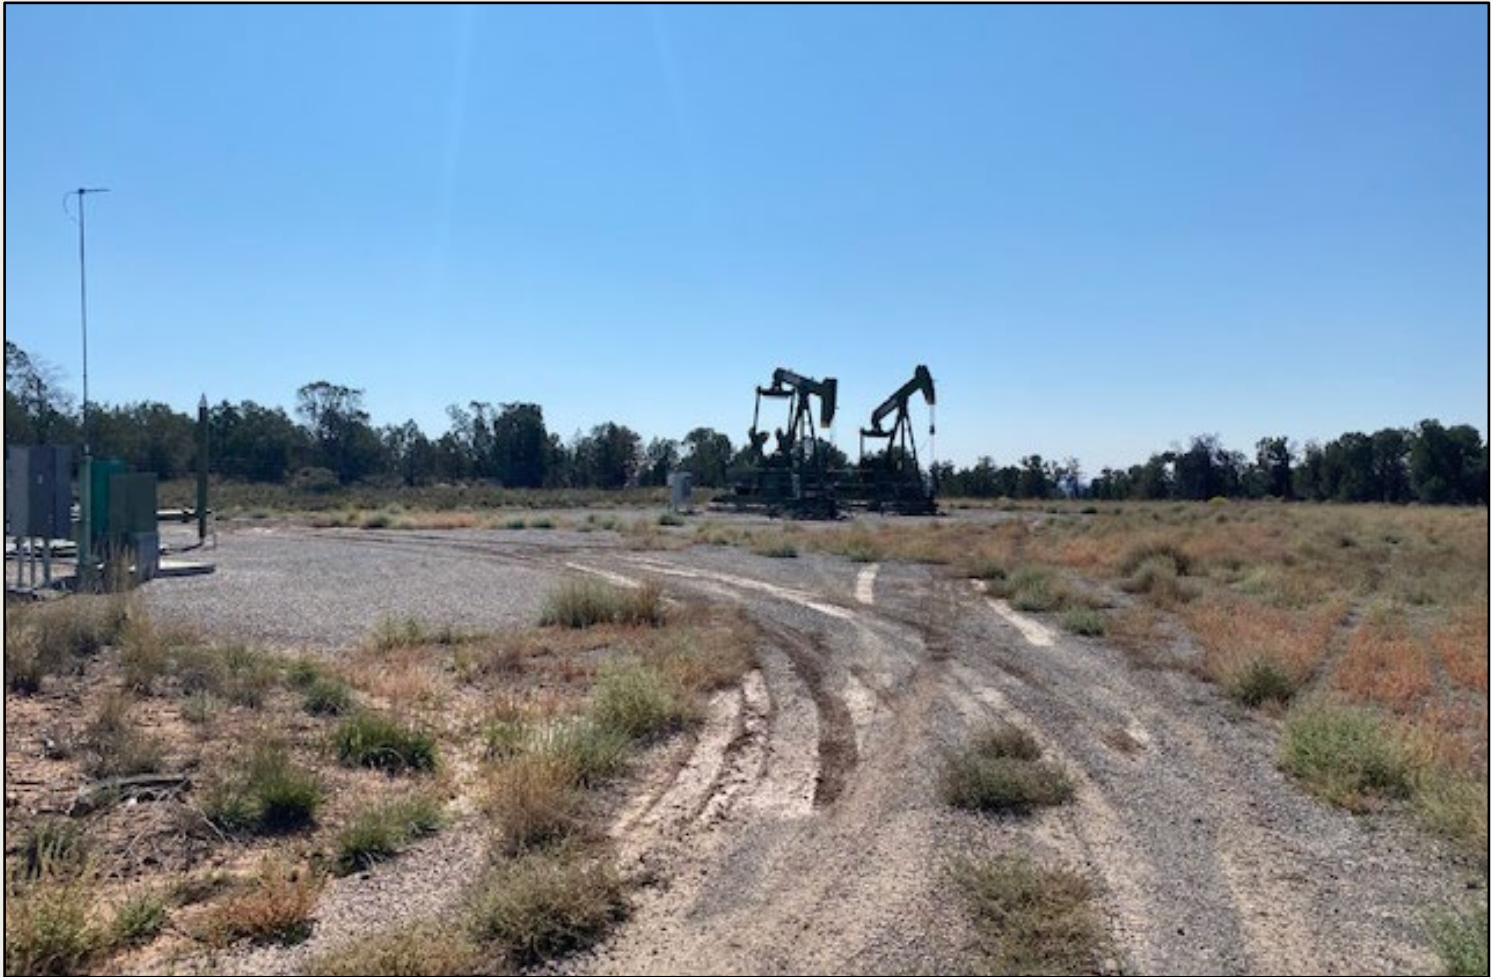
Photo 1. View of the project area from the well pad entrance facing center.

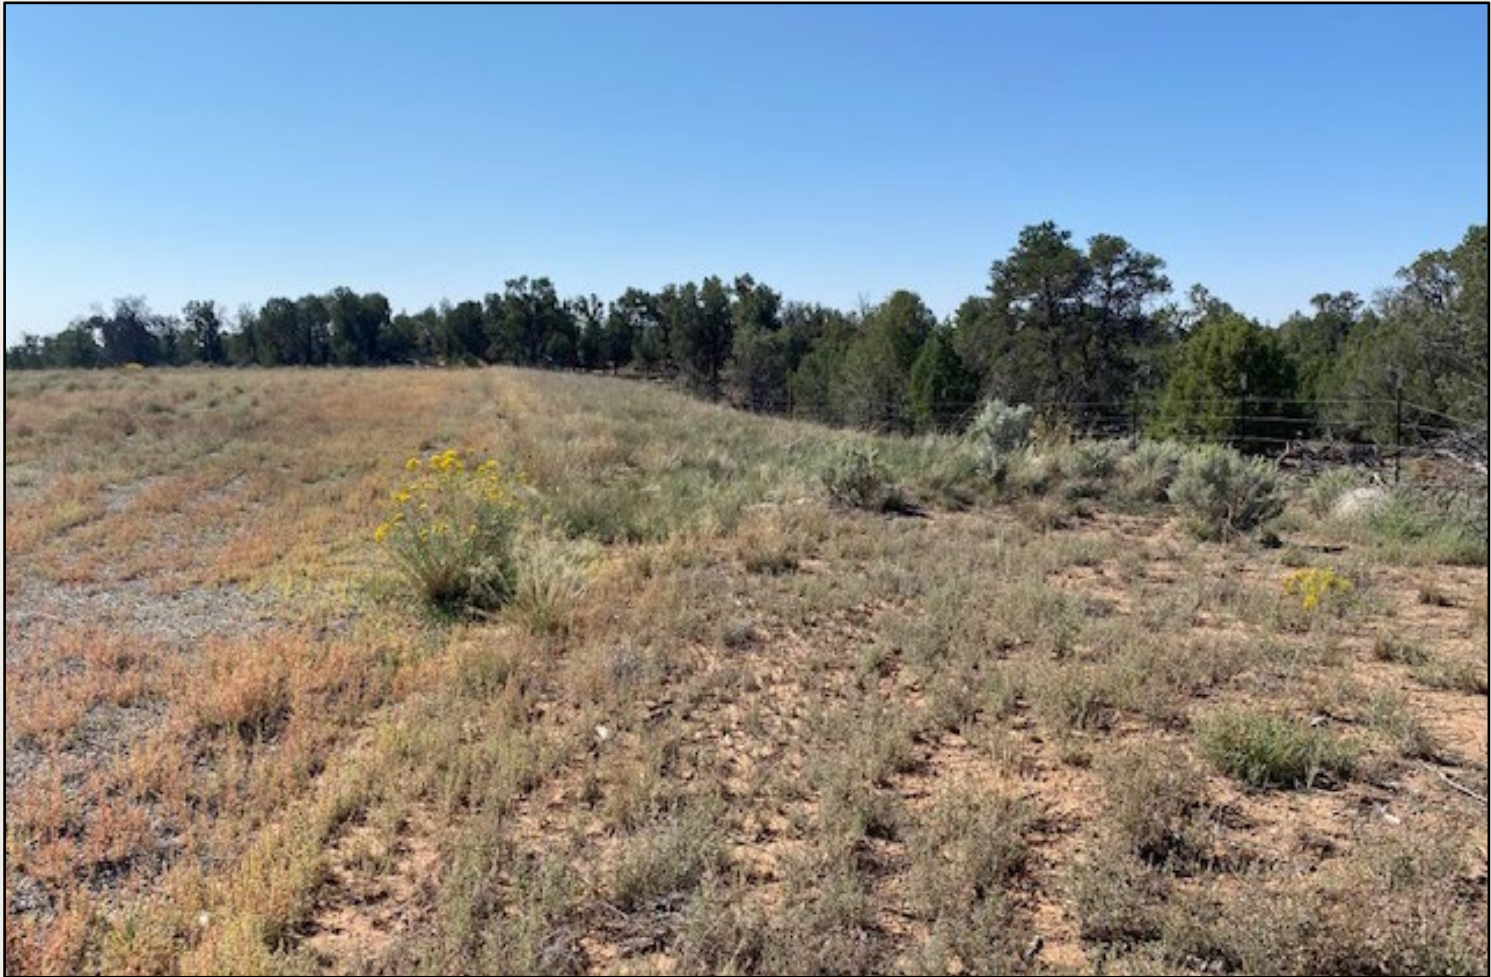
Photo 2. View of the western fill slope from the northwestern corner facing southward. Revegetation is progressing with western wheatgrass, crested wheatgrass, and rubber rabbitbrush.

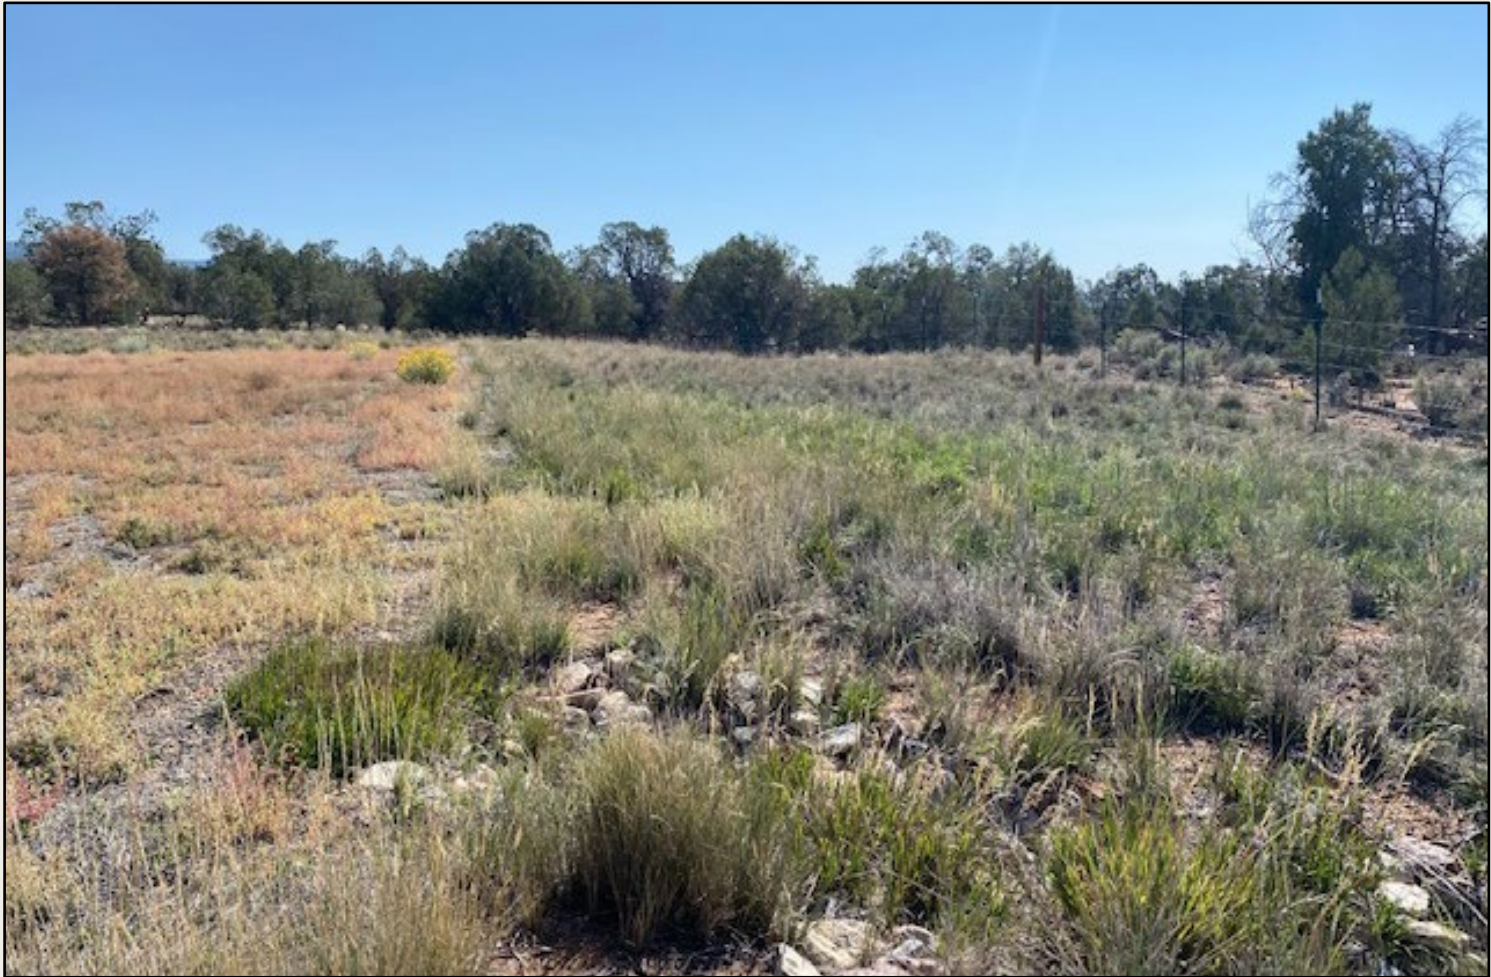
Photo 3. View of the southern project area from the southwestern corner facing eastward.

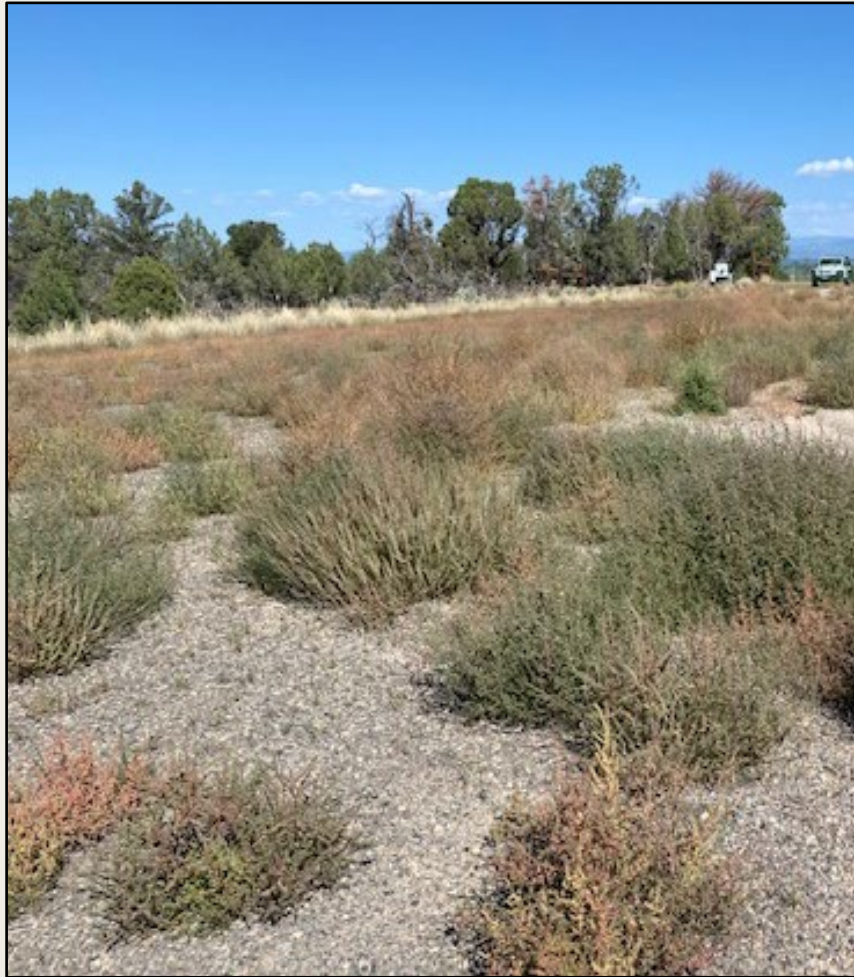
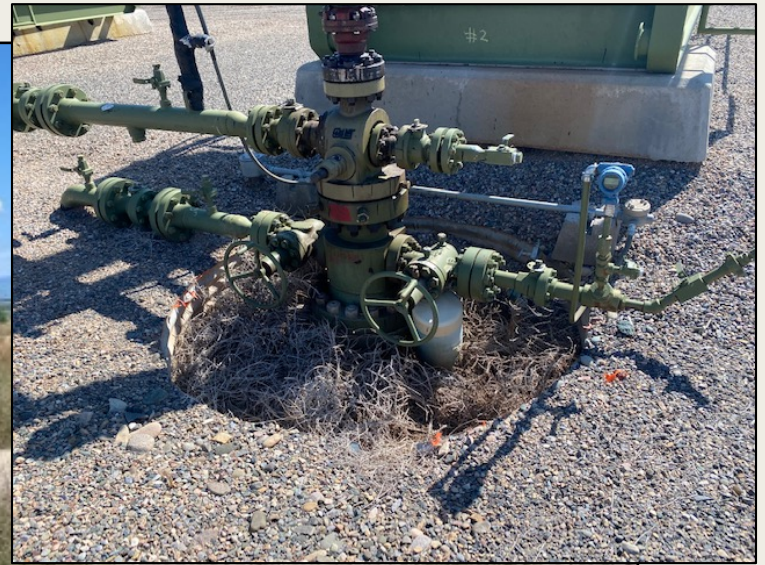
Photo 4. View of Russian thistles on the well pad and debris around the wellhead. Living R. thistles will soon break and become debris.

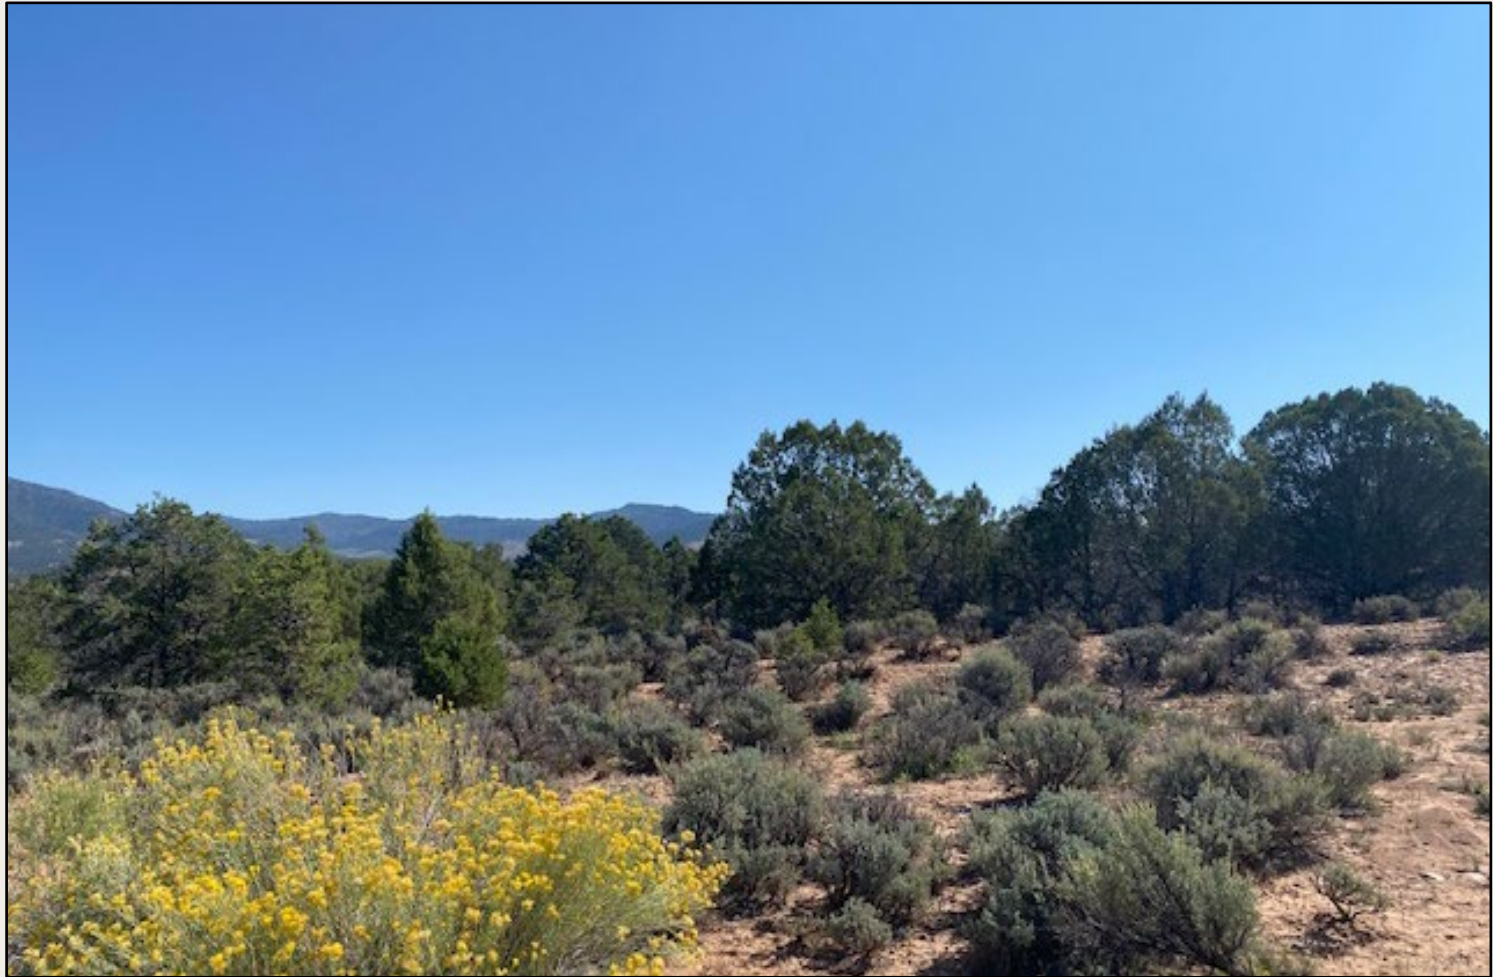
Photo 5. View of the reference area, comprised of sagebrush shrubland with open pinyon and juniper woodland and blue grama, squirreltail, four o'clock, and goldenaster in the understory.

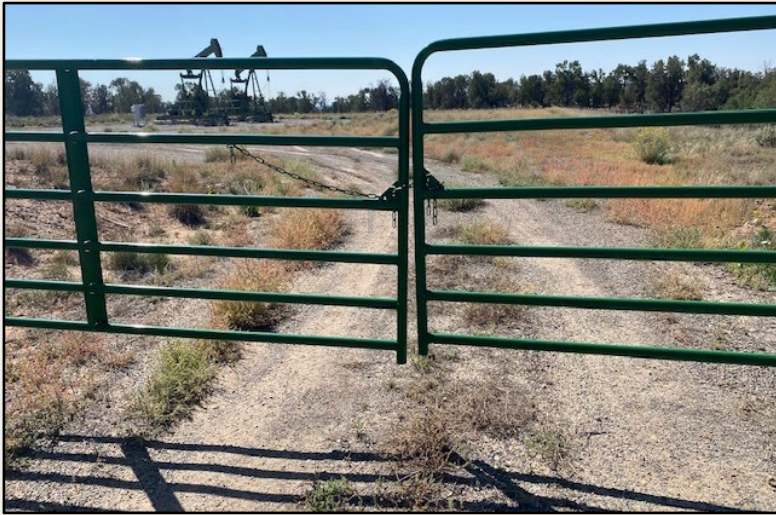
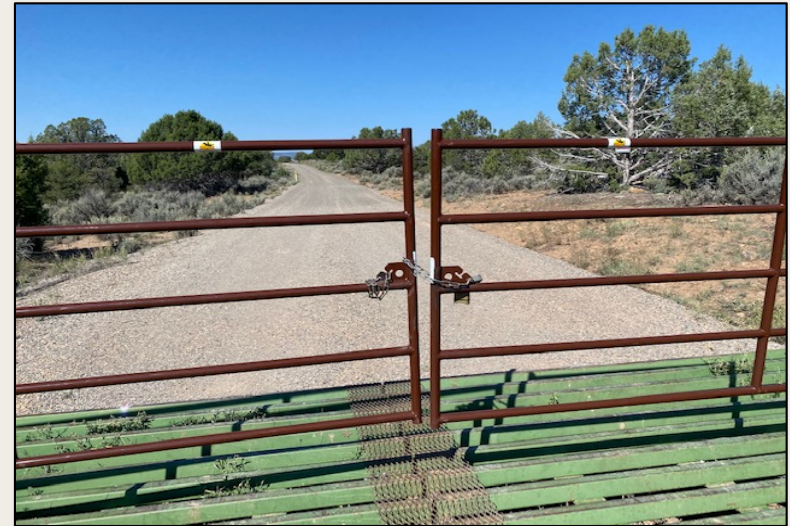
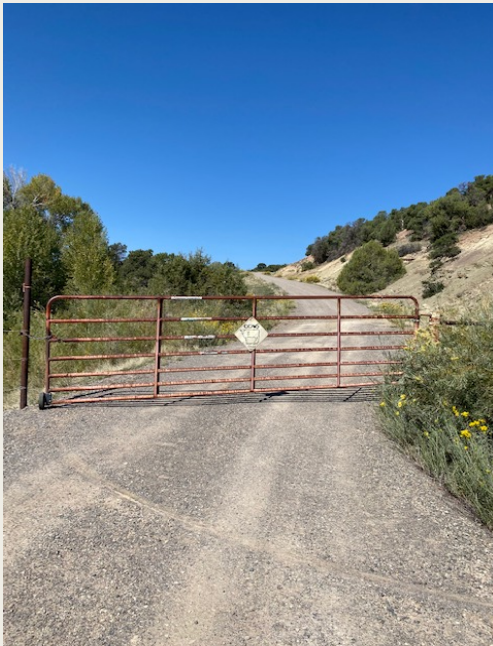
Photos 6-8. View of closed gates after leaving location.
