Inspection Photos  
Operator: Simcoe  
Facility: 067-06684  
Date: 9/16/2021

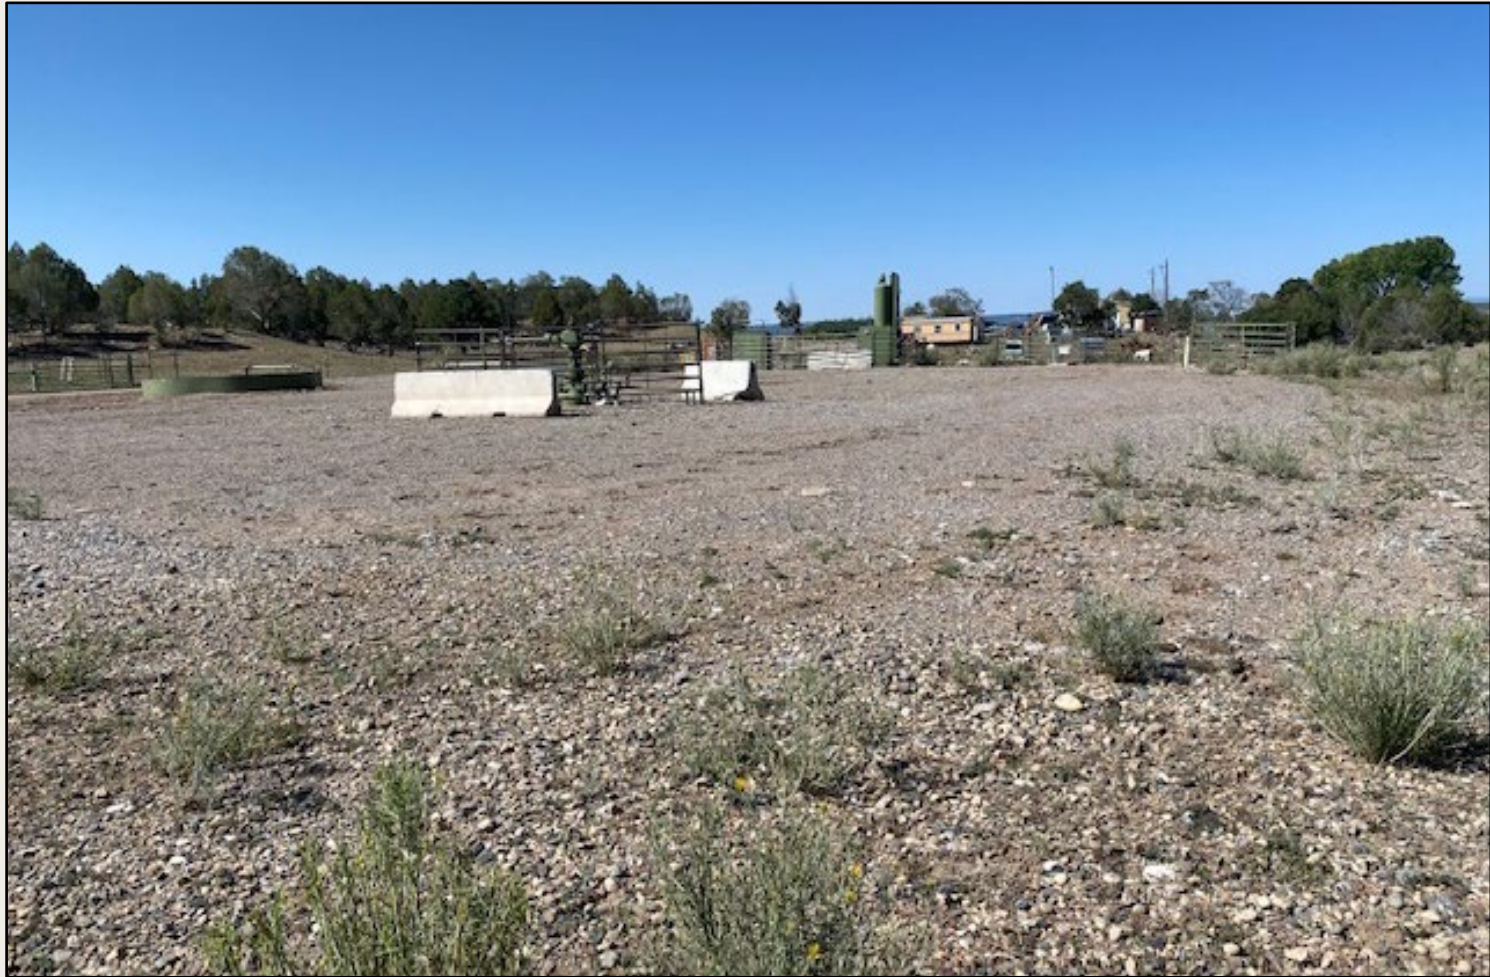
Photo 1. View of the project area from the northeastern corner facing center.

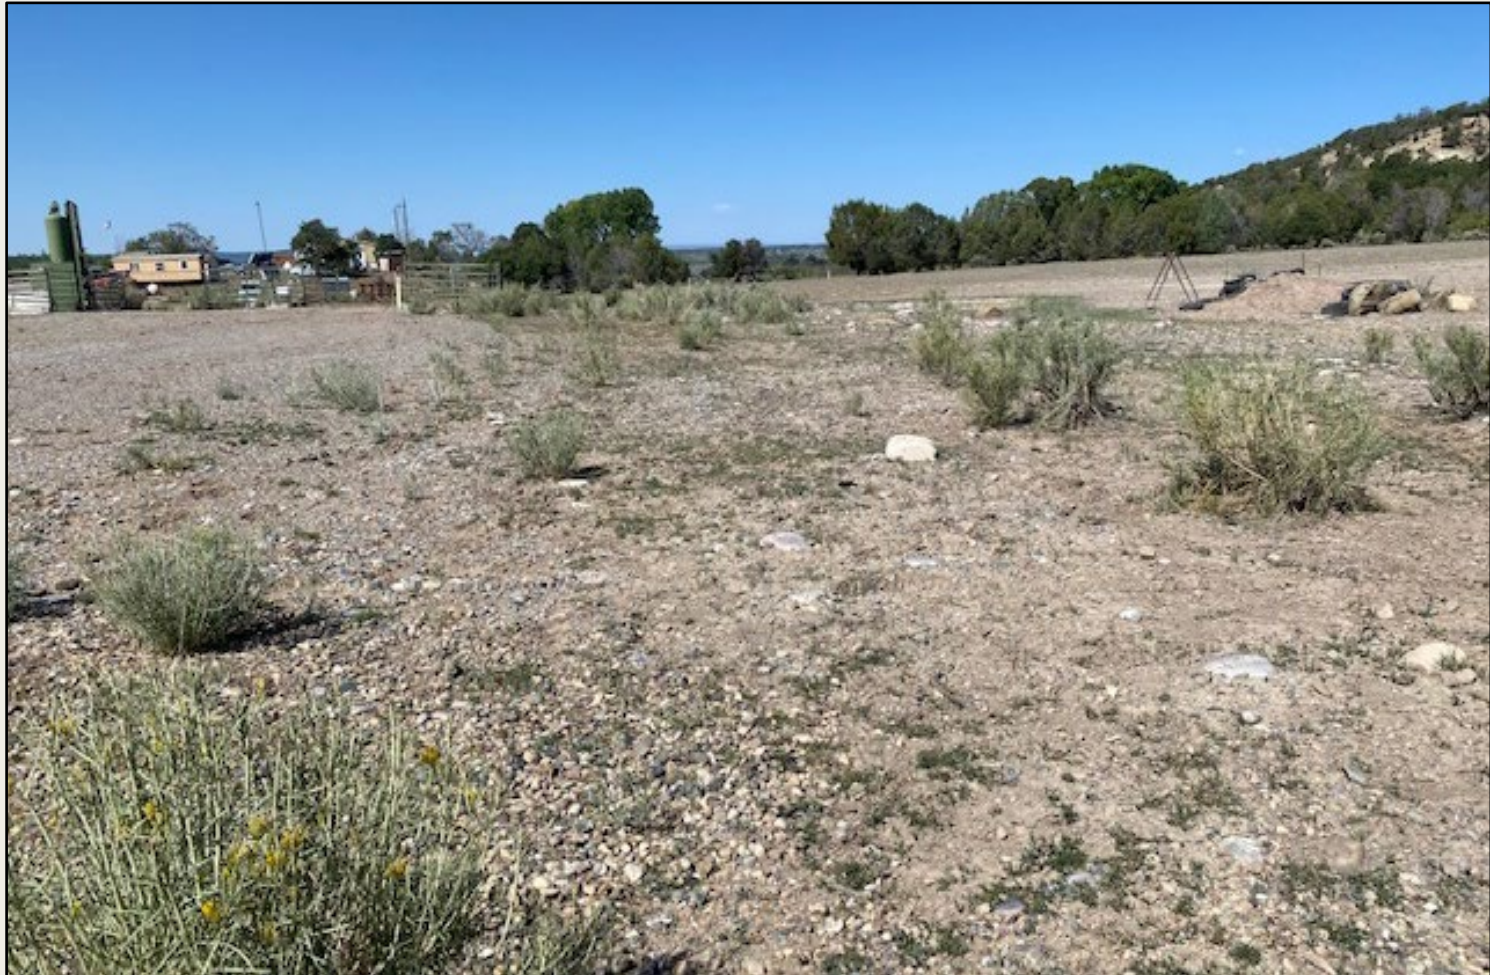
Photo 2. View of the northern fill slope from the northeastern corner facing southward. Revegetation is progressing with rubber rabbitbrush and western wheatgrass in a grazed vegetative condition.

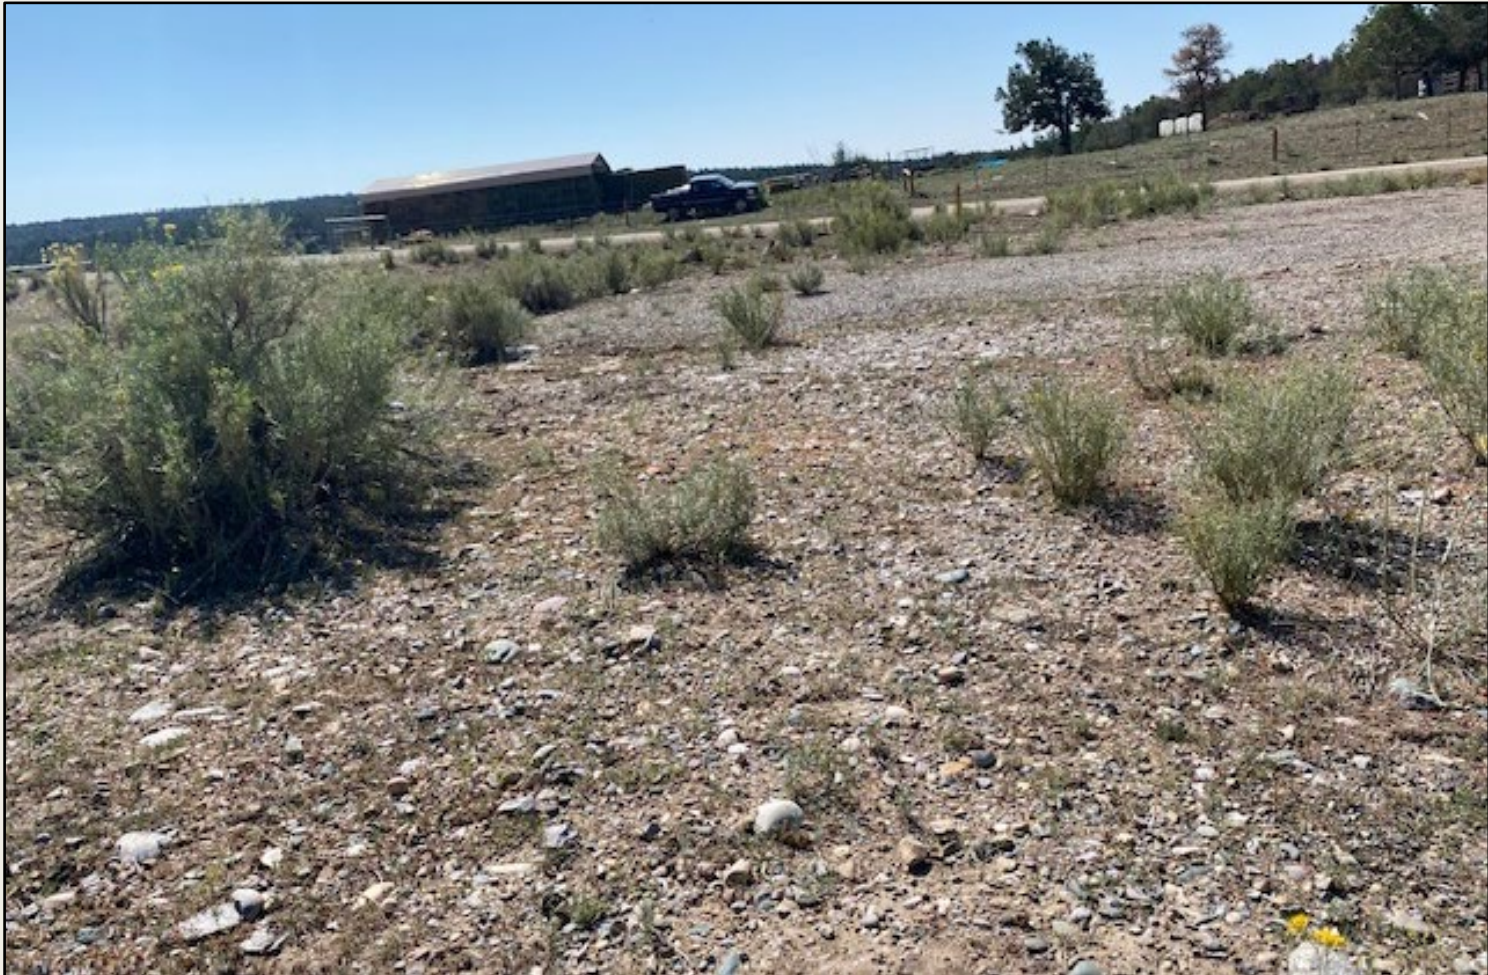
Photo 3. View of the eastern project area from the northeastern corner facing northward.

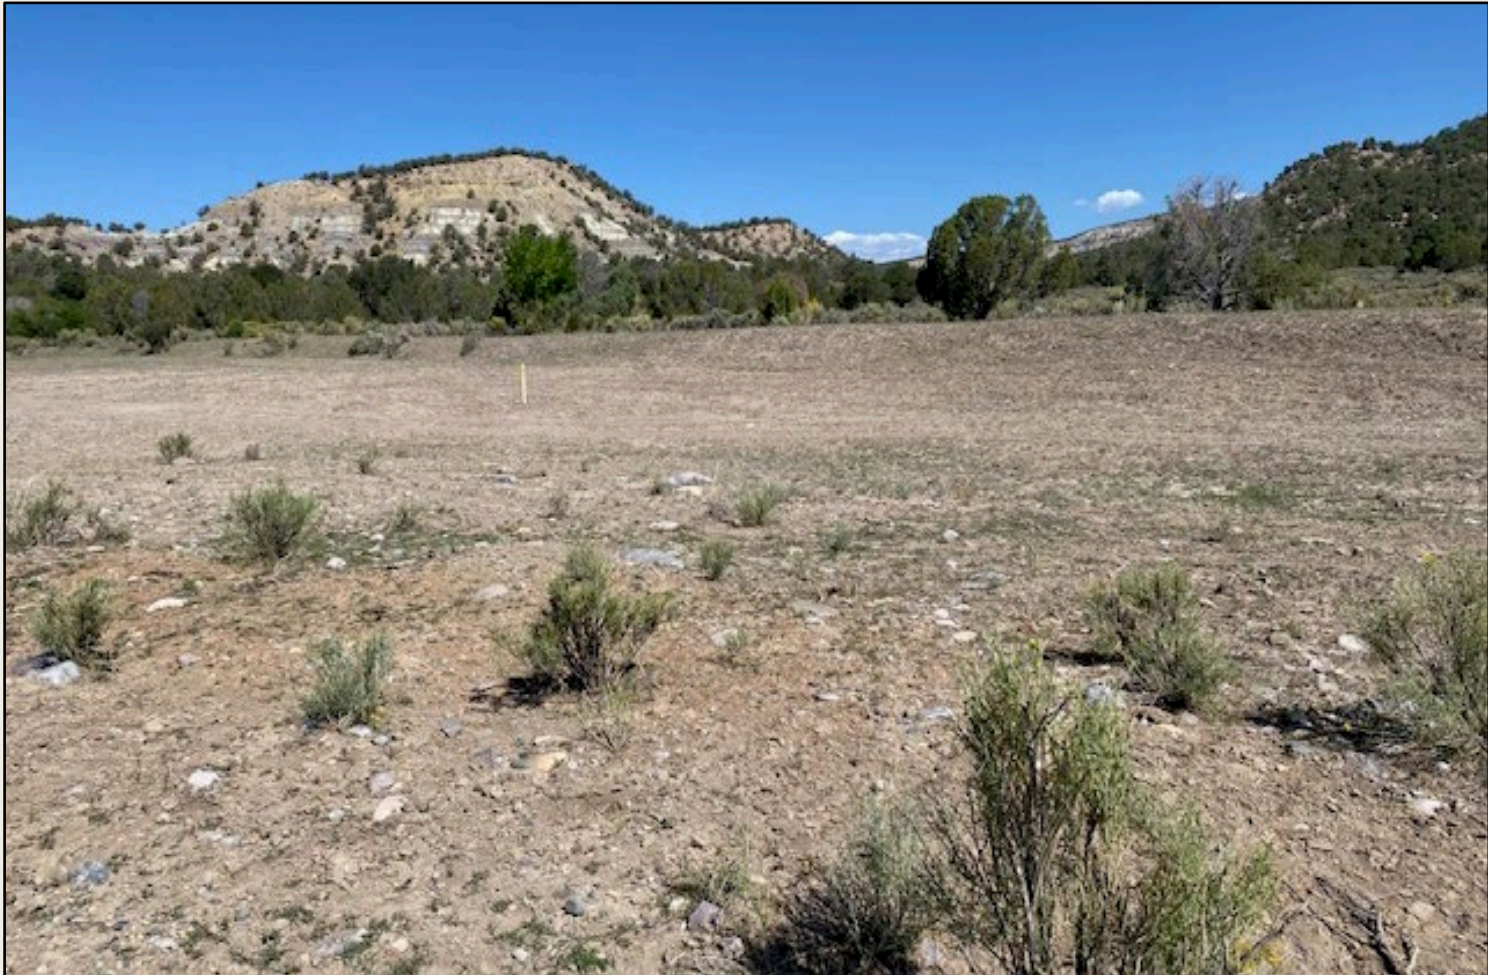
Photo 4. View of the reference area, comprised of open field, largely in a grazed vegetative condition.
