Inspection Photos
Location Name: Standley # 8-3, 6-2,5-2
Location ID: 335697

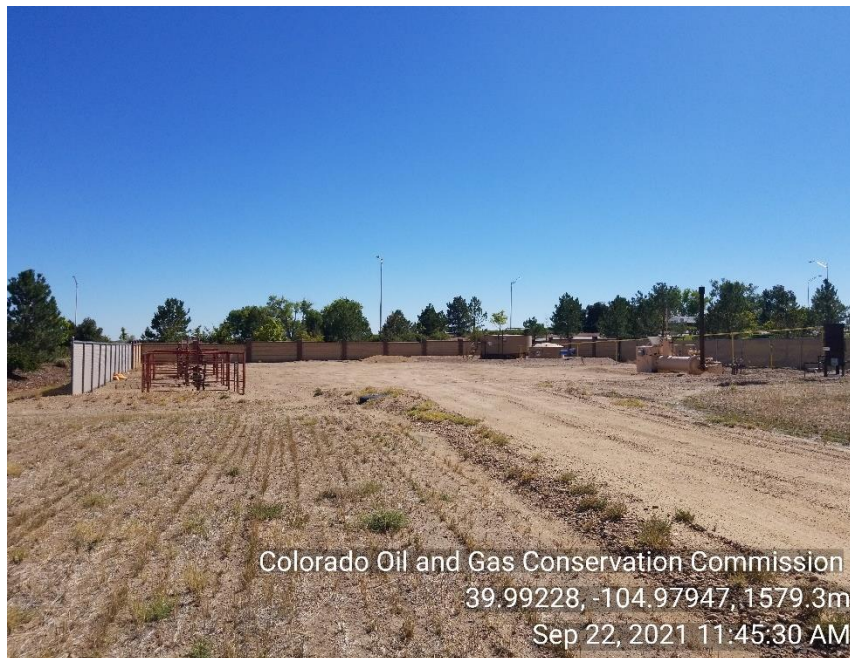
Photo 1 loc pic

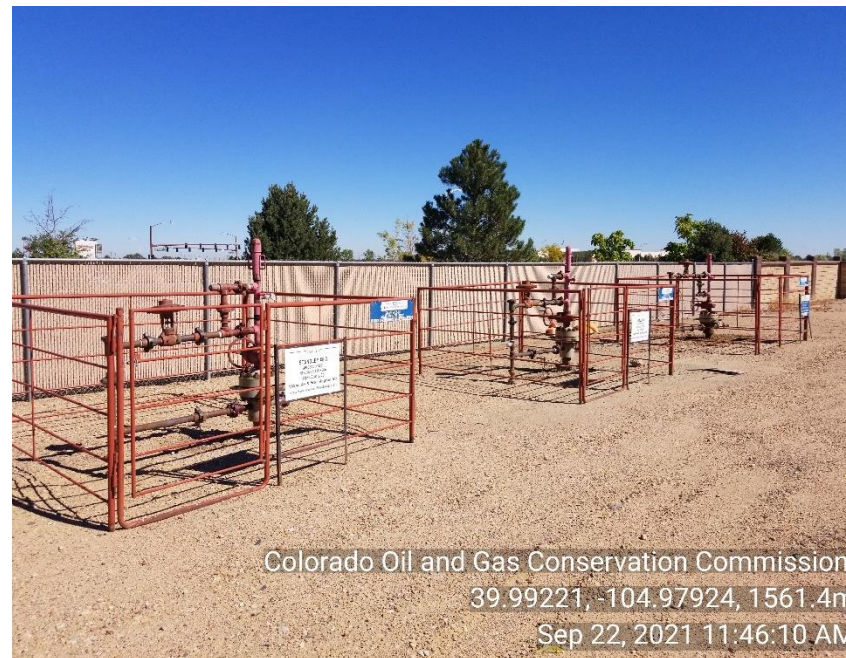
Photo 2 well heads

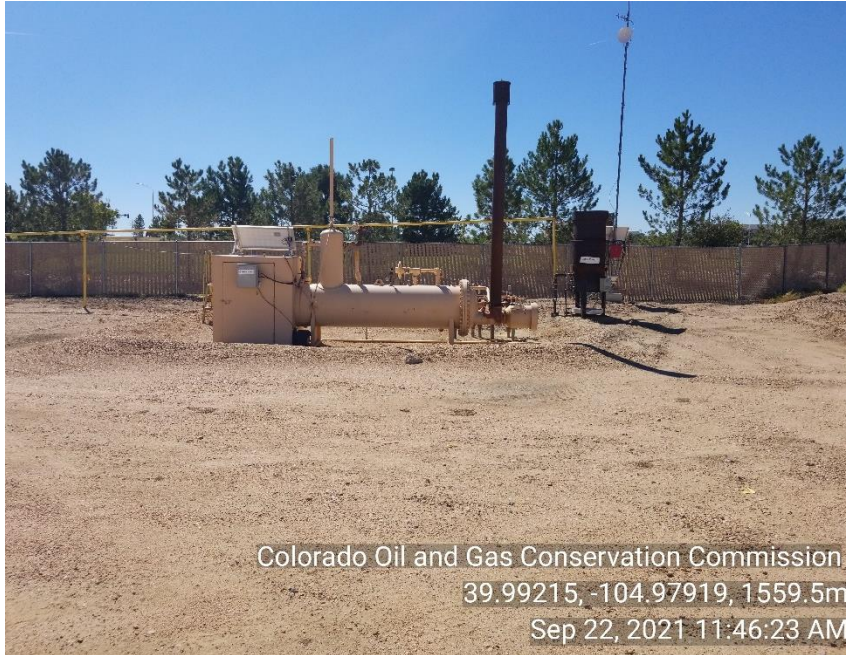
Photo 3 ECD and HOZ Sep

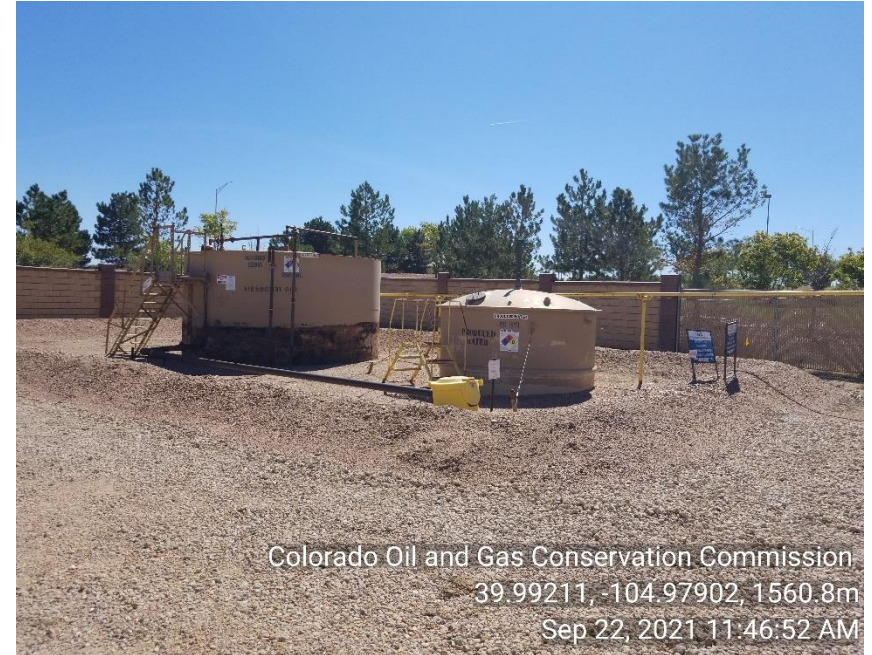
Photo 4 TNK BTRY

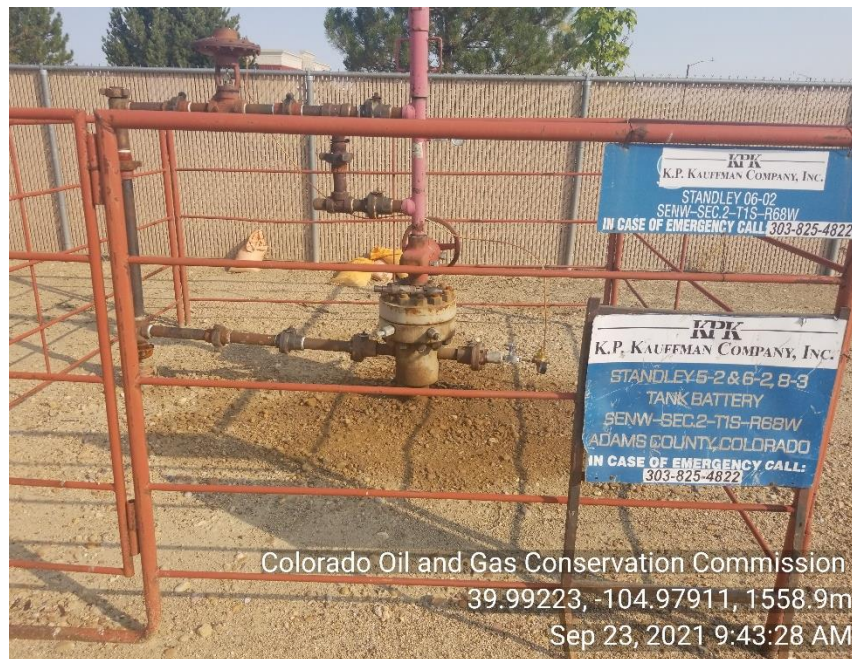
Photo 5 Stained soil around 6-2 well head Flow lines from well head appear to be in the closed position.

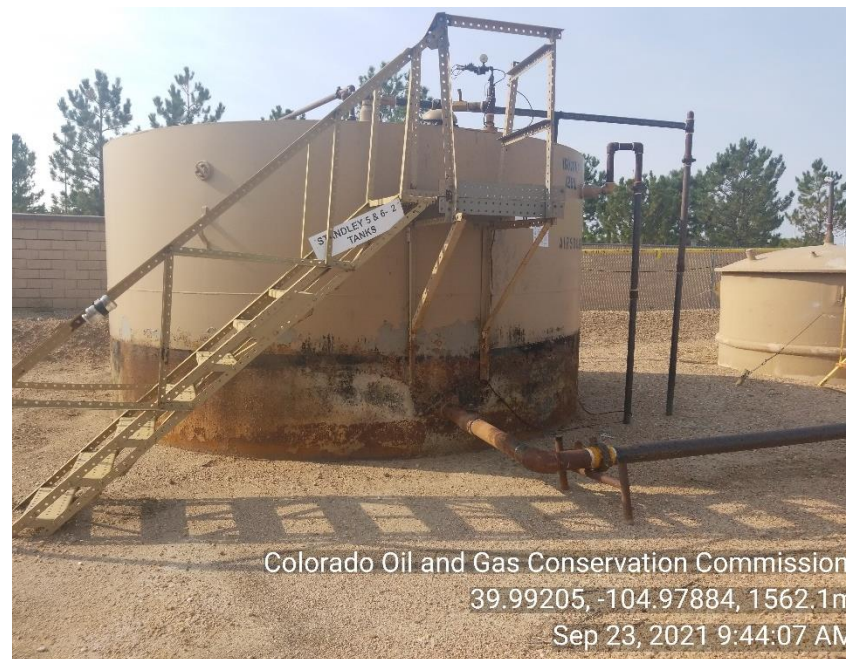
Photo 6 Crude oil tank next to public road and bottom half of tank appears to be rusting.

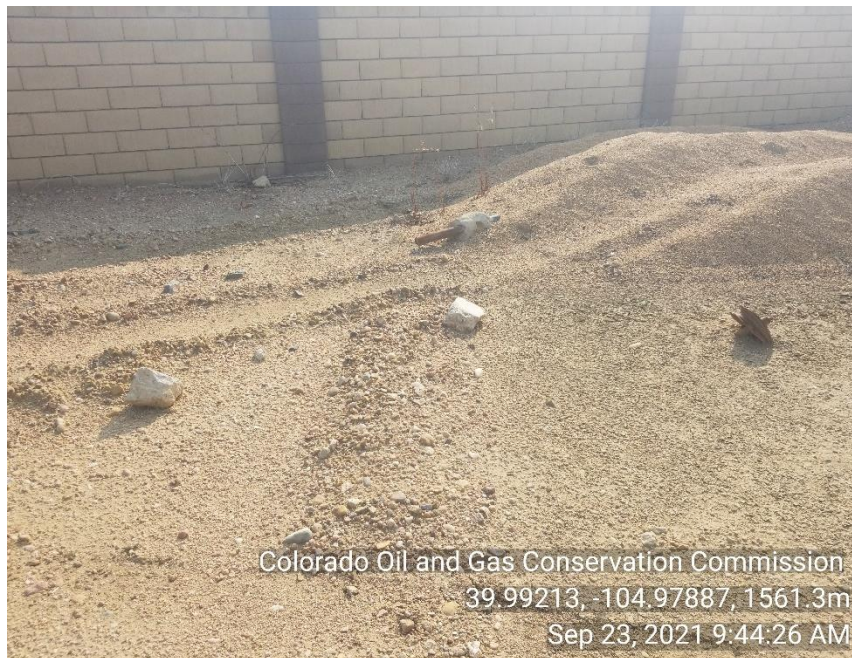
Photo 7 Cement and trash on location

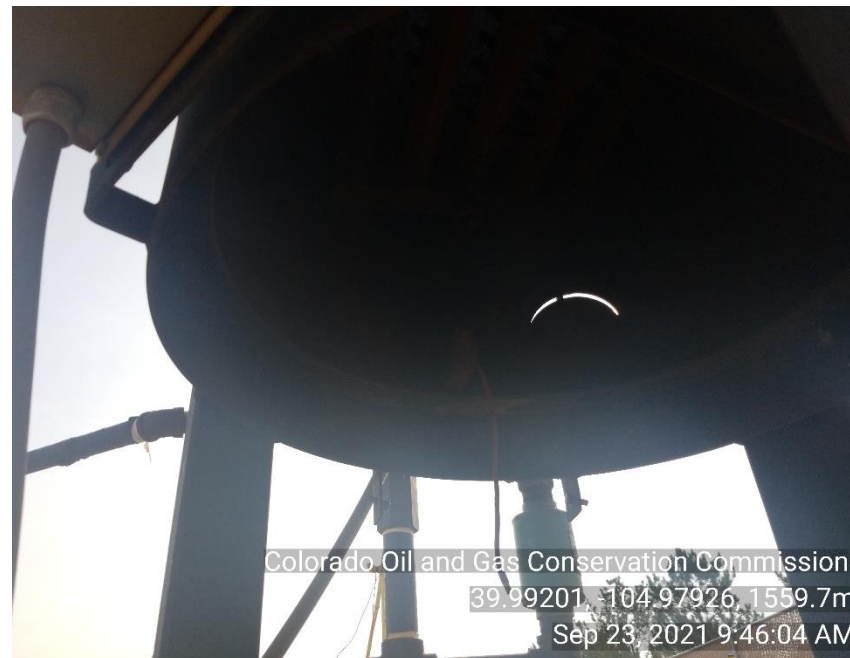
Photo 8 ECD appears to be taken apart and not functional

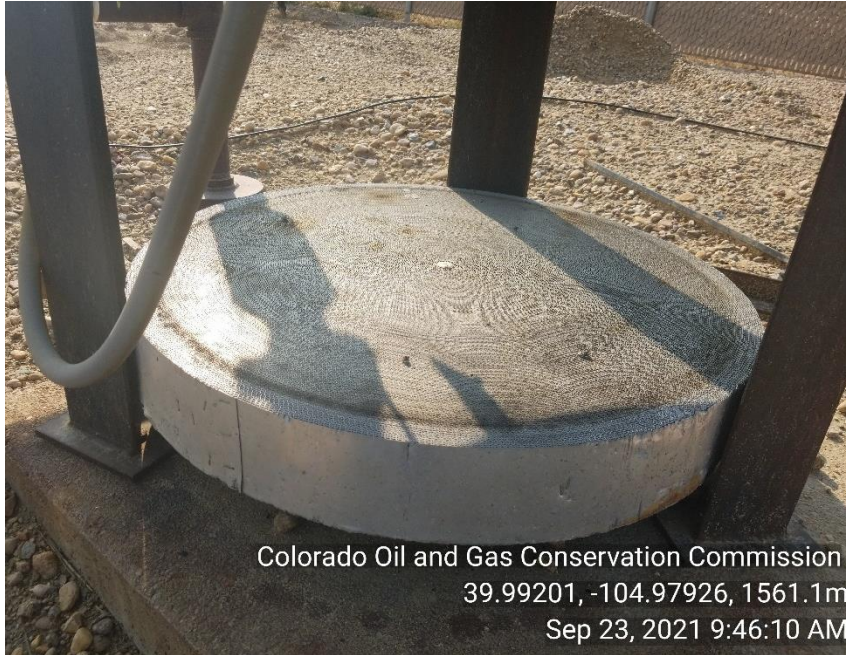
Photo 9 ECD fire arrester on ground

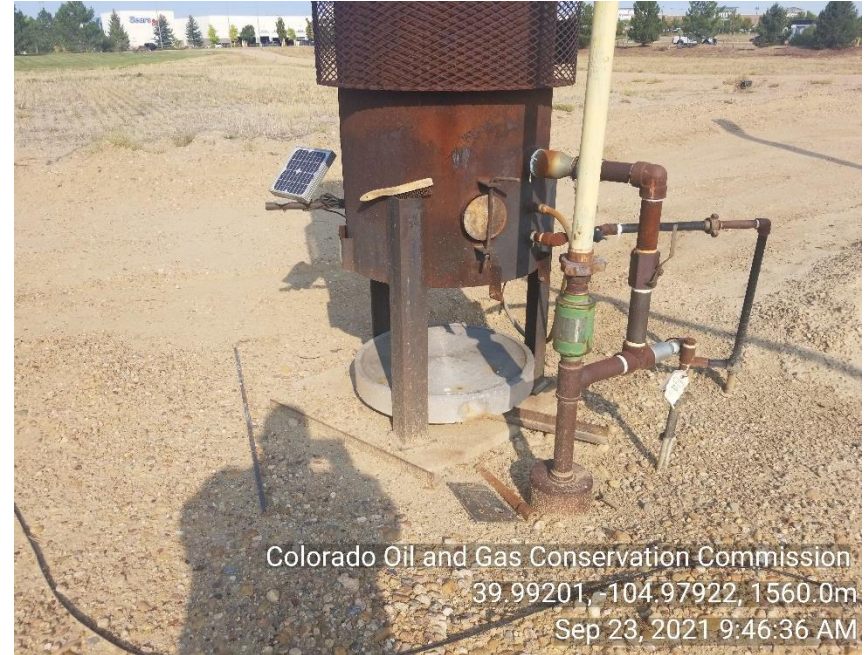
Photo 10 Miscellaneous parts around ECD

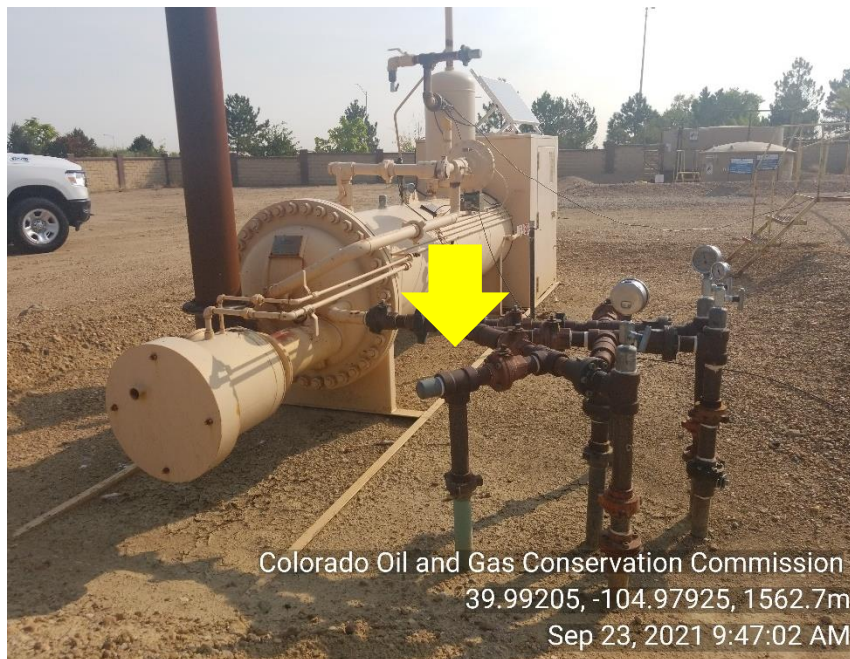
Photo 11 Sales line from separator has 2" bull plug installed

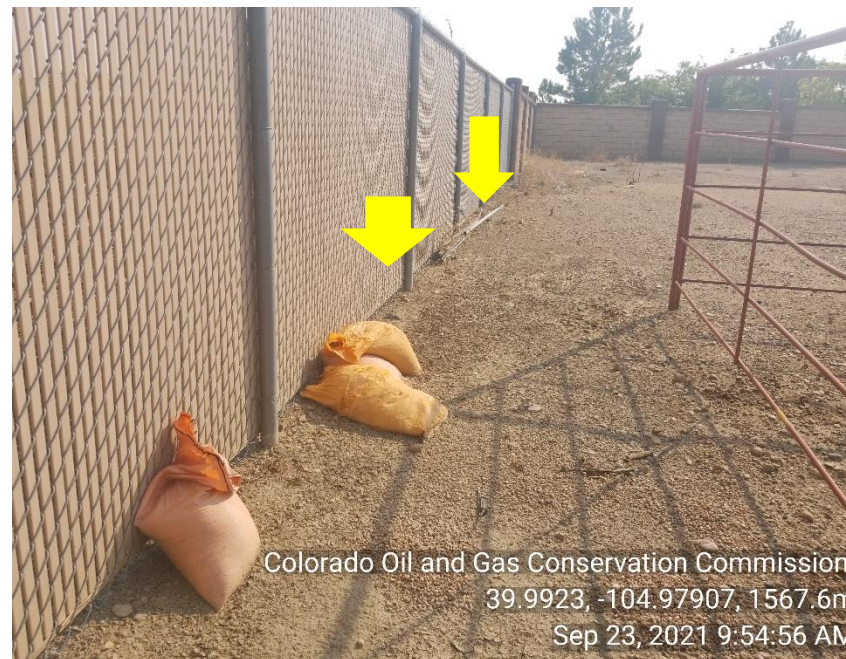
Photo 12 Trash on location.
