# Inspection Photos

API: 071-06811

Operator: WAPITI OPERATING LLC

Inspection Date: 9/23/2021

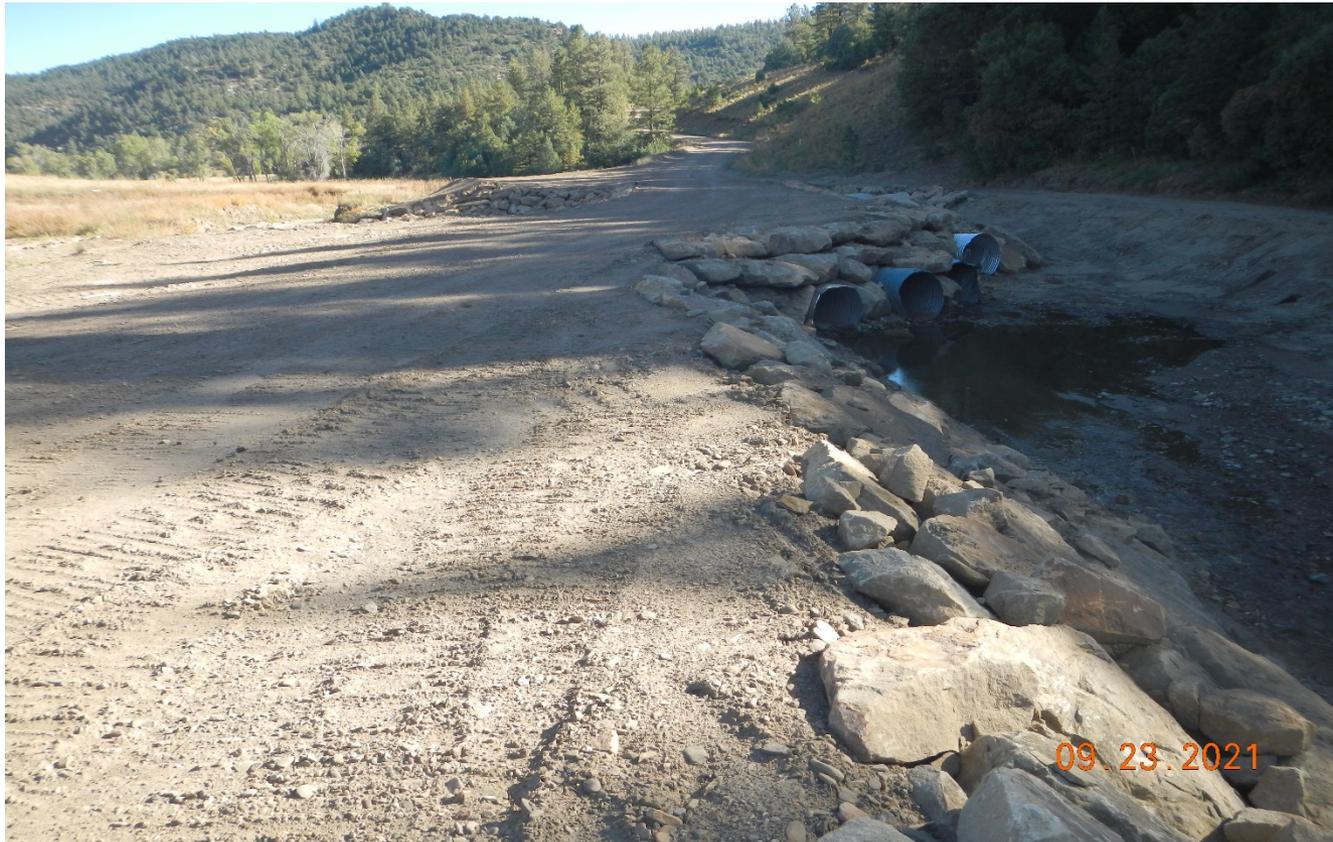
**Photo 1.** Facing northeast at the Lorencito creek crossing. The crossing has been repaired with an additional culvert installed.

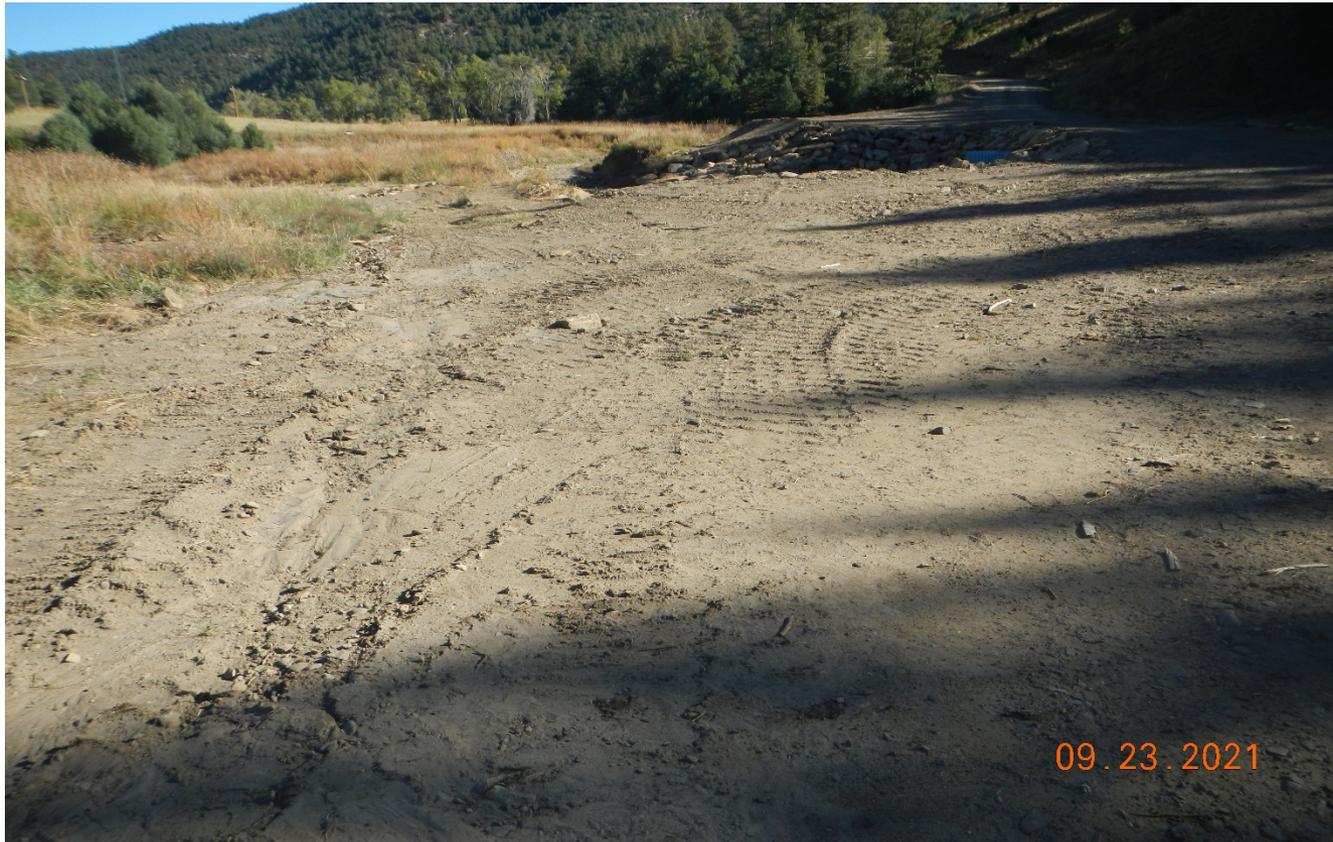
**Photo 2.** The disturbed bare soils along the roadside will need to be seeded and stabilized.

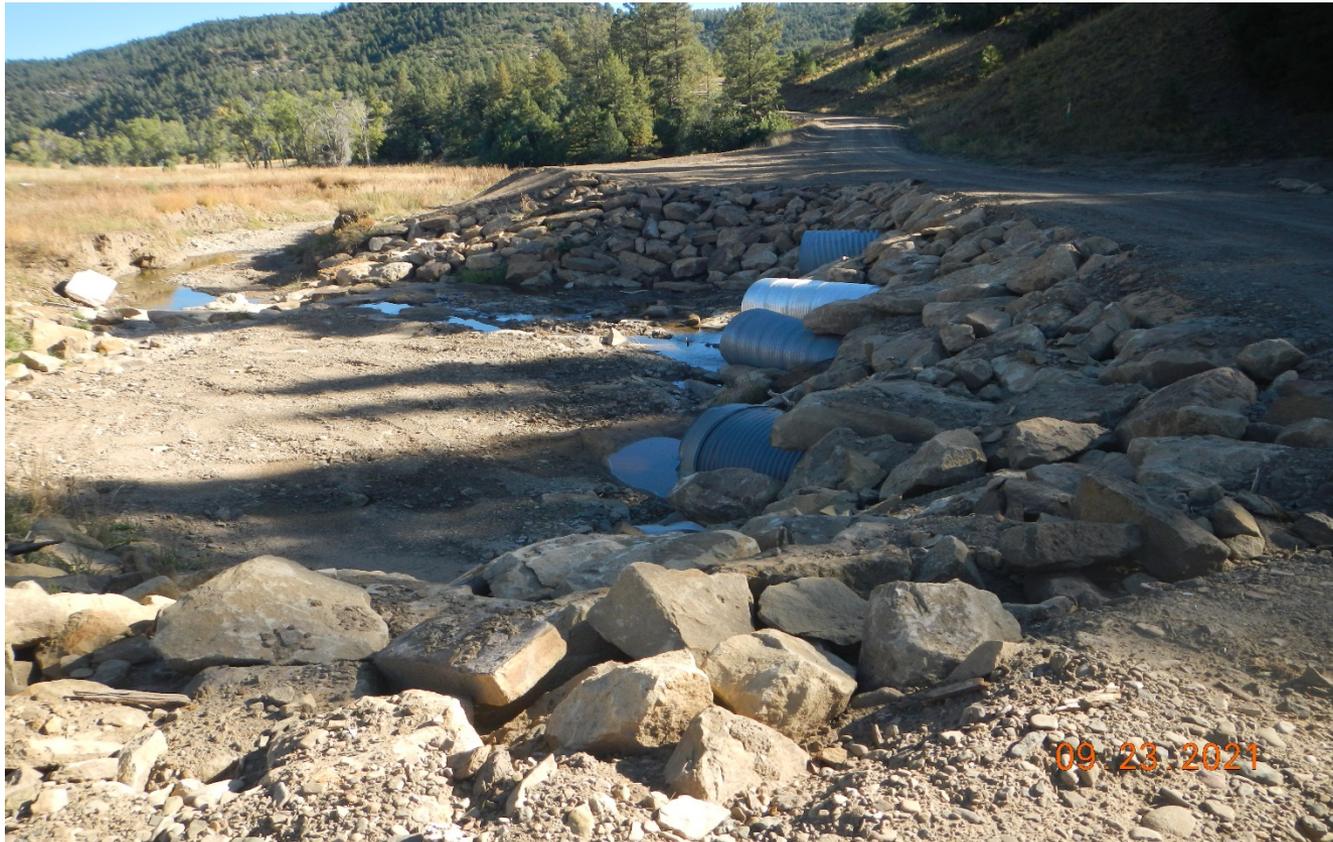
**Photo 3.** Facing toward the culvert outlets which are armored with rock rip/rap.

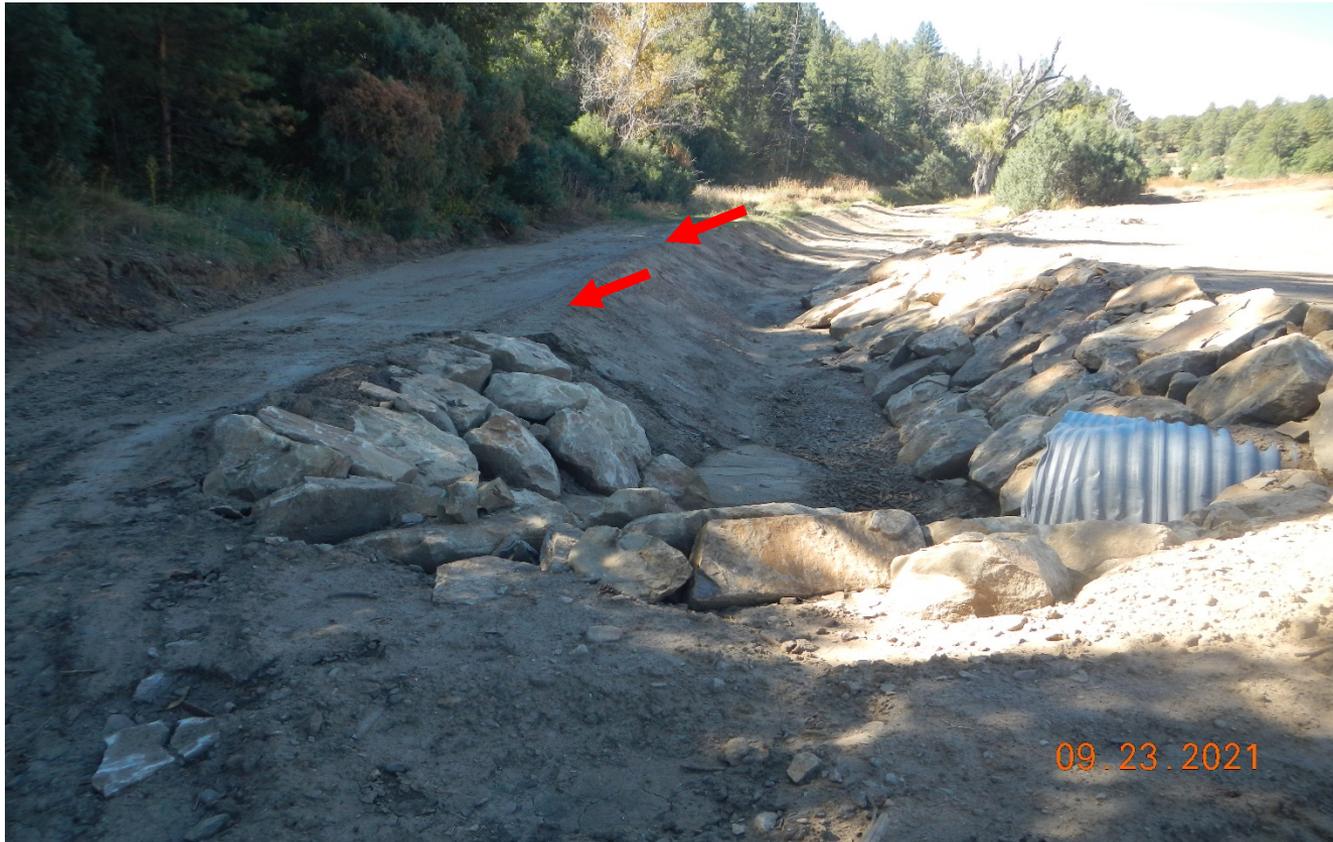
**Photo 4.** Facing at south side of the road at the additional culvert inlet. Disturbed bare shown at red arrow will need to be seeded and stabilized.

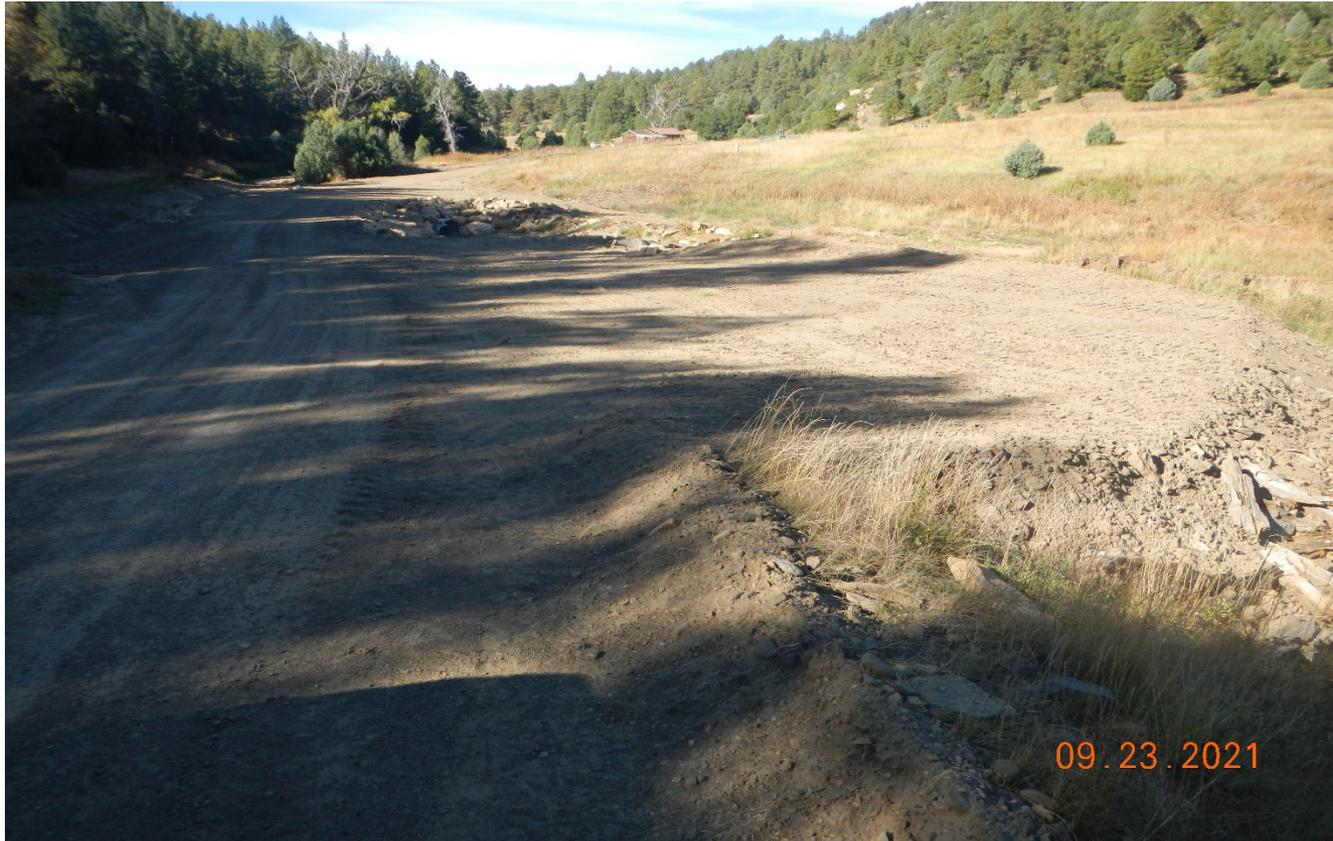
**Photo 5.** Facing back west at the Lorencito stream crossing which was repaired. The disturbed bare soils along the roadside will need to be seeded and stabilized.
