Inspection Photos

API: 071-09514

Operator: WAPITI OPERATING LLC

Inspection Date: 9/23/2021

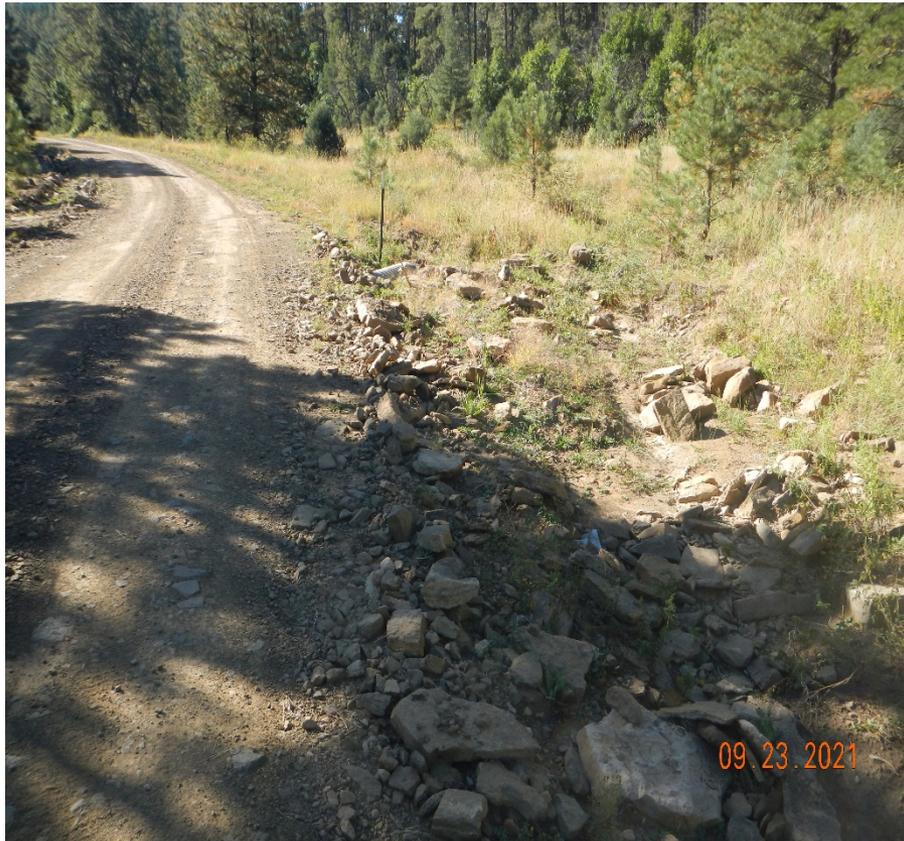
Photo 1. Facing southeast along the main road in the canyon. This culvert is filled in with sediment causing stormwater to flow down the side of the road.

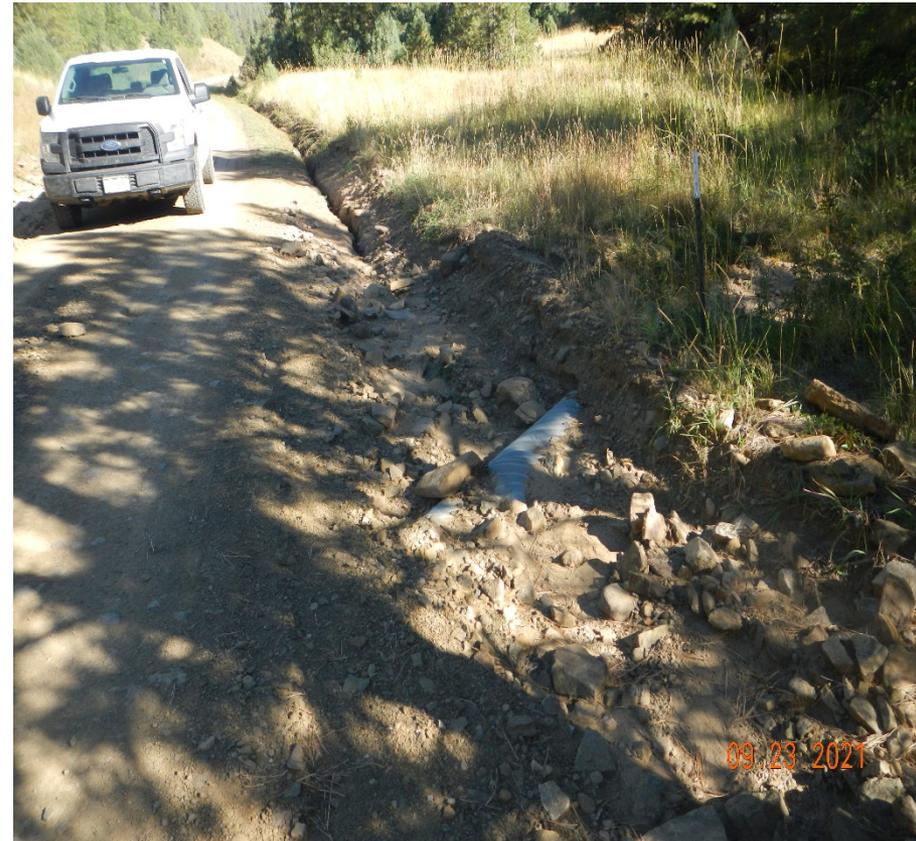
Photo 2. Facing northwest at the same culvert outlet which shows stormwater is flowing past the culvert causing erosion of the road.

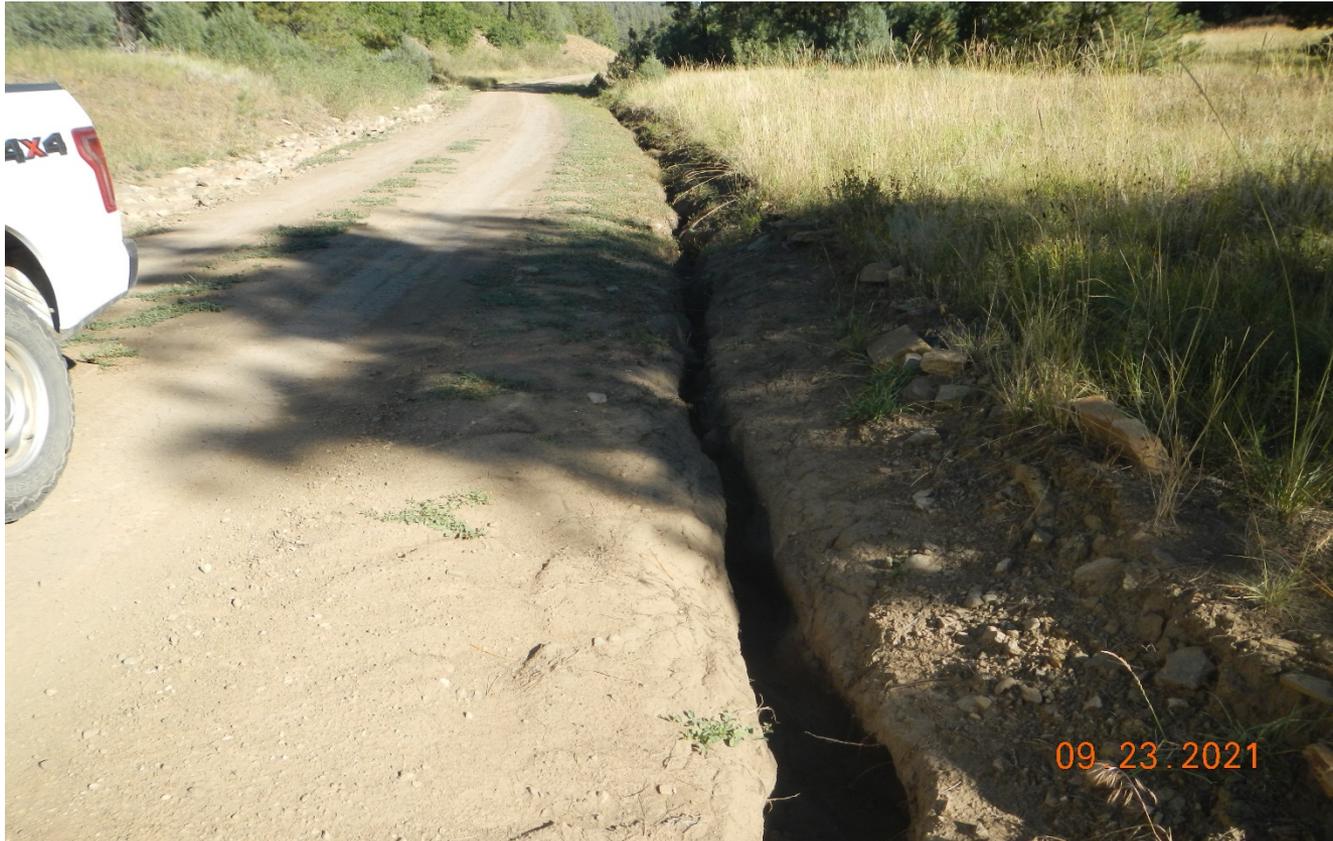
Photo 3. Stormwater is causing a deep erosion channel along the side of the road which needs to be repaired.

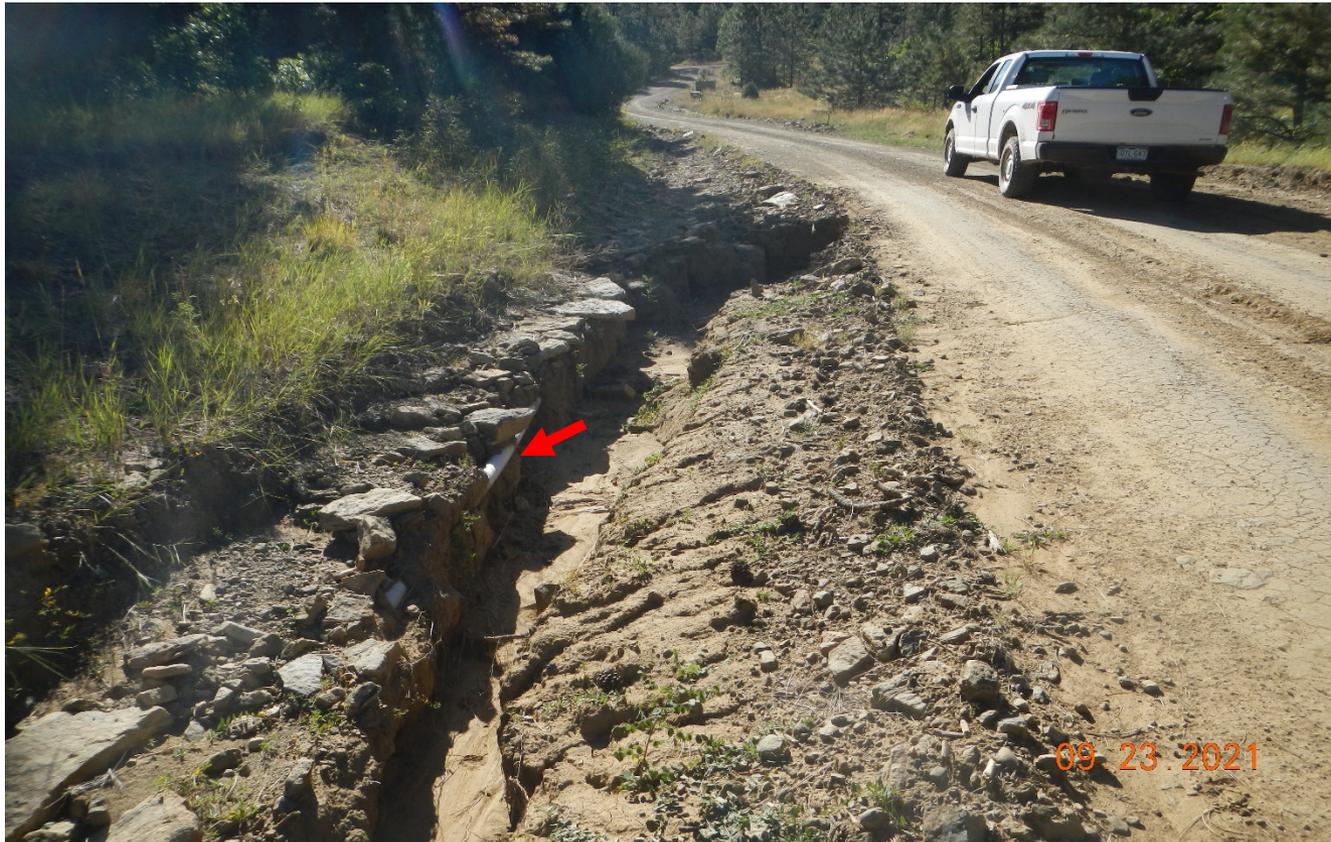
Photo 4. Further along the road is areas of erosion. There is an exposed pipeline which needs to be covered and protected.

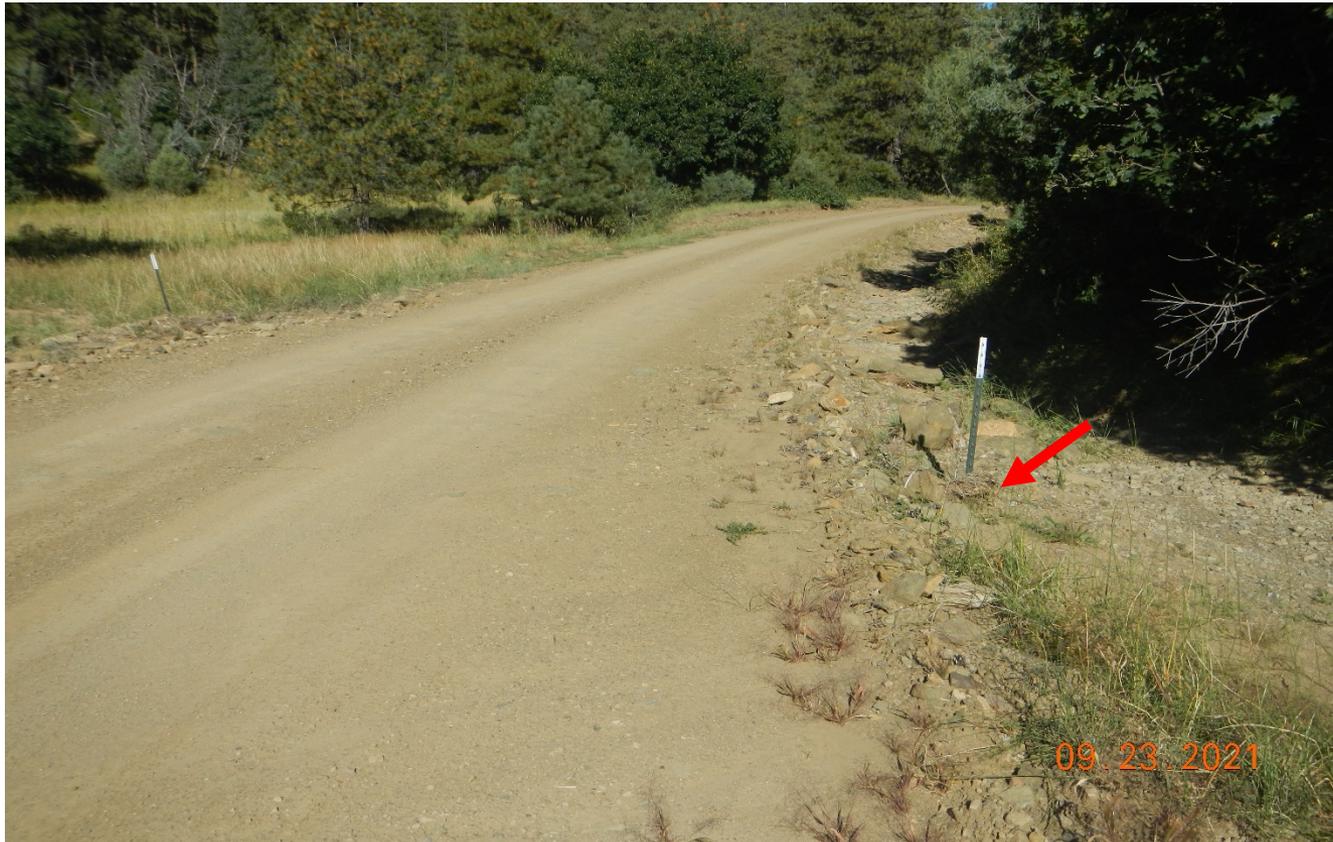
Photo 5. Another culvert further along the road is filled in with sediment.
