Inspection Photos

API: 071-06815

Operator: WAPITI OPERATING LLC

Inspection Date: 9/23/2021

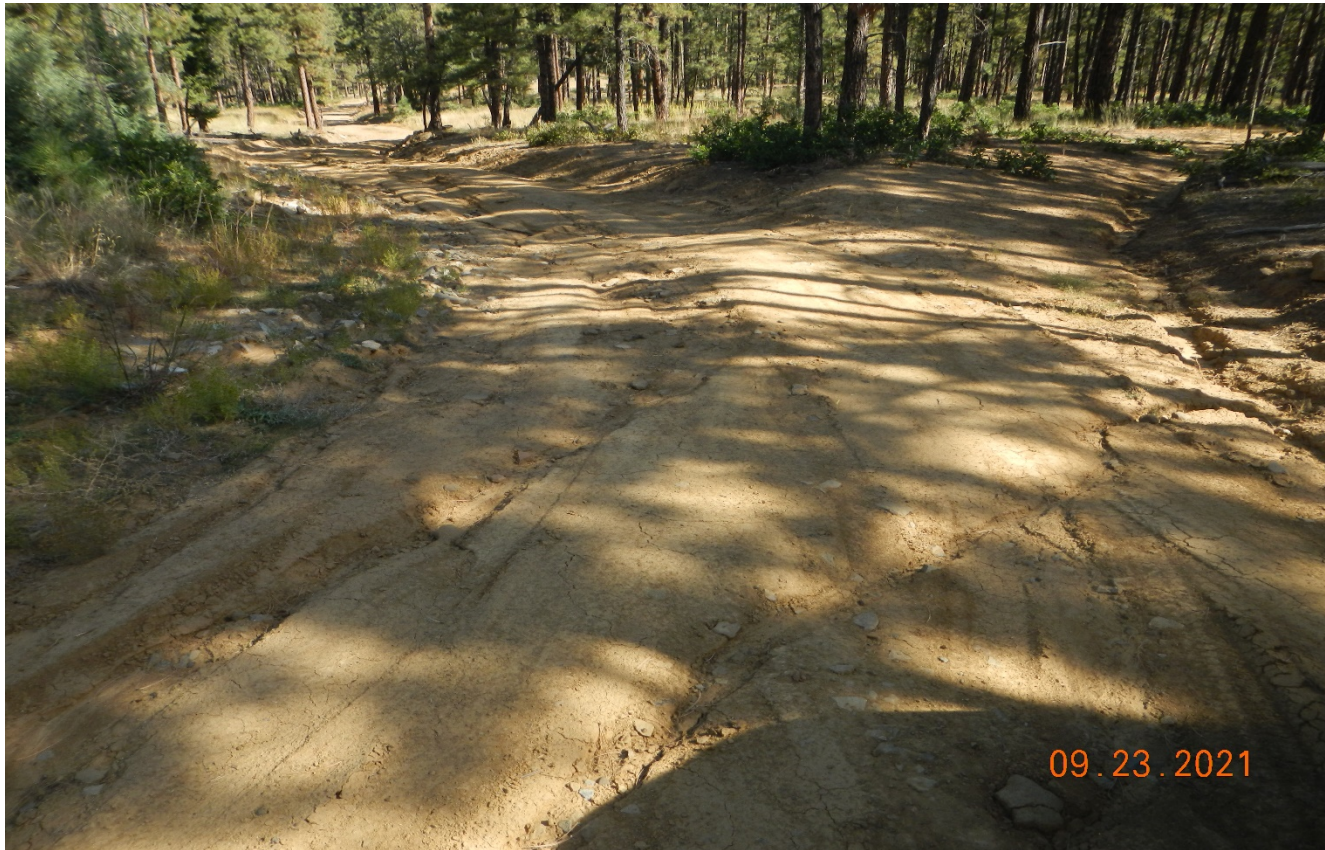
Photo 1. Facing north toward the access road. There is a berm and runoff ditch in this area of the road. There is sign stormwater is still directed down the road causing erosion.

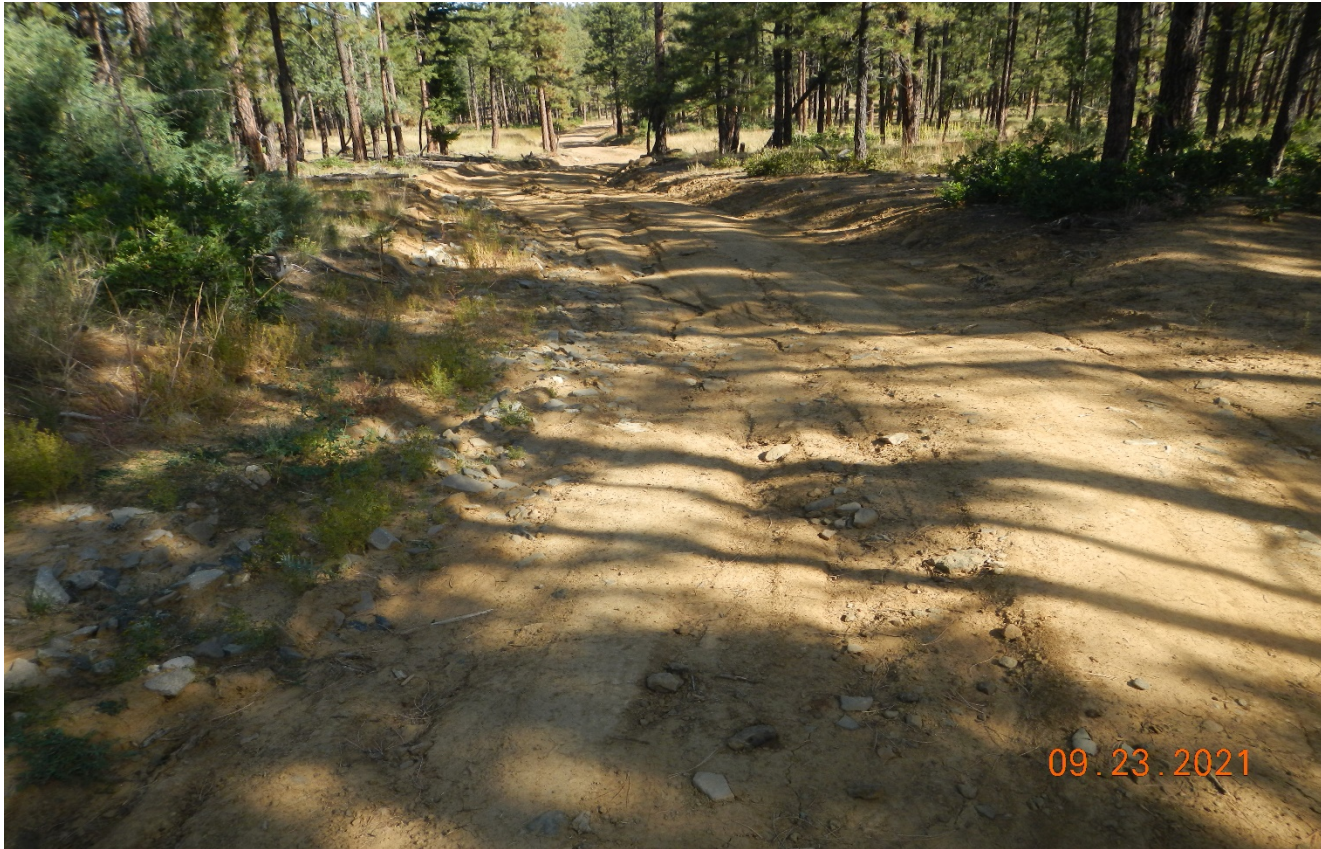
Photo 2. Stormwater directed down the road has caused erosion and degradation of the road.

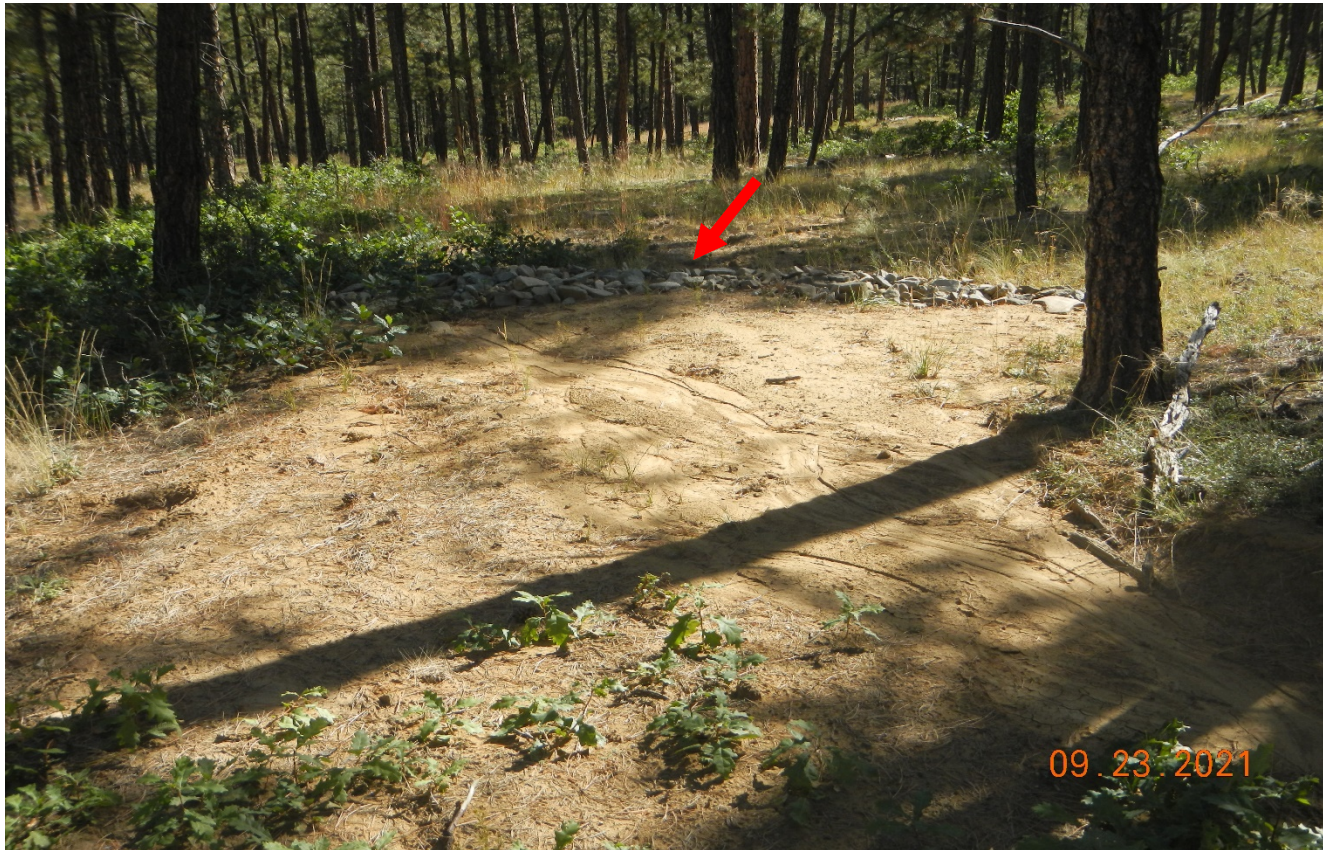
Photo 3. A rock rip/rap structure was installed since previous inspection which has contained sediment from the road. This sediment will need to be cleaned out. A sediment trap would be more appropriate in this area.

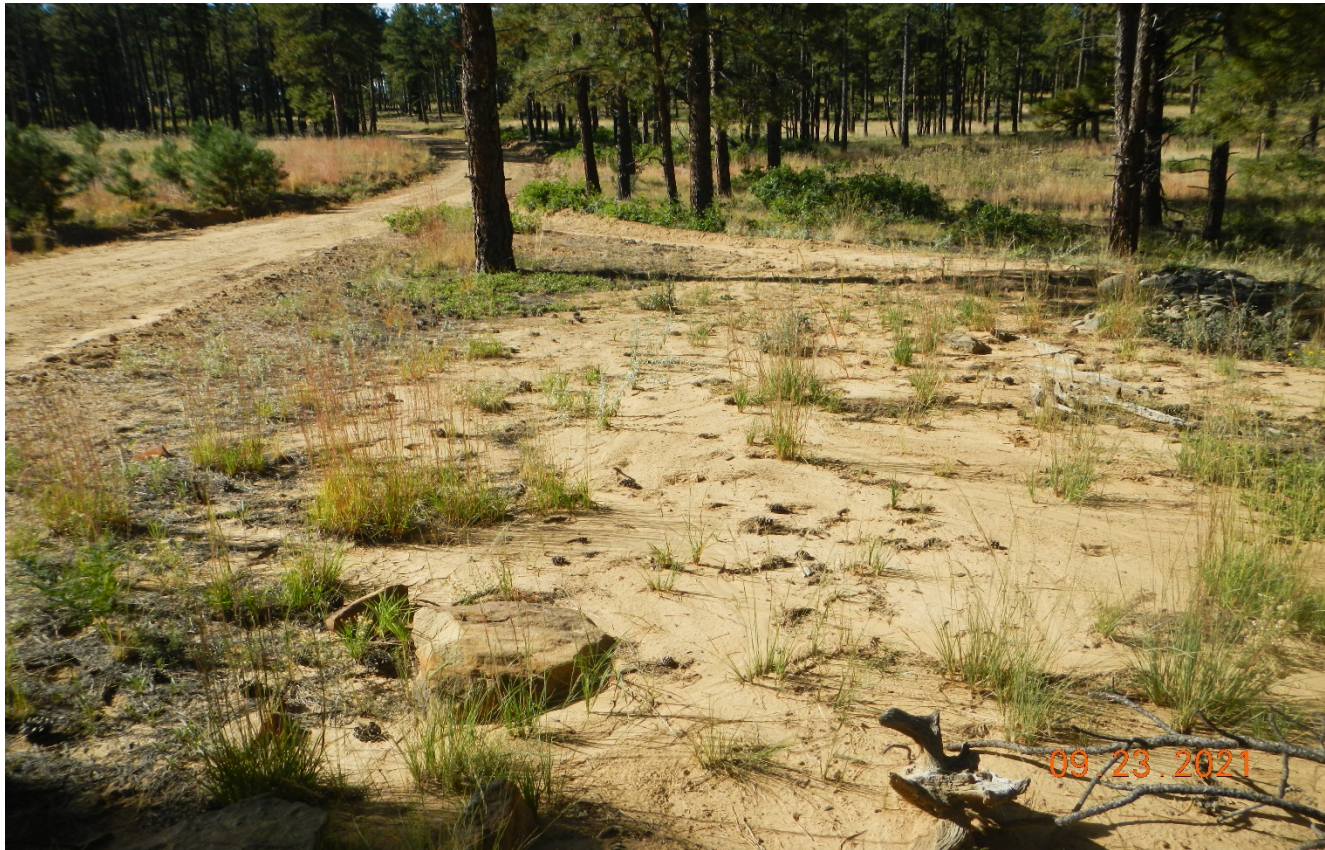
Photo 4. Facing south adjacent to the access road. This photo shows the sediment deposition off the road into the adjacent area. The road needs to be stabilized to prevent erosion.
