# Inspection Photos

API: 071-08769

Operator: WAPITI OPERATING LLC

Inspection Date: 9/23/2021

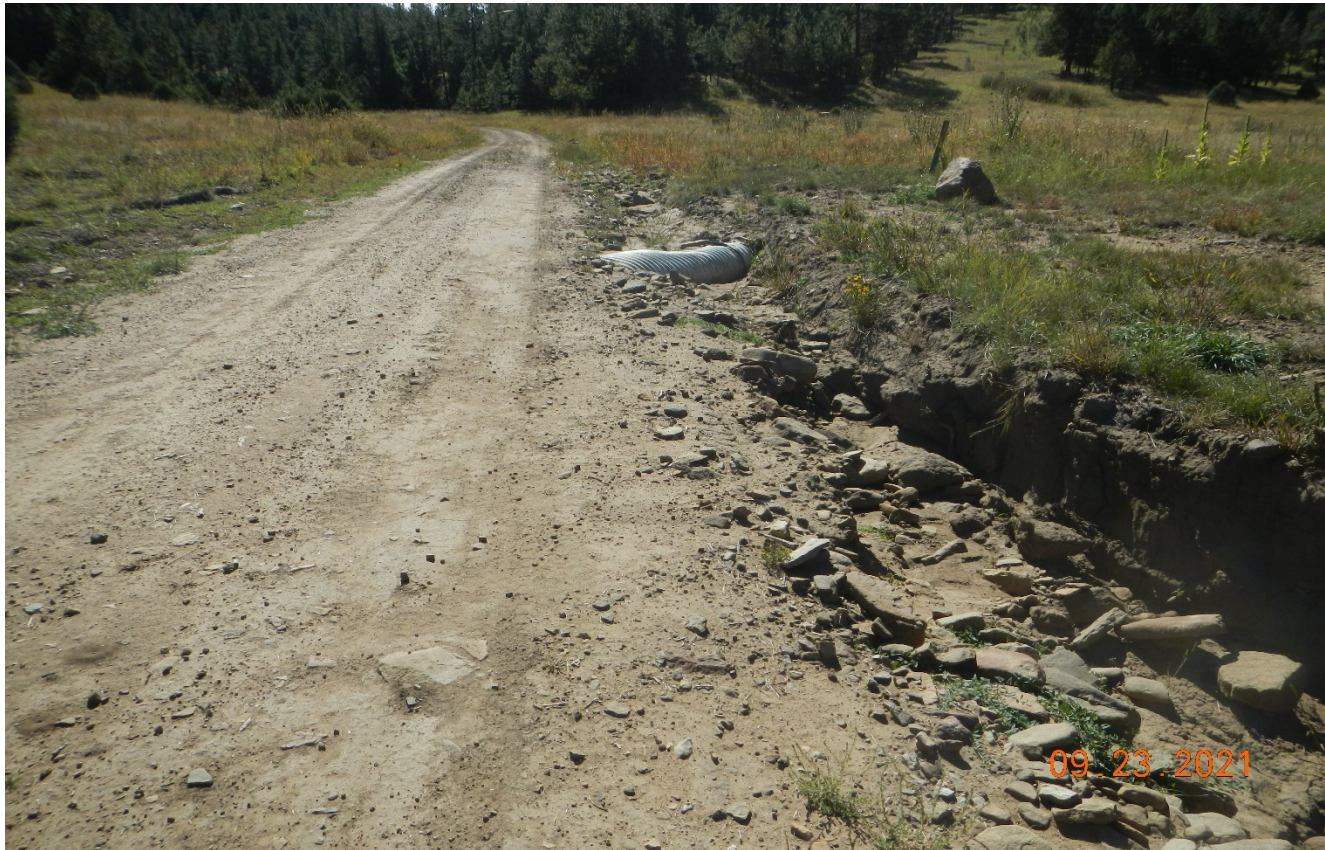
**Photo 1.** Facing southeast along the main road at the upper part of Lorencito Canyon. There is erosion along the road from recent storm event. Stormwater is bypassing the culvert. Previous corrective action was not completed.

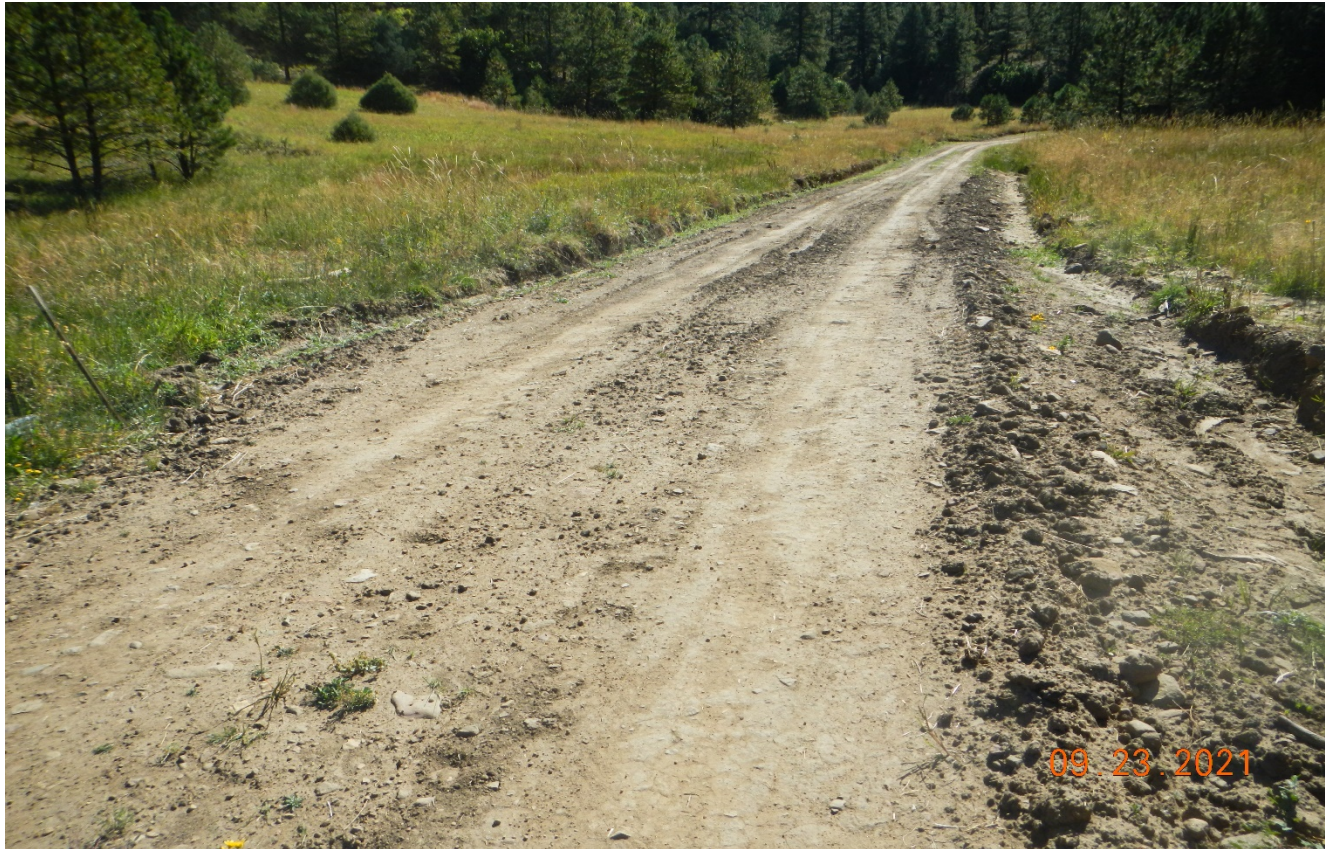
**Photo 2.** The culvert along the road are filled in with sediment causing stormwater to flow down the side of the road. Lat/Long:37.00499,-104.83742. Previous corrective action was not completed.

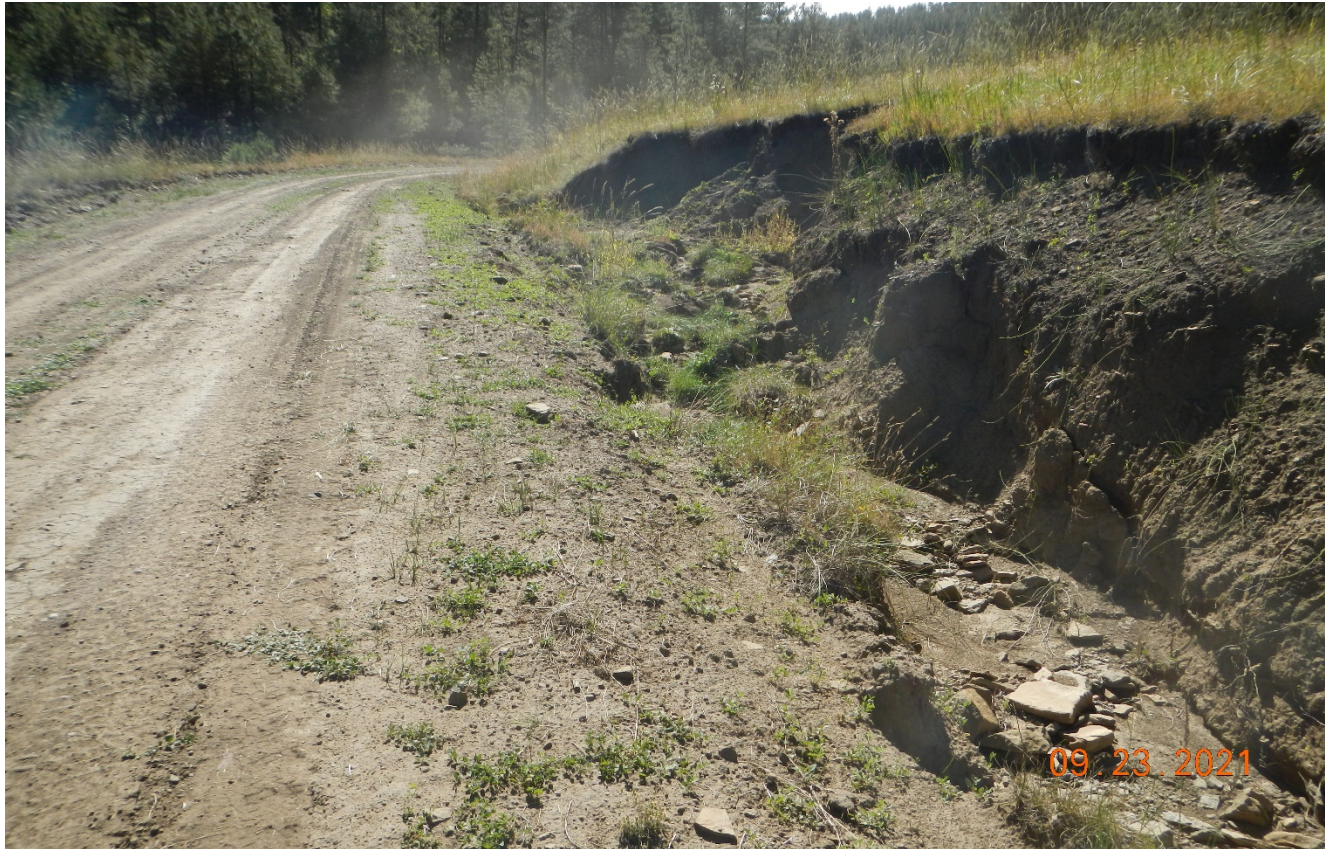
**Photo 3.** The side of the road is eroded and not stabilized at Lat/Long:36.99952,-104.83425. This area needs to be resloped, seeded, and stabilized.

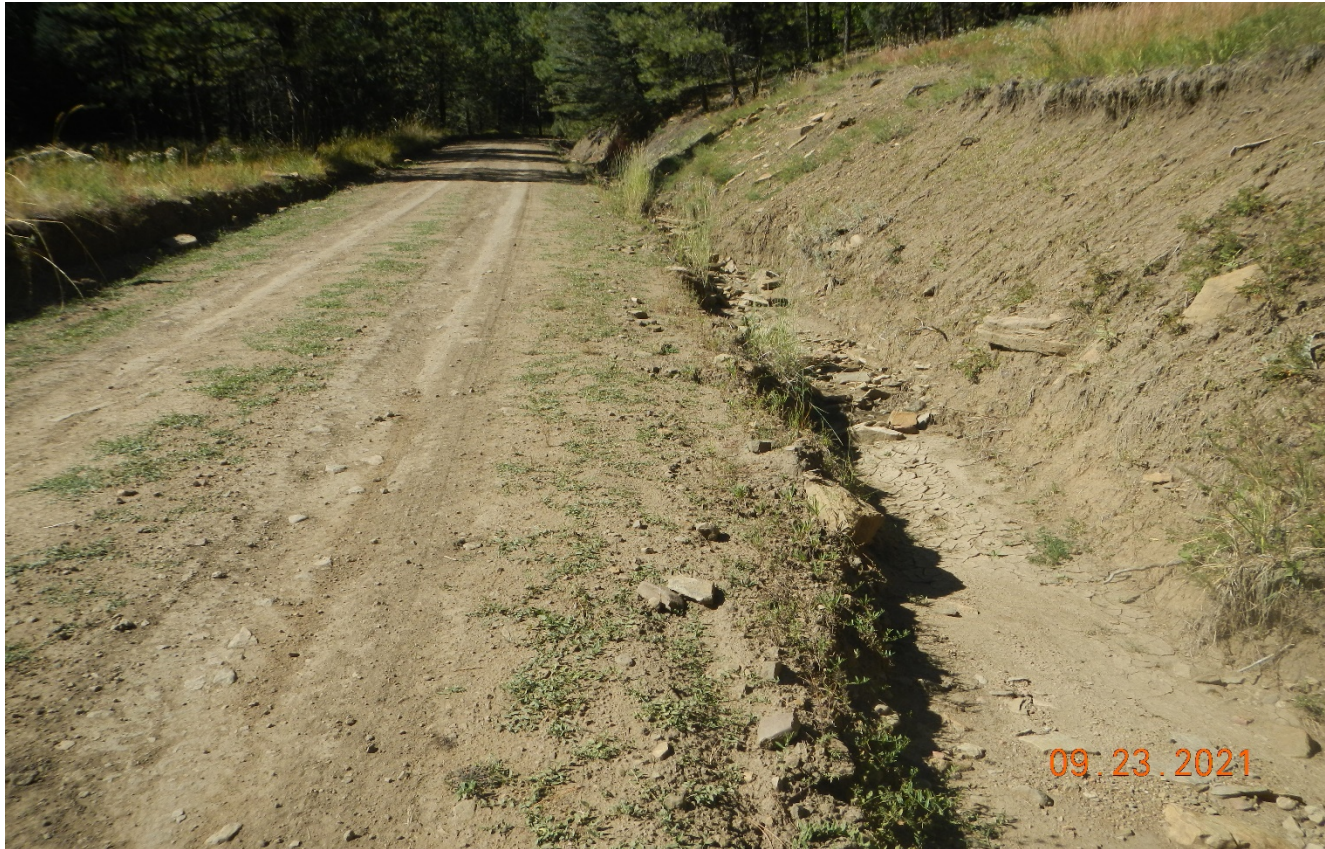
**Photo 4.** Further up the road in the canyon is erosion along the roadside with insufficient BMP's.

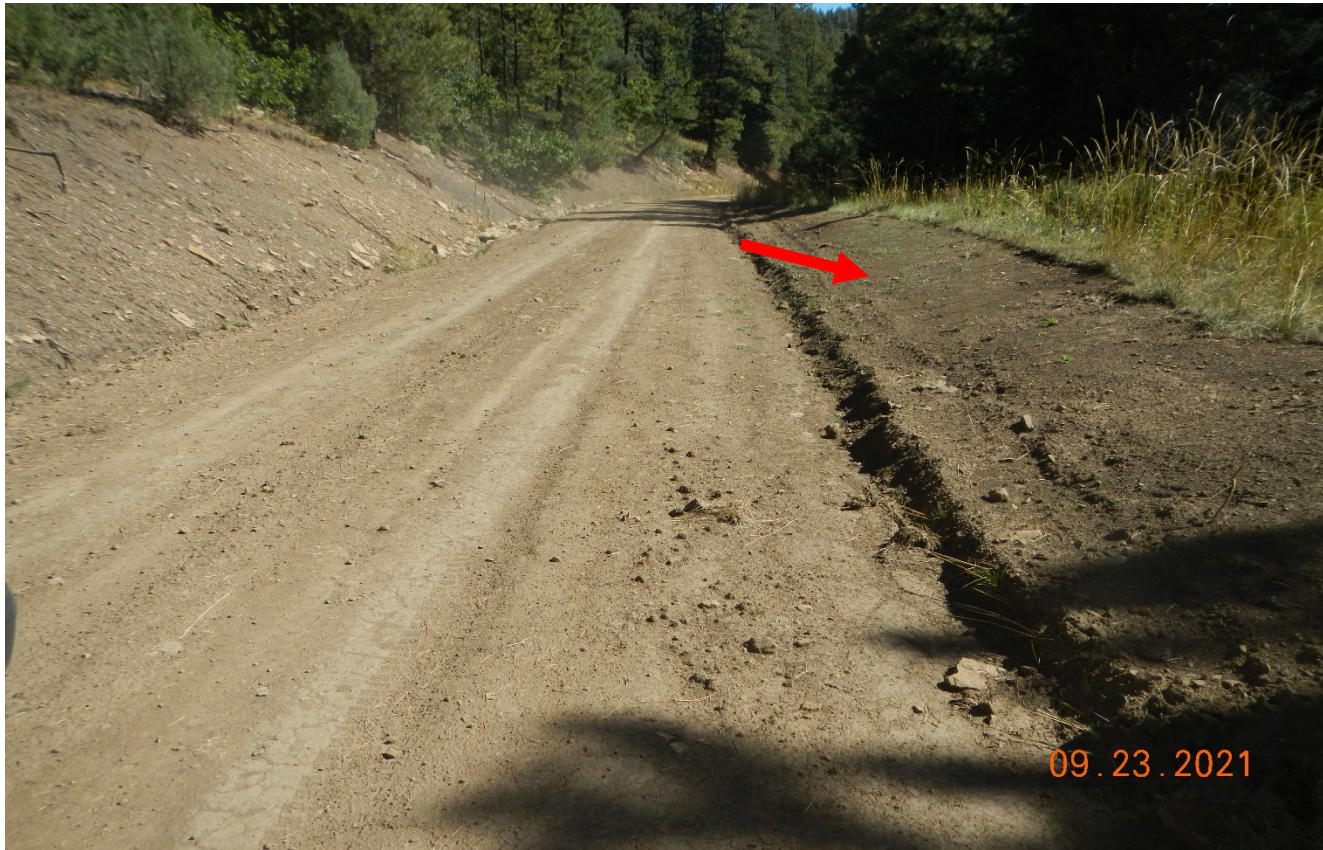
**Photo 5.** There was grading performed along the road. The disturbance along the side of the road shown at red arrow needs to be seeded and reclaimed.
