# Inspection Photos

API: 071-07915

Operator: WAPITI OPERATING LLC

Inspection Date: 9/23/2021

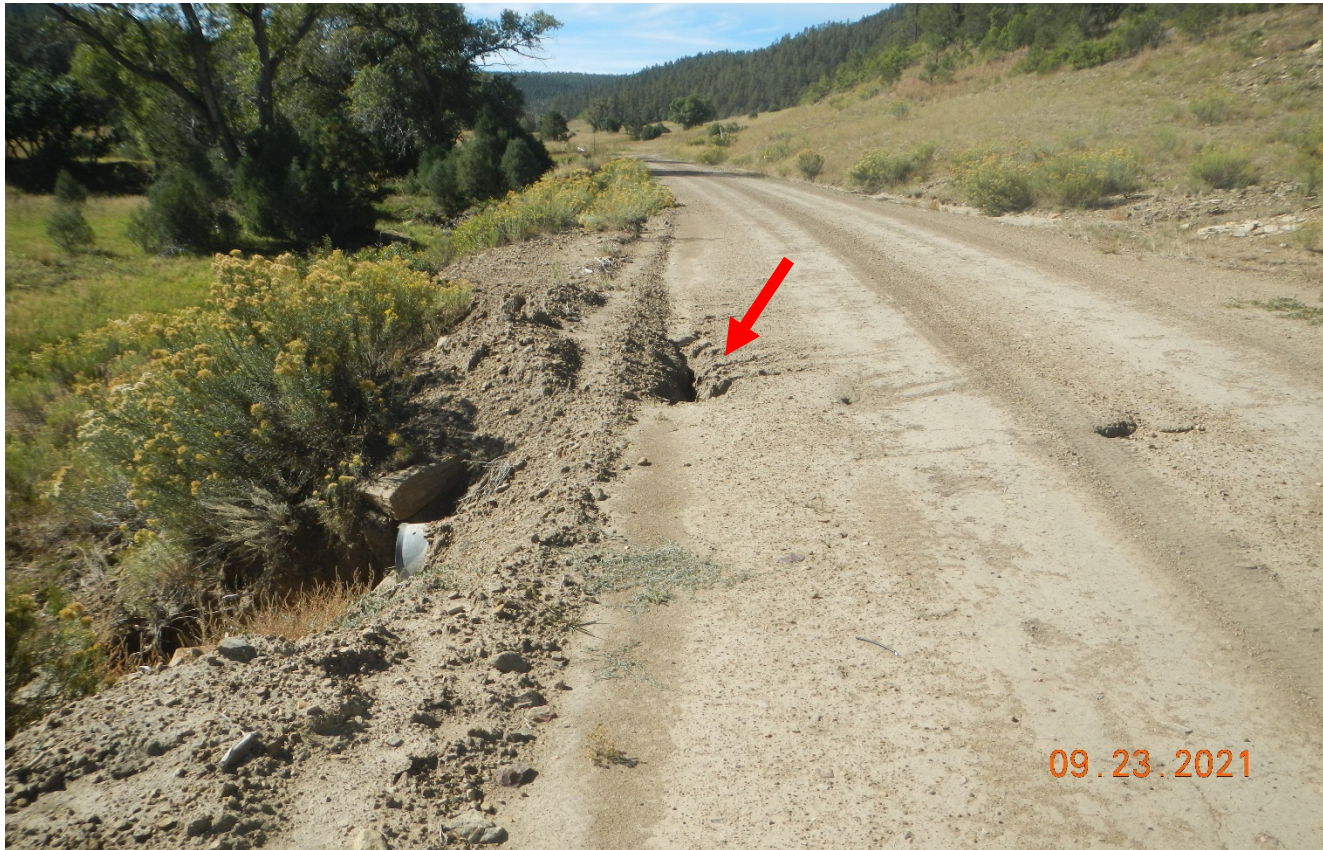
**Photo 1.** Facing southwest along the main road in the canyon. The road has been graded however, there is still culvert maintenance needed. Red arrow points to erosion undercutting by the culvert which will end up eroding.

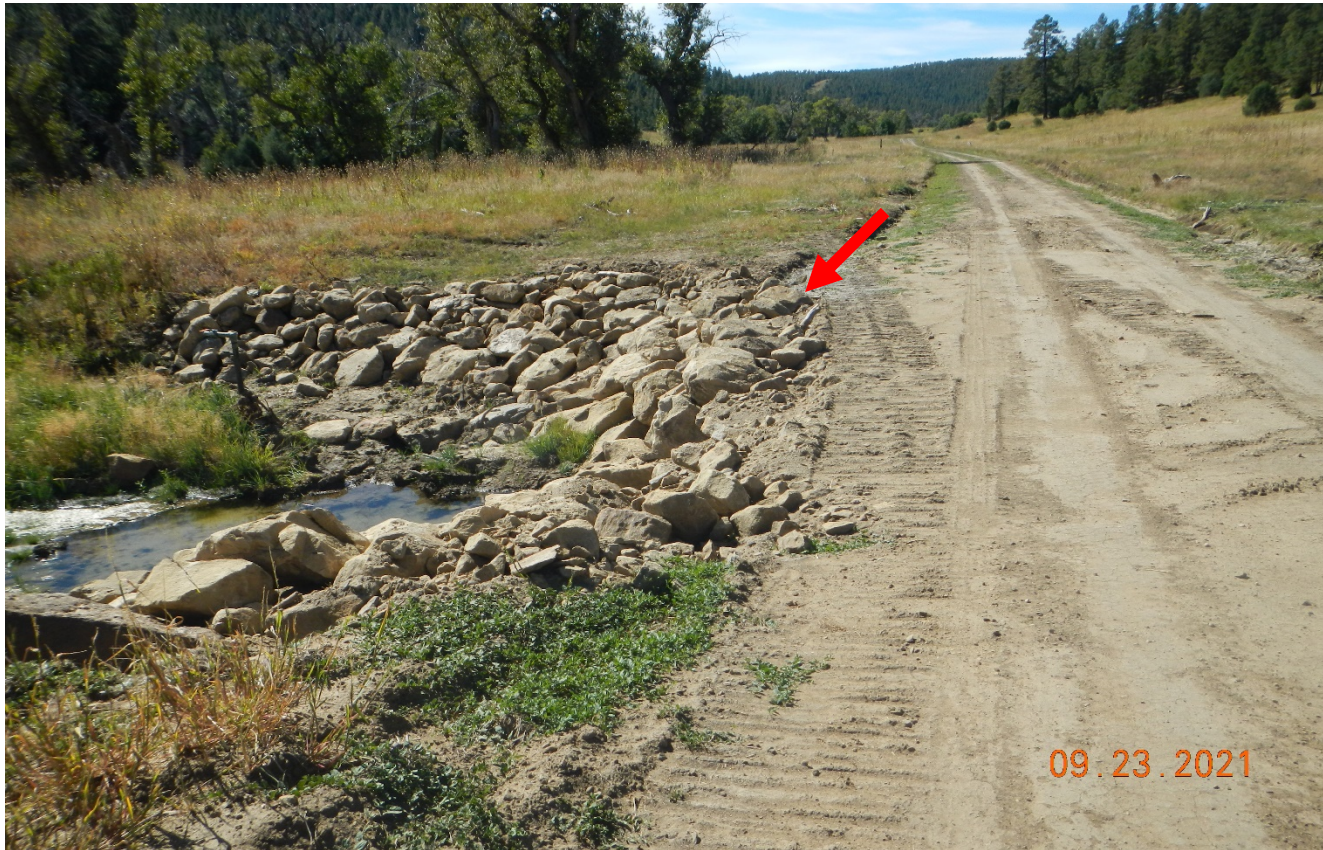
**Photo 2.** This culvert outlet has been repaired with rock armoring. One issue is observed, there is no diversion for stormwater off the road shown at red arrow which will cause stormwater to pool in this area.

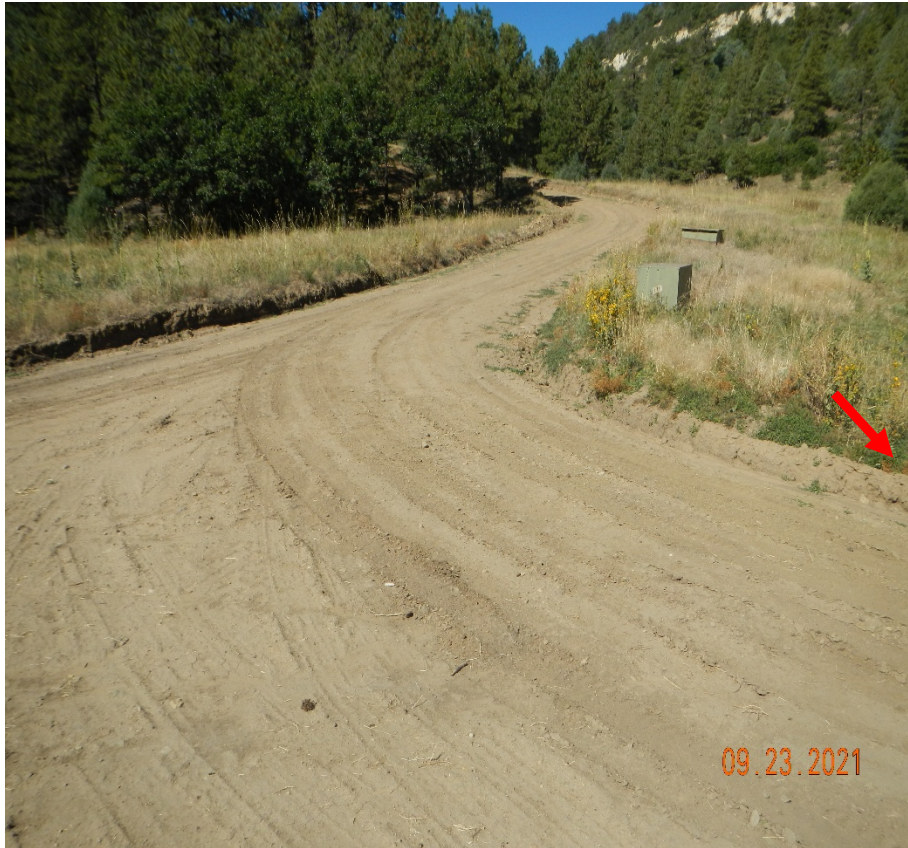
**Photo 3.** Facing west toward the access road ascending the hillside. The road has been graded. The culvert inlet shown in photo 4 is near the red arrow.

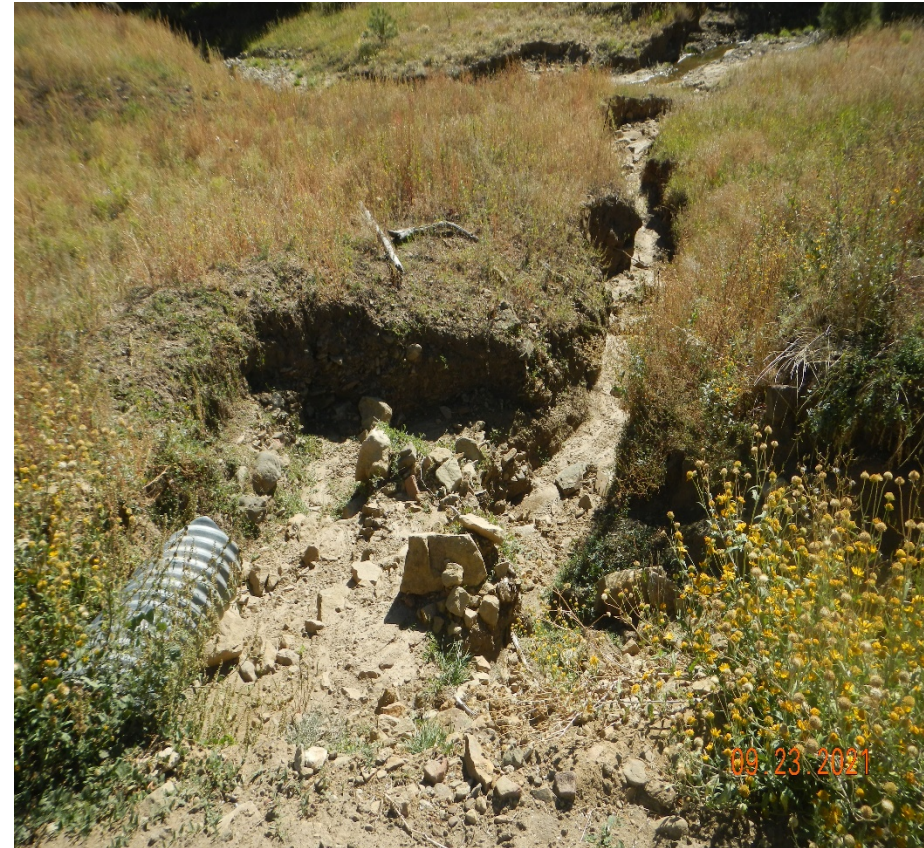
**Photo 4.** The culvert outlet is eroded and does not have outlet protection.

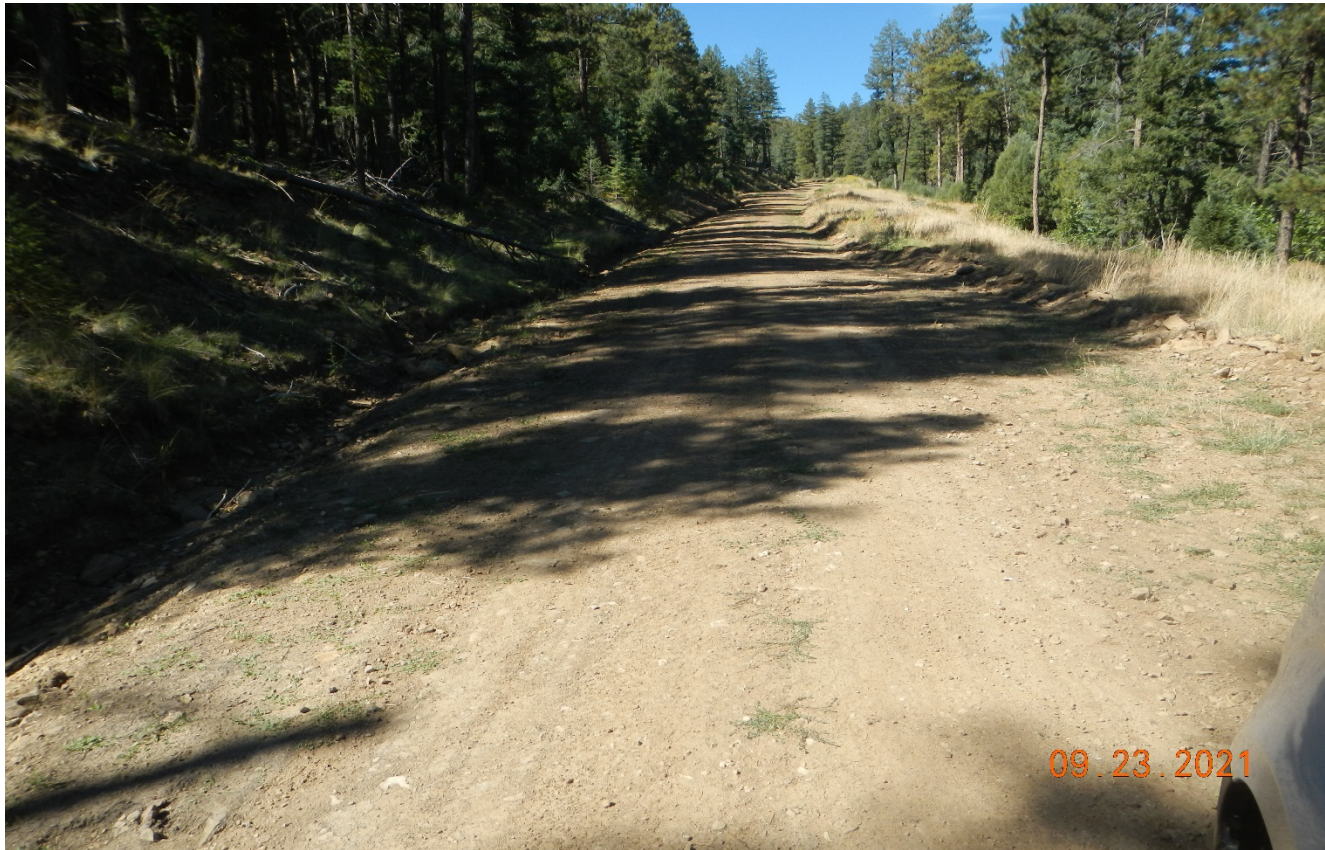
**Photo 5.** Facing west along the road ascending the hillside.

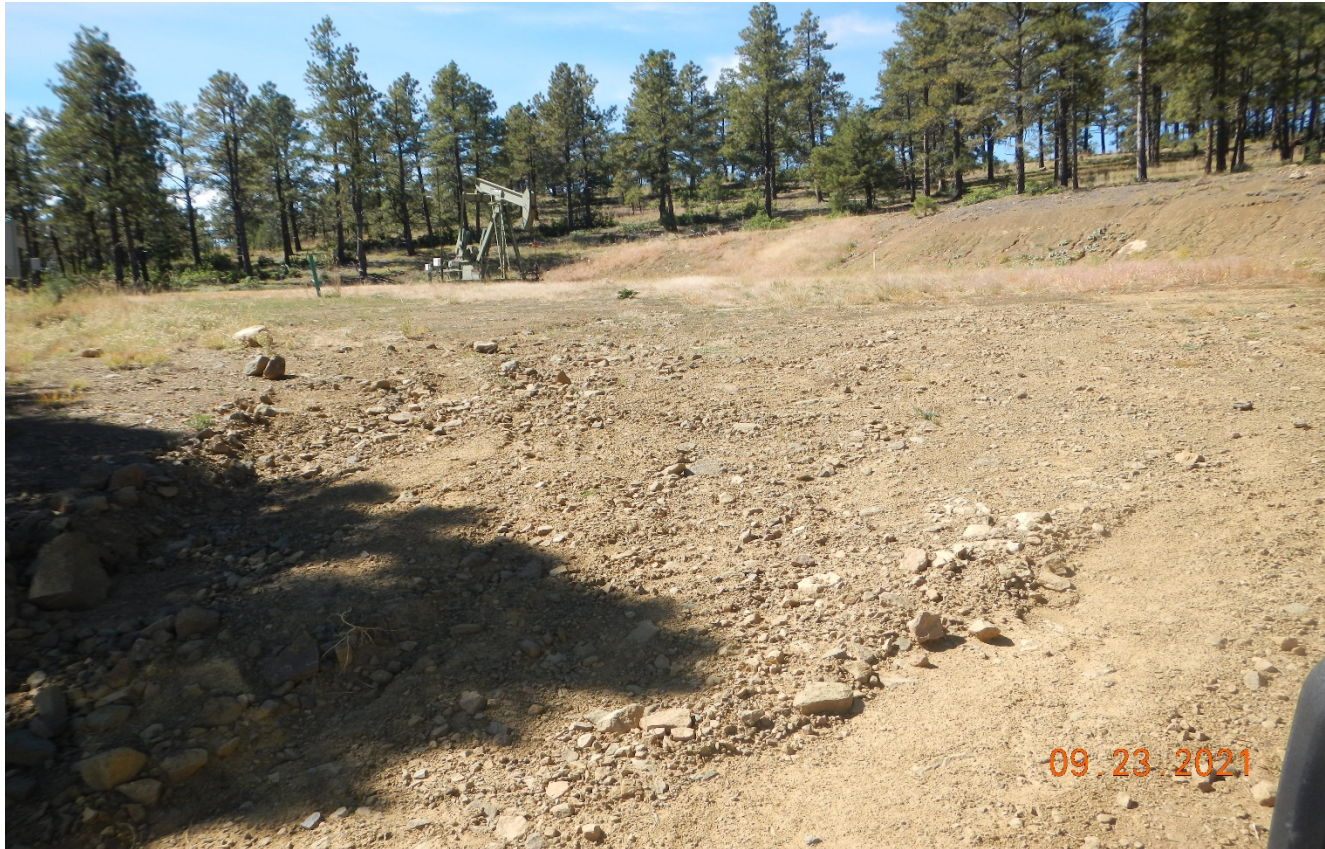
**Photo 6.** Facing southwest toward the location.

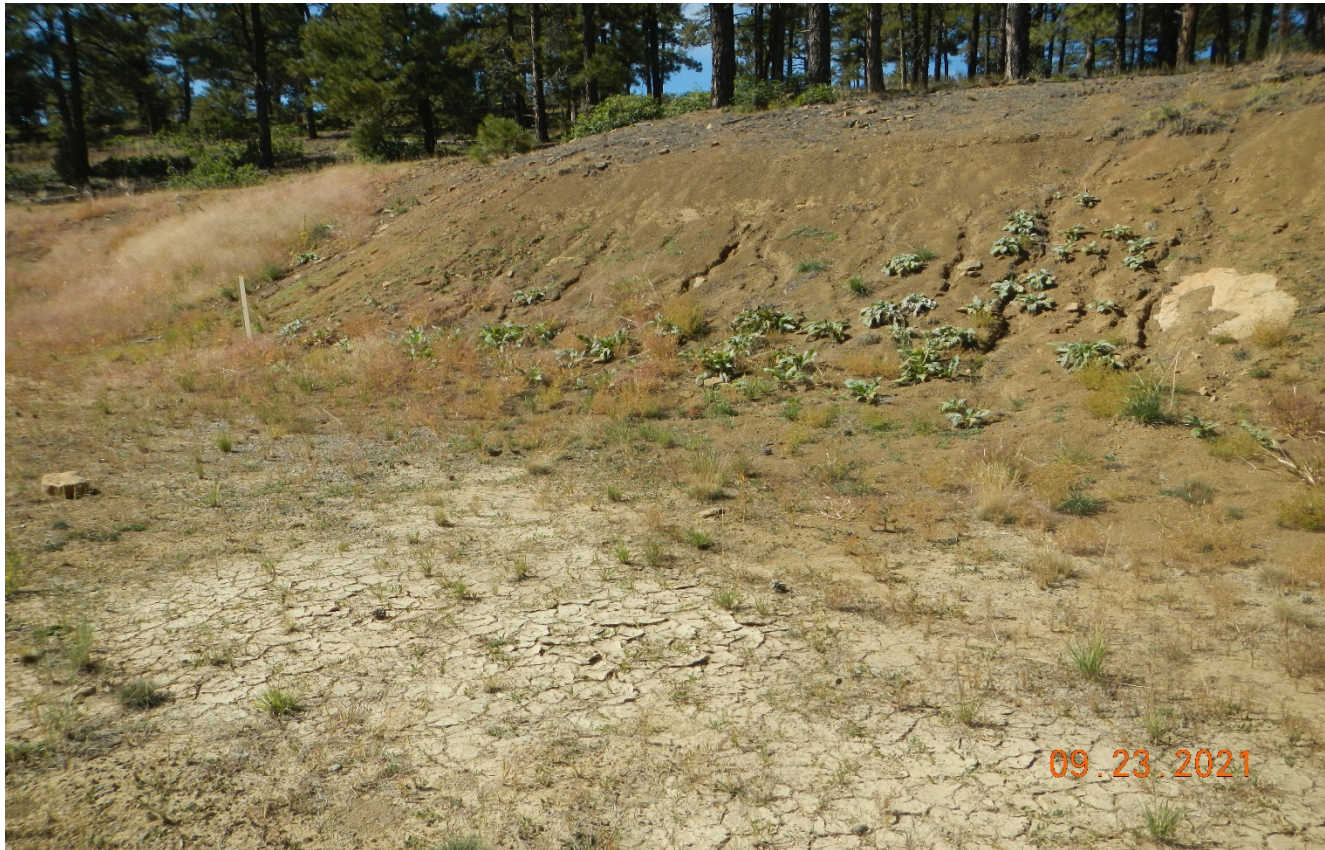
**Photo 7.** Facing toward the cut slope of the location. The noxious weeds along the cut slope were not controlled.
