Inspection Photos
Location Name: Marie Gerhardt B 2
Location ID: 317863

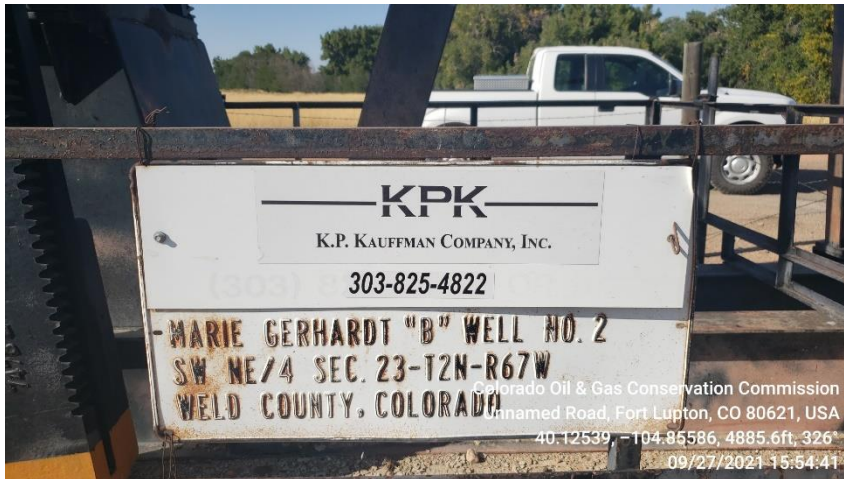
Photo 1 WH sign

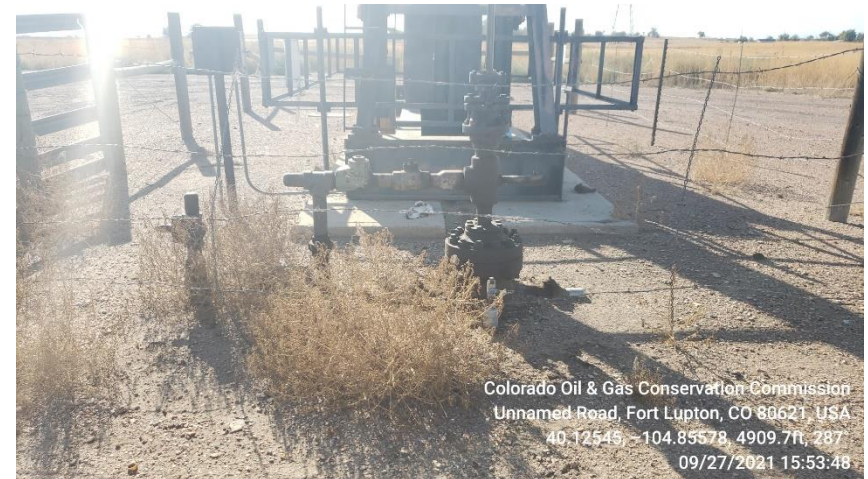
Photo 2 weeds growing around WH

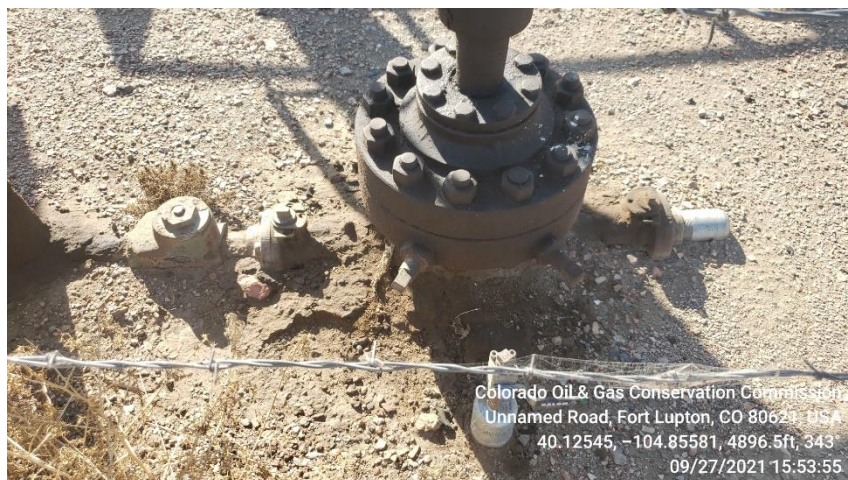
Photo 3 Stained soil around WH

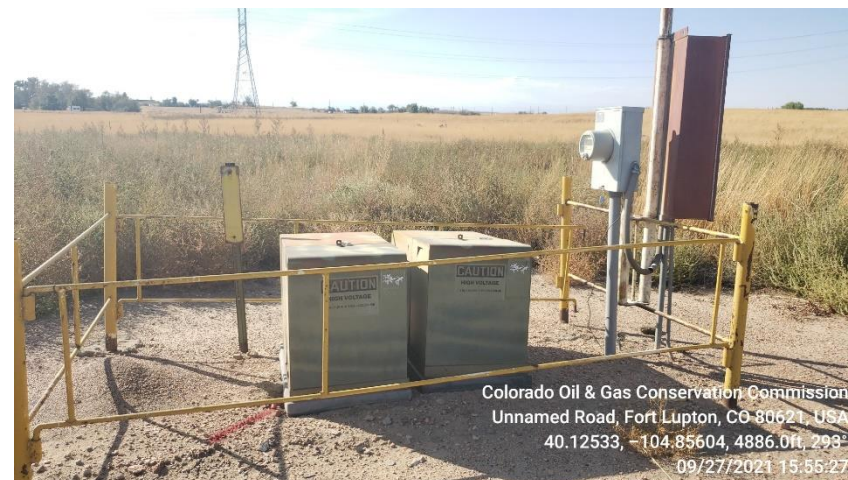
Photo 4 ancillary equipment

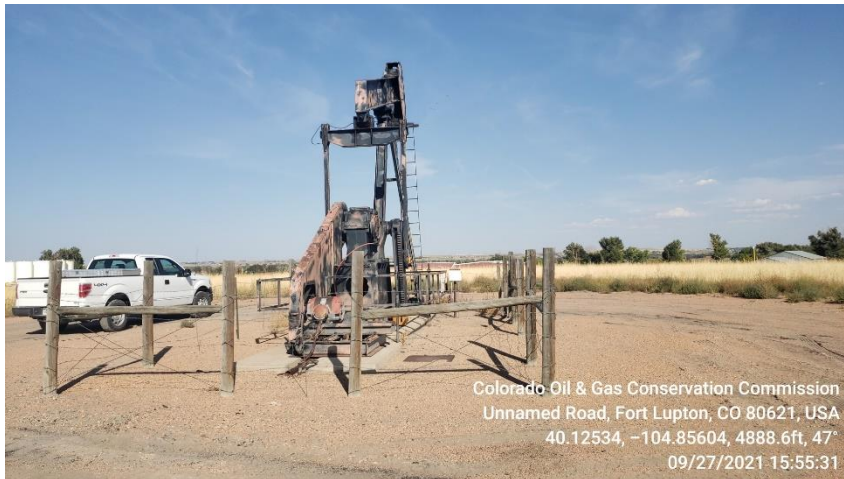
Photo 5 Pump Jack

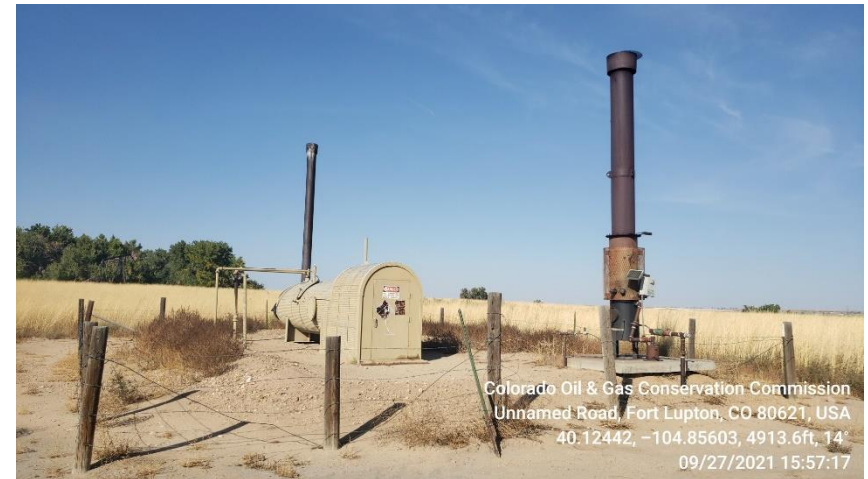
Photo 6 Horiz. Heated Sep., ECD

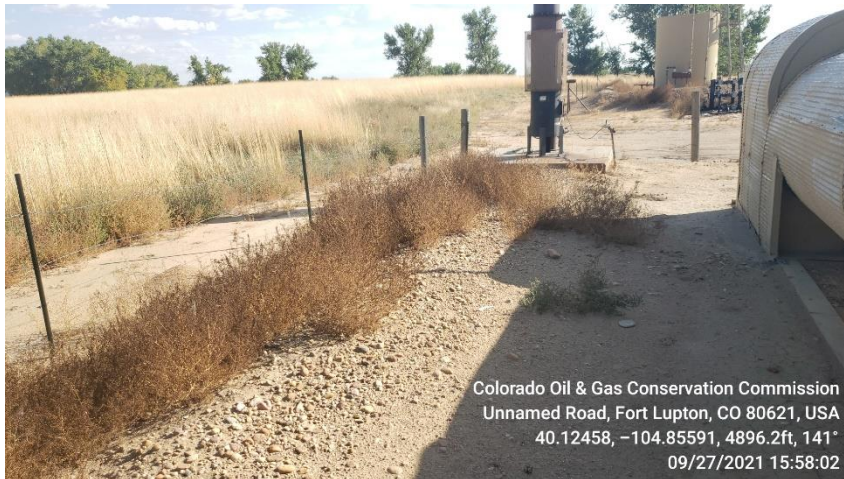
Photo 7 dead weeds inside Separator/ECD fencing

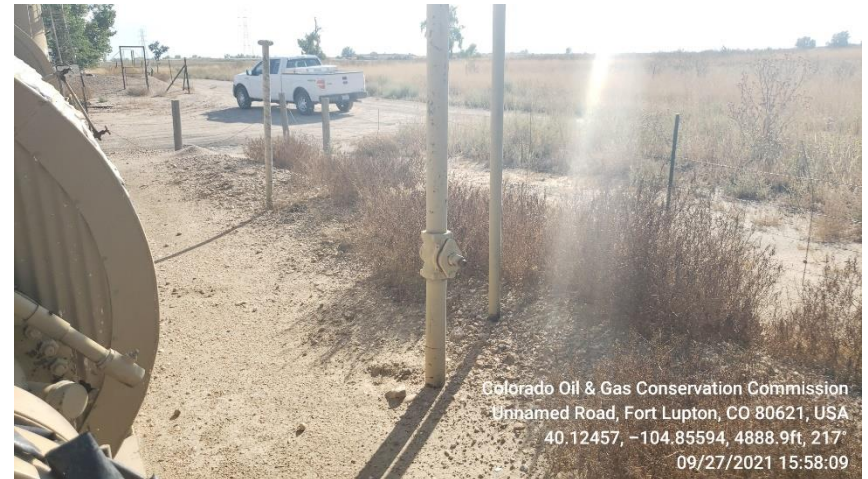
Photo 8 dead weeds inside Separator/ECD fencing

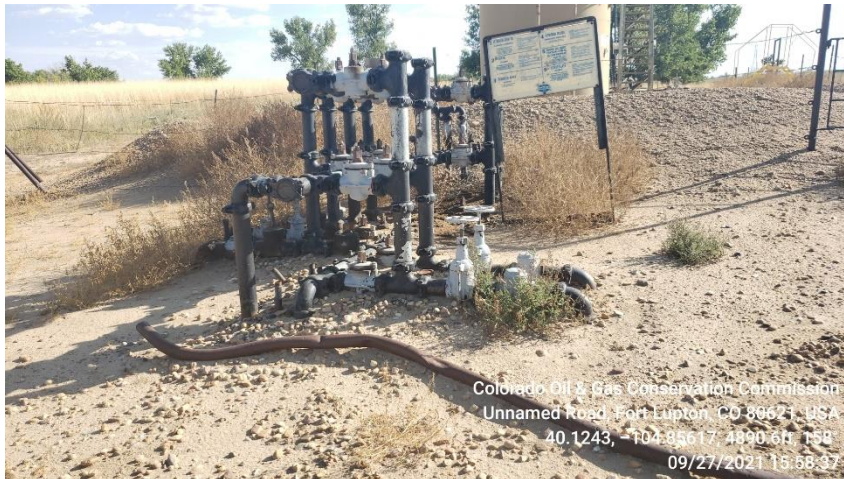
Photo 9 Flow line manifold

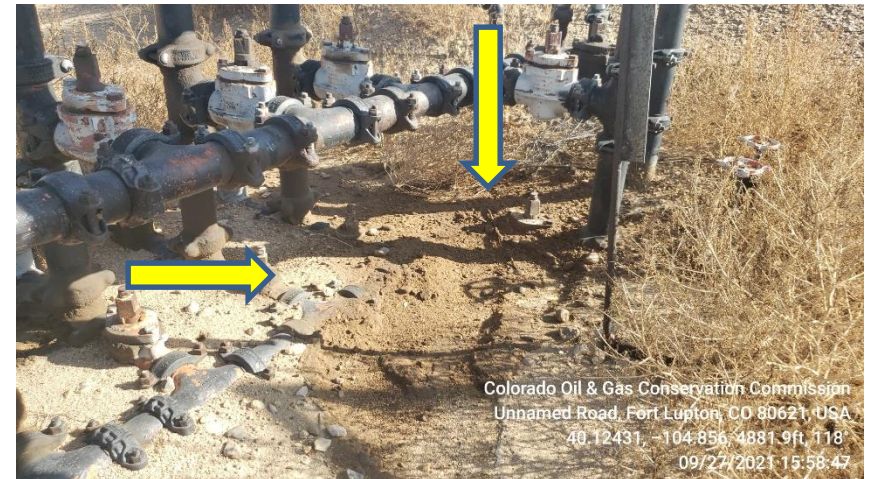
Photo 10 Stained soil by the flow line manifold

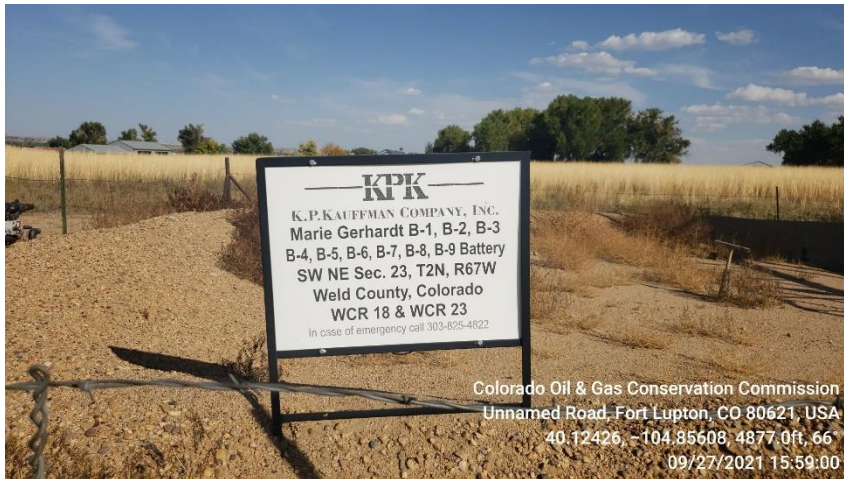
Photo 11 TB sign

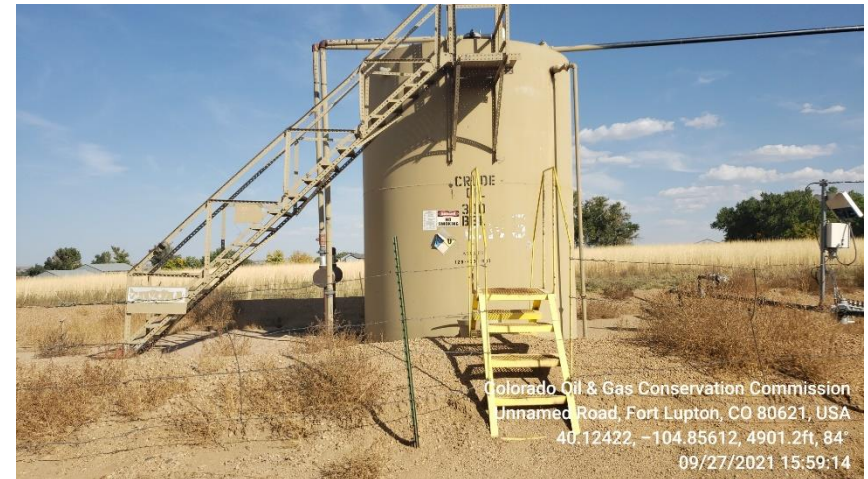
Photo 12 TB

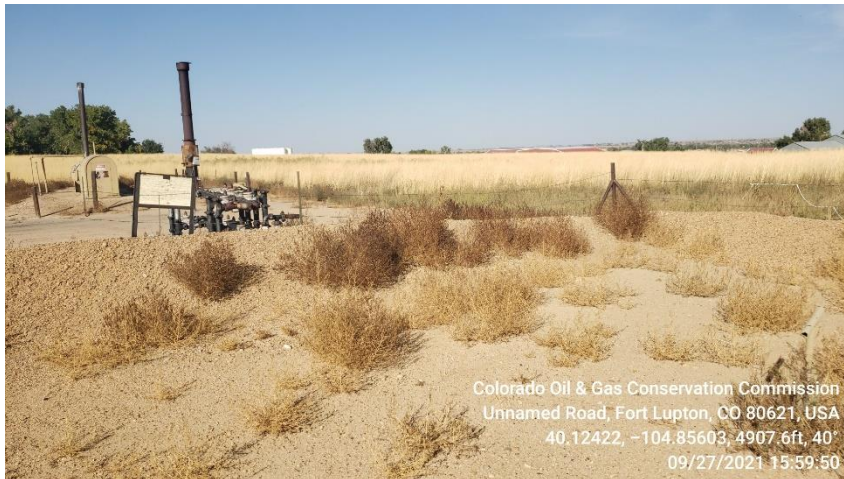
Photo 13 Dead weeds in TB berm

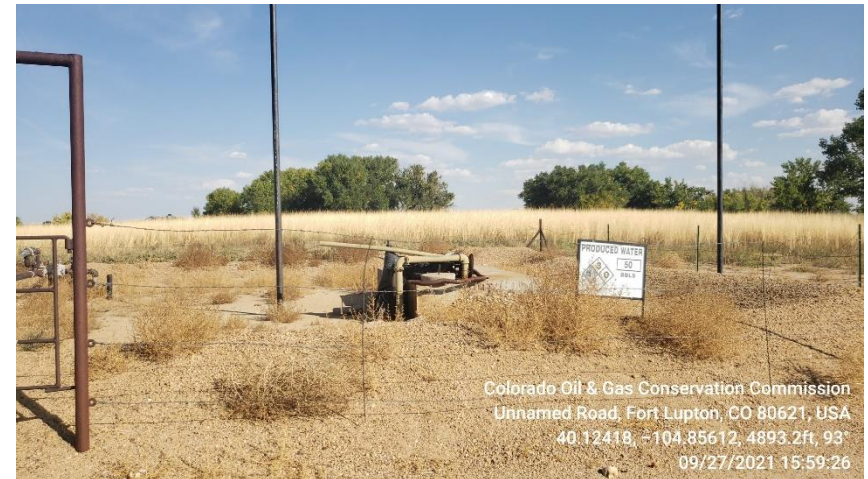
Photo 14 Dead weeds around PW vessel

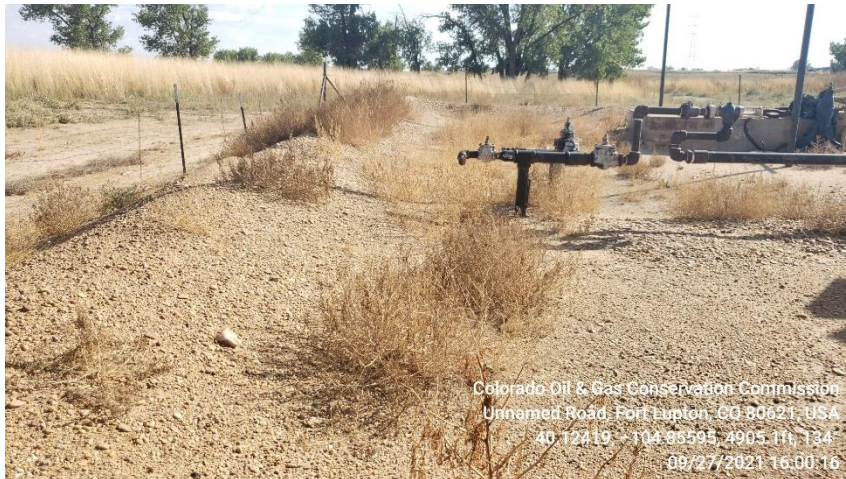
Photo 15 Dead weeds in TB berm

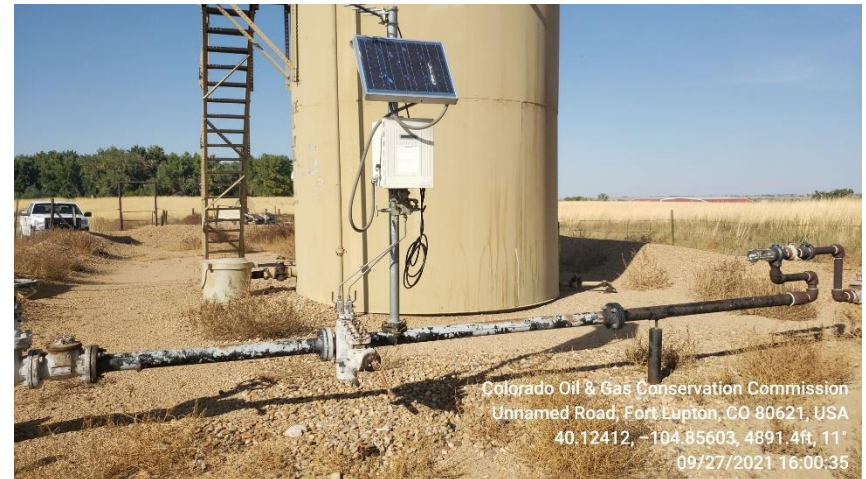
Photo 16 Dead weeds in TB berm, Gas Meter Run

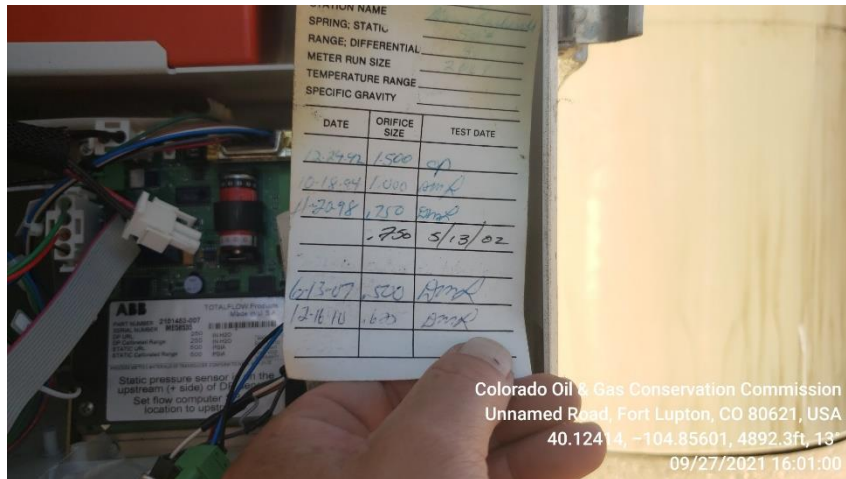
Photo 17 Card in meter box indicates that calibration is not current

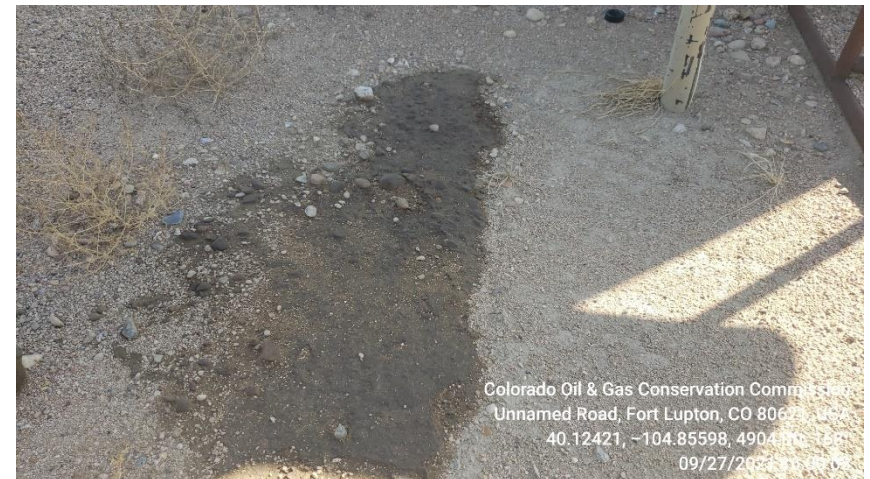
Photo 18 Stained soil by Crude tank

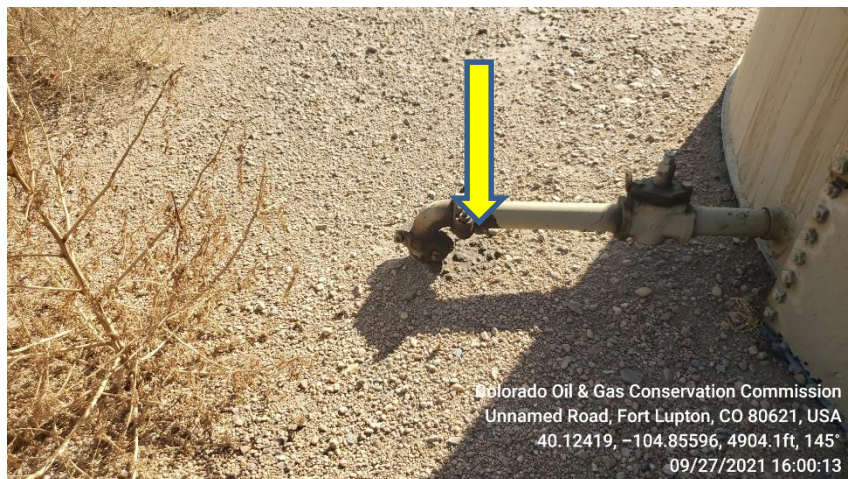
Photo 17 Stained soil by Crude tank flow line
