Attachment B

SITE NAME: Booth 7-26							DATE: 6/30/2021	REM. PROJECT #: 18518	WEATHER: Sunny, 80s.		
SITE DIRECTIONS: 1 mile north on CR 47 from CR 76. West on access road around Saxon Lake. Follow access road as t							CLIENT: PDC/Delbert Pace				
LEGALS AND LAT/LONG: 40.551485 -104.628950							TASMAN PERSONNEL: Tyler Murrel				
SOIL TYPES: Clayey Sand - SC							SURFACE GRADIENT: Northeast				
SOIL SAMPLING							FACILITY INFRASTRUCTURE				
Date/Time	Soil Sample ID	PID (ppm)	Visual	Olfactory	Photo?	Grab or Lab Sample?	EQUIPMENT		Quantity		
							Above Ground Storage Tank (AST)		0		
6/30/2021 12:06	WH01 @ 6'	3.4	No Staining	No Odor	Yes	Lab	Buried or Partially Buried Vessel		0		
6/30/2021 12:13	FLR01 @ 2.5'	0.3	No Staining	No Odor	Yes	Lab	Separator		0		
6/30/2021 15:25	FLR01-B @ 7'	3.6	No Staining	No Odor	Yes	Lab	Emission Control Device (ECD)		0		
6/30/2021 12:44	WHS01-N @ 0-6"	0.0	No Staining	No Odor	Yes	Grab	Dump Line		0

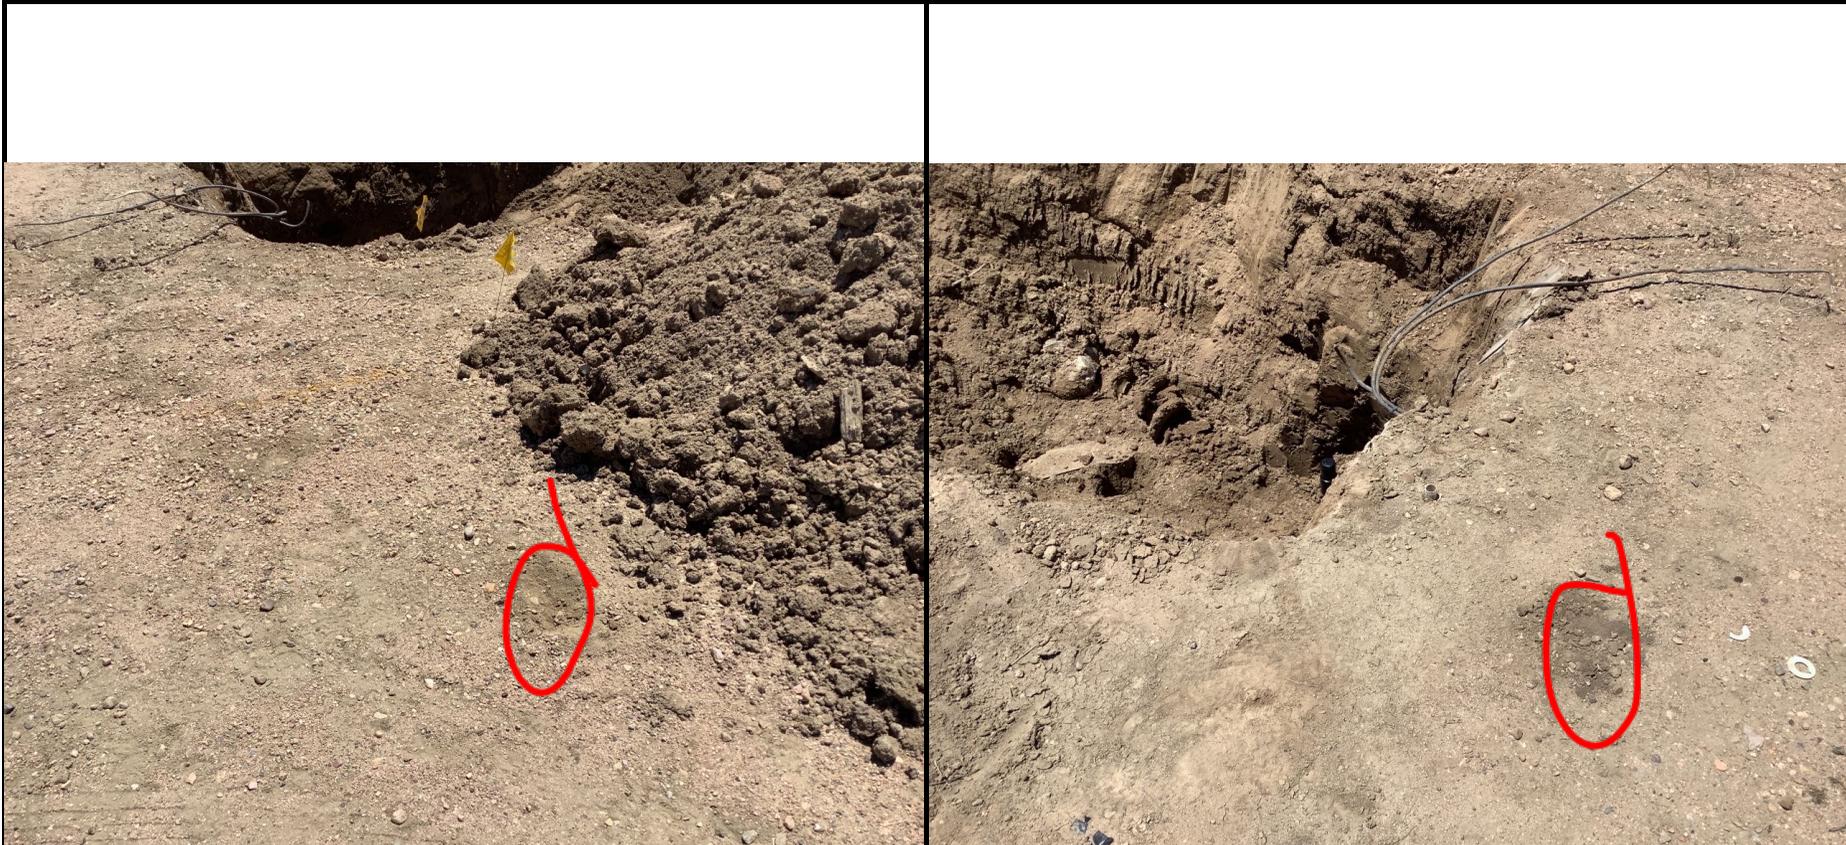
Notes/Conditions: WHS01-W @ 0-6"

Notes/Conditions: WHS01-N @ 0-6"

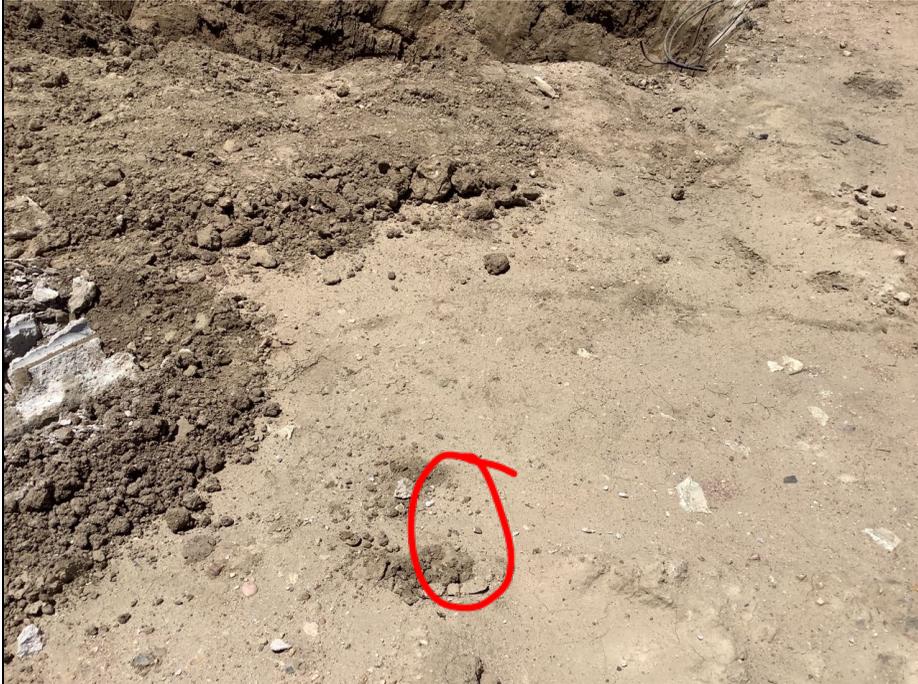
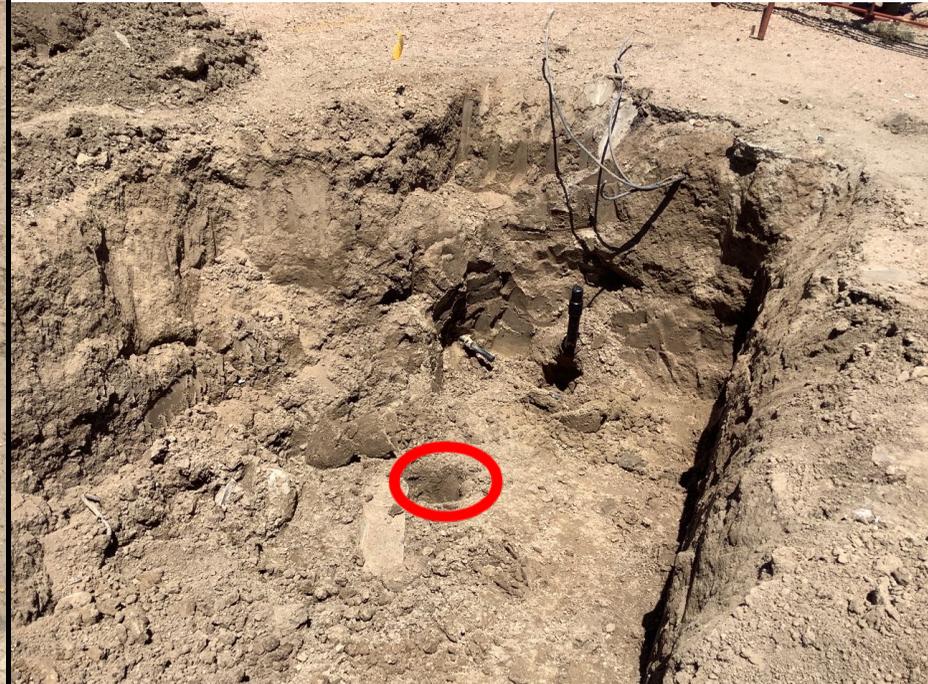
Material:	Volume:	Contents:	Material:	Volume:	Contents:
Notes/Conditions: WHS01-E @ 0-6"			Notes/Conditions: WH01 @ 6" Cut and capped flowline at riser

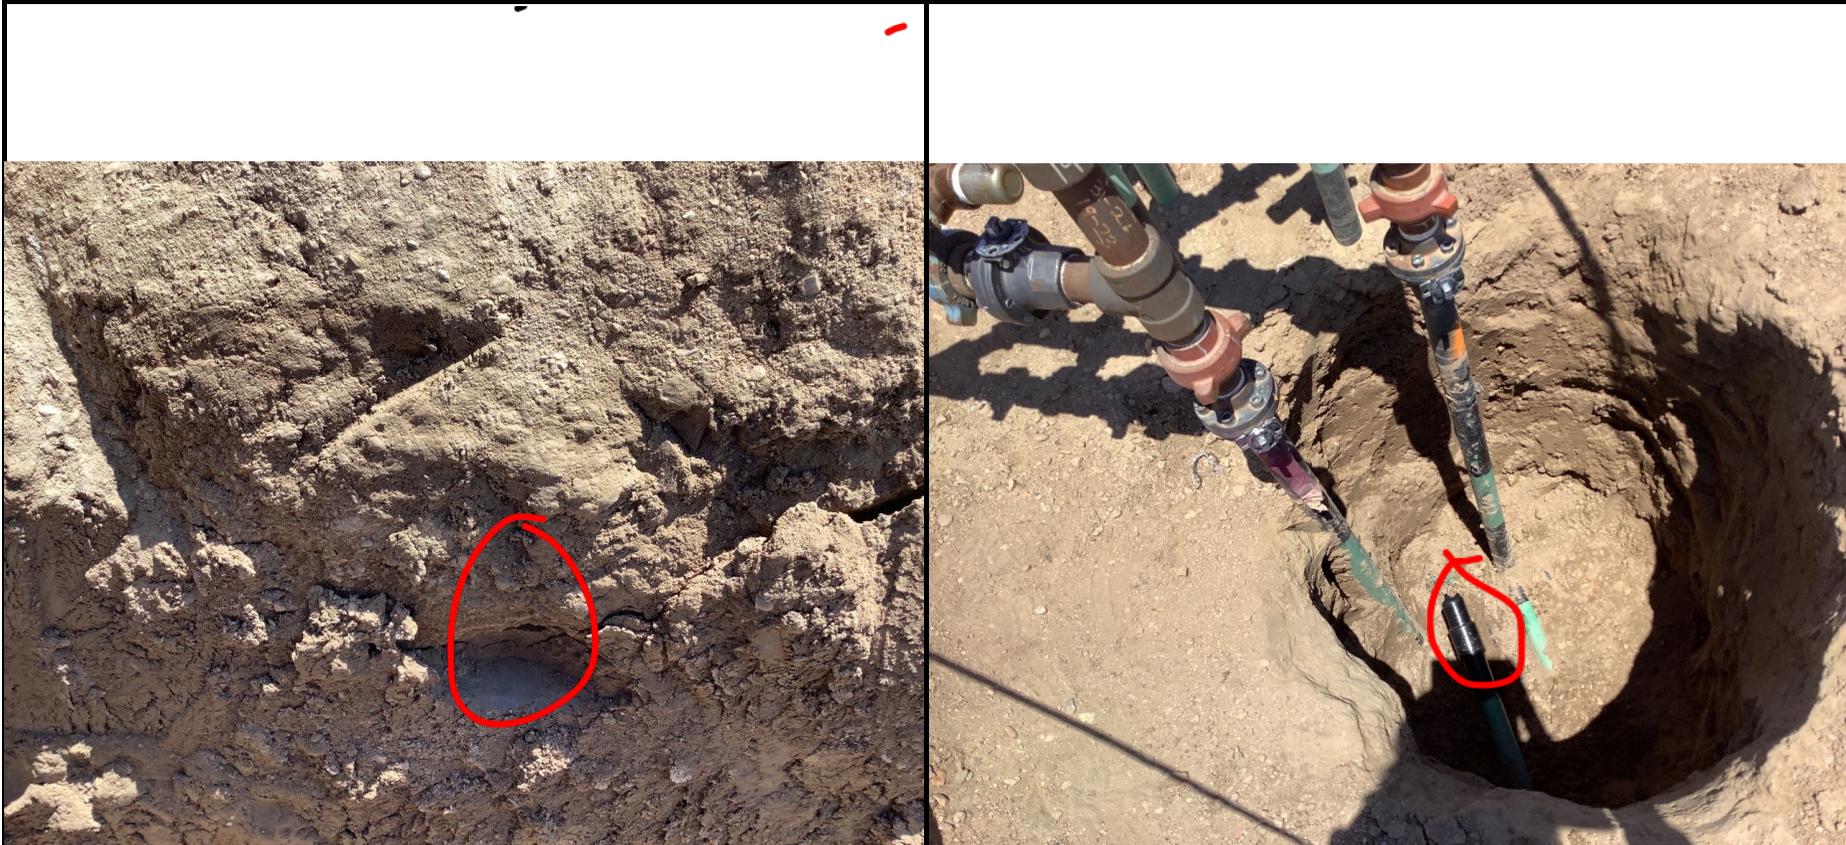
Equipment ID:		Equipment Type:	
Material:	Volume:	Contents:	
Notes/Conditions: FLR01 @ 2.5'

Equipment ID:		Equipment Type:	
Material:	Volume:	Contents:	
Notes/Conditions: FL01-01 @ 5' sample collected adjacent to cut and capped flowline at separator

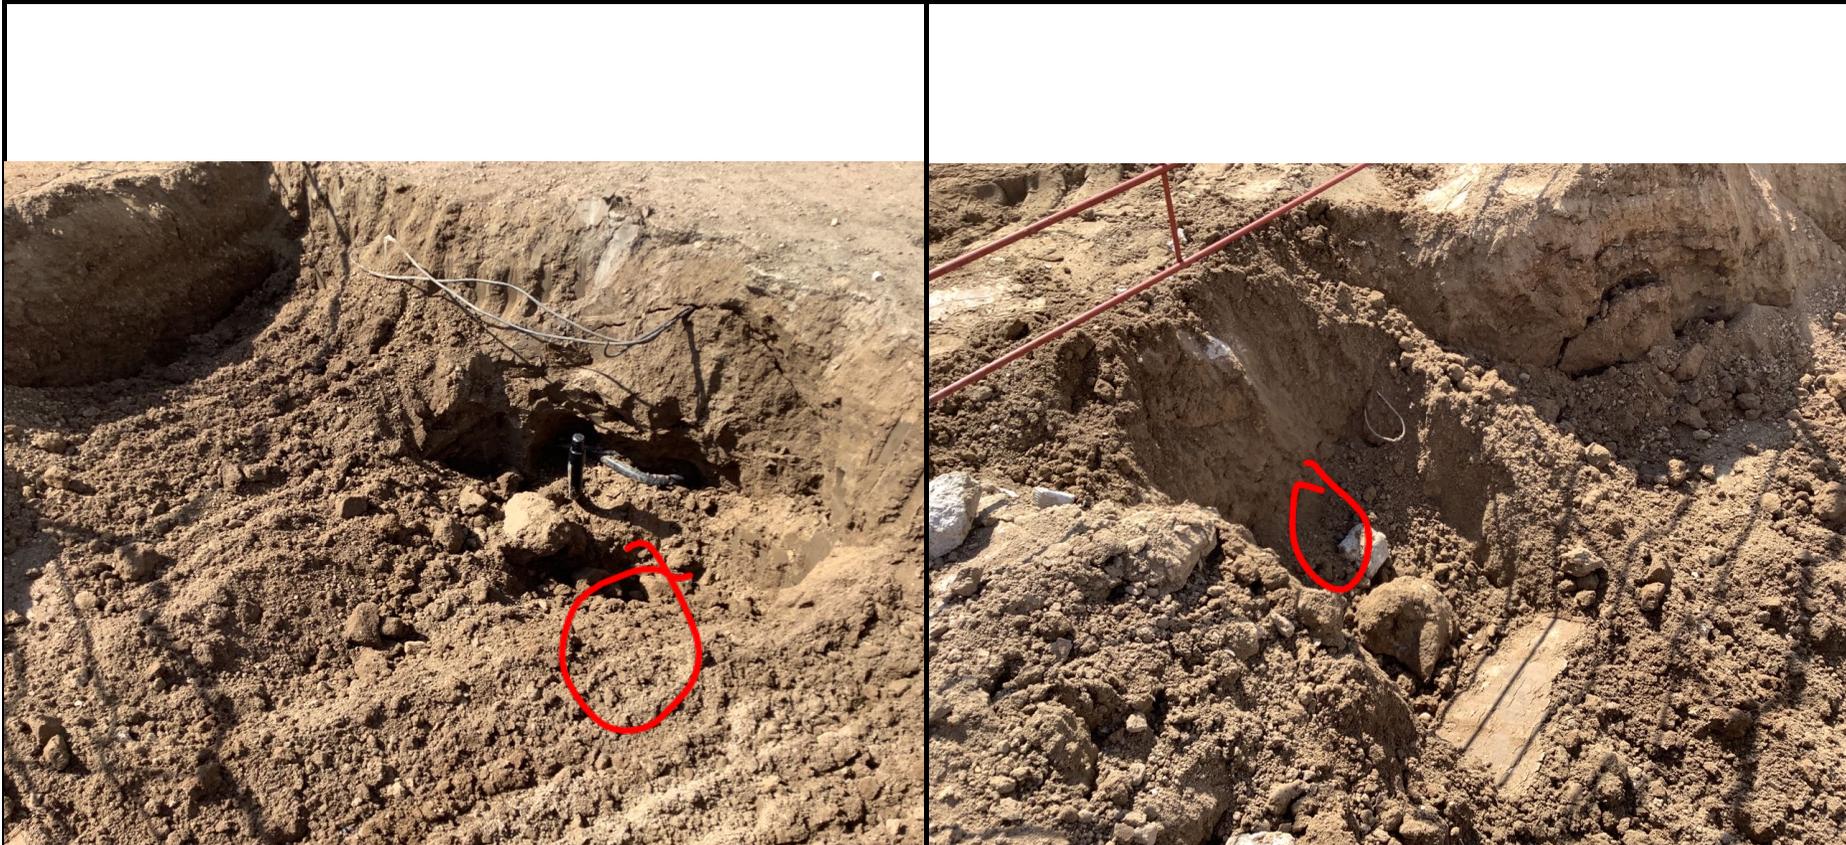
Notes/Conditions: FLR01-B @ 7'
Crew started backfill before photos started.

Notes/Conditions: FLR01-S @ 3'
Crew started backfill before photos started.

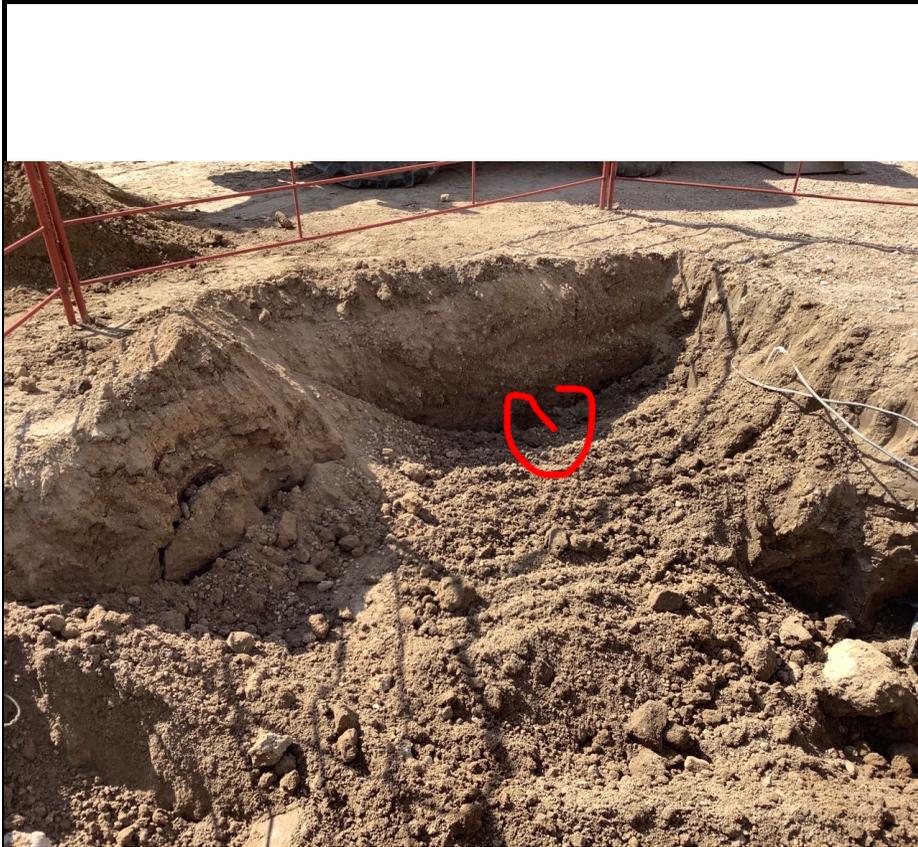
Notes/Conditions: FLR01-W @ 3'
Crew started backfill before photos started.

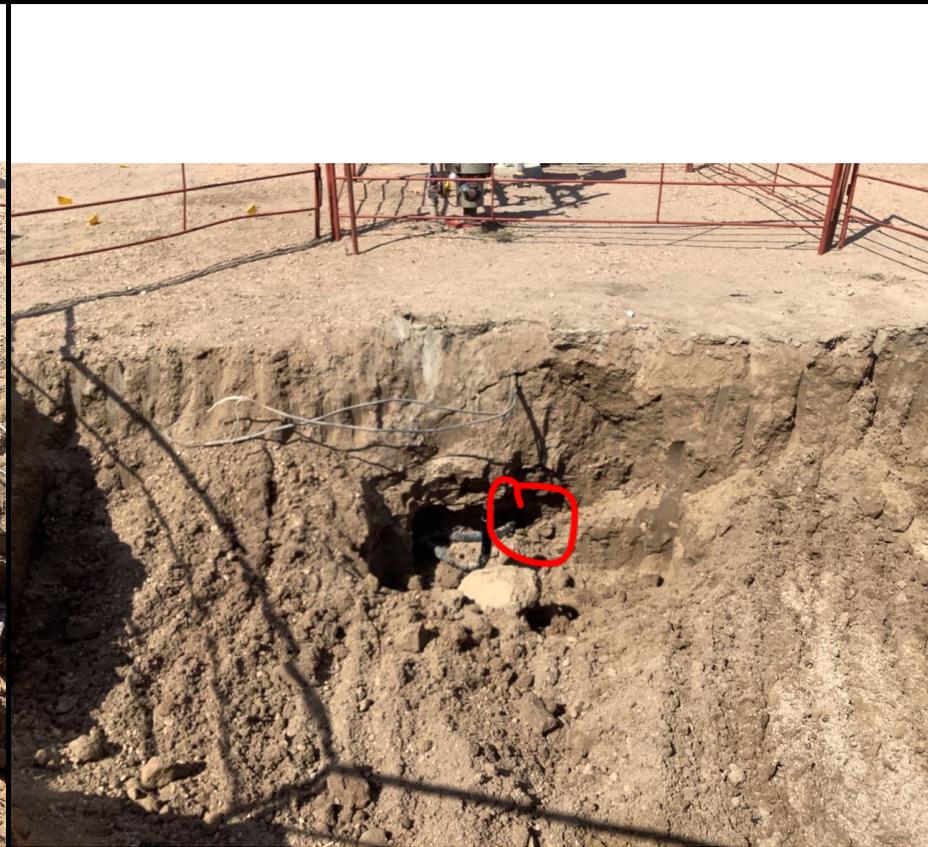
Notes/Conditions: FLR01-N @ 3'
Crew started backfill before photos started.

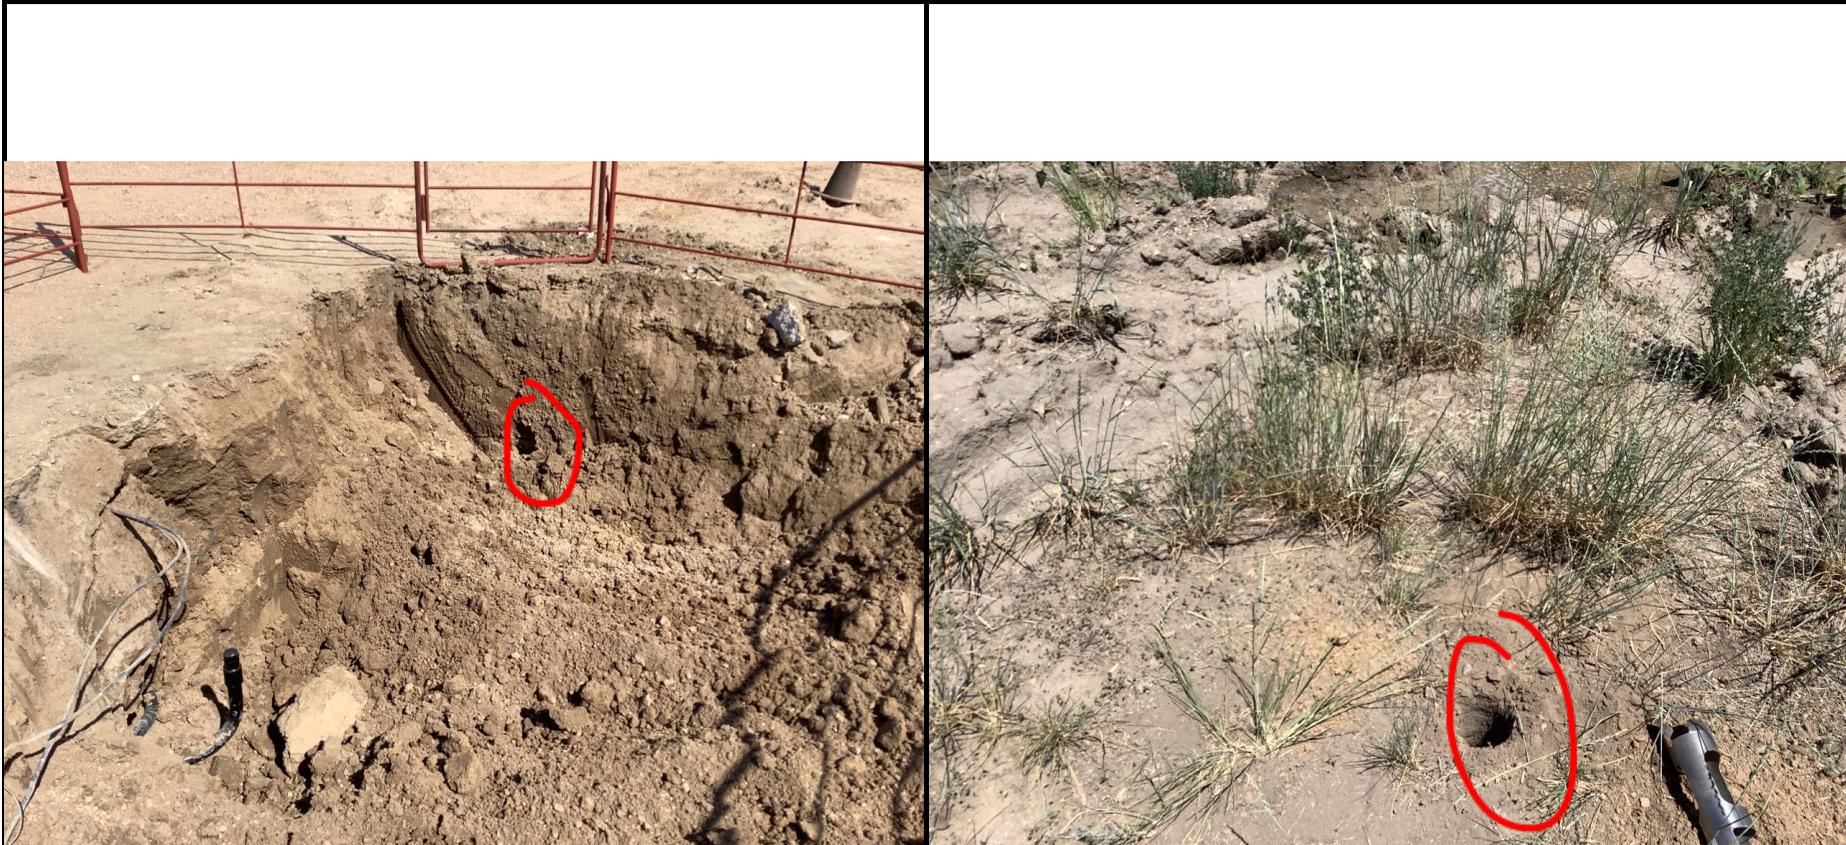
Equipment ID:		Equipment Type:		Equipment ID:		Equipment Type:	
Material:	Volume:	Contents:		Material:	Volume:	Contents:	
Notes/Conditions: FLR01-E @ 3' Crew started backfill before photos started.				Notes/Conditions: BKG01 @ 2.5'
