Inspection Photos

9/24/2021

Operator: GUNNISON ENERGY LLC # 10515

Location ID: 453805

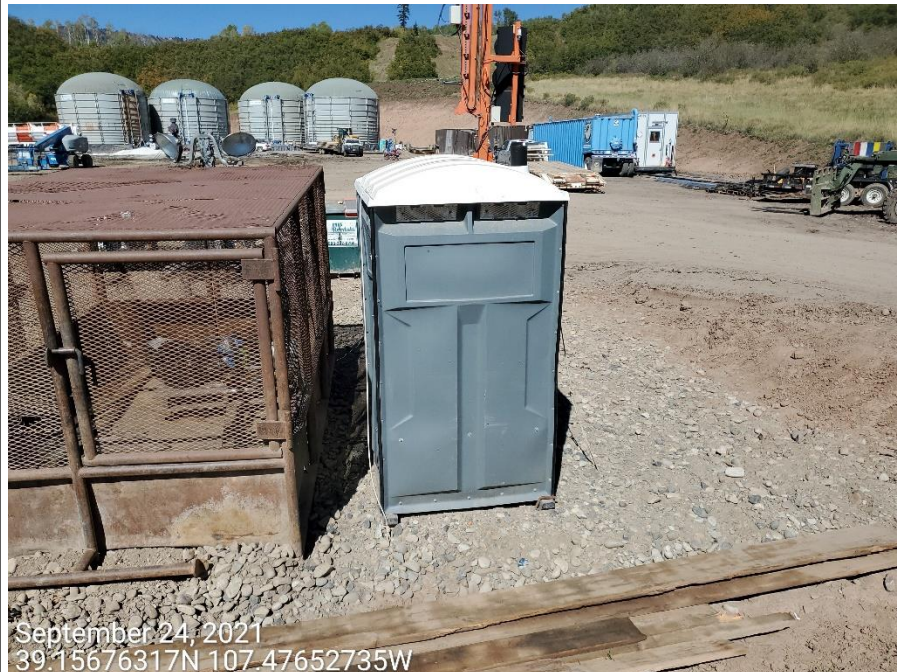
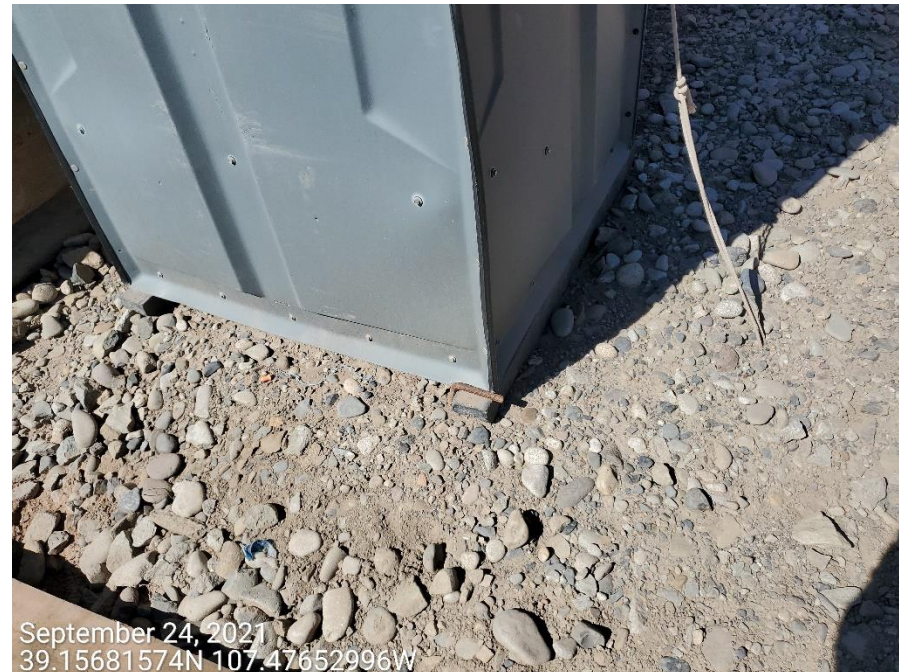
Photo 1: Photo taken from the south end of the Location. Photo shows 1 of the 2 porta-johns on the Location. Photo shows porta-john has been properly secured

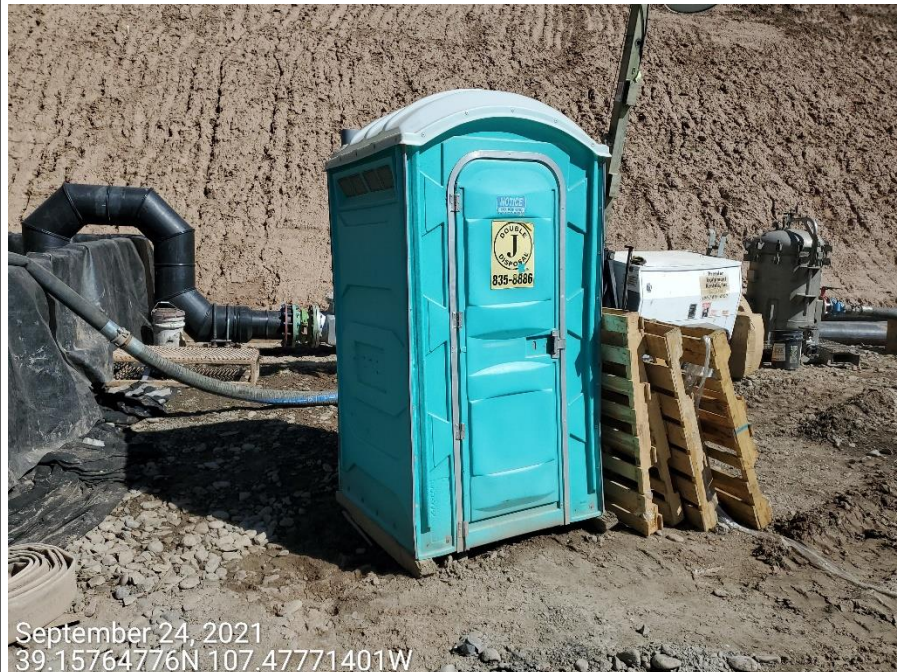
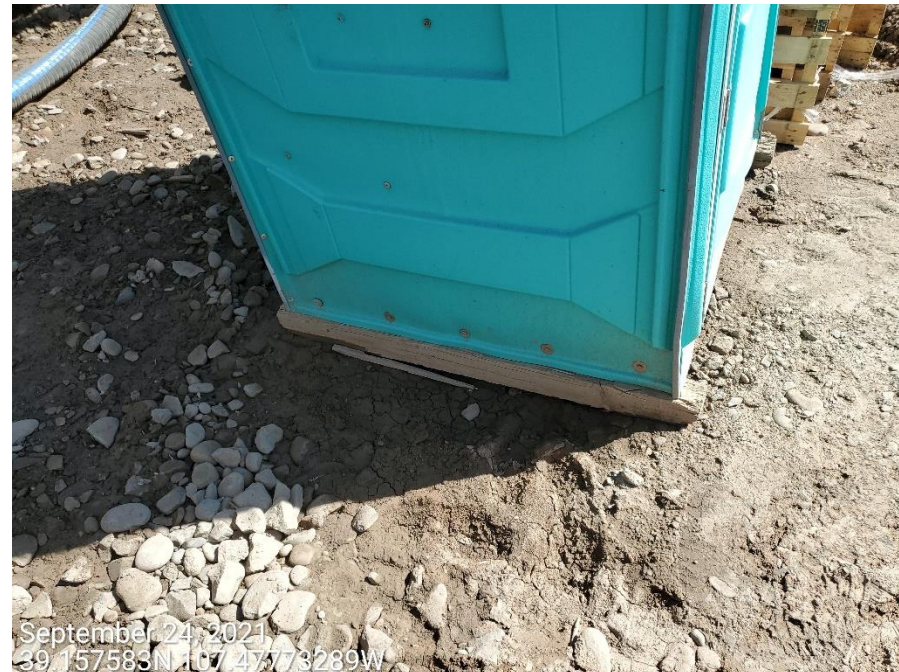
Photo 2: Photo taken from the north end of the Location. Photo shows second porta-john on the Location. Photo shows porta-john has NOT been properly secured per corrective actions,.

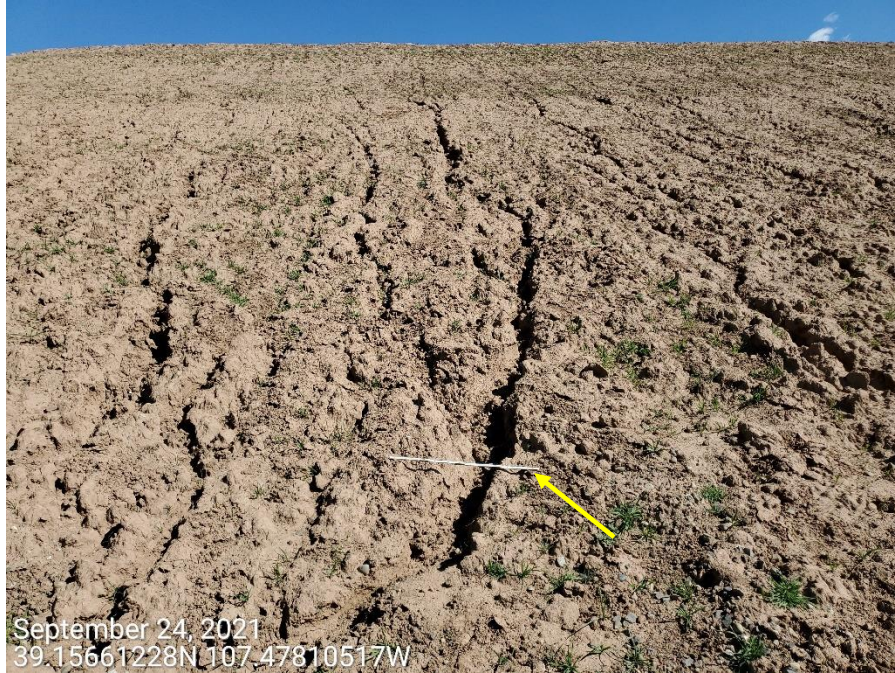
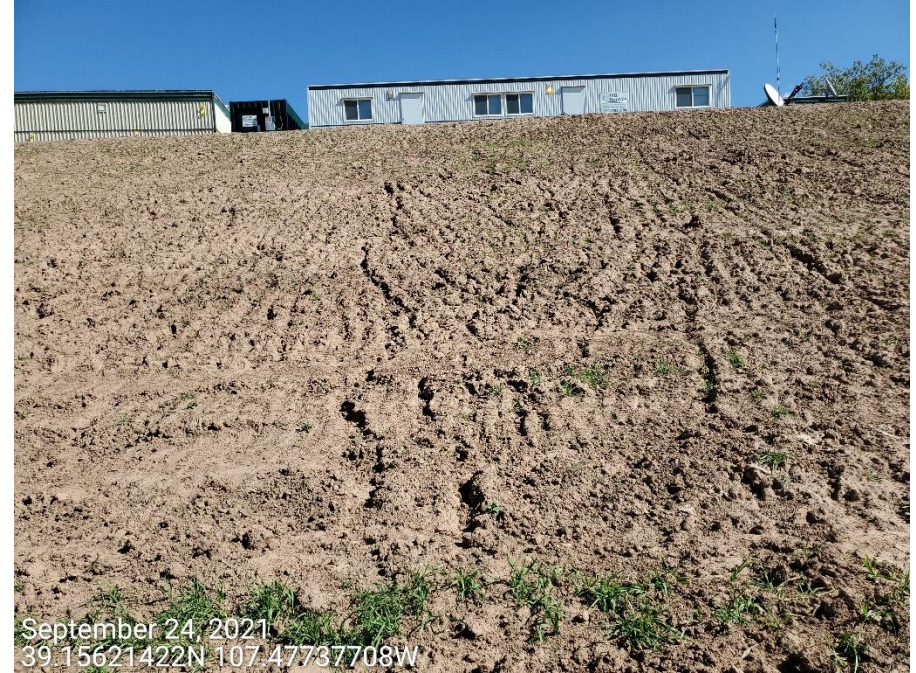
Photo 3: Photos taken from the fill slopes on the west end of the Location. Photo shows stormwater and erosion control measures to protect/stabilize the slopes of the location remain missing or inadequate. 2 foot measuring stick for reference.

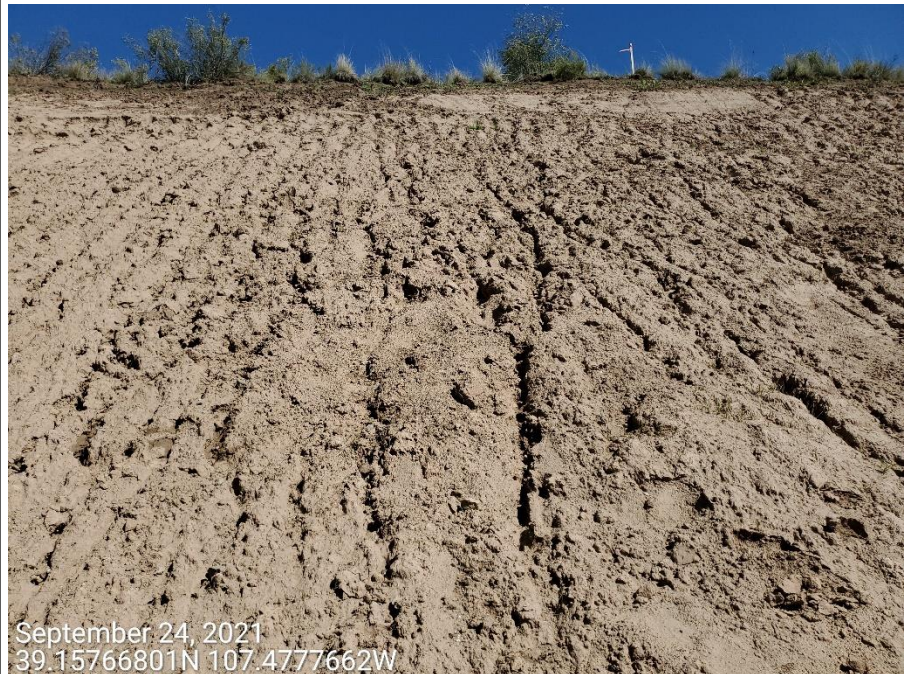
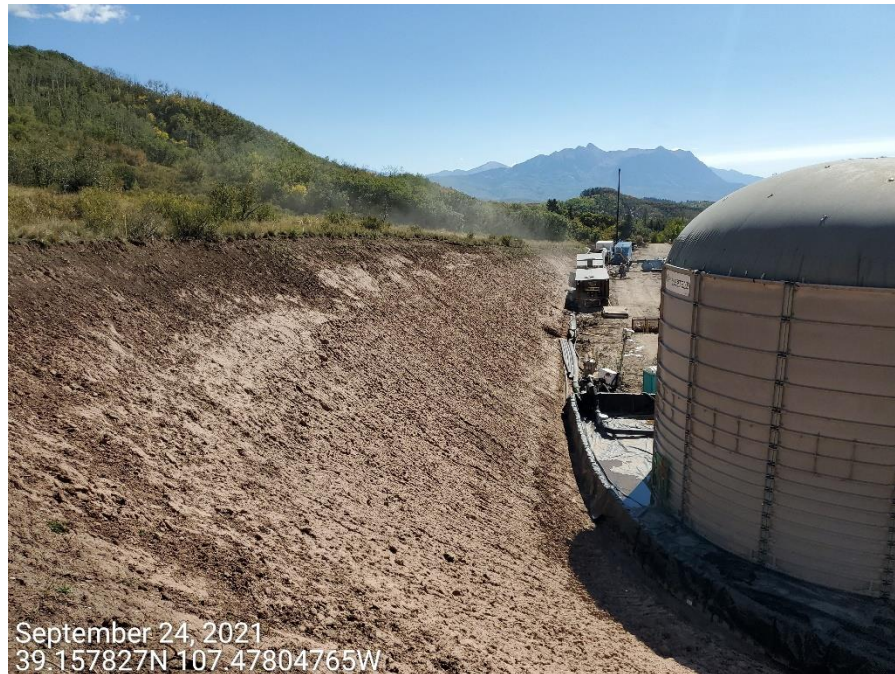
Photo 4: Photos taken from the cut slopes on the west end of the Location. Photo shows stormwater and erosion control measures to protect/stabilize the slopes of the location remain missing or inadequate.

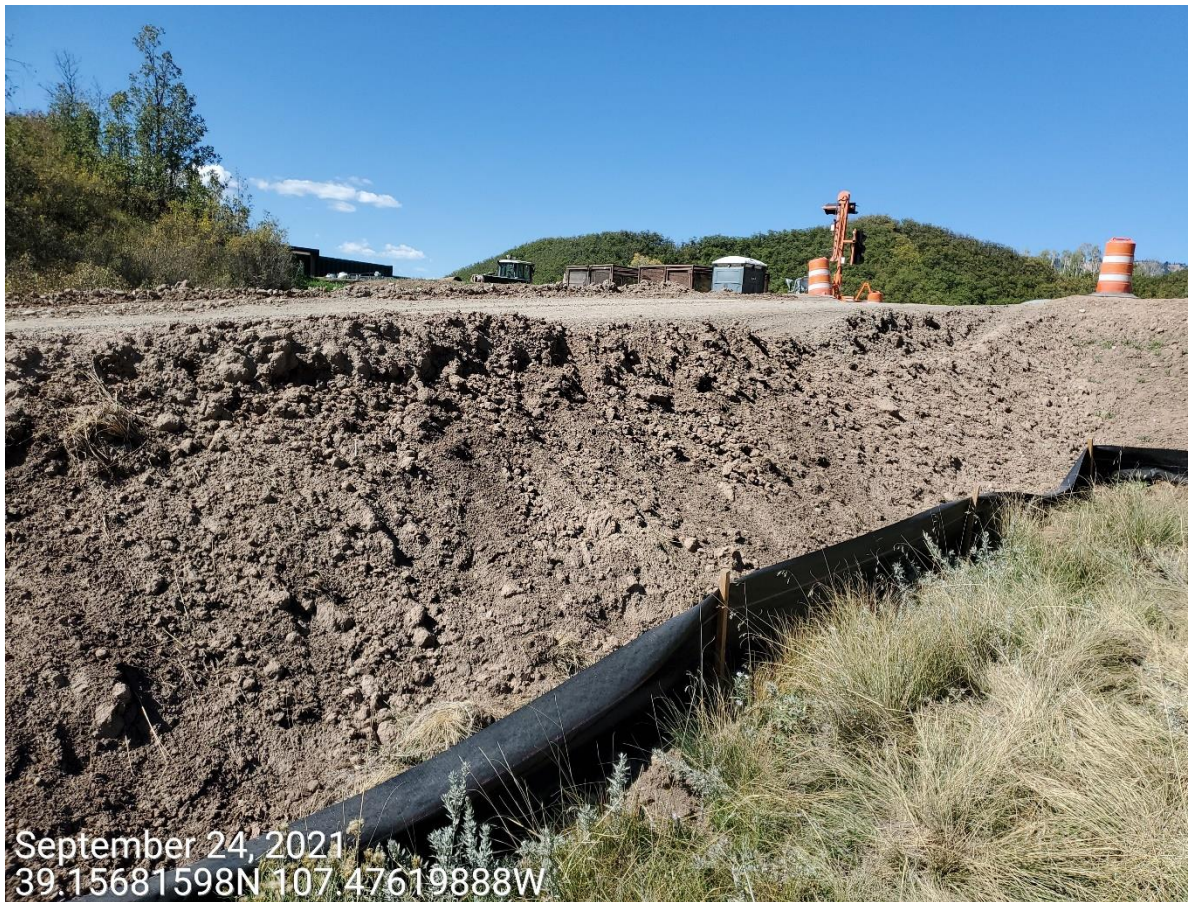
Photo 5: Photo taken from the fill slopes on the southeast end of the Location. Photo shows stormwater and erosion control measures to protect/stabilize the slopes of the Location remain missing or inadequate.

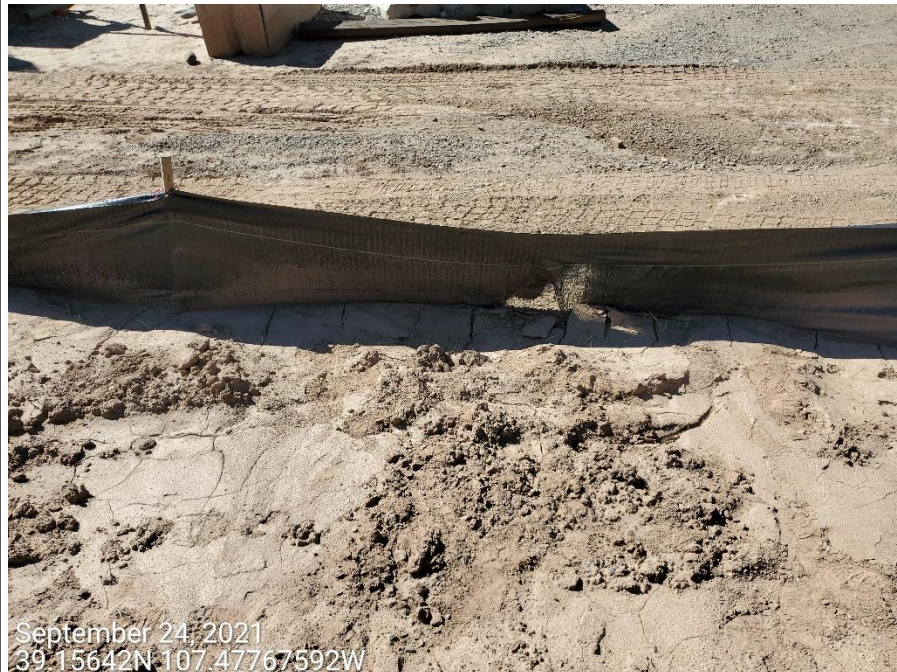
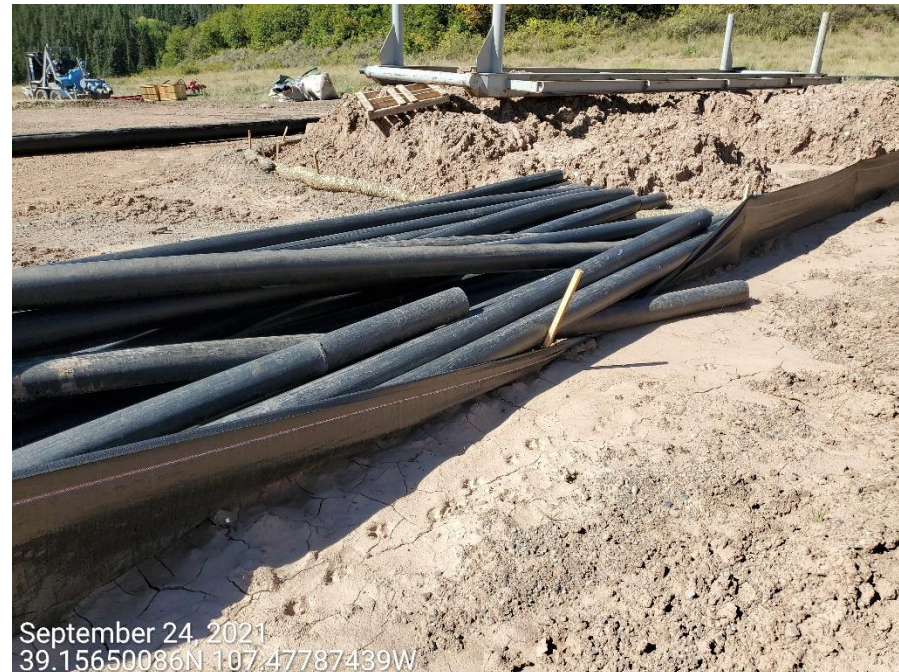
Photo 6: Photos taken from the western perimeter of the Location. Photo shows perimeter controls (silt fence) remain in improper functioning condition per good engineering practices.

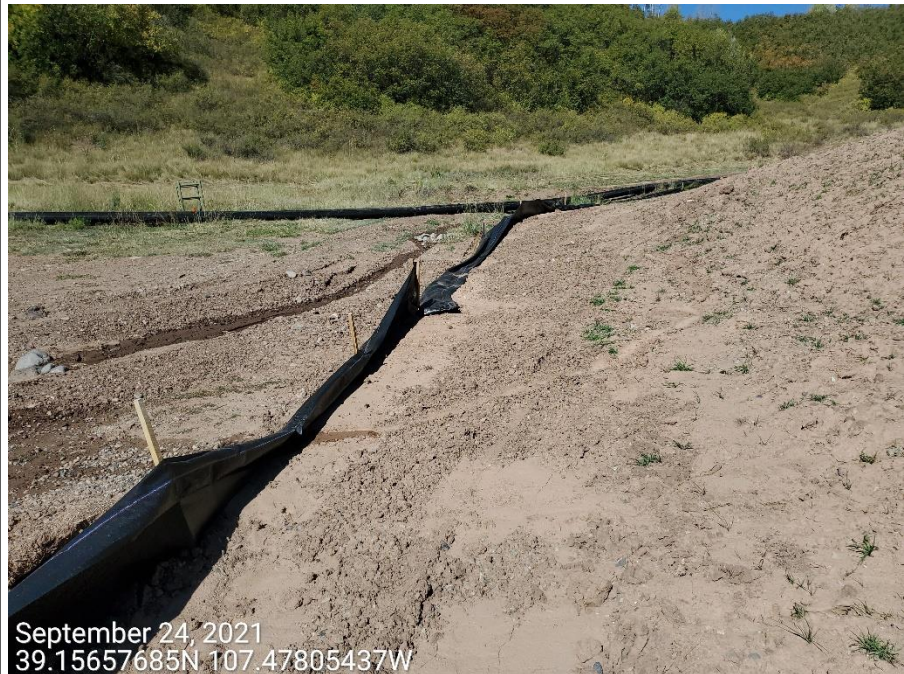
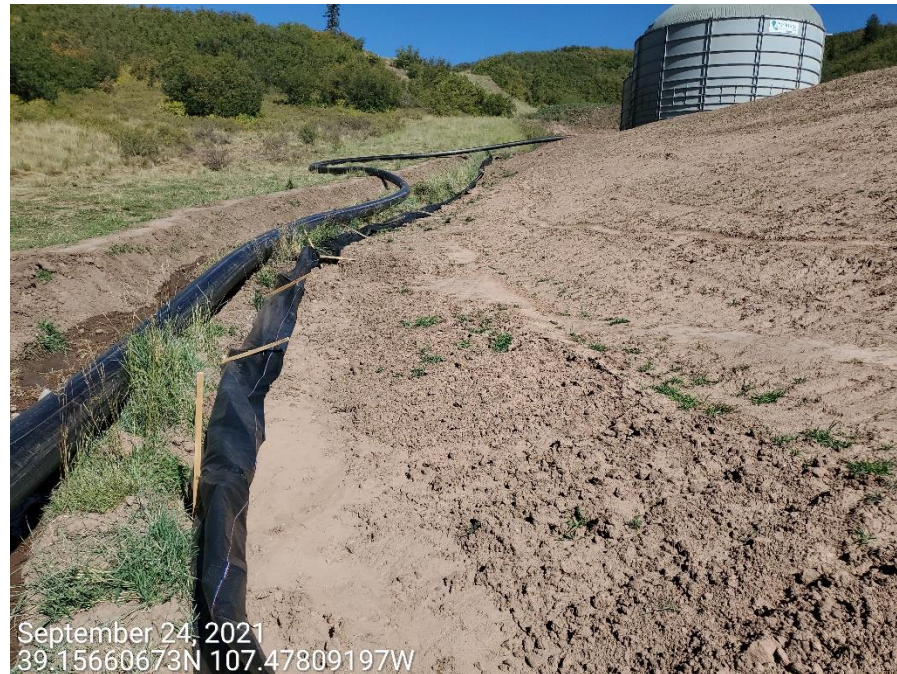
Photo 7: Photos taken from the western perimeter of the Location. Photo shows perimeter controls (silt fence) remain in improper functioning condition per good engineering practices.

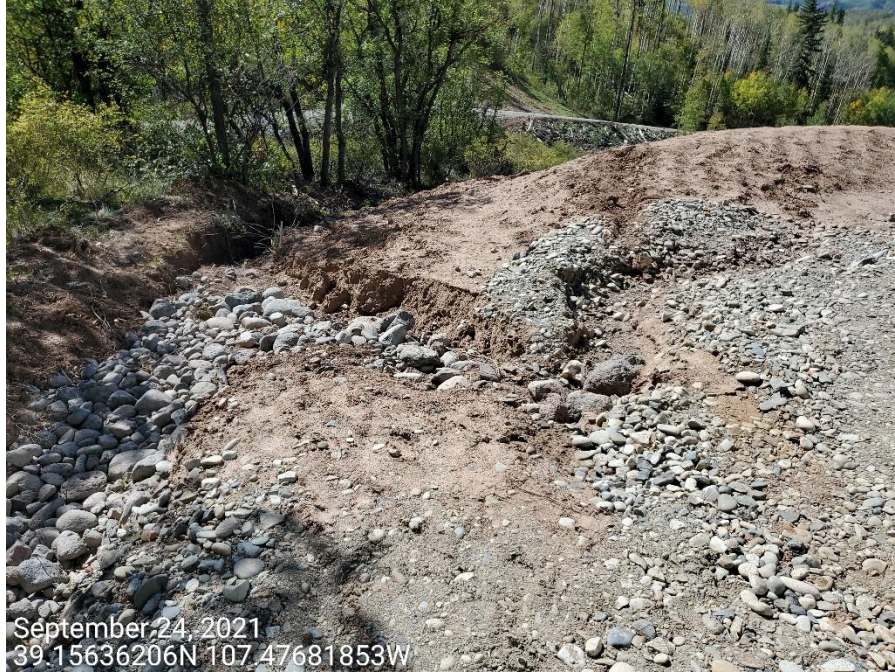
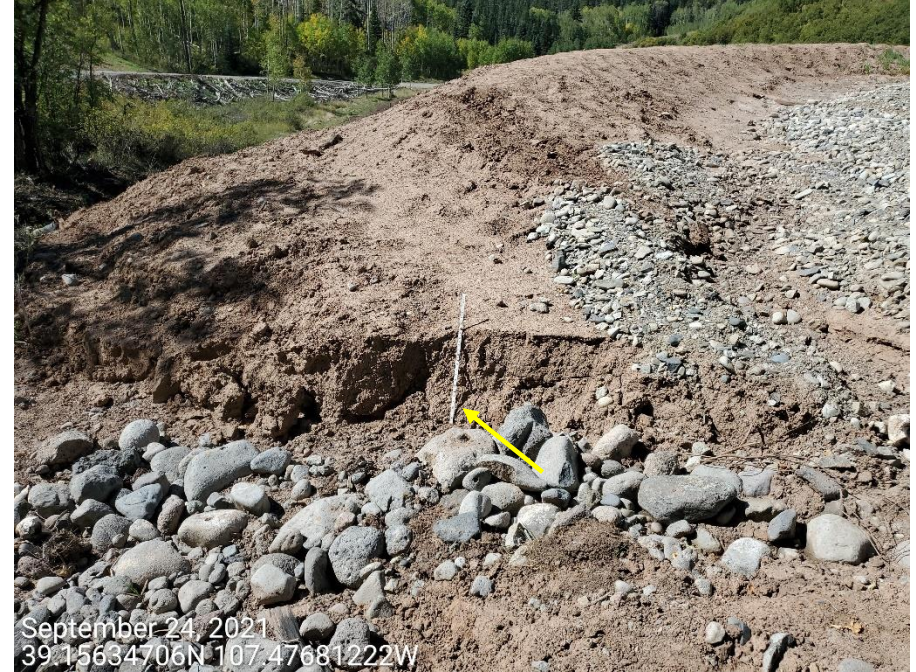
Photo 8: Photo taken from the southwest end of the pad. Photo shows that the stormwater outlets leading from the pad; erosion degradation remains evident at outlets; controls have not been installed in accordance with good engineering practices, or maintained in proper functioning condition. Two foot measuring stick for reference.

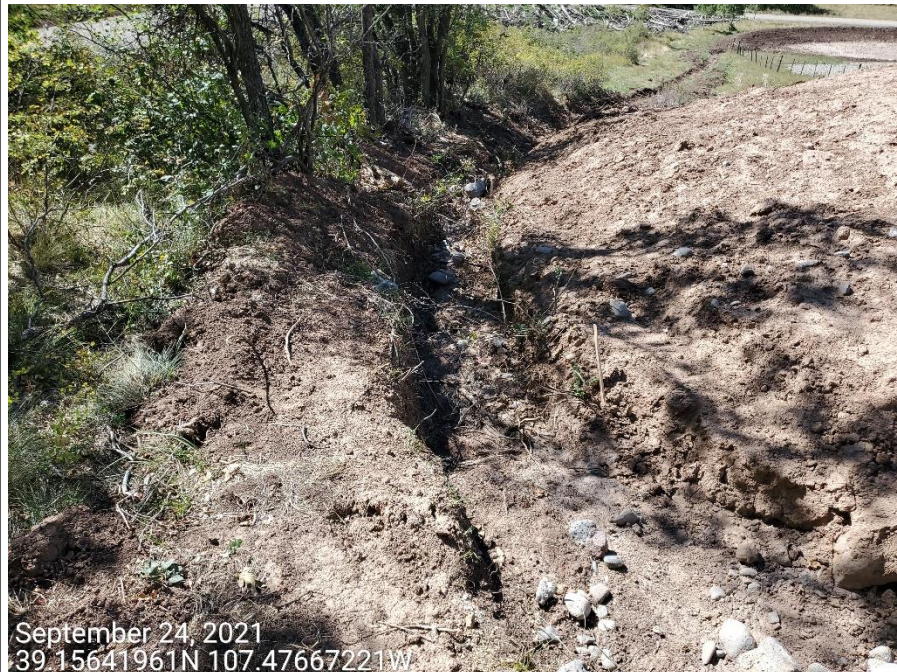
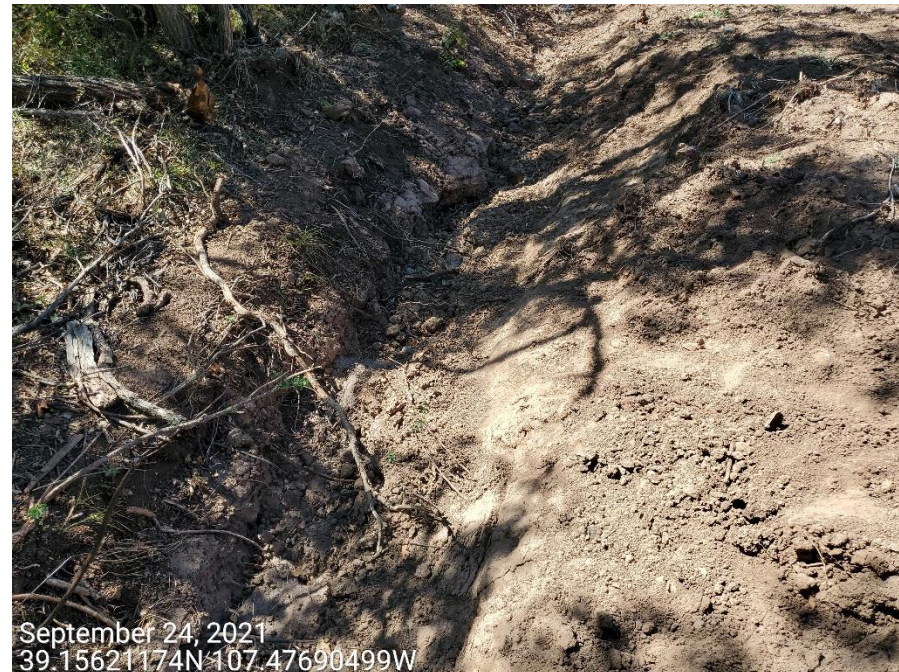
Photo 9: Photos taken from the stormwater “ditch” leaving from the Location. Photo shows section of the control that remains improperly constructed with vertical slopes with unconsolidated soils.

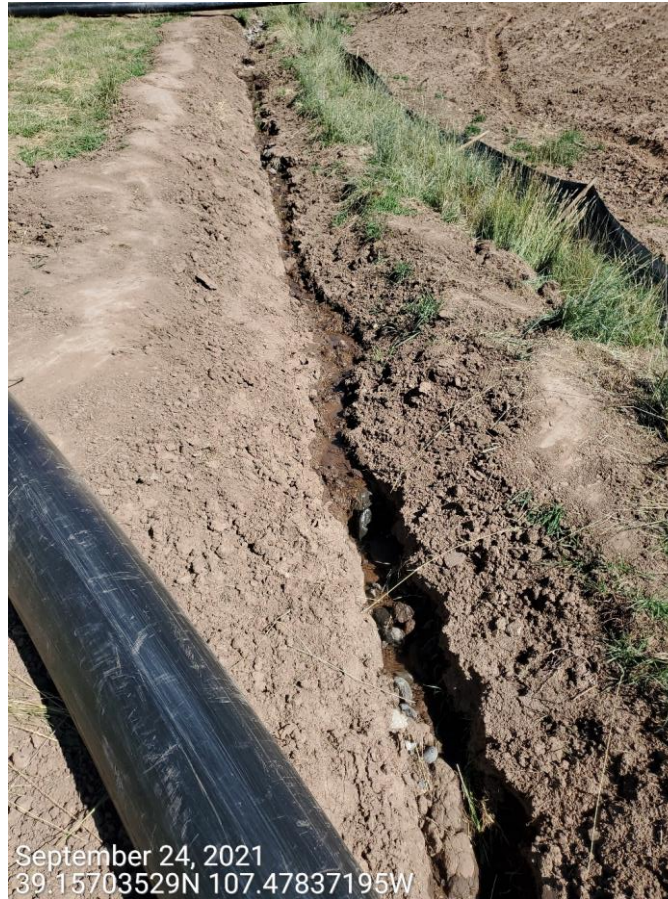
Photo 10: Photo taken from the stormwater ditch on the northern end of the Location. Photo shows sections of the ditch where Operator has regraded the slopes. Photo shows soils within ditch have not been properly consolidated; soils are loose material and considered a pollutant source. Photo also shows channel incision and degradation due to runoff within the ditch.

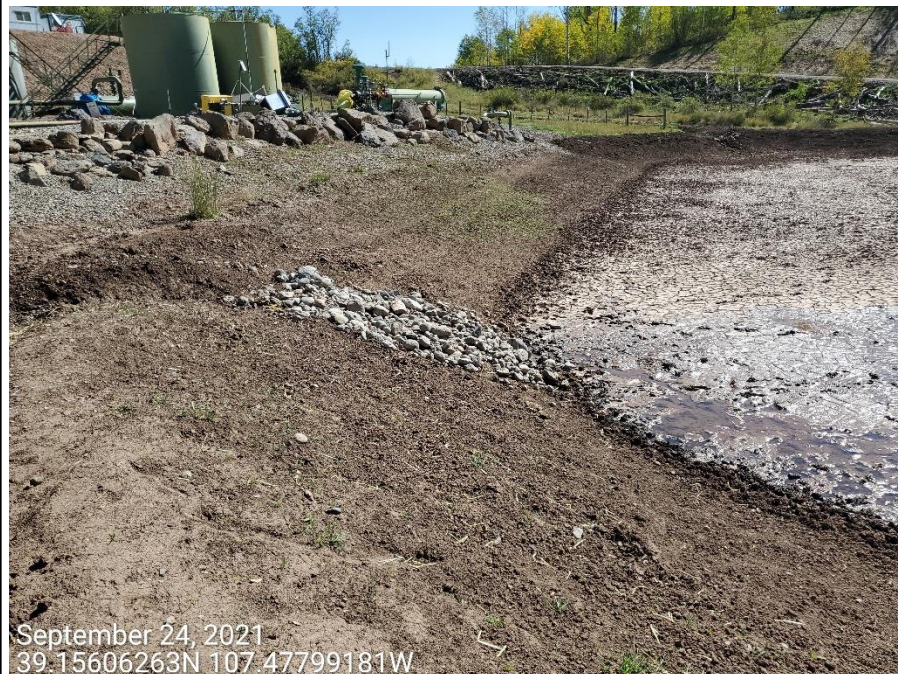
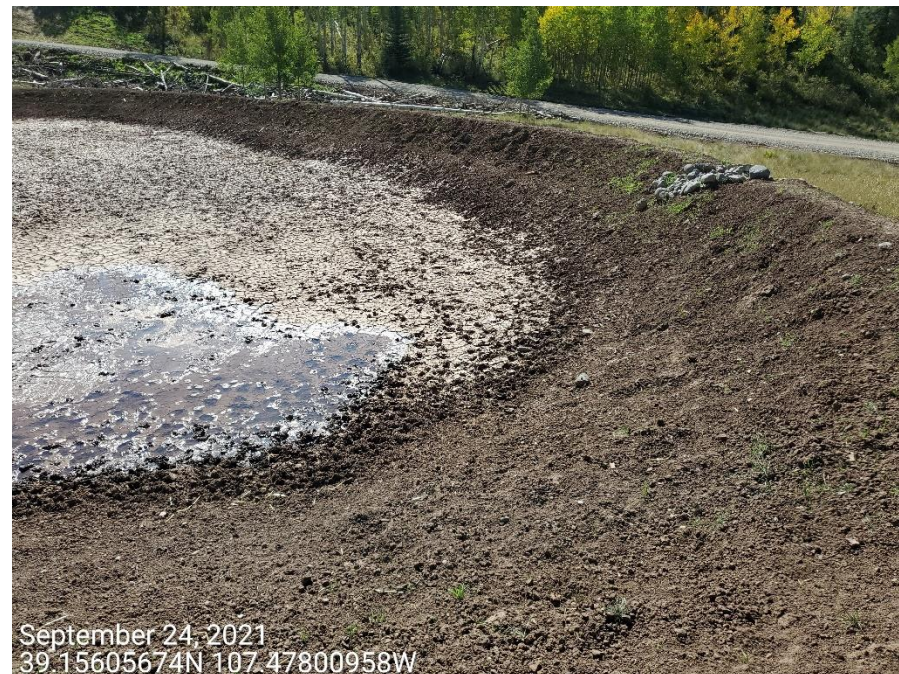
Photo 11: Photo provides overview of the sediment trap/pond to the west of the Location.

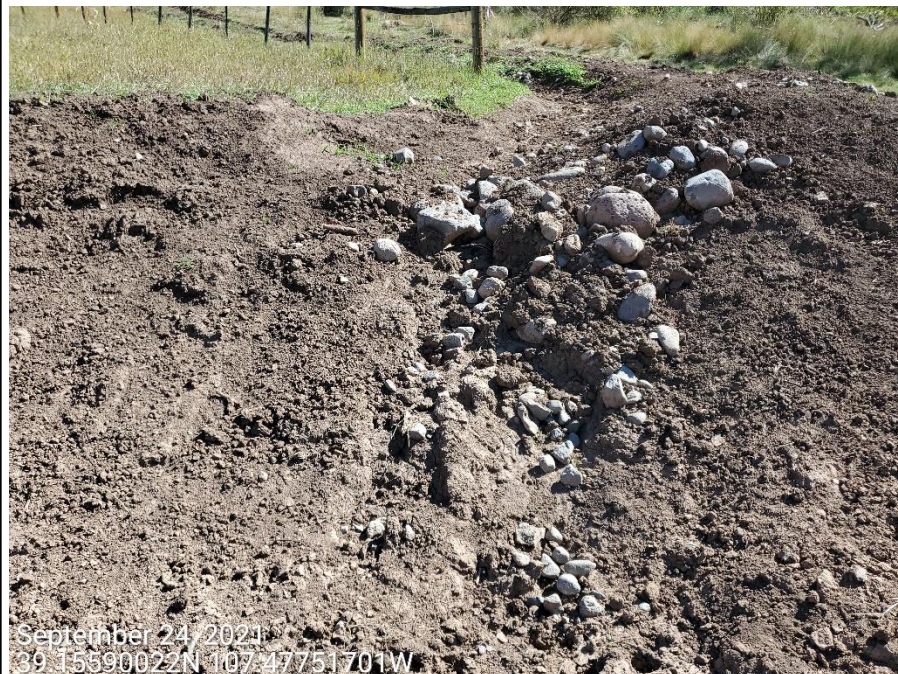
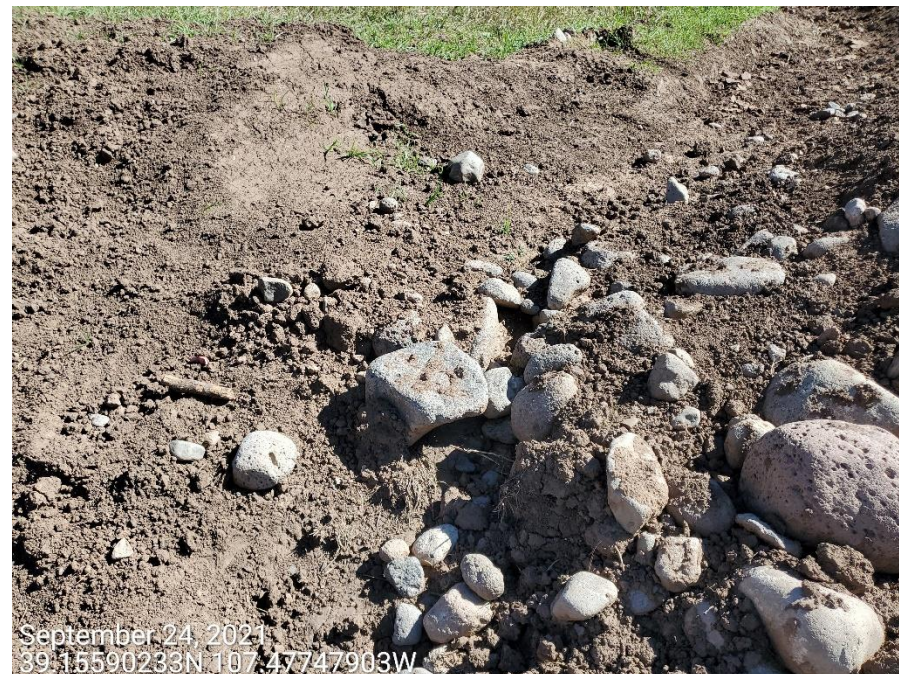
Photo 12: Photos taken from the sediment trap/pond west of the Location. Previous inspections documented that the inlets were inadequate. Photos show inlets remain inadequate per good engineering practices.

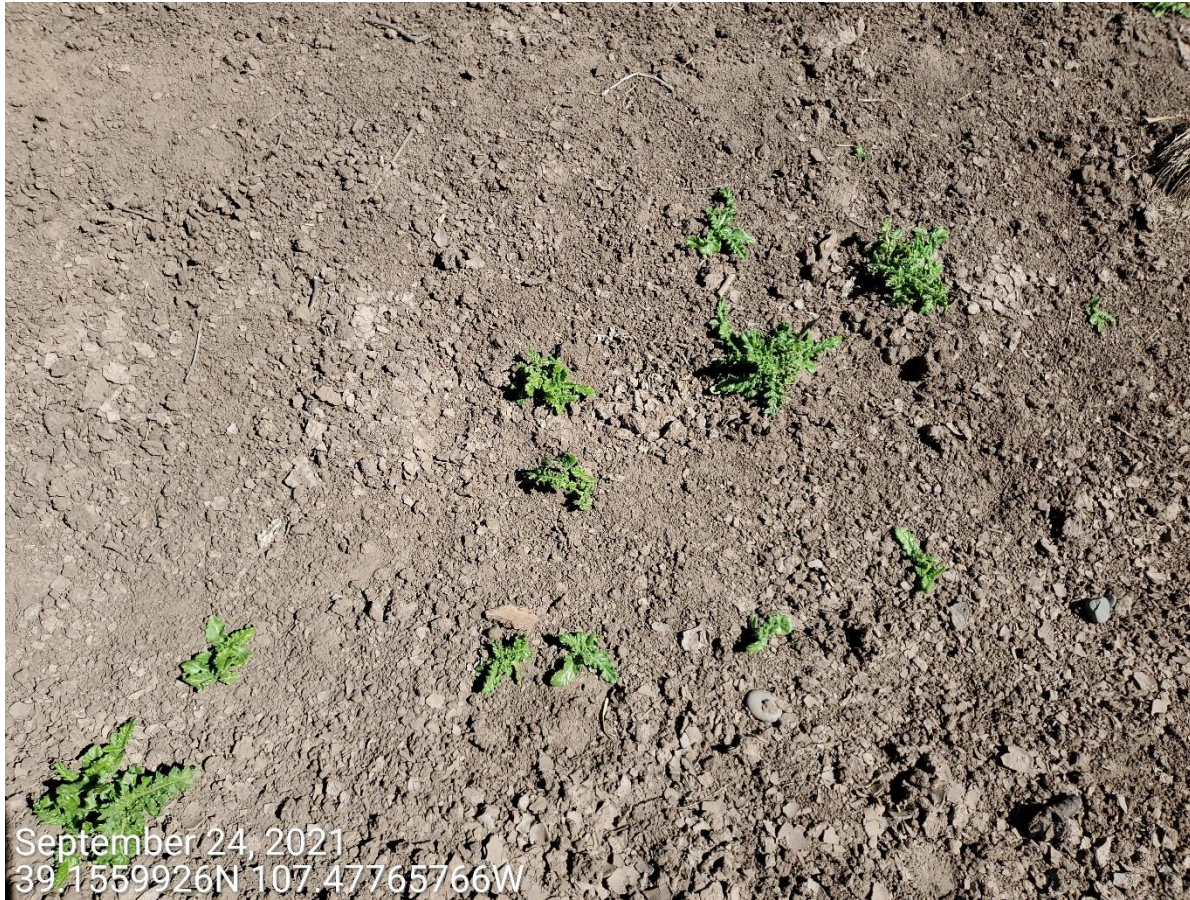
Photo 13: Photo provides overview of the sediment trap/pond to the west of the Location. Photo shows Canada thistle rosettes; noxious weeds establishing within trap/pond.

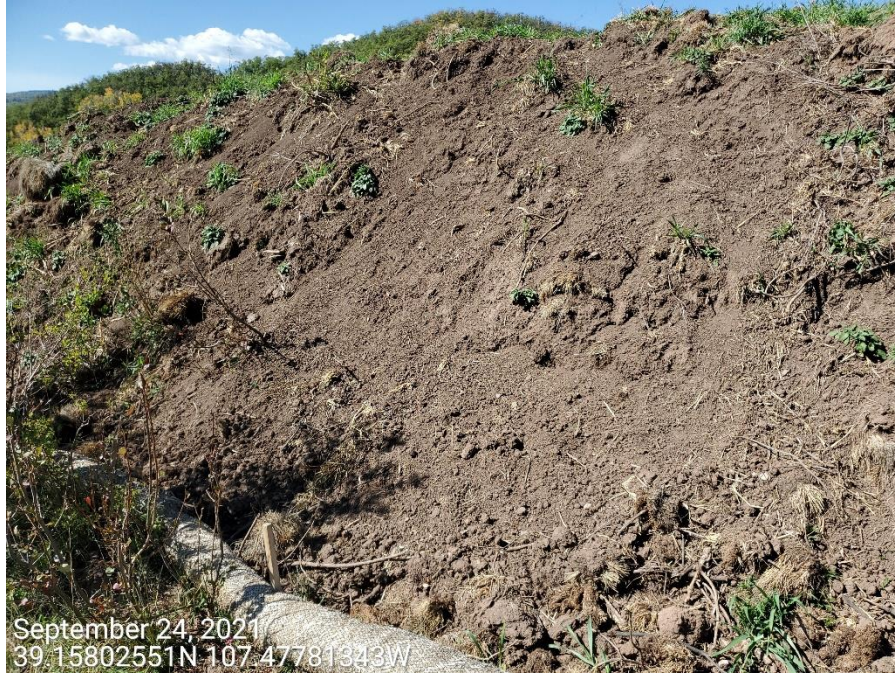
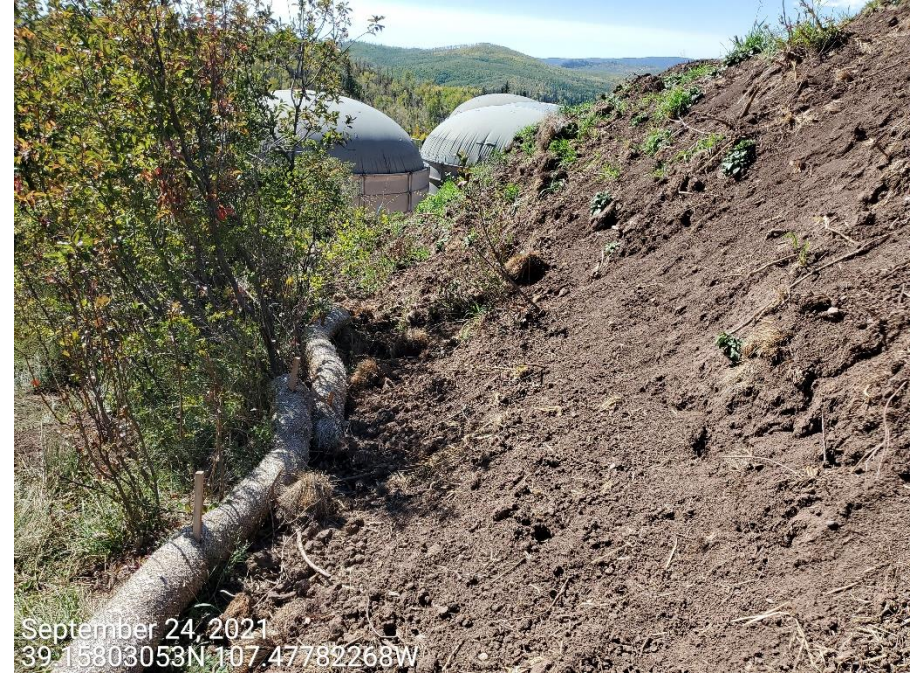
Photo 14: Photo taken from the topsoil stockpile on the north end of the Location. Photo shows BMPs remain missing or insufficient to stabilize and protect the entire topsoil stockpile; BMPs also remain missing or insufficient along the entire perimeter of the topsoil stockpile to prevent sediment transport.

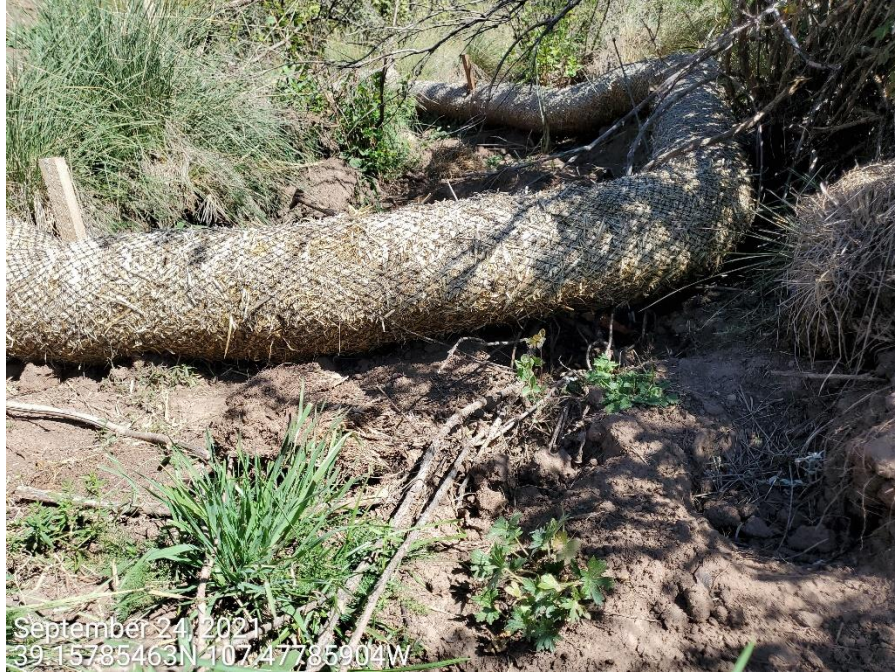
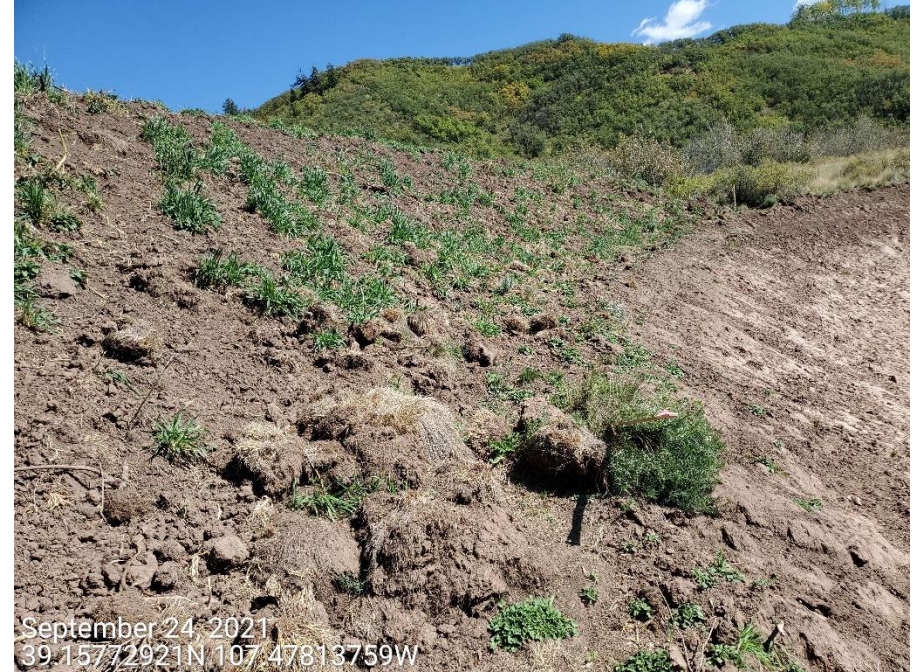
Photo 15: Photo taken from the topsoil stockpile on the north end of the Location. Photo on the left shows Operator has installed erosion logs (straw wattles) along the eastern/northern/western perimeter of the topsoil stockpile; BMP has not been installed in accordance with good engineering practices and is inadequate to manage stormwater and prevent sediment transport. Photo on the right shows perimeter controls remains missing or insufficient on the southern perimeter of the topsoil stockpile to prevent sediment transport.

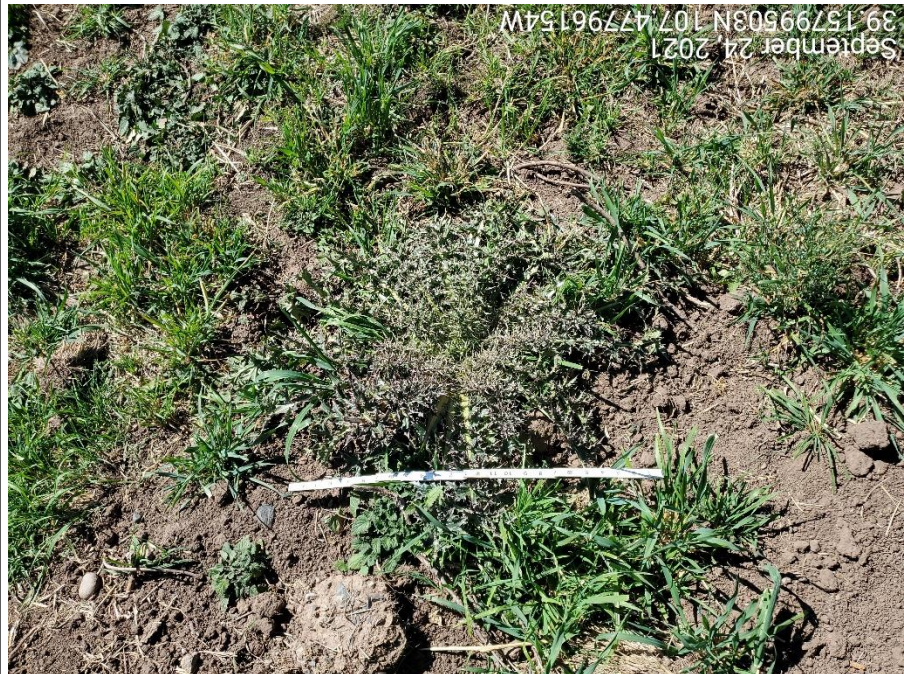
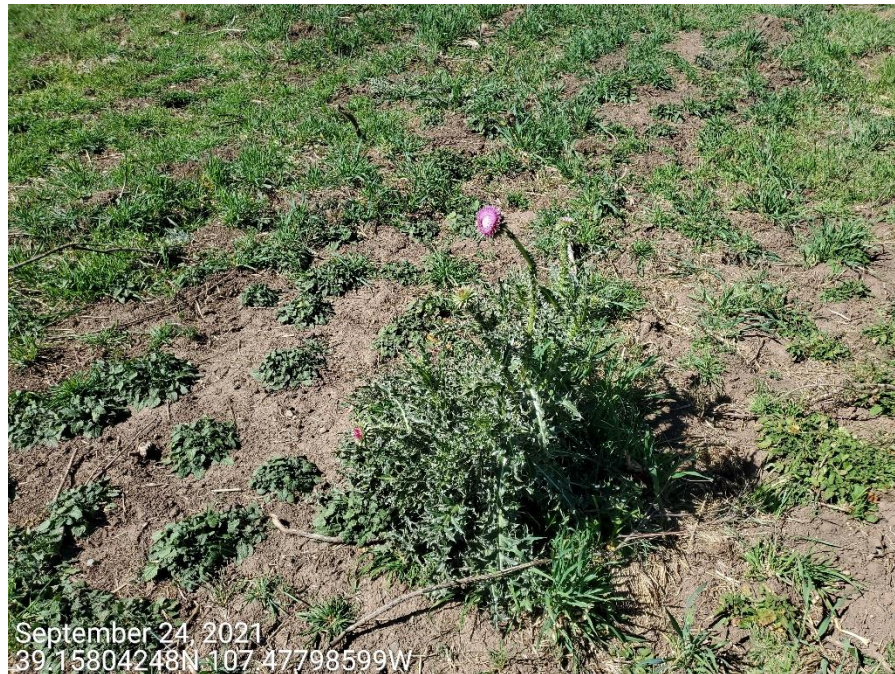
Photo 16: Photos taken from the topsoil stockpile. Photo shows noxious weed establishment observed on the stockpiled soils.

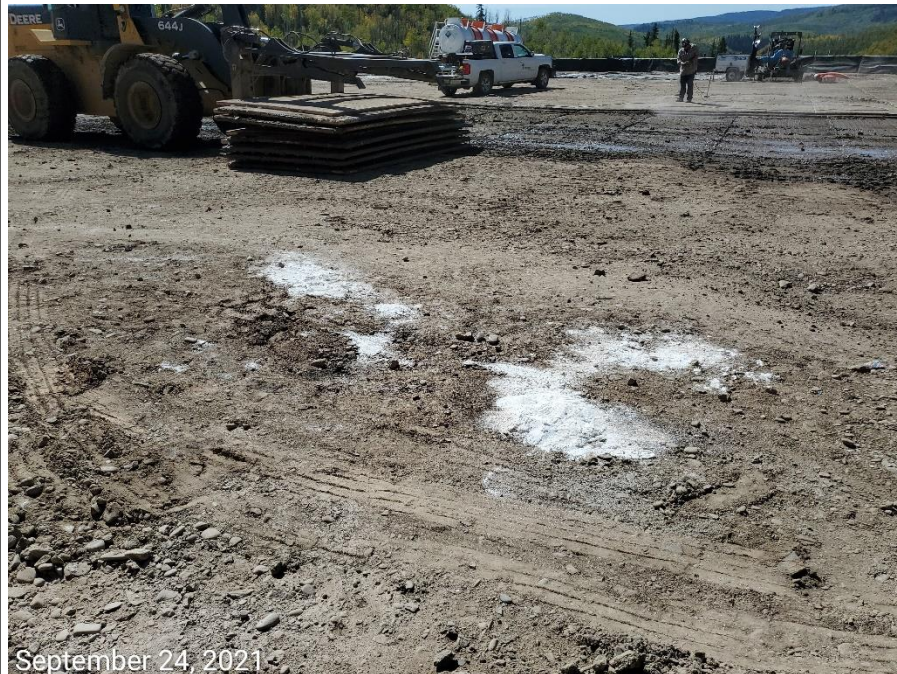
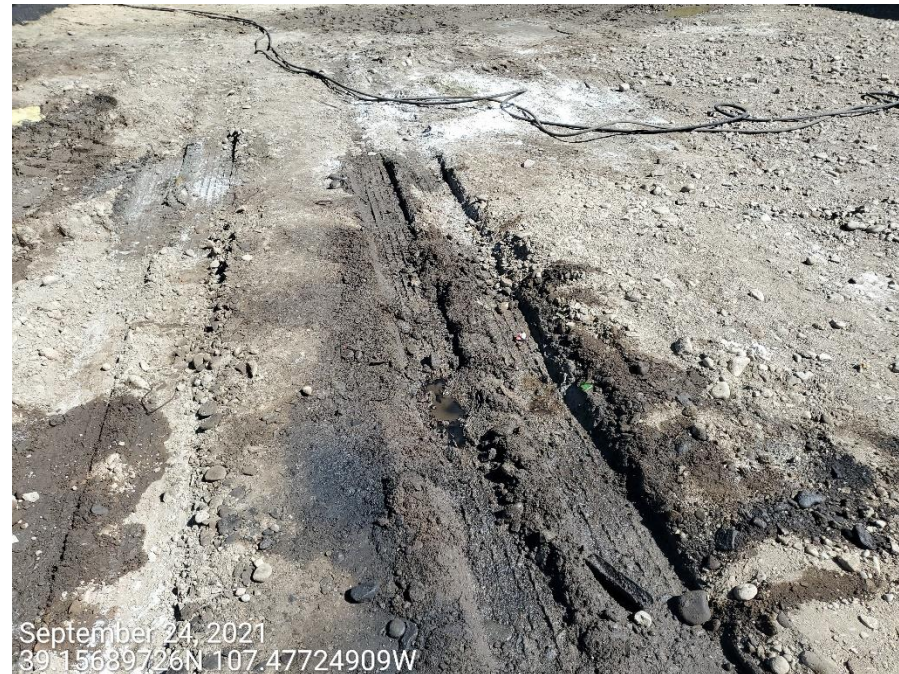
Photo 17: Previous inspections documented improper materials management that resulted in several spills throughout the Location. Materials previously observed on the Location have largely been removed, however, photos show example of various spills observed remaining on the Location

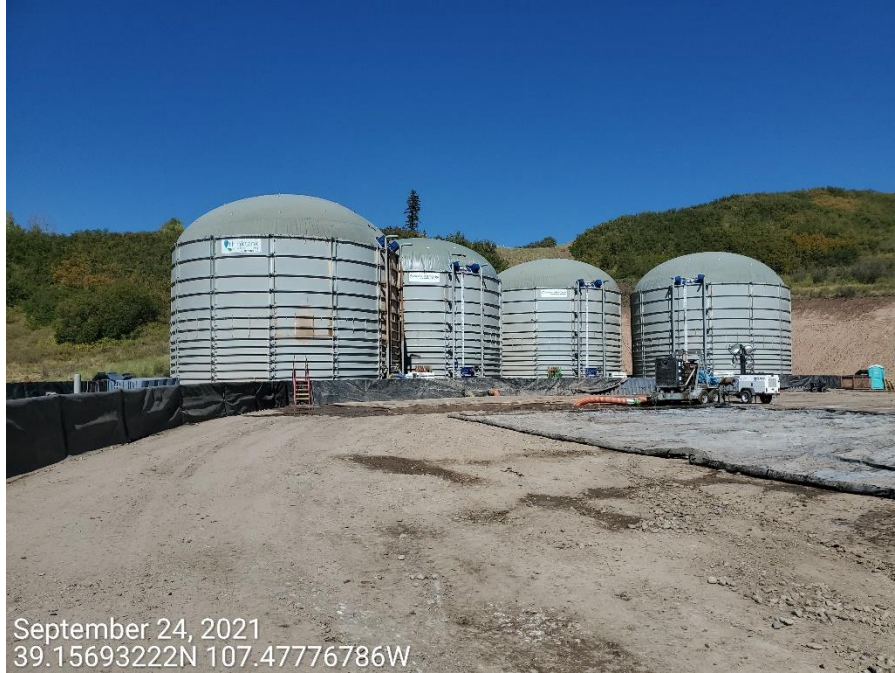
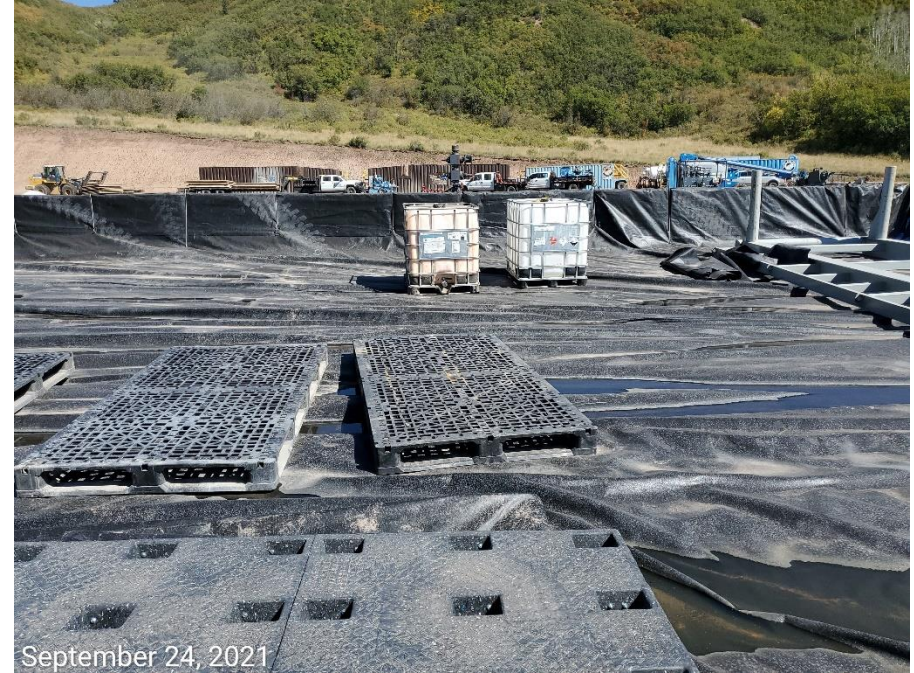
Photo 18: Photo on left shows four (4) “Minion tanks” stored on the north end of the location; tanks used to store recycled water to supply completion operations. Previous inspections observed containers within inadequate containment or spill prevention BMPs. Photo on the right shows remaining containers on Location have been placed into secondary containment.
