Inspection Photos

9/24/2021

Operator: GUNNISON ENERGY LLC # 10515

Location ID: 453805

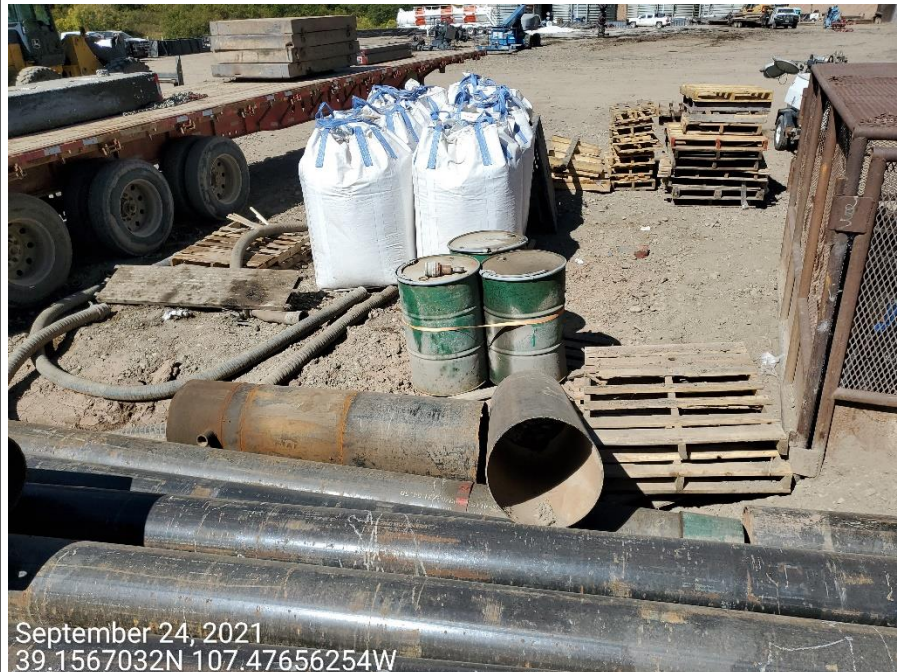
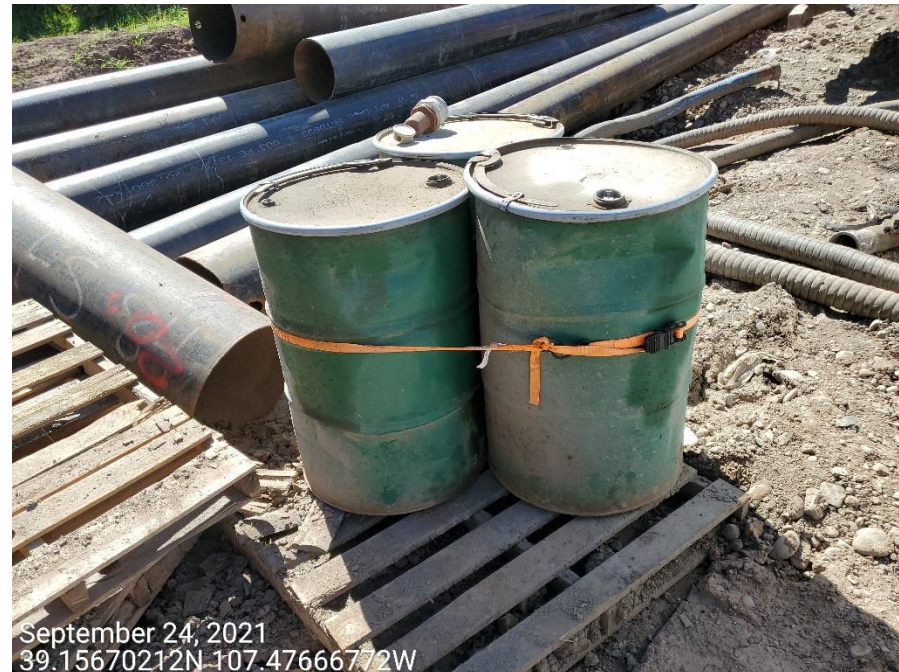
Photo 19: Photo taken from the south end of the Location. Photo shows green barrels previously documented with unknown contents; safety labeling information identifying contents remains missing on containers.
