Inspection Photos

REM Project # 19966

Location #316764

Inspection Date: 9/15/2021

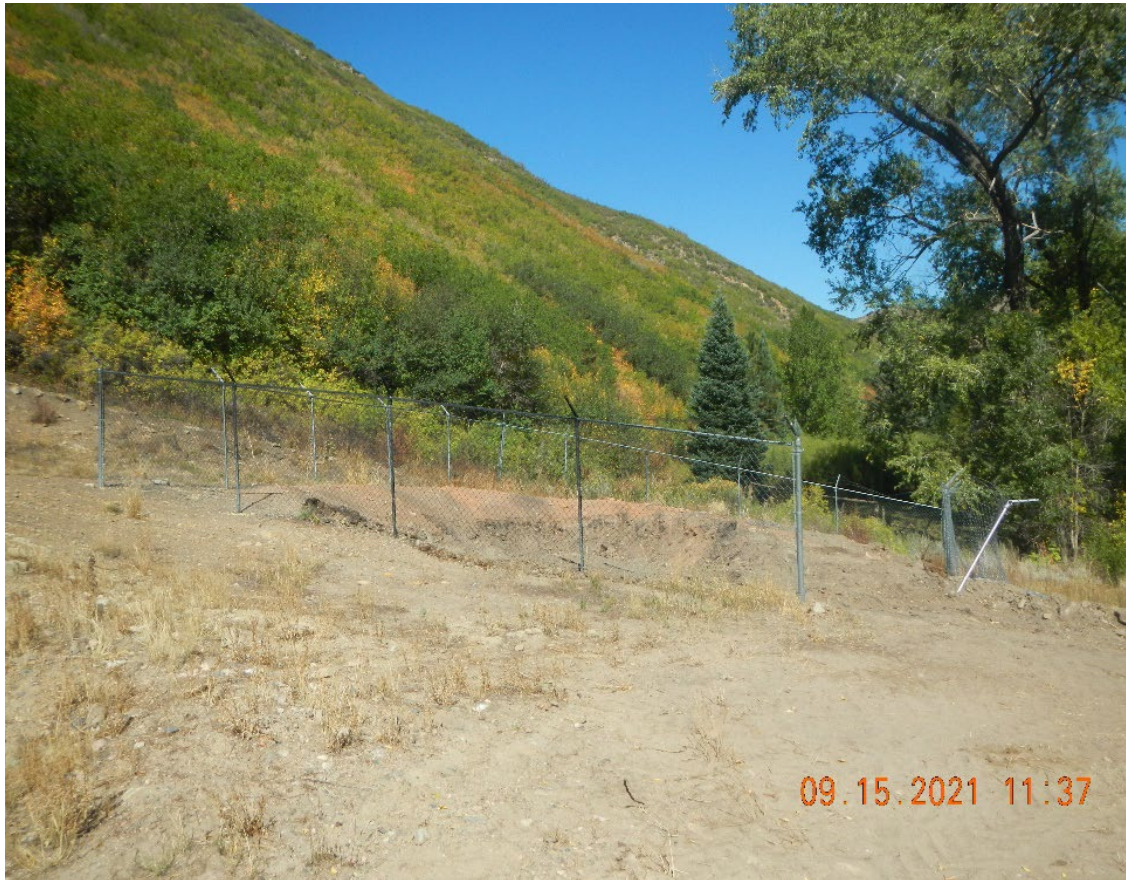
Photo #1 looking mostly north from well pad at area of former flare pit.
The fence on the right hand side of pit was removed to allow
equipment access to the pit.

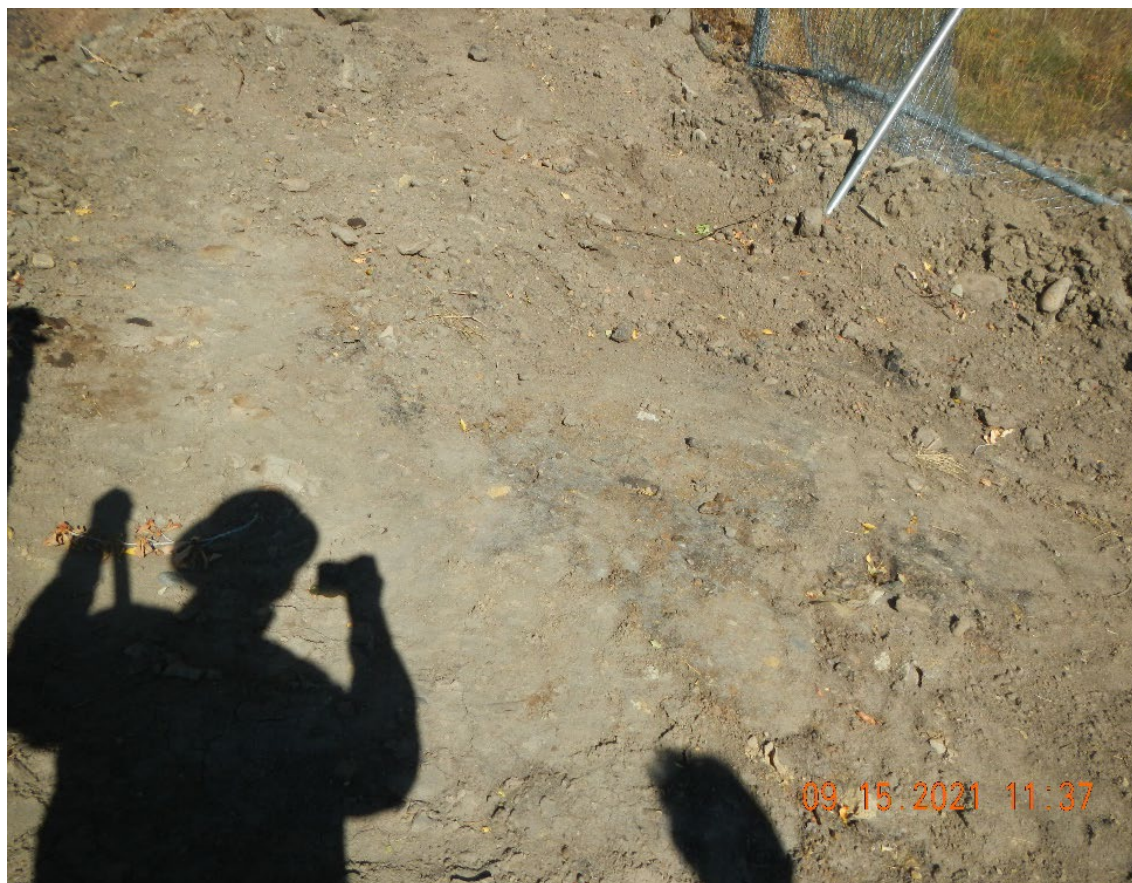
Photo #2 staining observed at entry to pit.

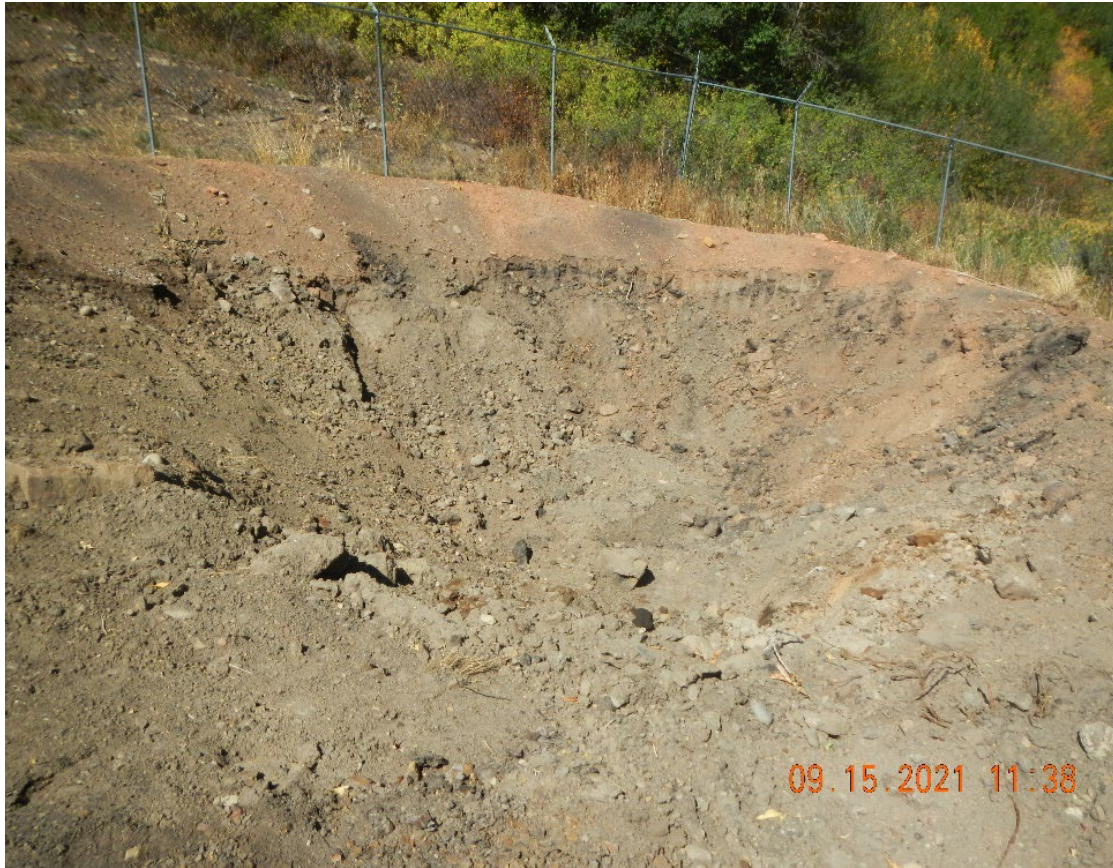
Photo #3 looking west from entry to pit. It was observed that soil had been removed from pit and stored on pad surface in a liner.

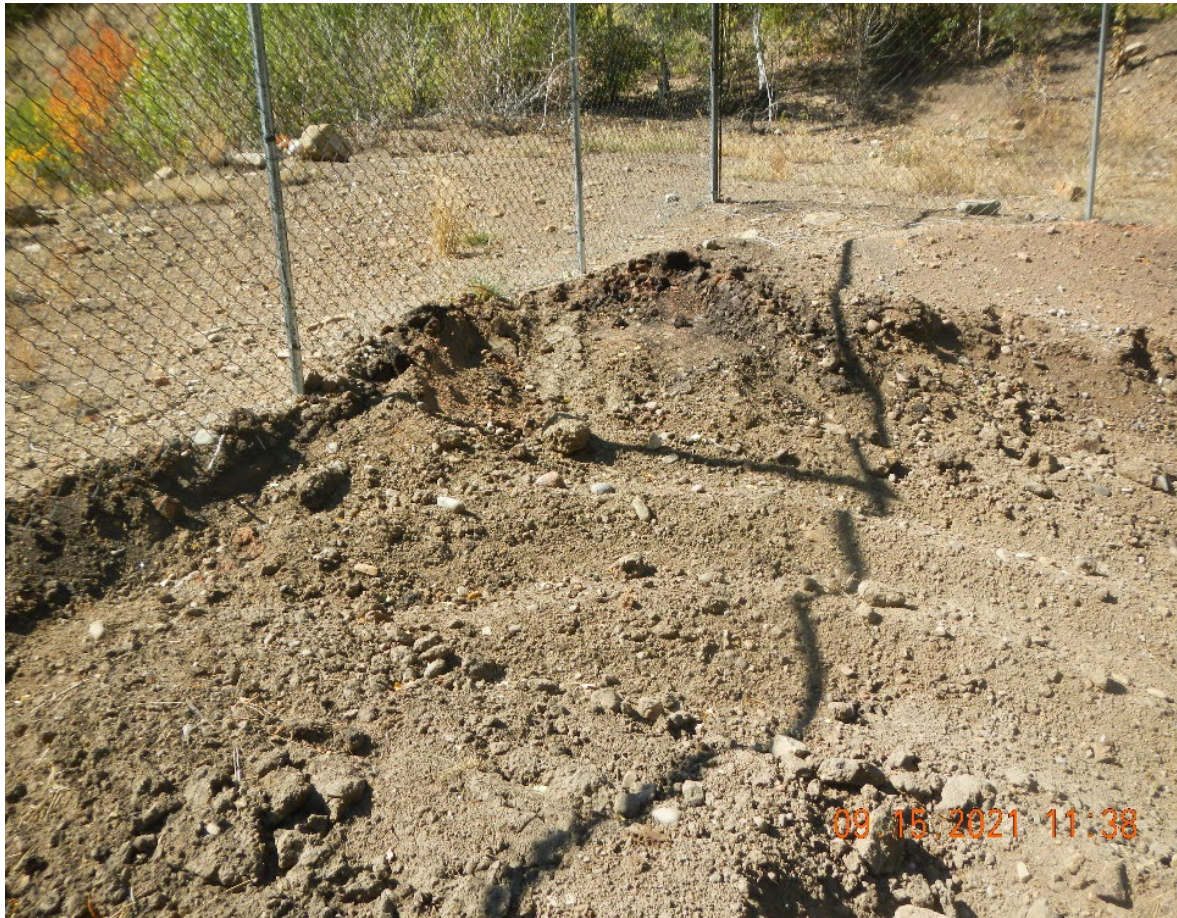
Photo #4 the fence on left of photo is east, the downgrade side of facility (east).

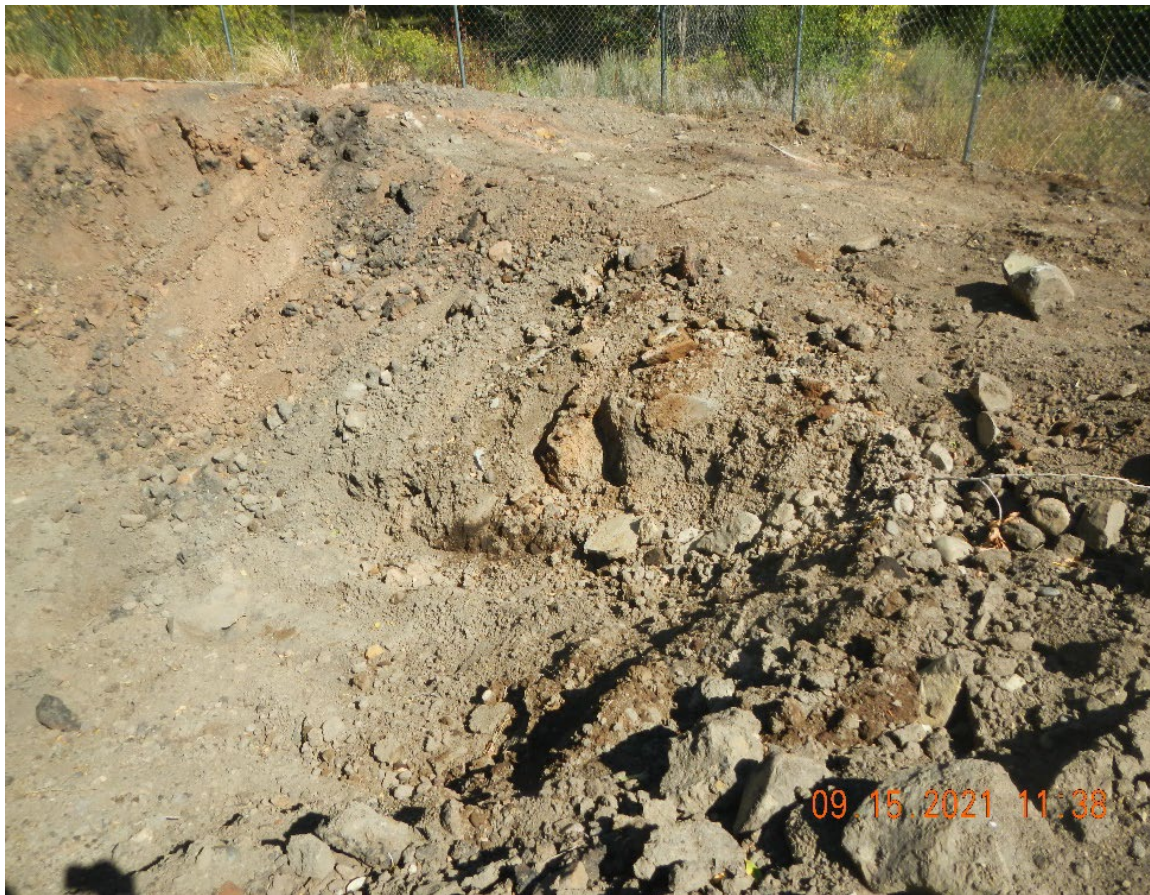
Photo #5 Stained soil observed, soil had strong hydrocarbon odor.

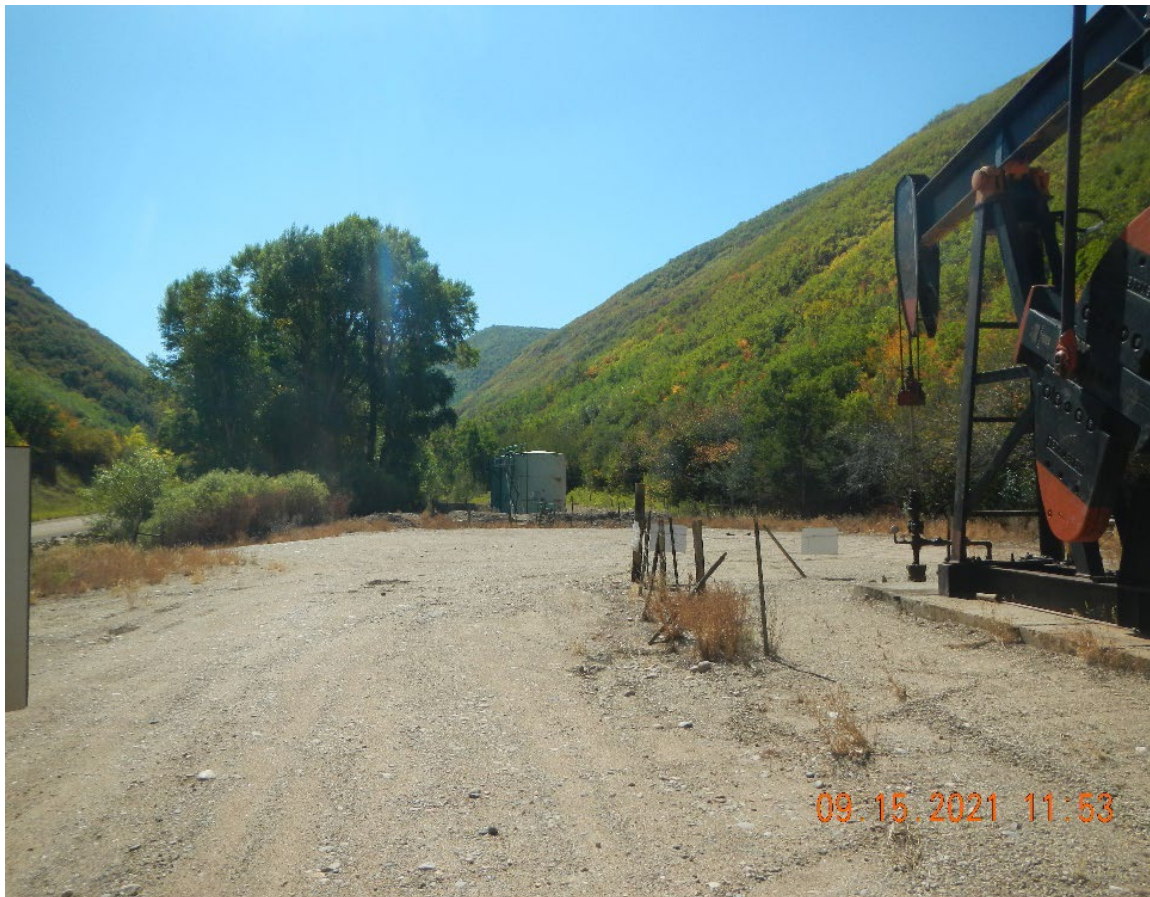
Photo #6 looking mostly south from pad.

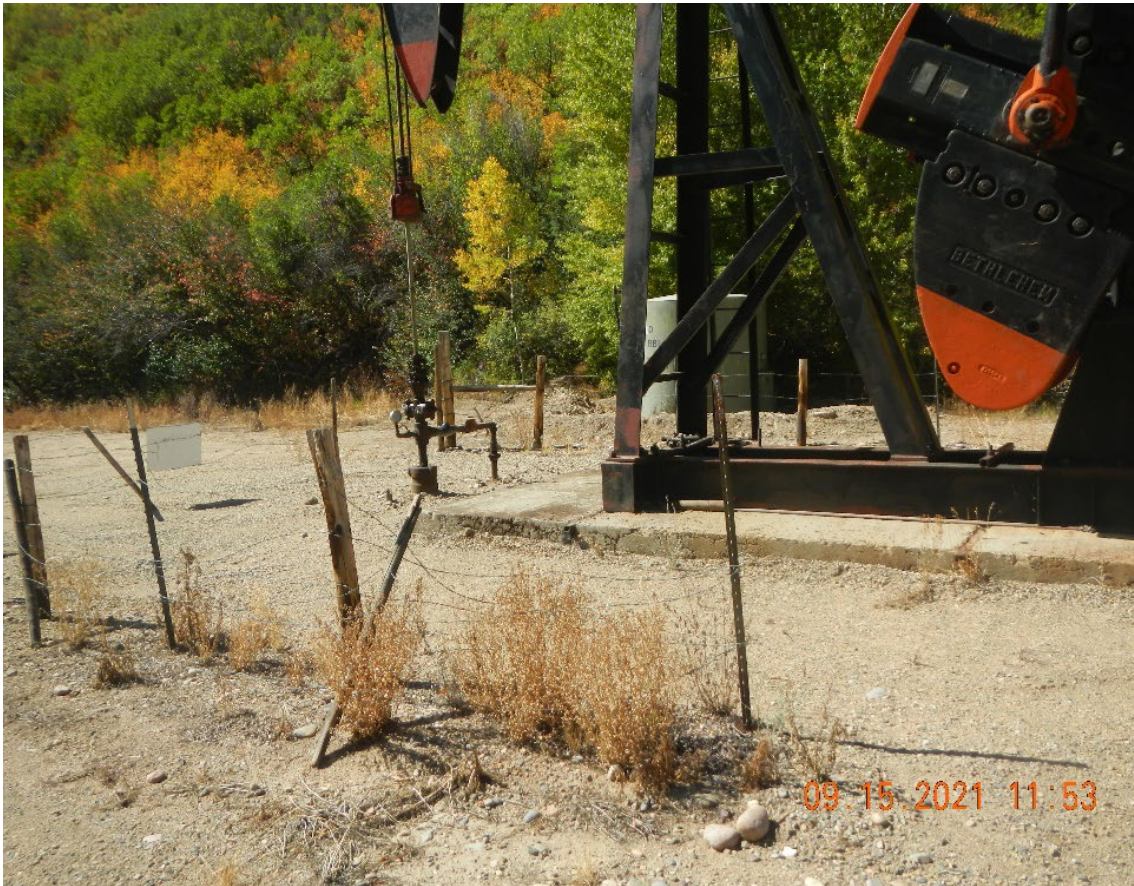
Photo #7 fence around well had been partly removed. Well was SI at the time of inspection.

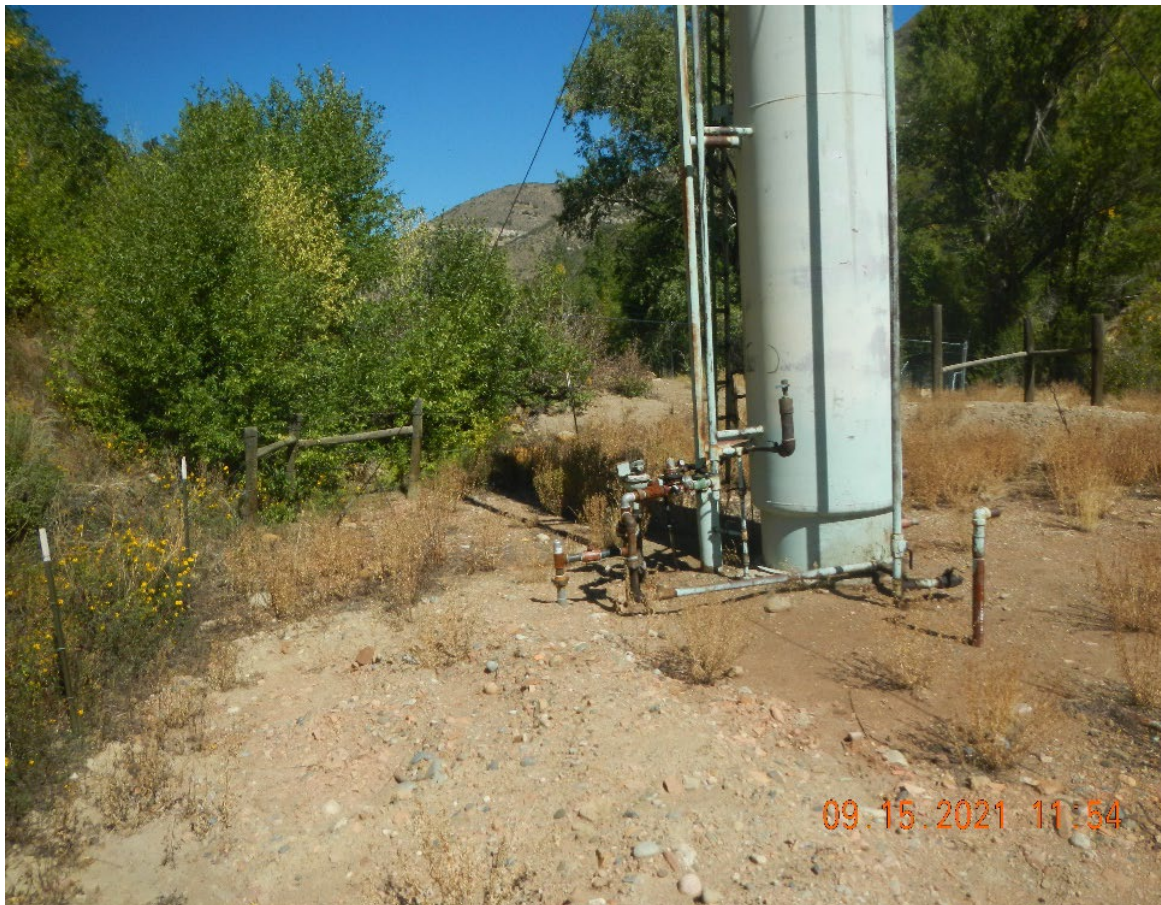
Photo #8 treater north-west of wellhead.

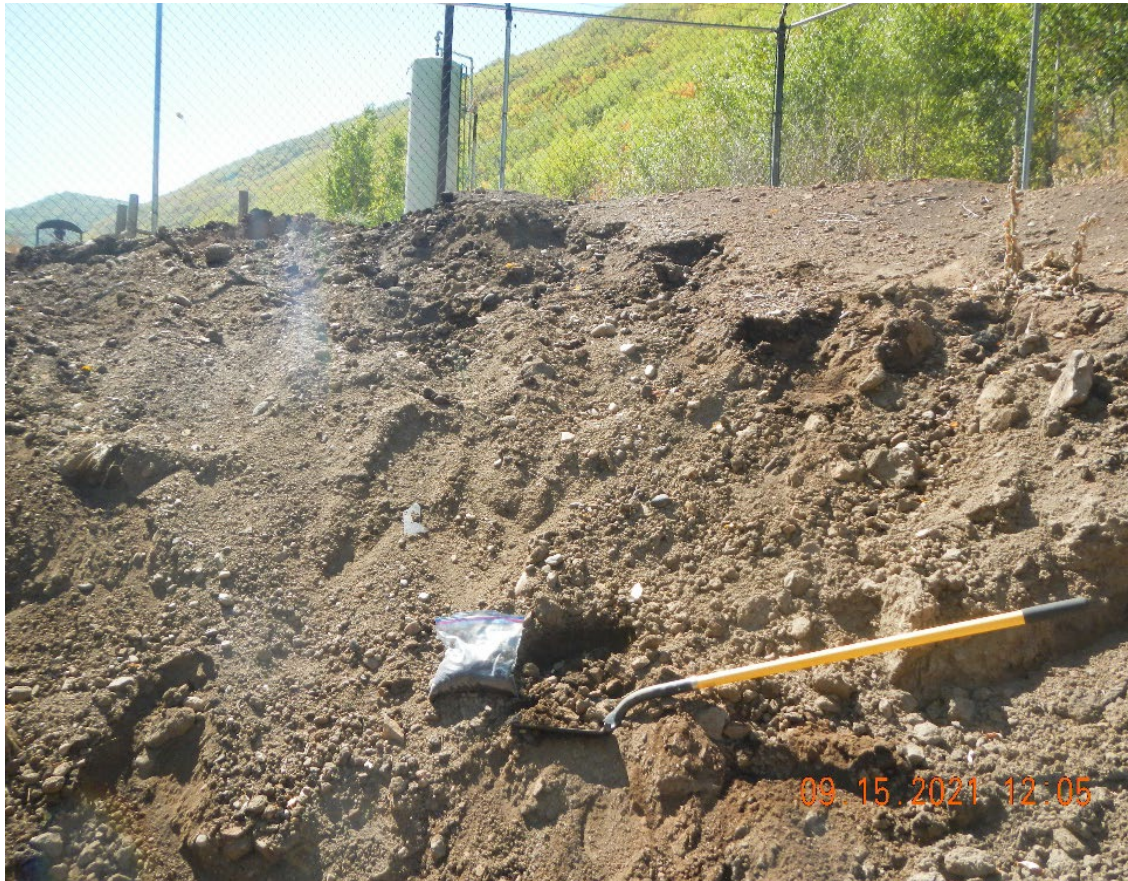
Photo #9 bag seen in photo was sampled with a PID. PID indicated 138 total VOC. Pit bottom PID read 48 ppm total VOC. Sample had odor and had visual indication of hydrocarbon impact, impact was seen at pit bottom and around the circumference of entire pit.

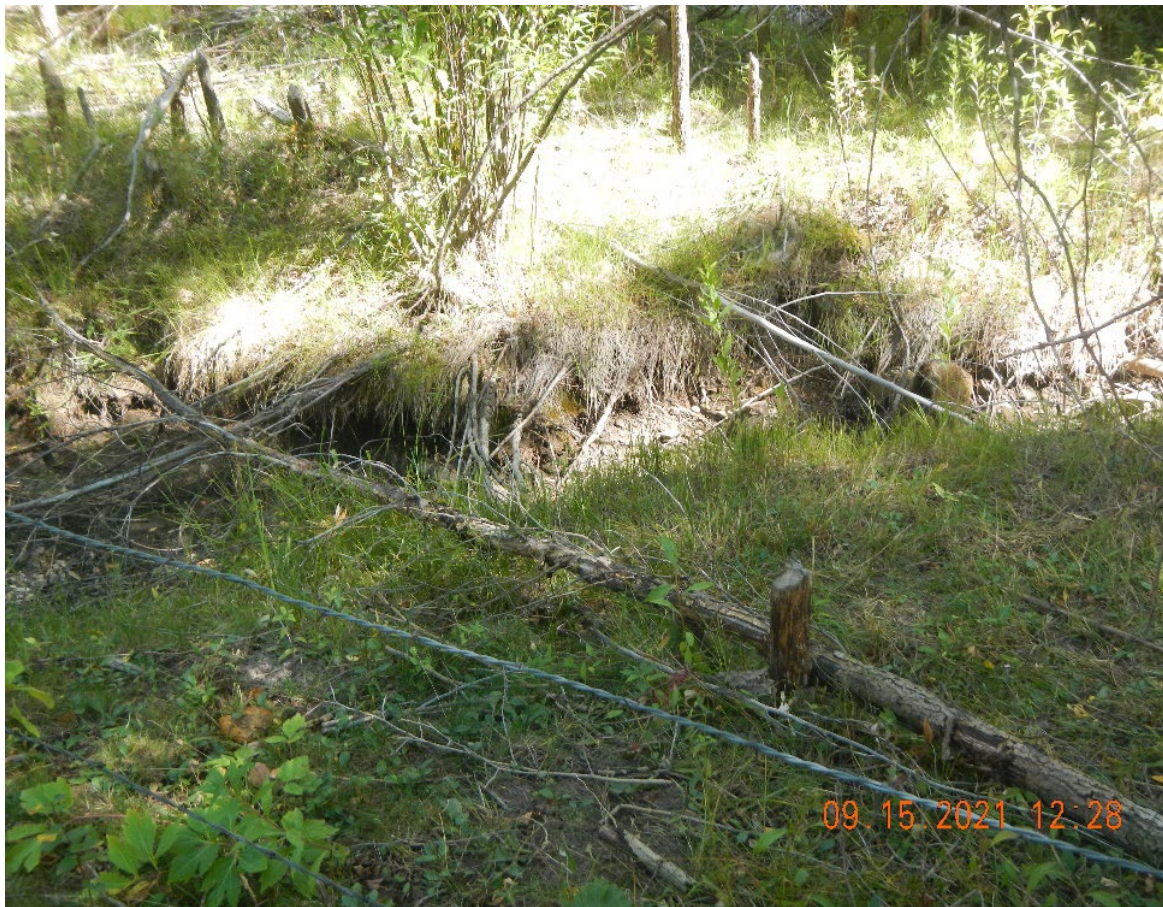
Photo #10 photo ~70 feet from east side of pit, Sage Creek (dry) next to county road 37.

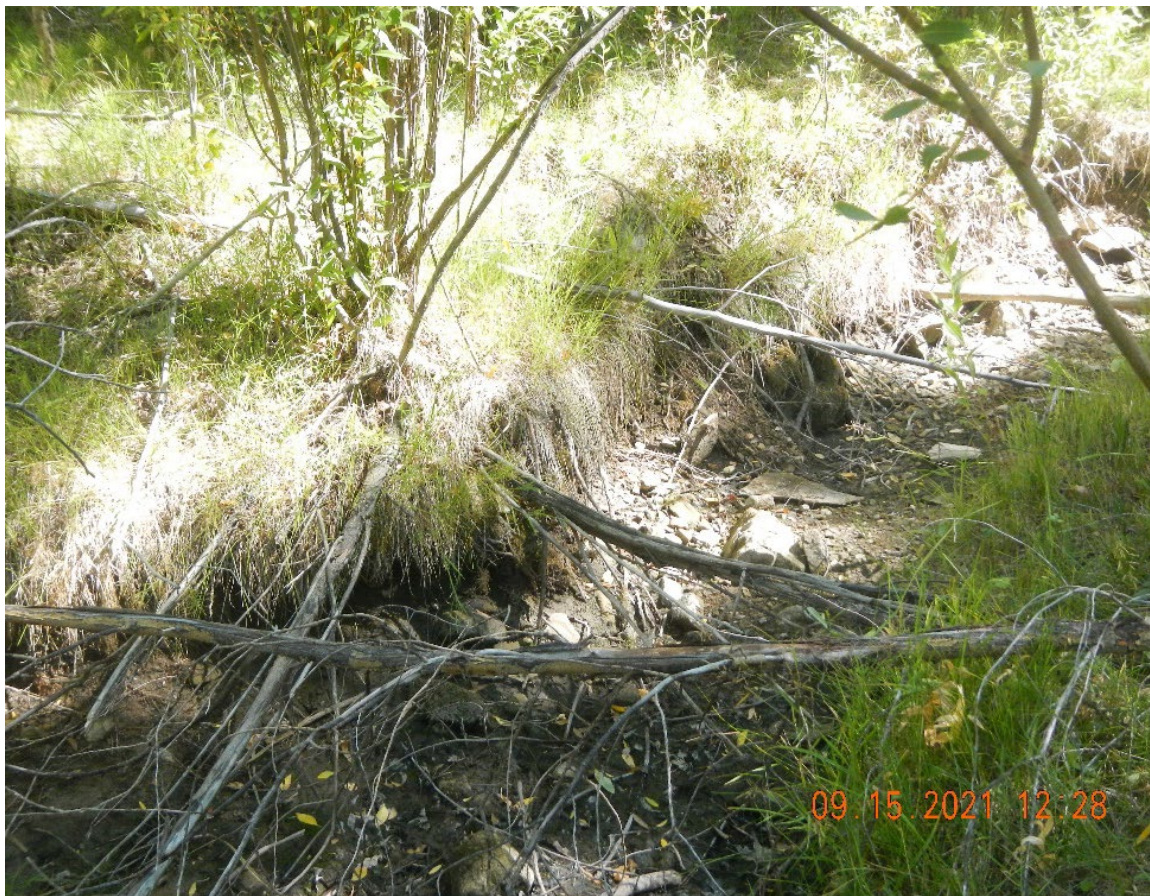
Photo #11 seasonal creek (Sage Creek) ~70 from pit.

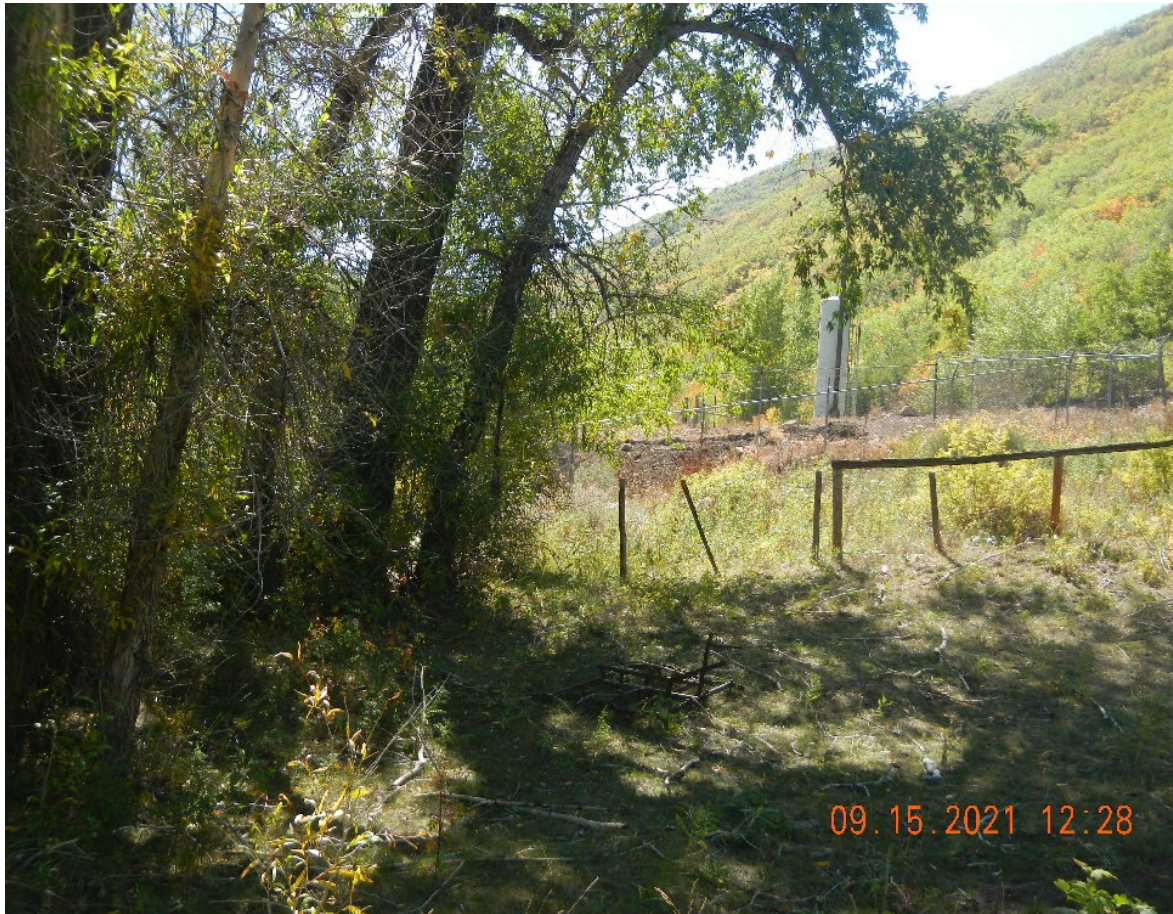
Photo #12 photo taken from state landboard public access surface adjacent to location. Pit can be seen just above the fence post in center of photo.

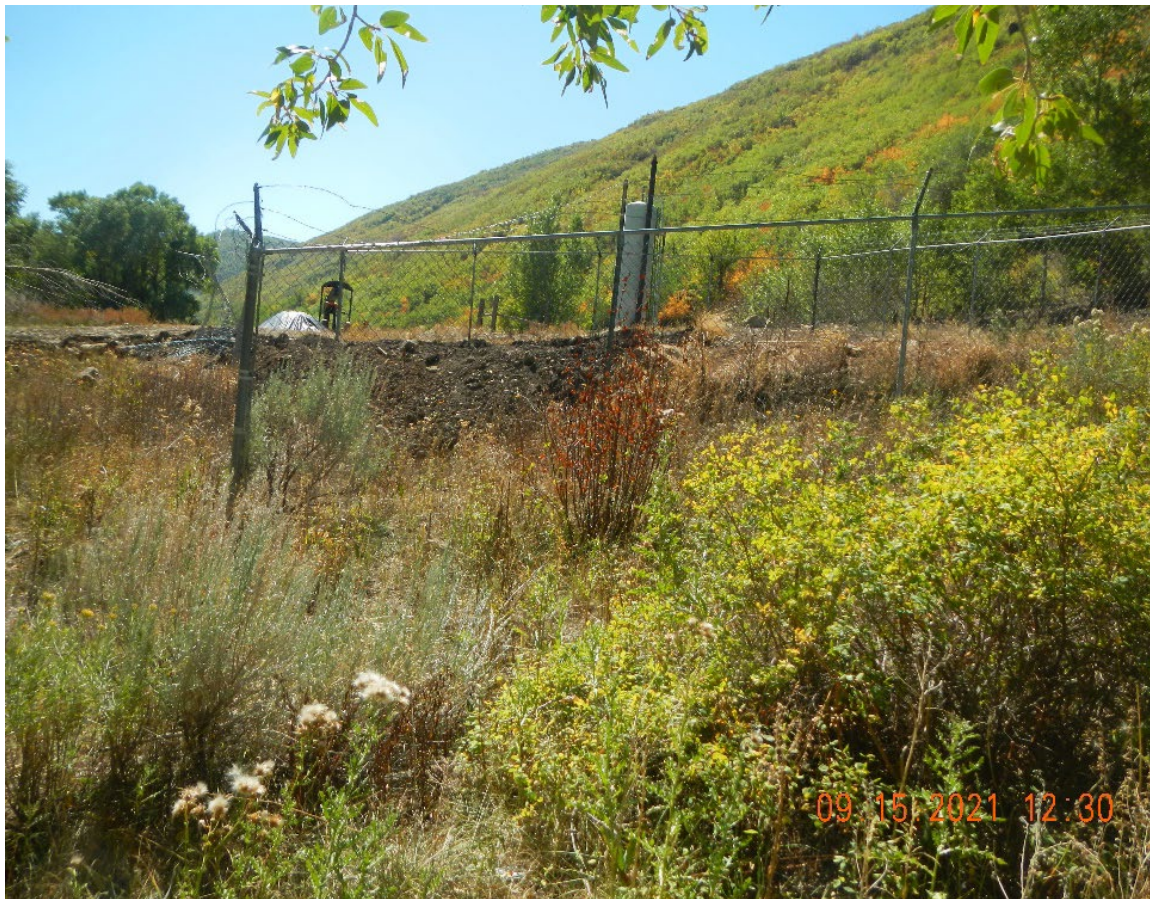
Photo #13 looking mostly south at former pit.

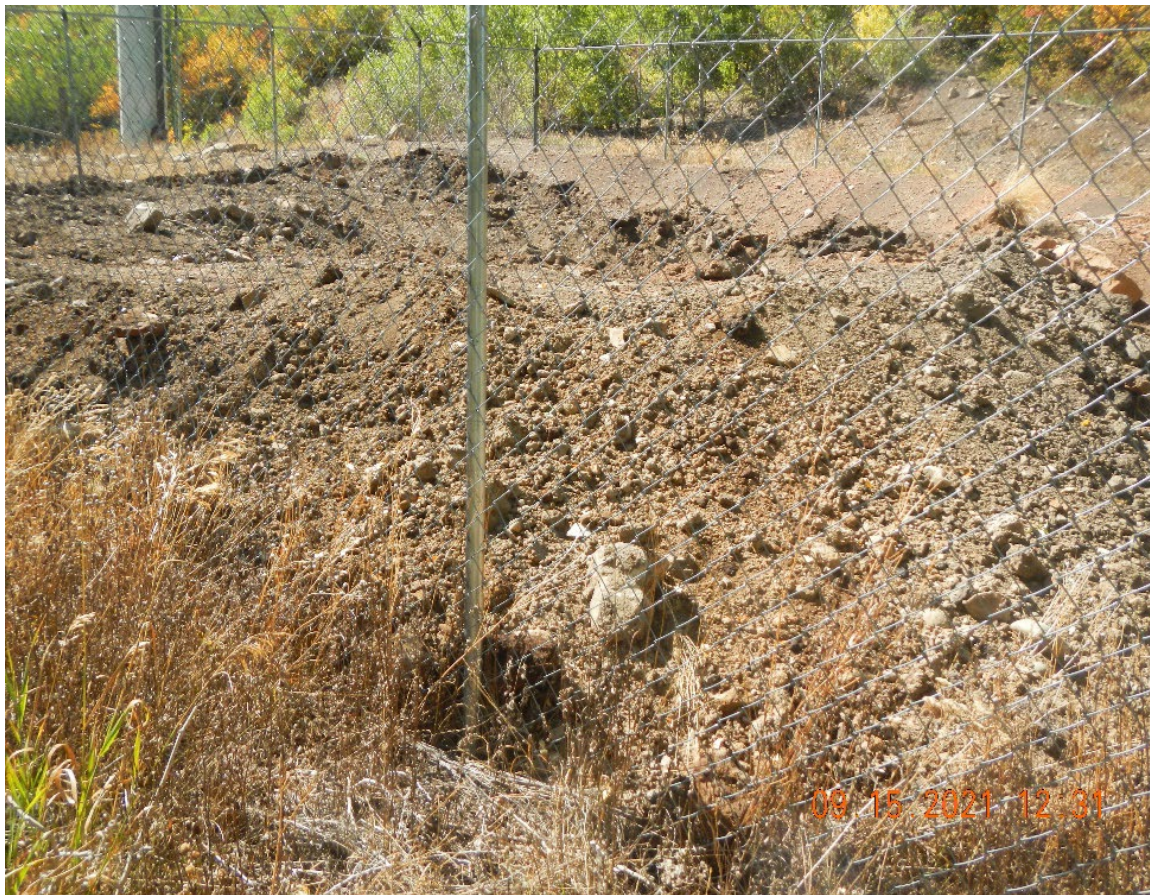
Photo #14 close up of pit looking south west.

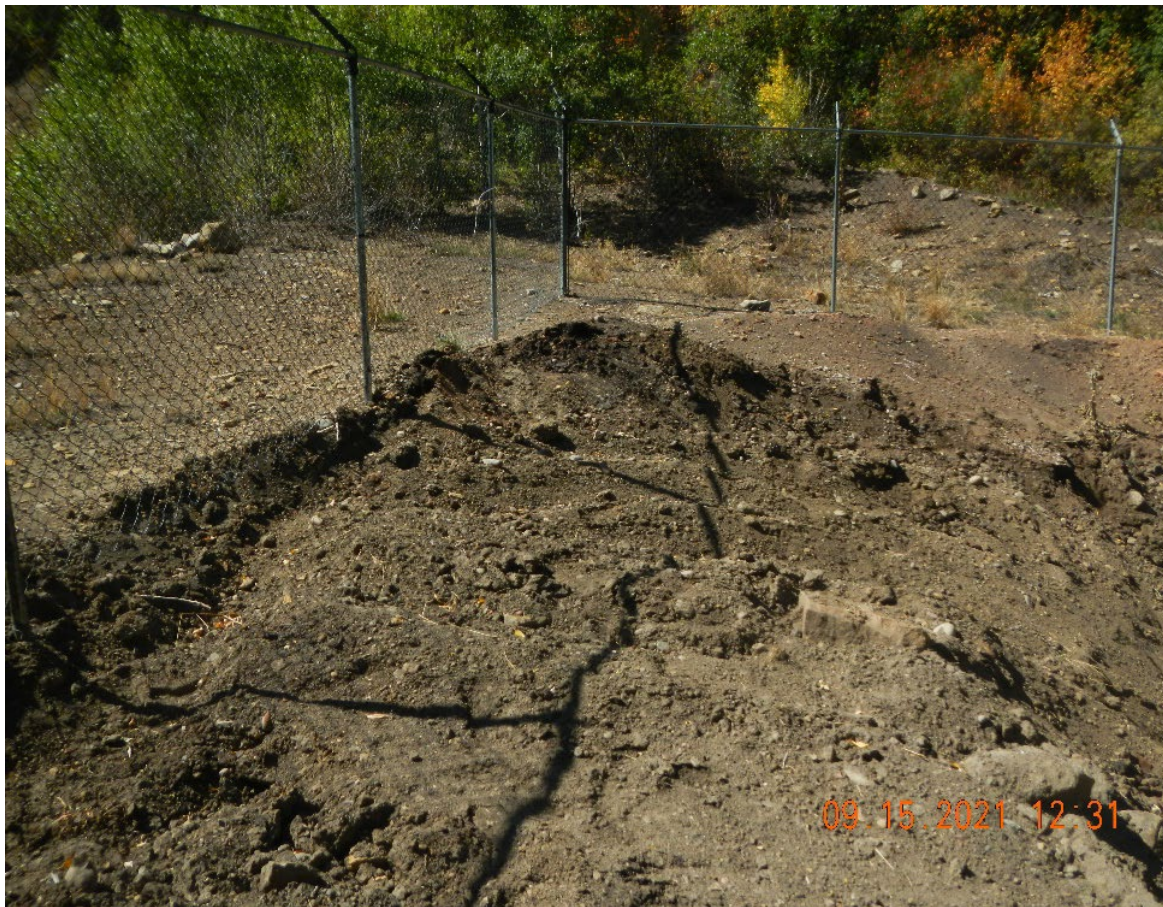
Photo #15 inside old fenced area of pit.

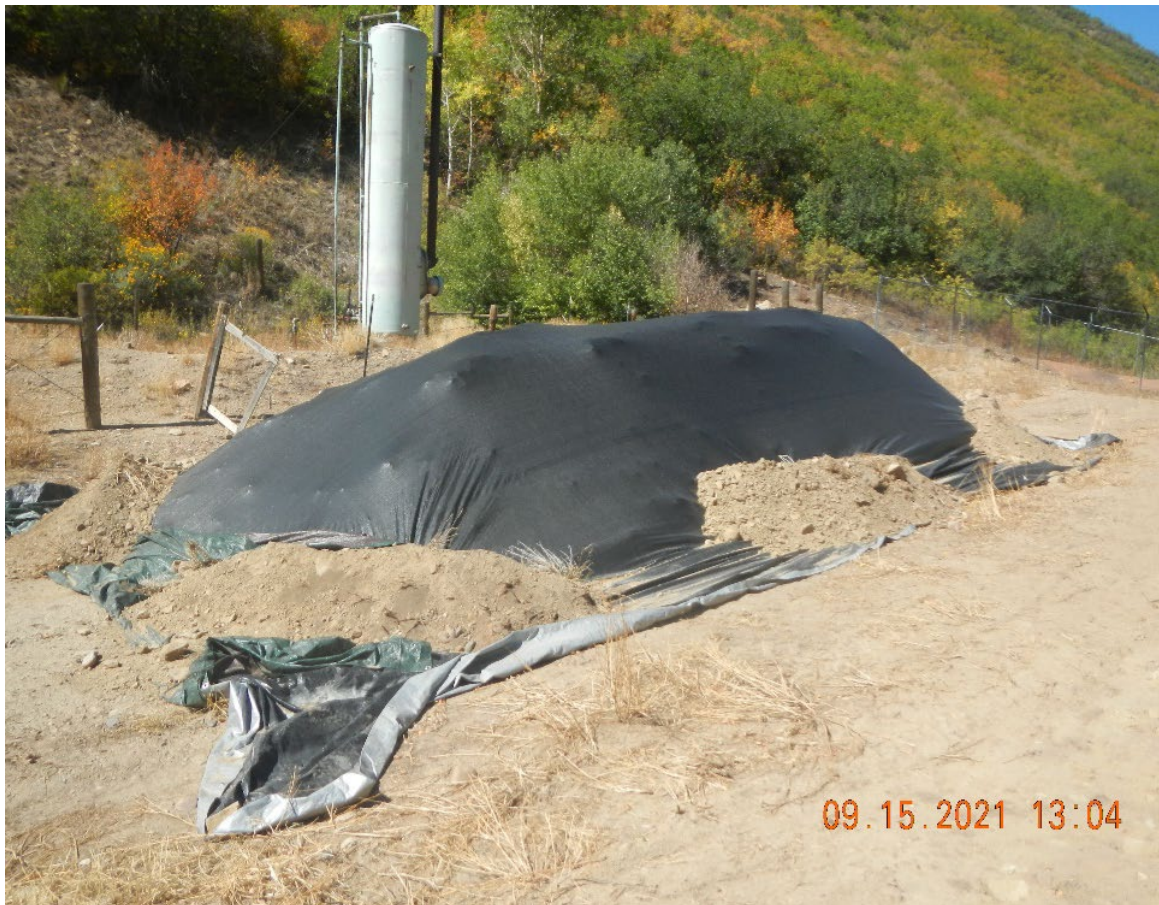
Photo #16 stockpiled soil that was reported as removed from pit.
Corrective Action: remove stock piled soil. During inspection, the waste was sampled by Bayless Contractor for disposal-characterization.

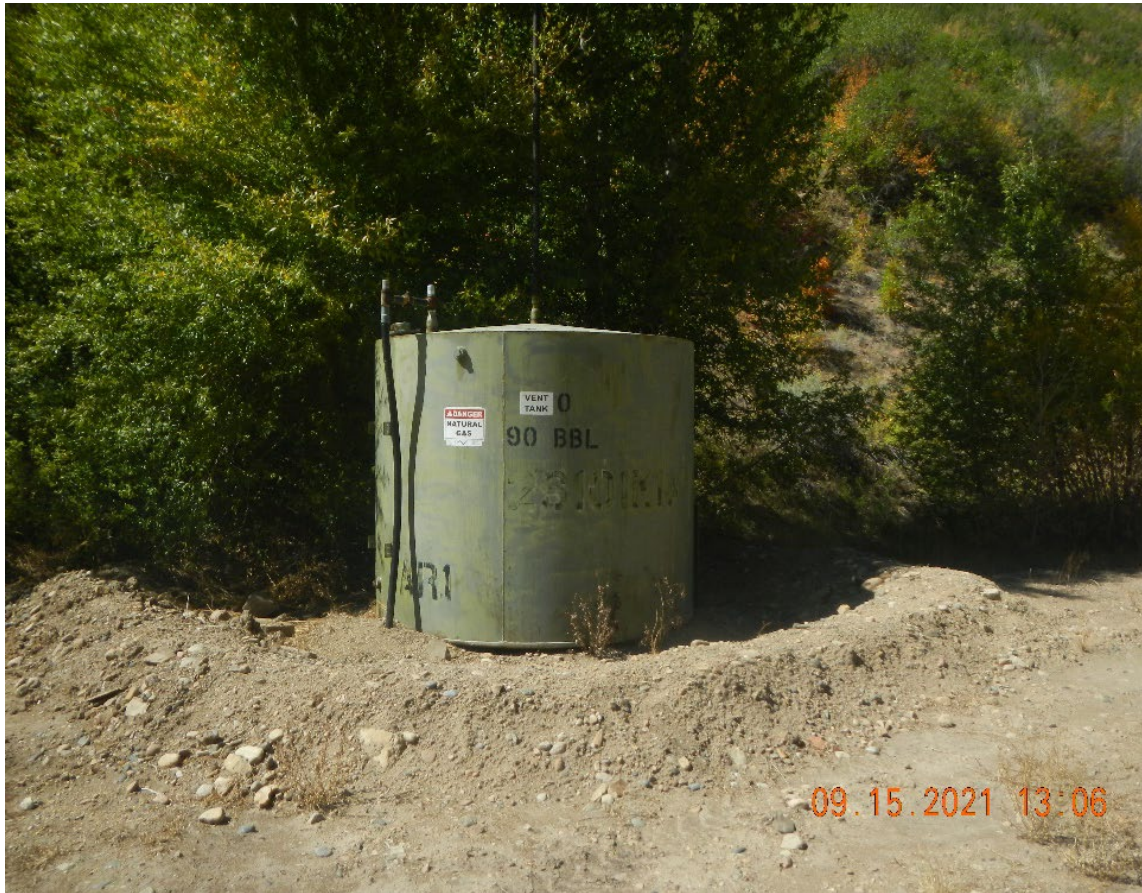
Photo #17 tank is ~35 feet west of wellhead. Tank labeling indicates that tank is being used to vent gas.

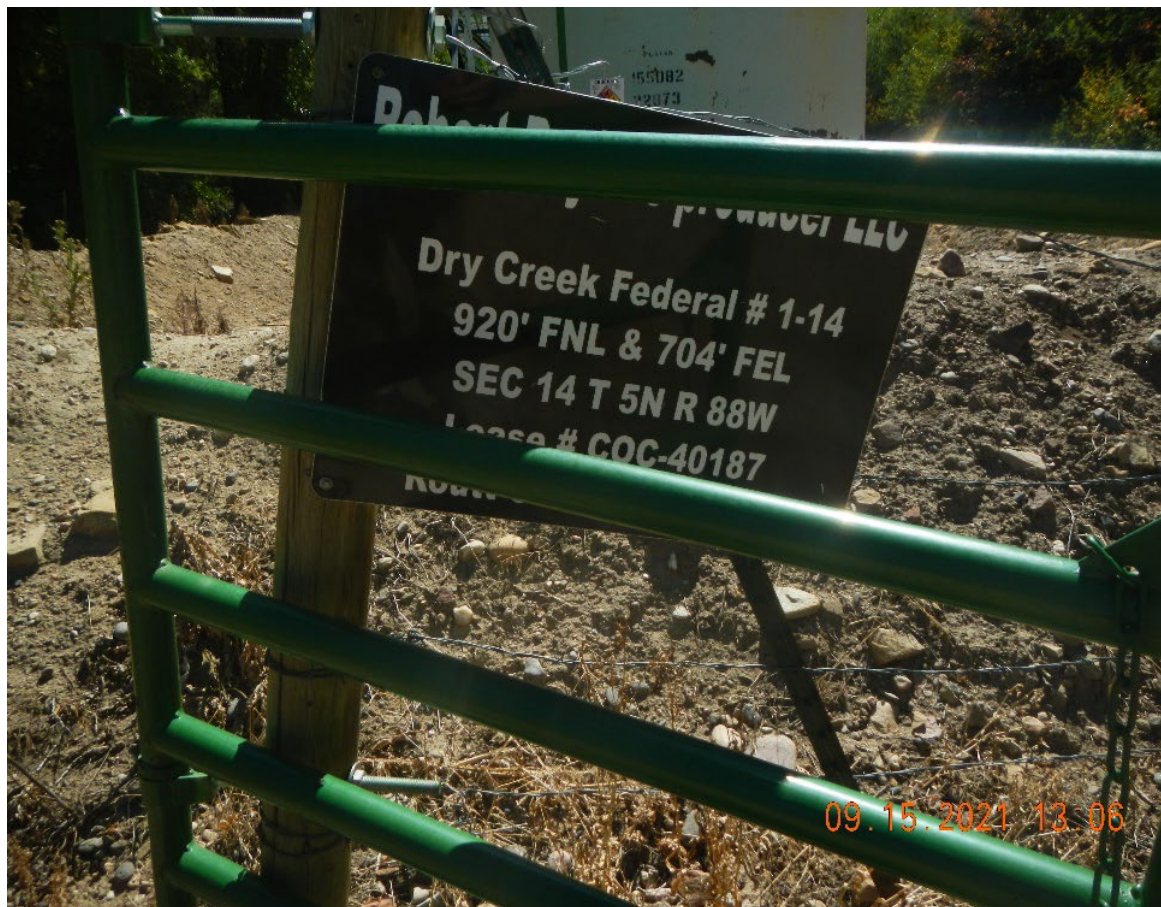
Photo #18 sign near wellhead.

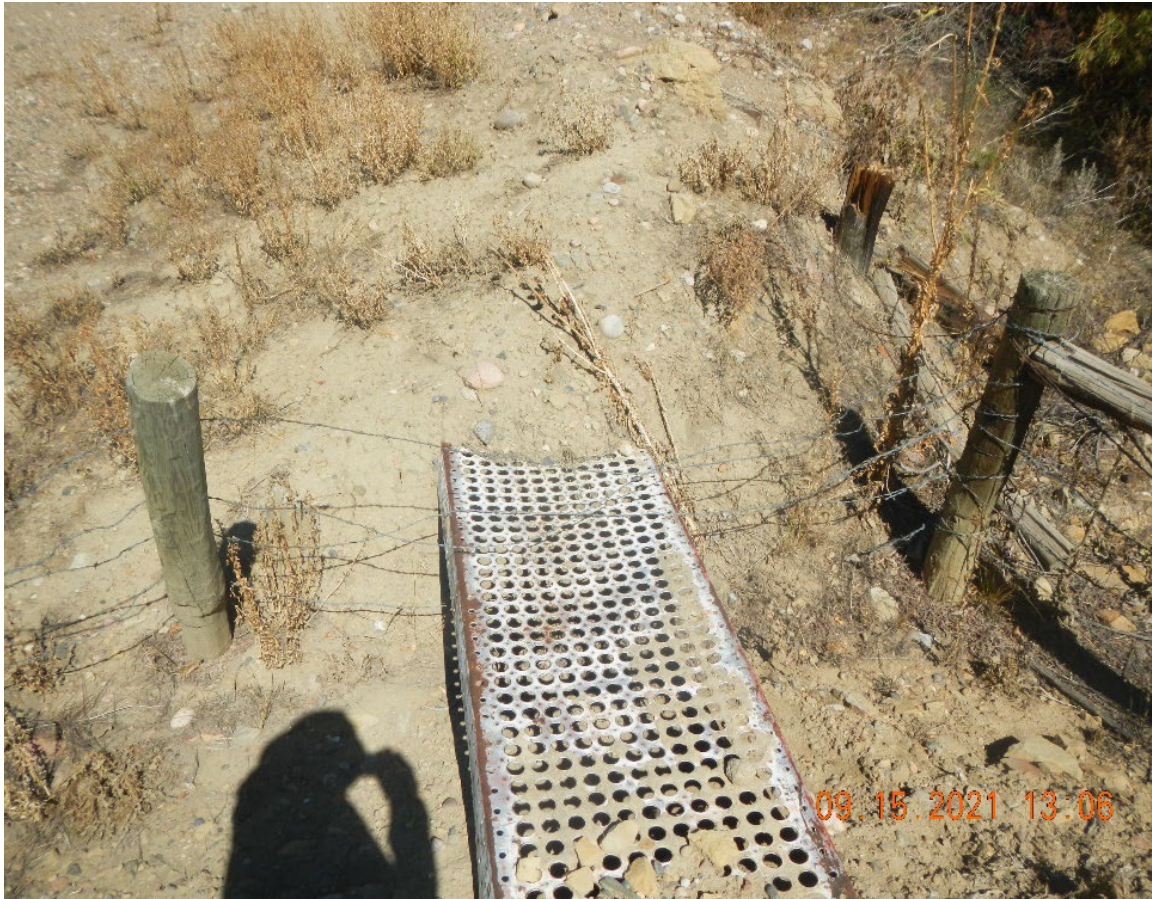
Photo #19 fencing at tank battery.

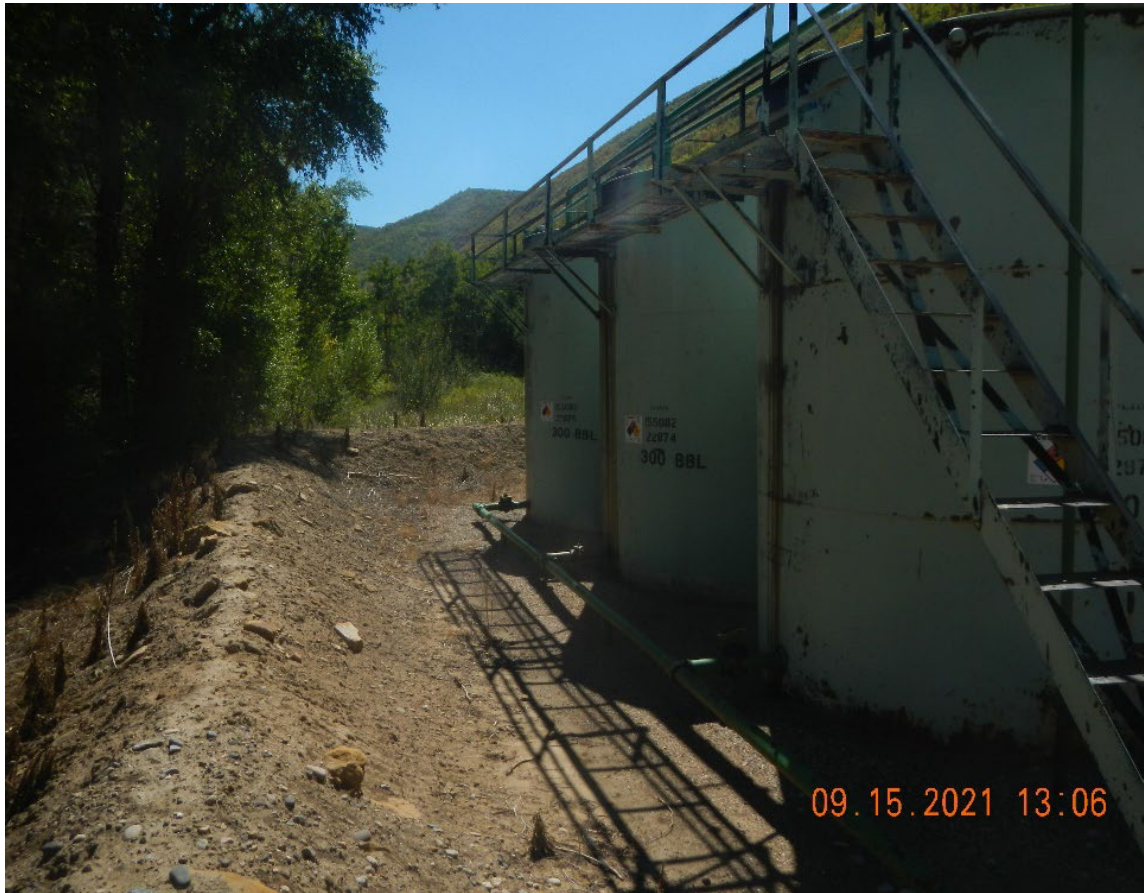
Photo #20 looking south at tank battery.
