Inspection Photos

API: 071-09140

Operator: OGRIS OPERATING LLC

Inspection Date: 9/28/2021

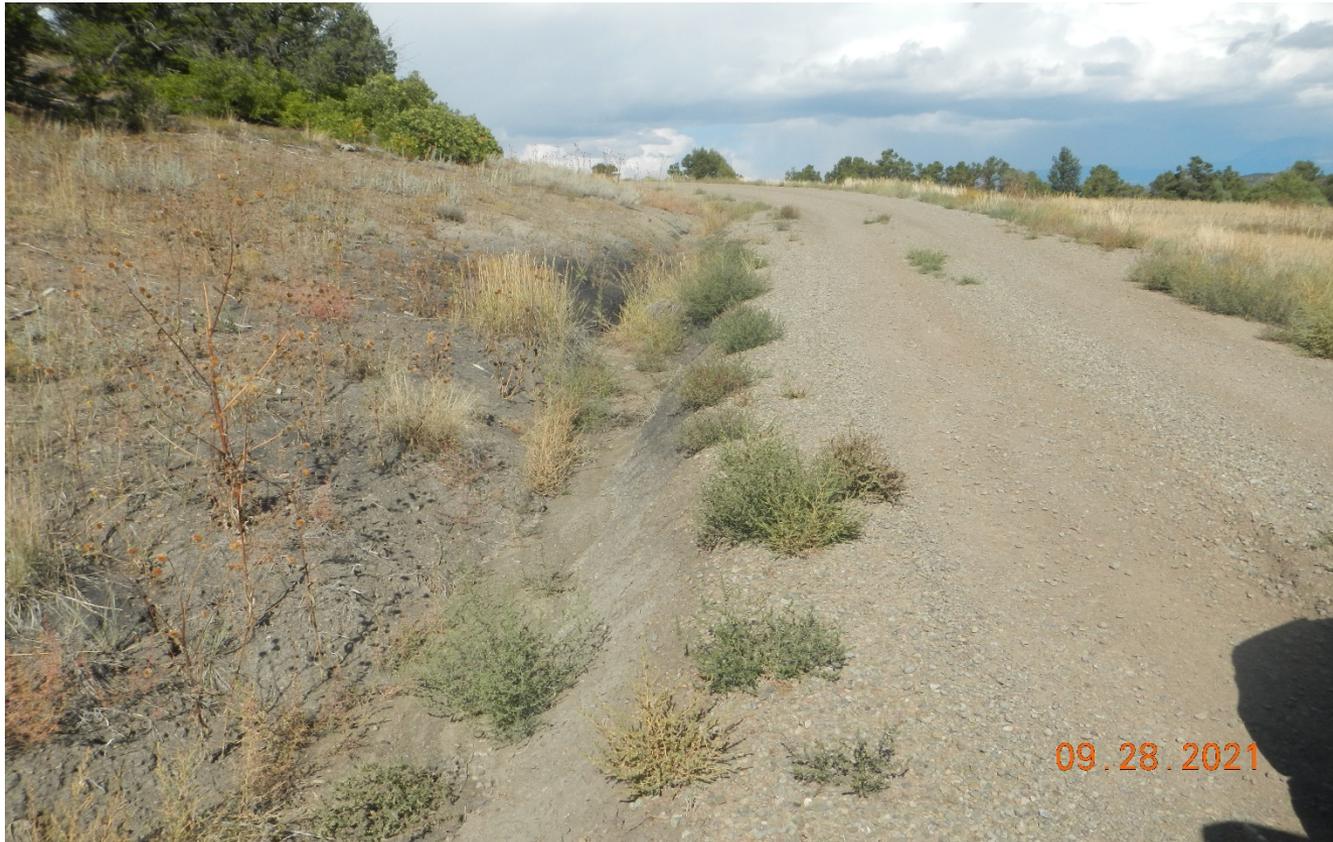
Photo 1. Facing northeast along the main access road. There is erosion along the side of the road which needs BMP's to prevent further erosion.

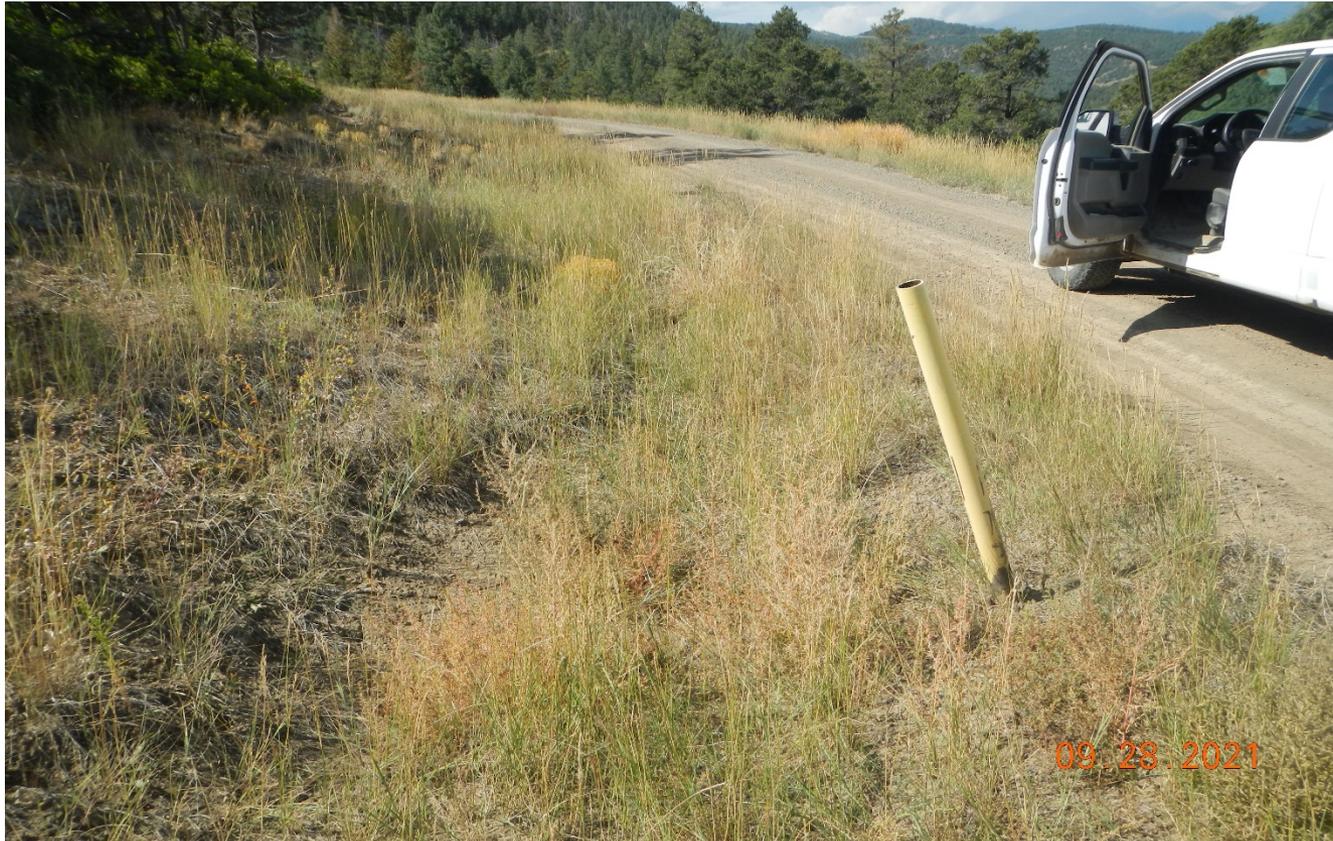
Photo 2. Facing west along access road. The culvert is filled in with sediment and stormwater from the road is not being directed toward the culvert from the road.

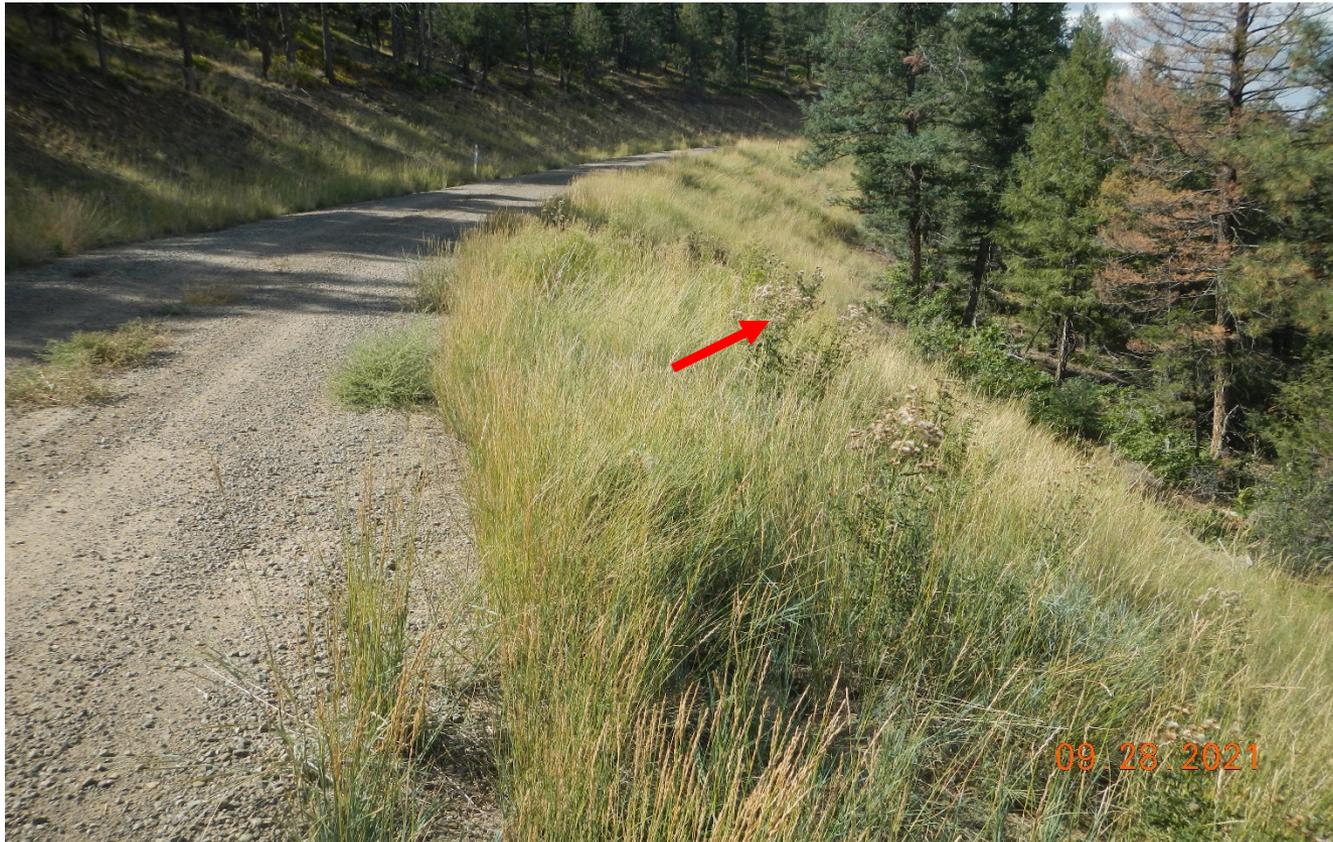
Photo 3. There is noxious weeds along the access road traveling to the location. Arrow points to Canada thistle.
