Caerus Piceance LLC
O2E
Location # 334695

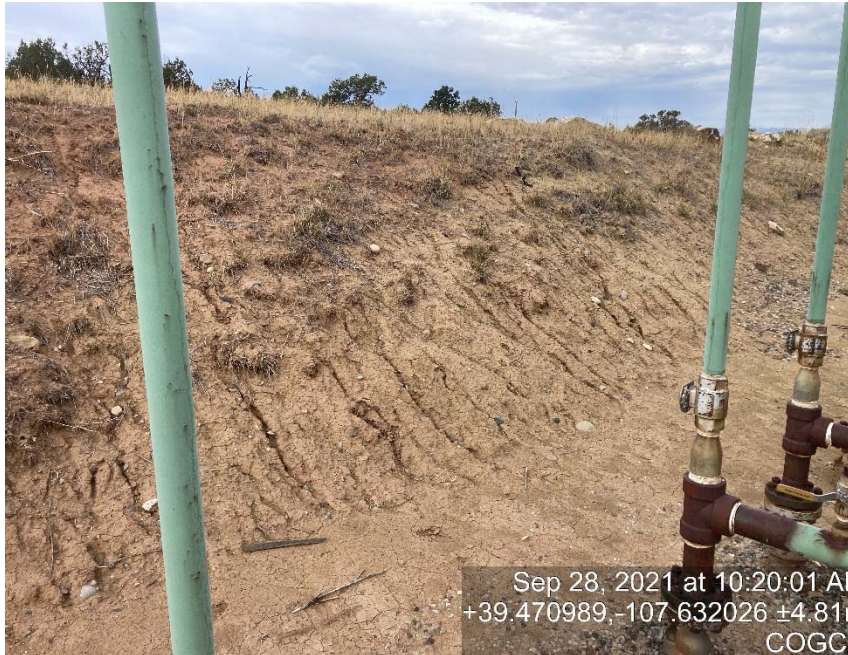
Lack of stabilization/erosion

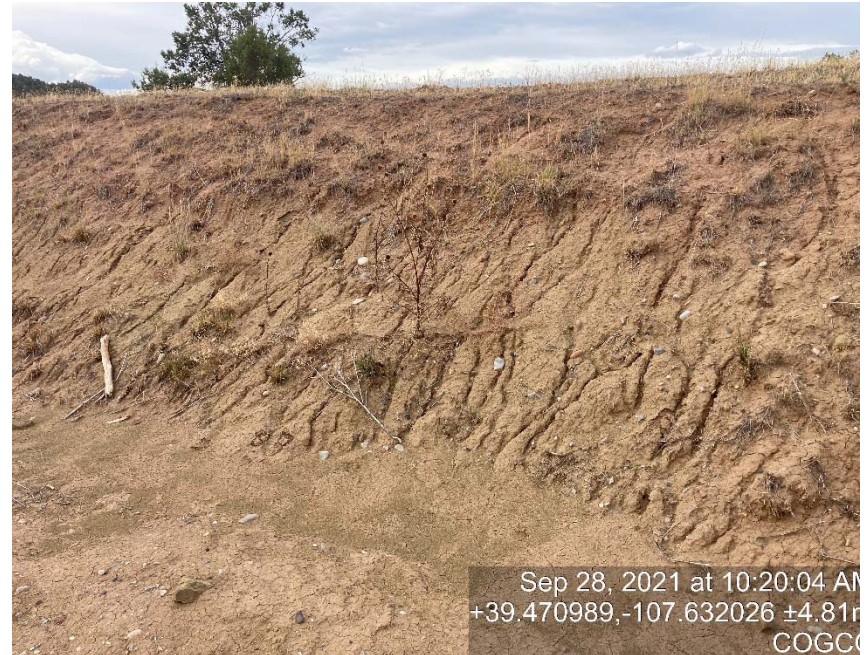
Lack of stabilization/erosion

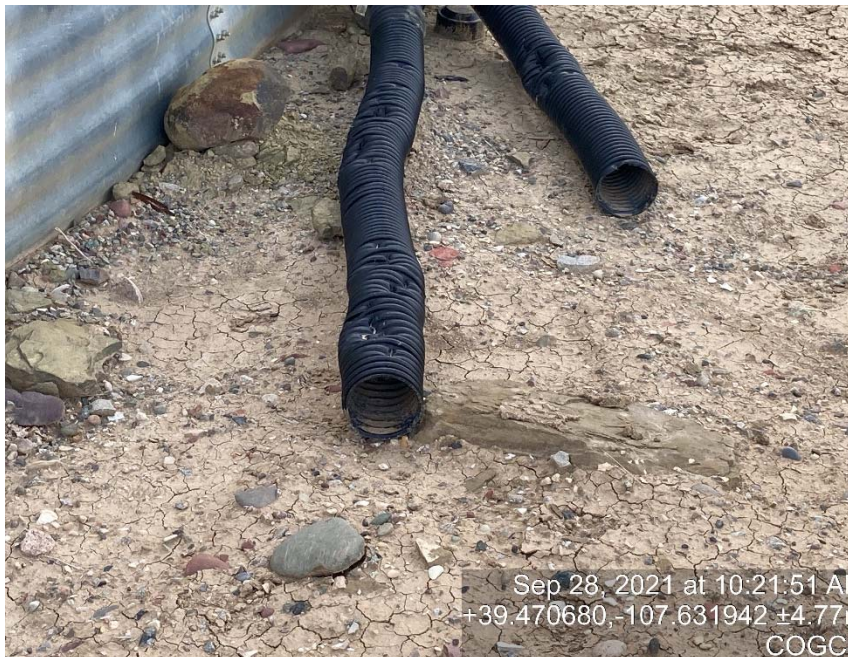
Open ended piping

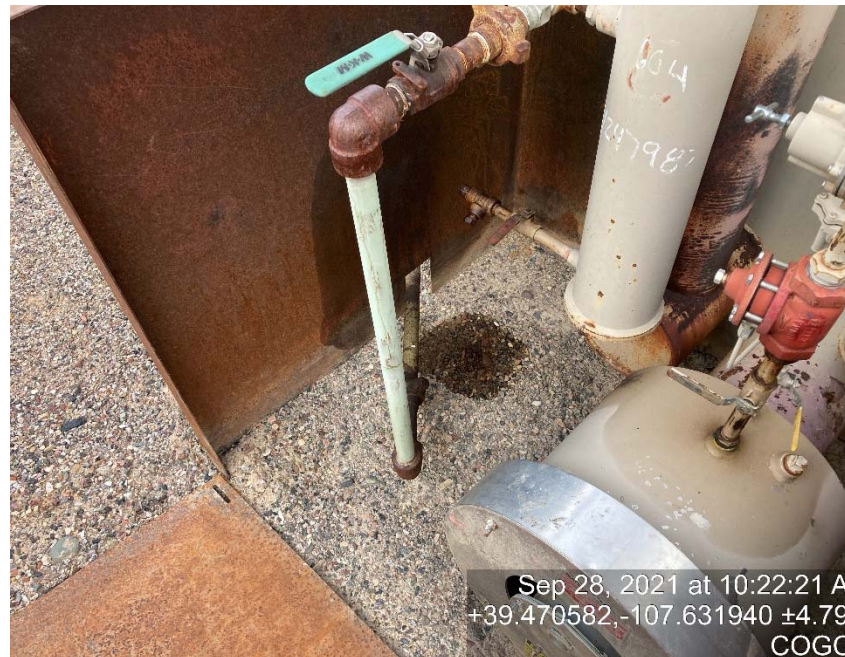
Staining

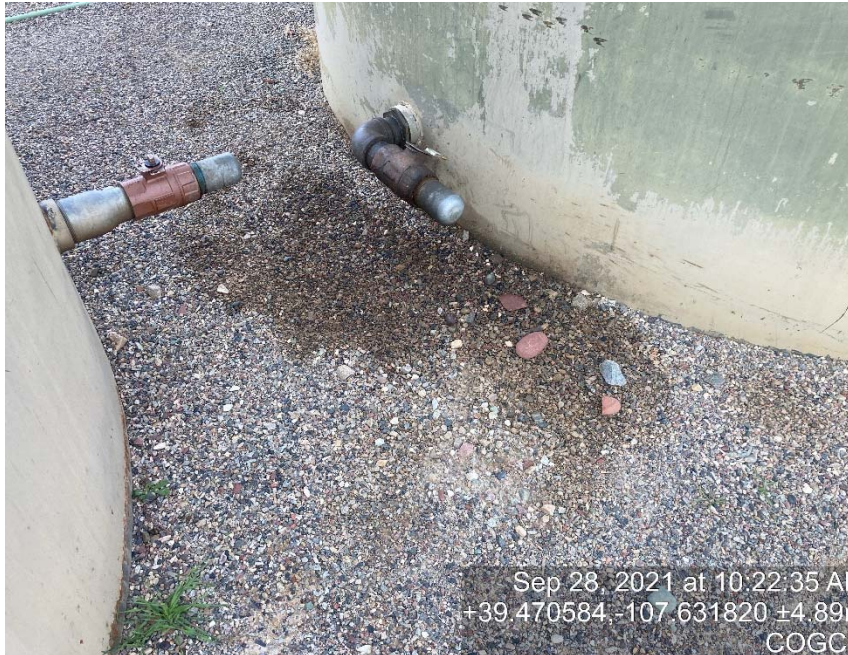
Staining

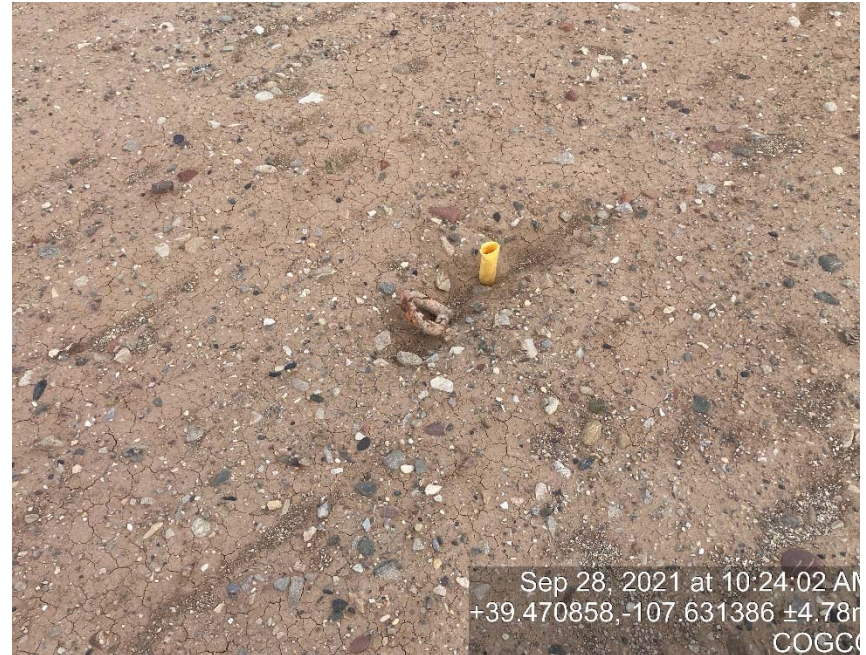
Improperly marked dead man

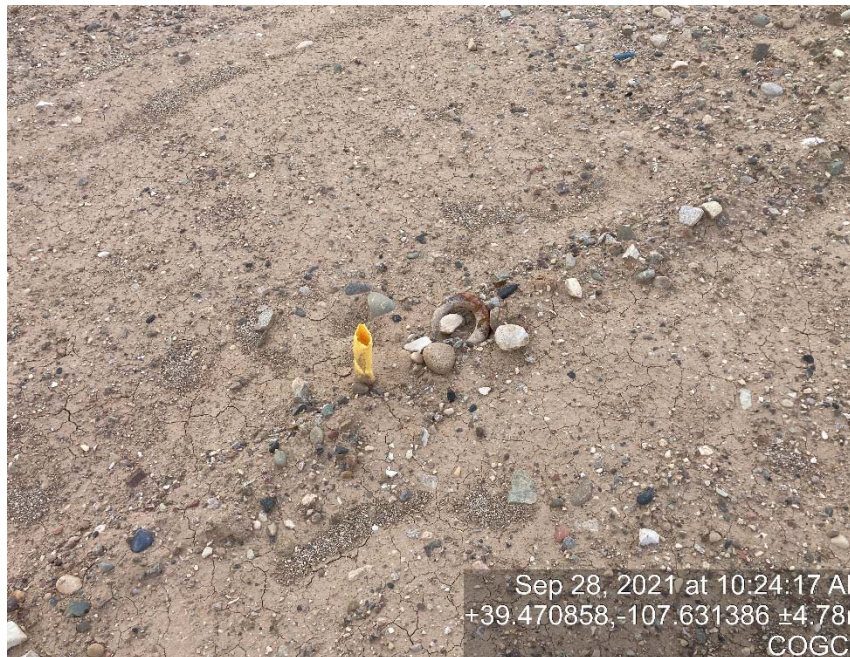
Improperly marked dead man
