**Inspection Photos**  
**Location Name: UPRR 42 Pan Am AF 1**  
**Location ID: 332876**

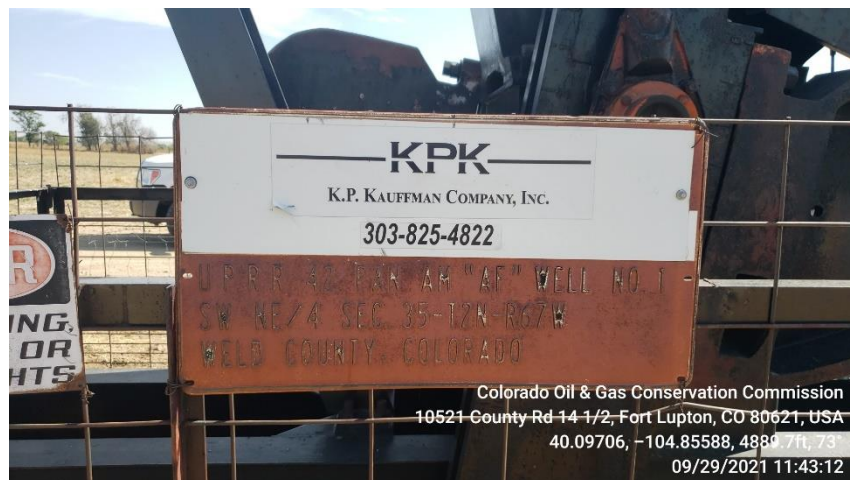
**Photo 1 WH sign**

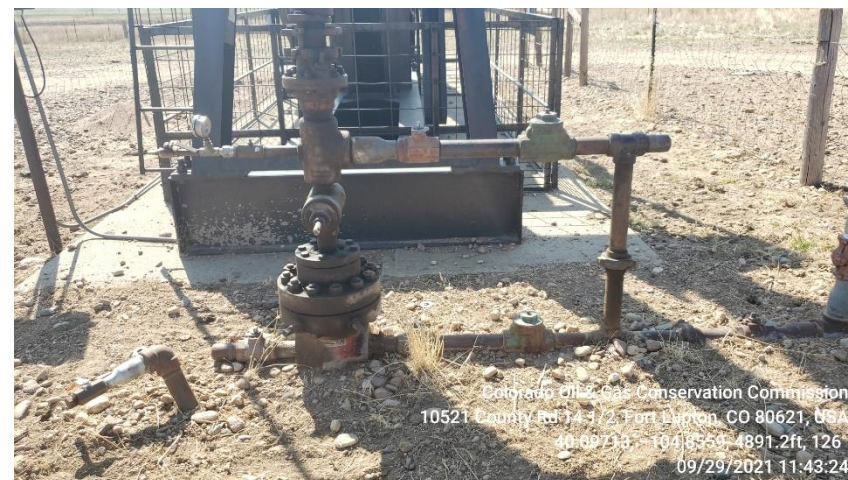
**Photo 2 WH**

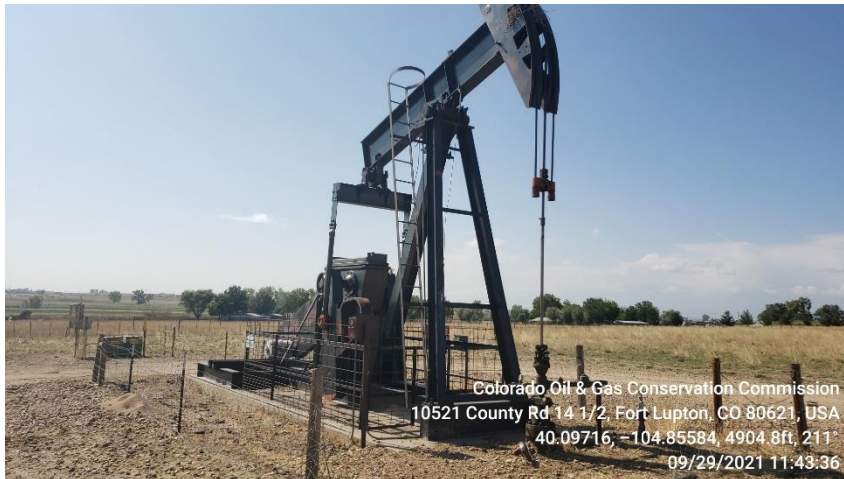
**Photo 3 pump jack**

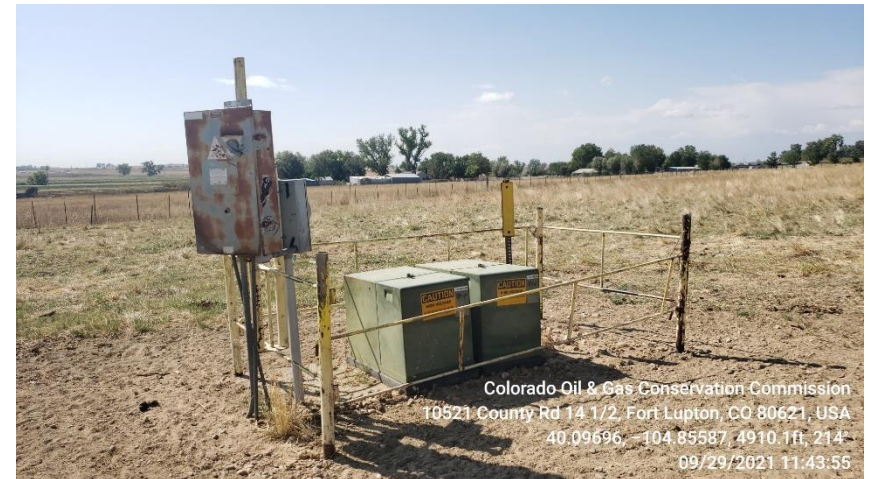
**Photo 4 ancillary equip.**

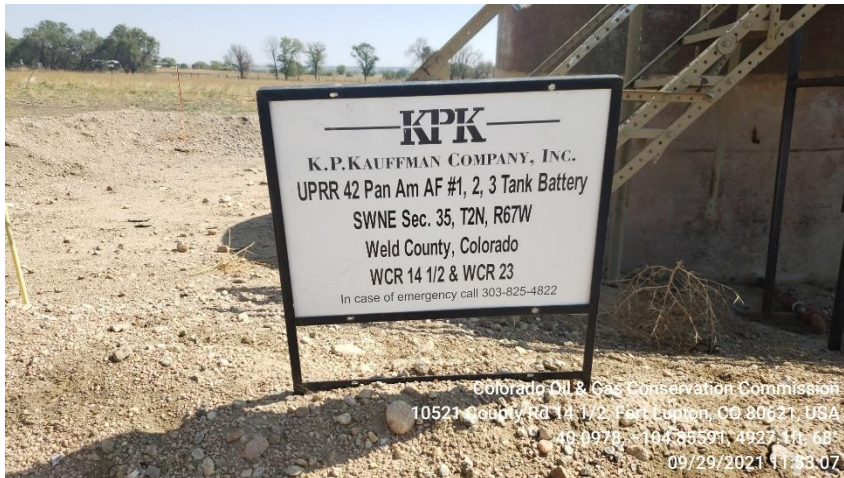
**Photo 5 TB sign**

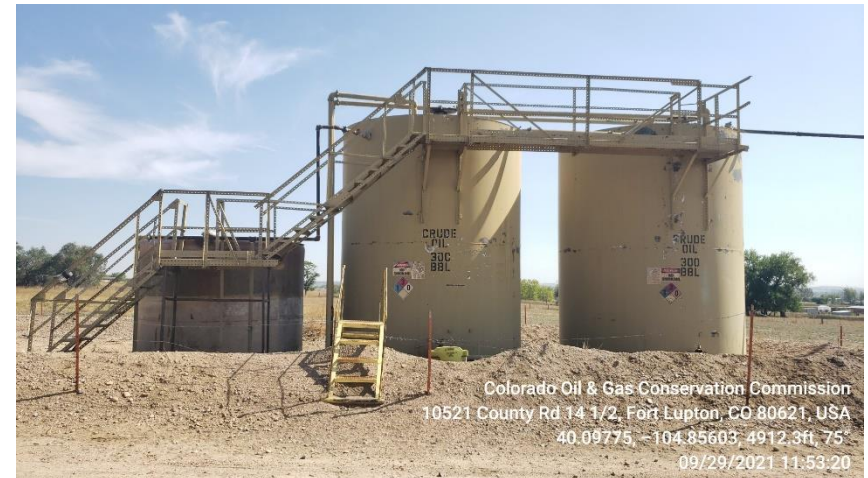
**Photo 6 TB**

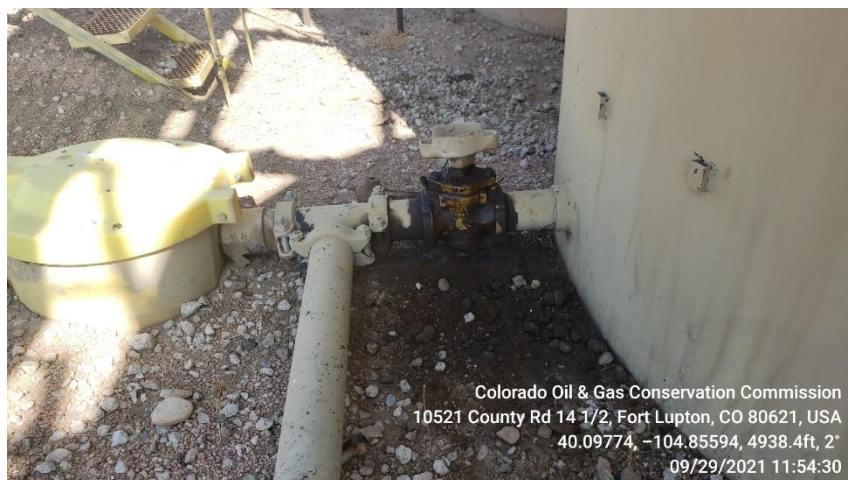
**Photo 7 Stained soil by crude oil tank load out line.**

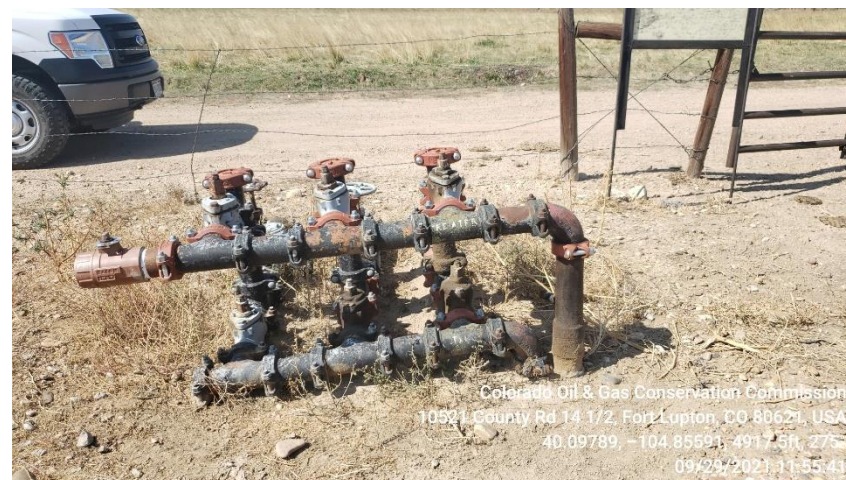
**Photo 8 Flow line manifold**

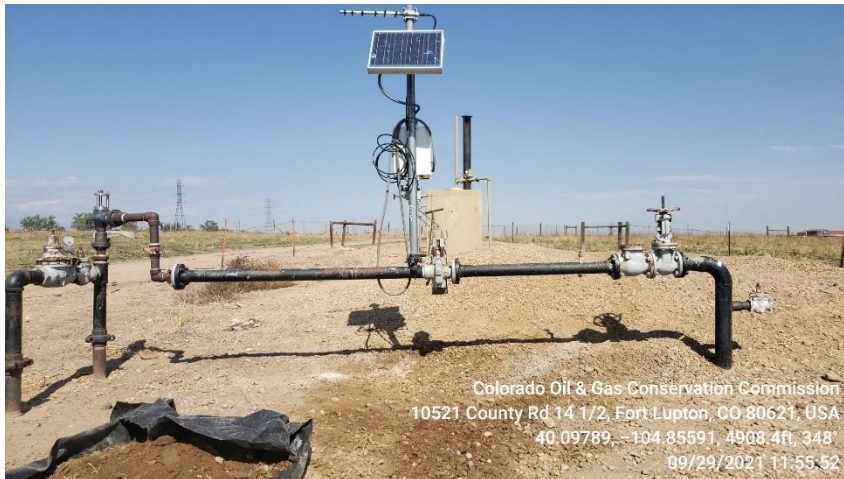
**Photo 9 Gas Meter Run**

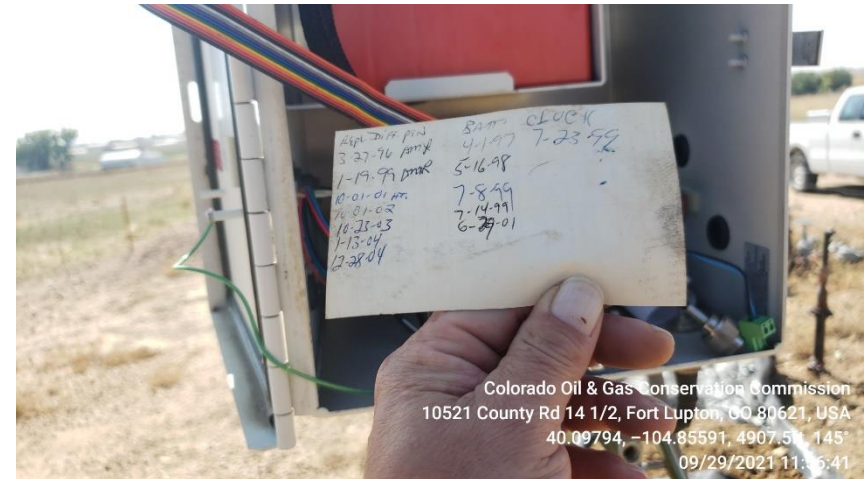
**Photo 10 Card in meter box indicates calibration is not current.**

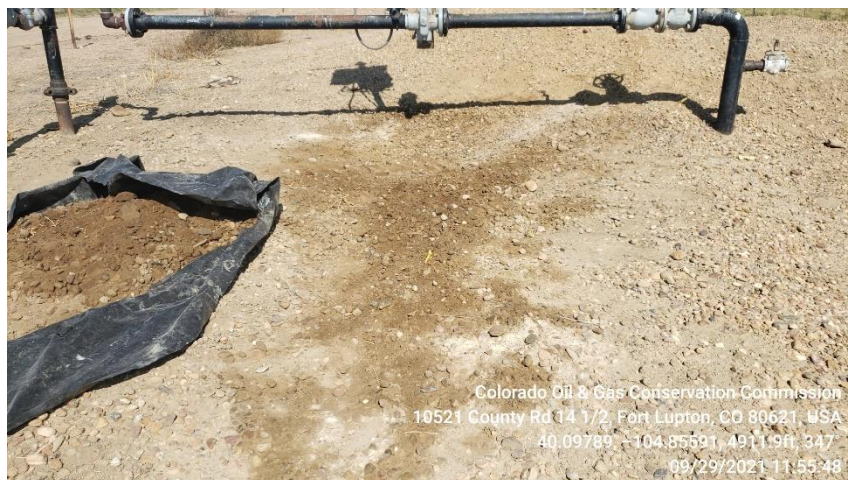
**Photo 11 Stained soil by the Gas Meter Run**

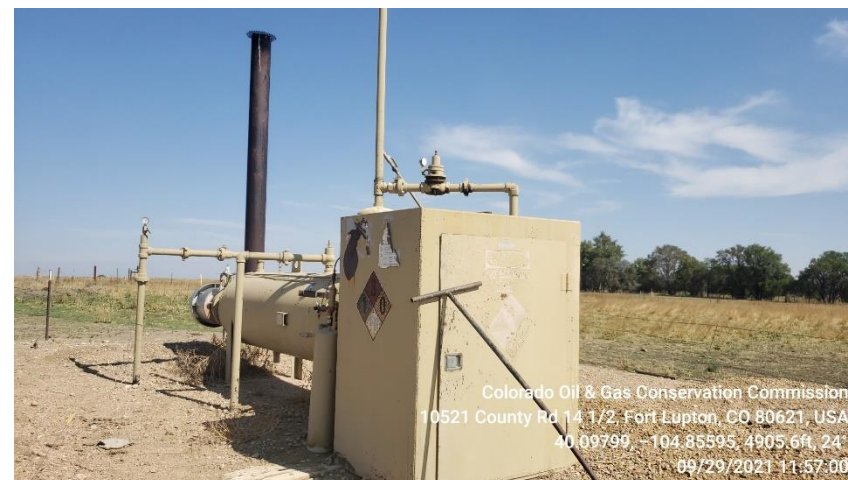
**Photo 12 Horizontal Heated Separator.**
