Inspection Photos
Location Name: Simpson A9
Location ID: 319940

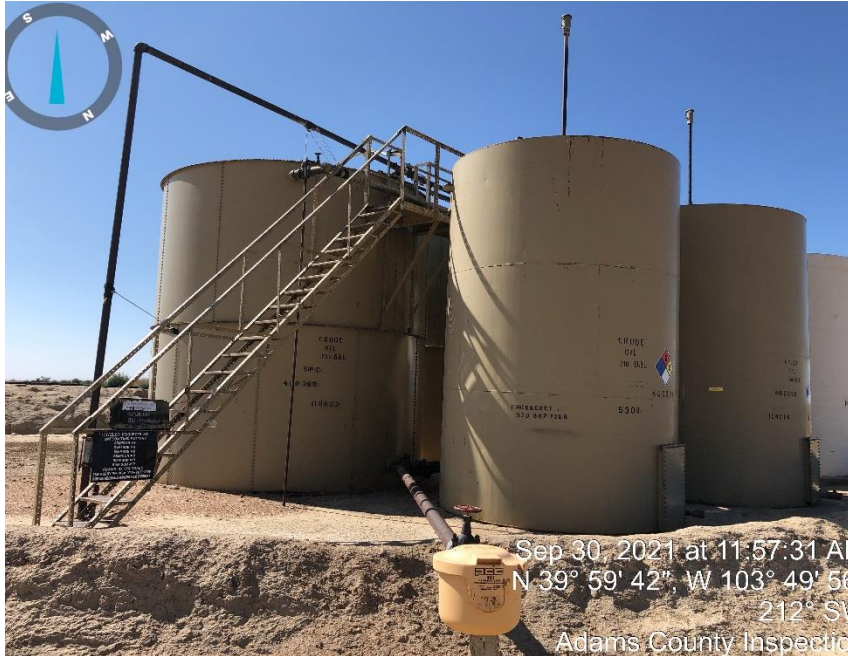
Photo #1 East side of Tanks.

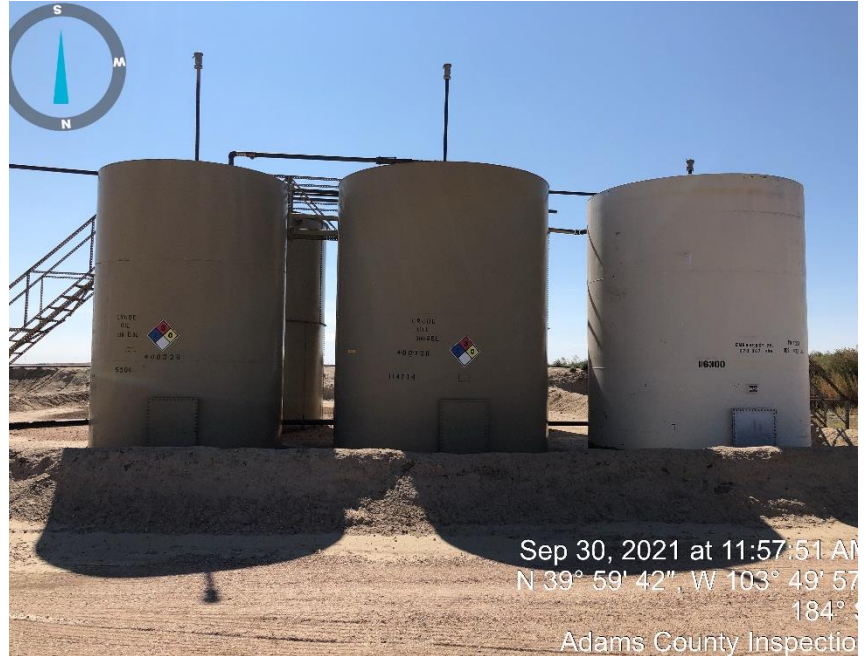
Photo #2 North side of Tanks.

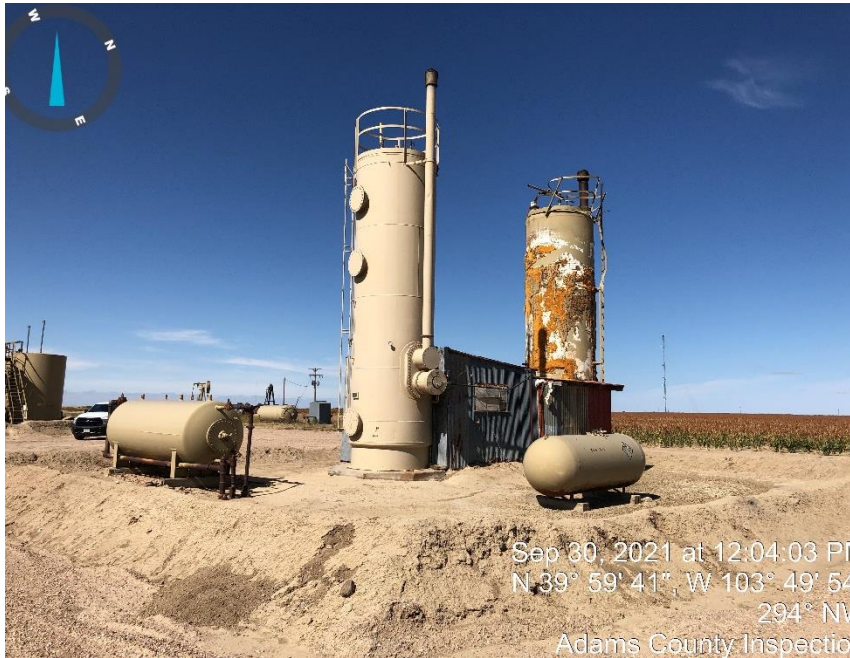
Photo #3 South East side of Vertical Separators.

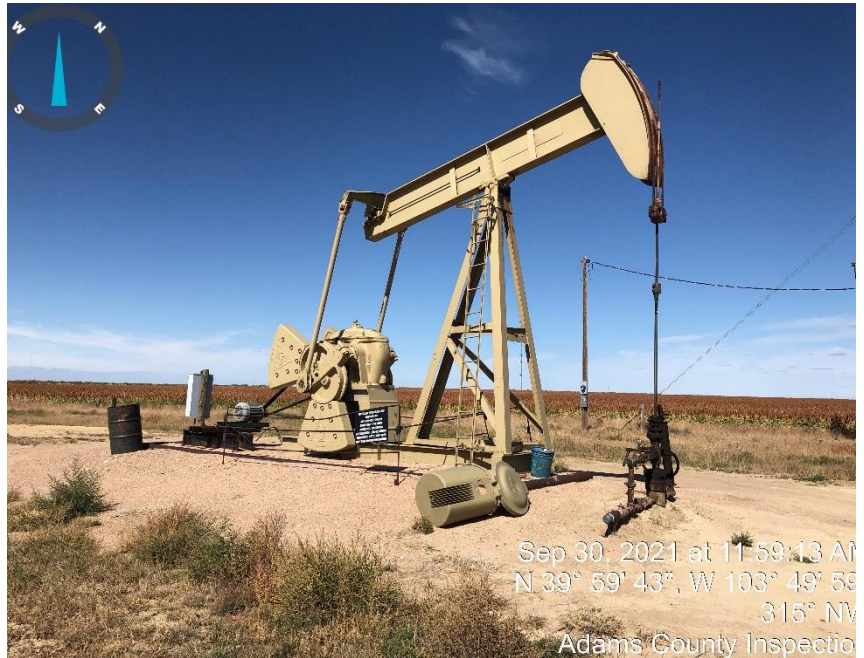
Photo #4 South East side of Pump Jack.

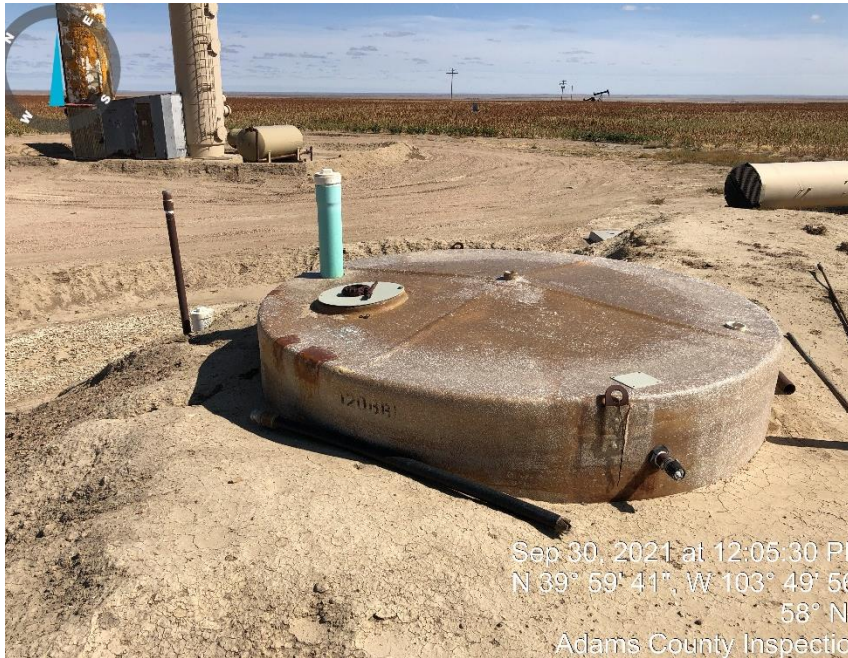
Photo #5 South West side of tank.

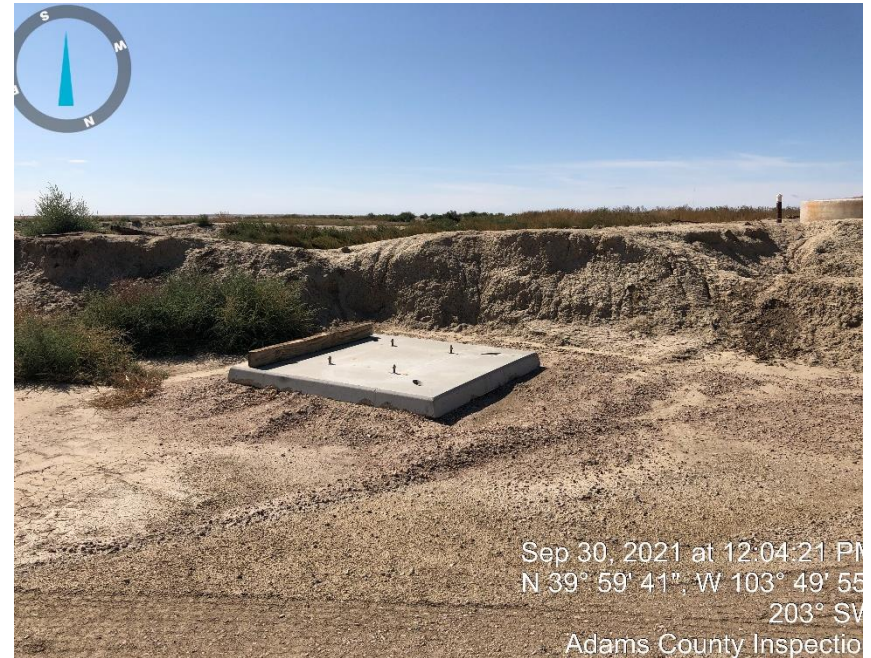
Photo #6 North side of new pad for potential ECD.

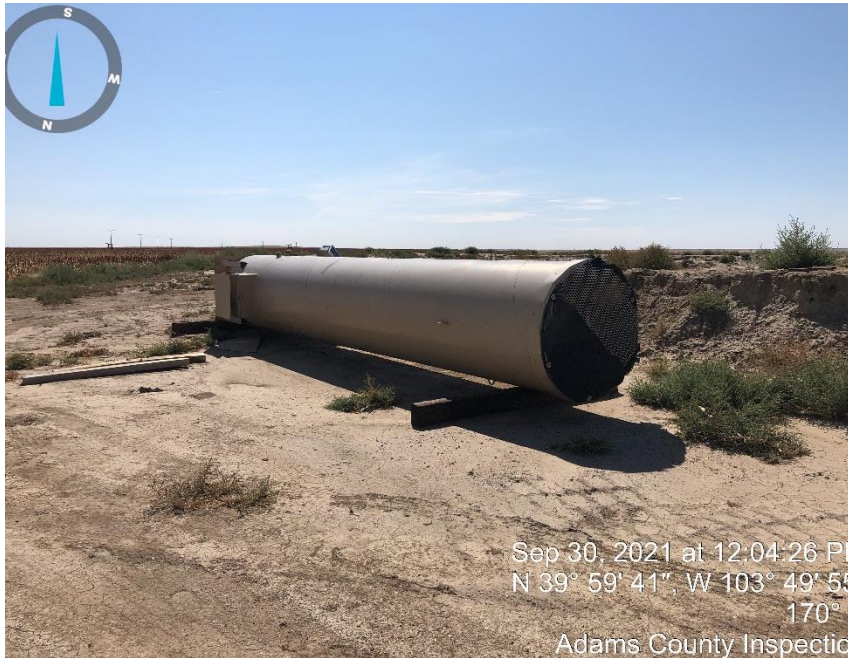
Photo #7 North side of ECD, East of concert pad.

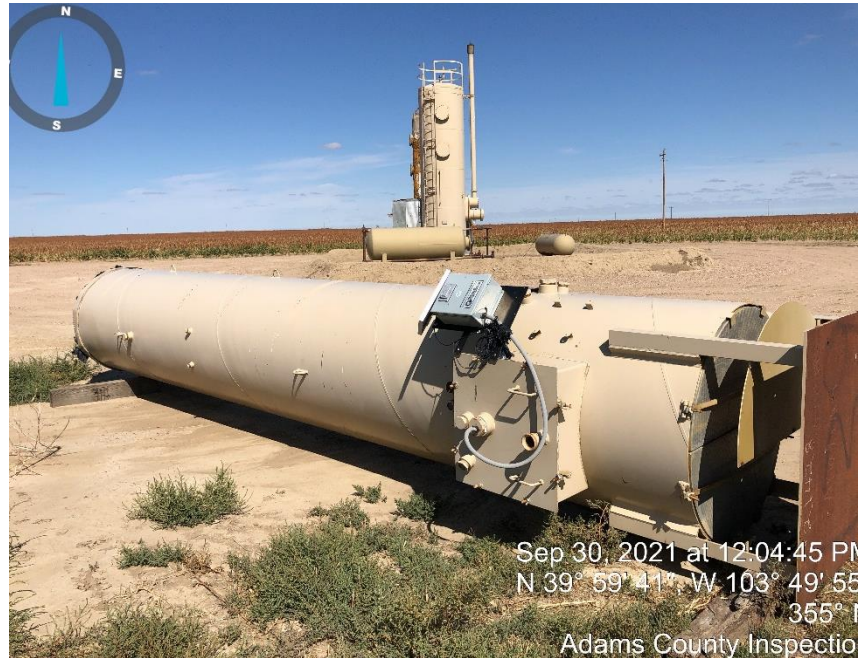
Photo #8 South side of ECD.

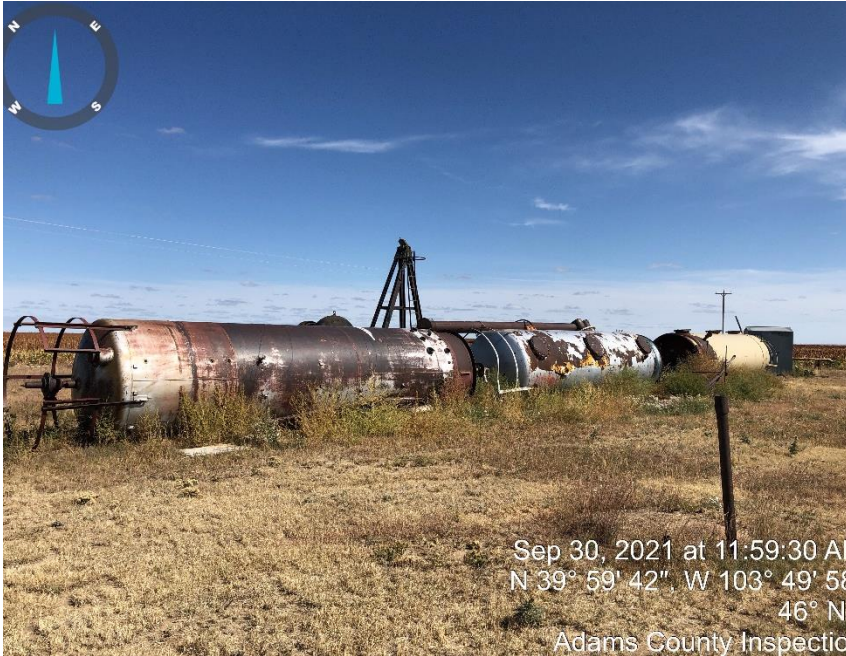
Photo #9 south side of versus unused equipment.

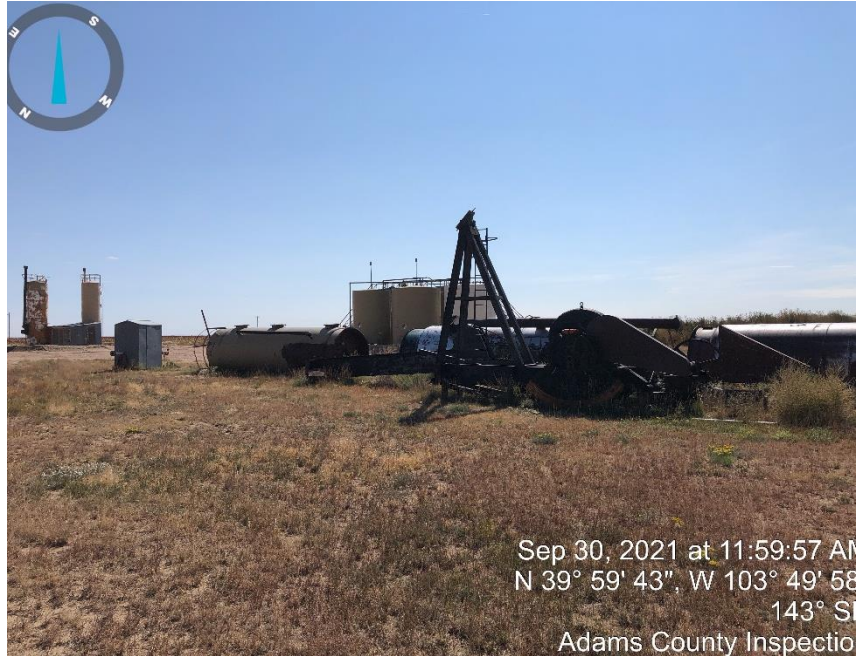
Photo #10 North side of versus unused equipment.

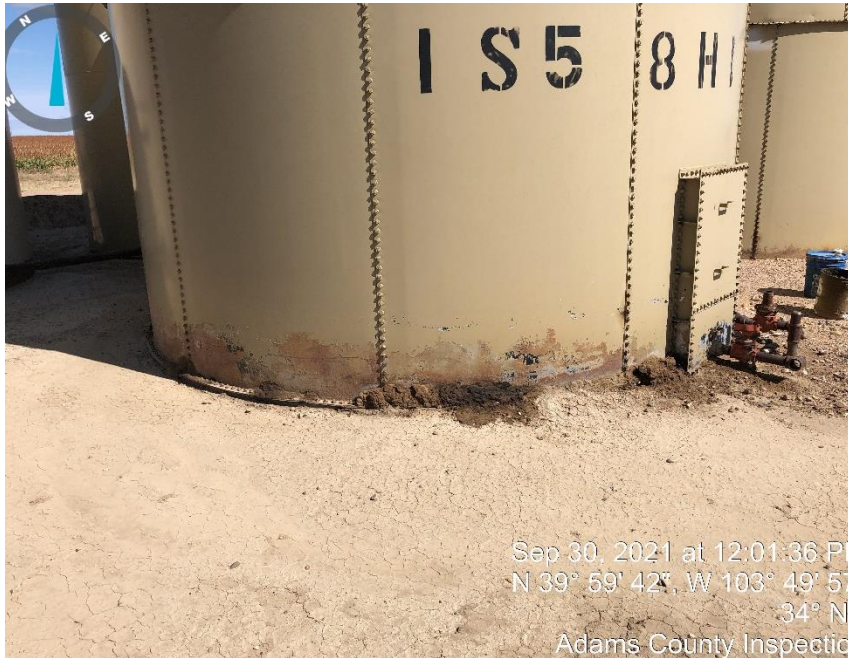
Photo # 11 South West side of crude tank, stained soil from leaking tank.

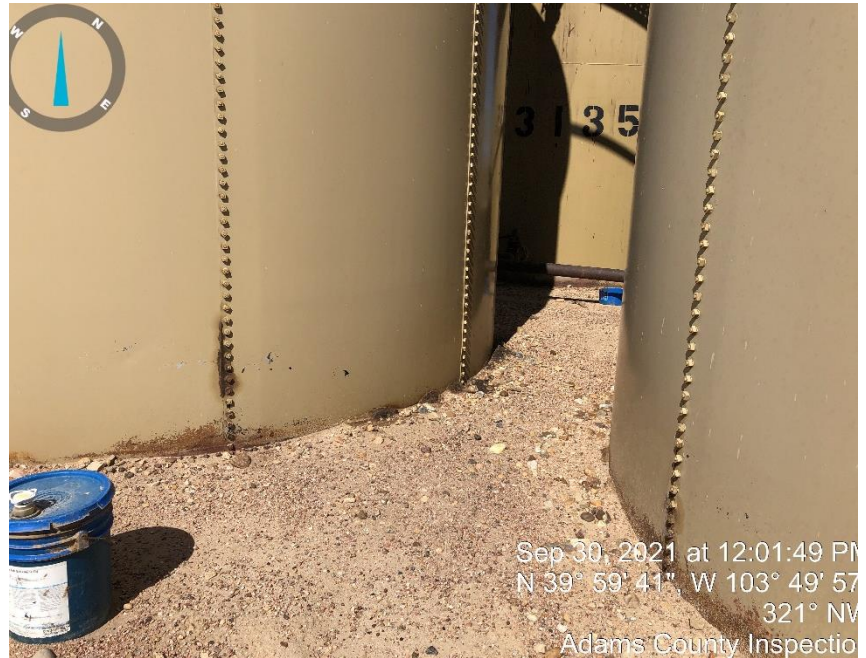
Photo #12 South side of crude tank, stained soil from leaking tank.

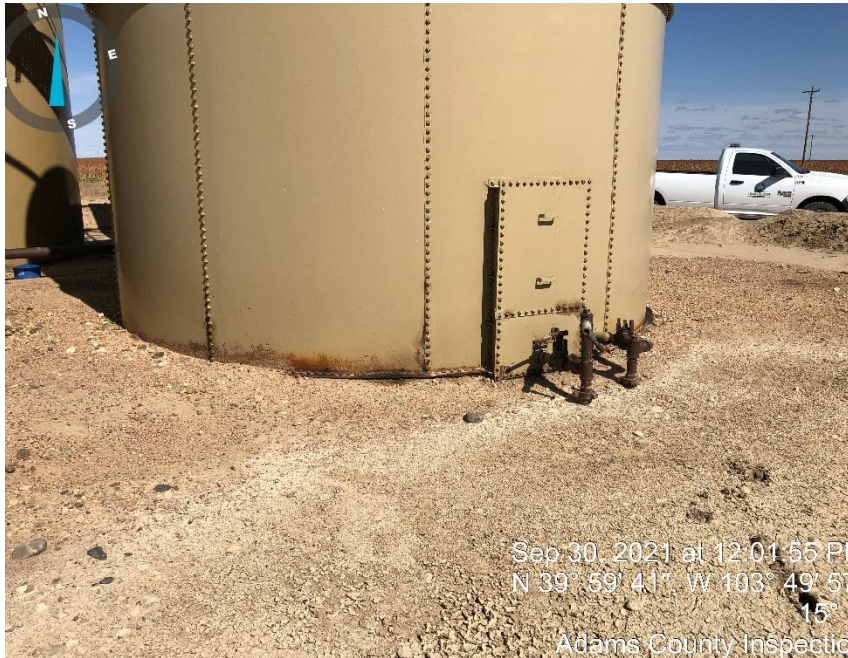
Photo #13 South West side of East crude tank, stained soil from leaking tank.

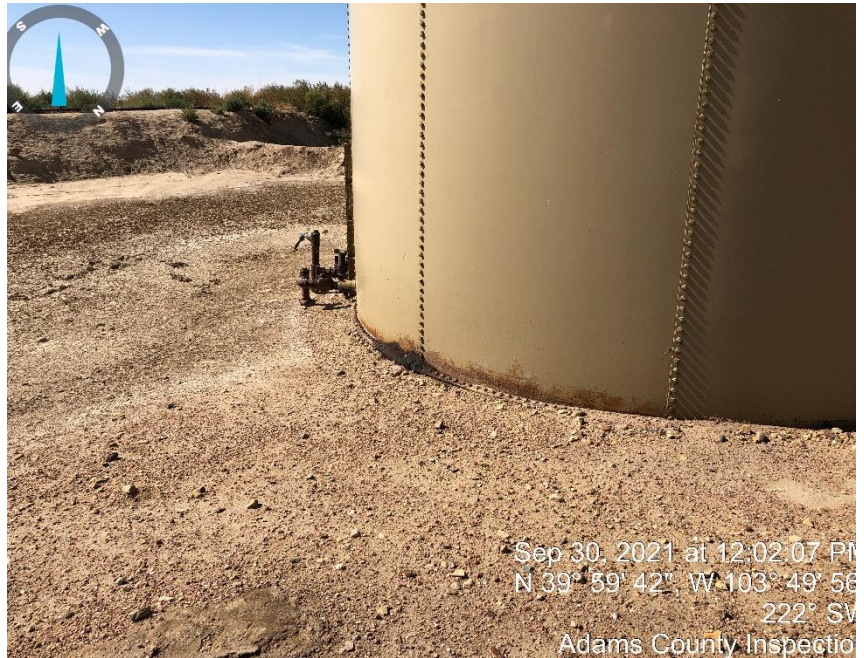
Photo #14 East side of East crude tank, stained soil from leaking tank.

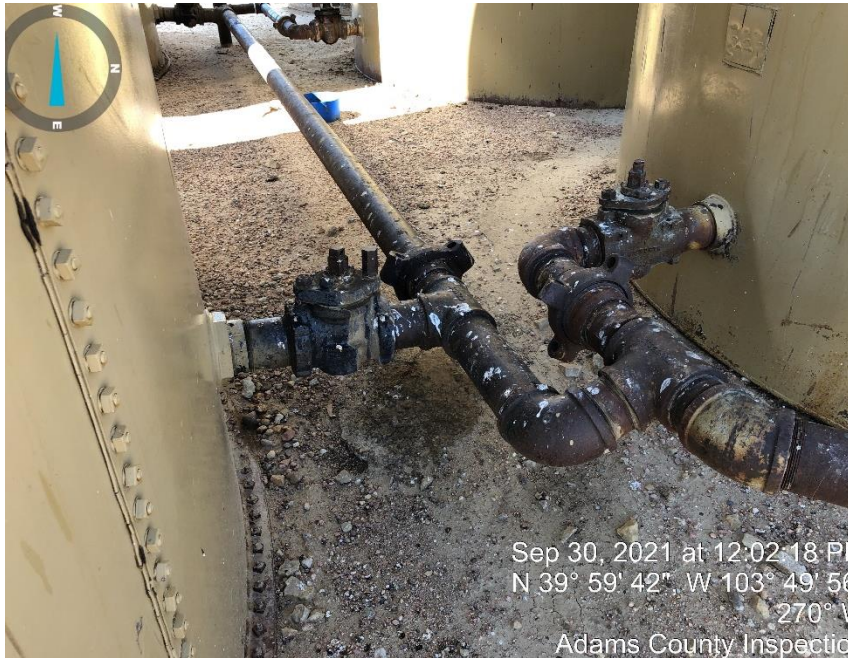
Photo #15 stained soil under valves in-between crude tanks

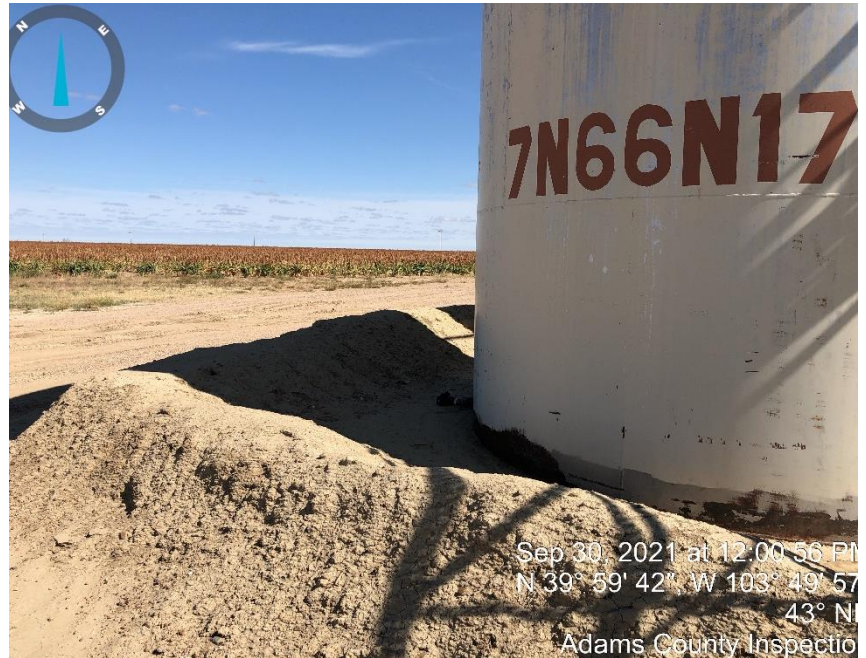
Photo #16 West side of unmaintained berm around tanks.

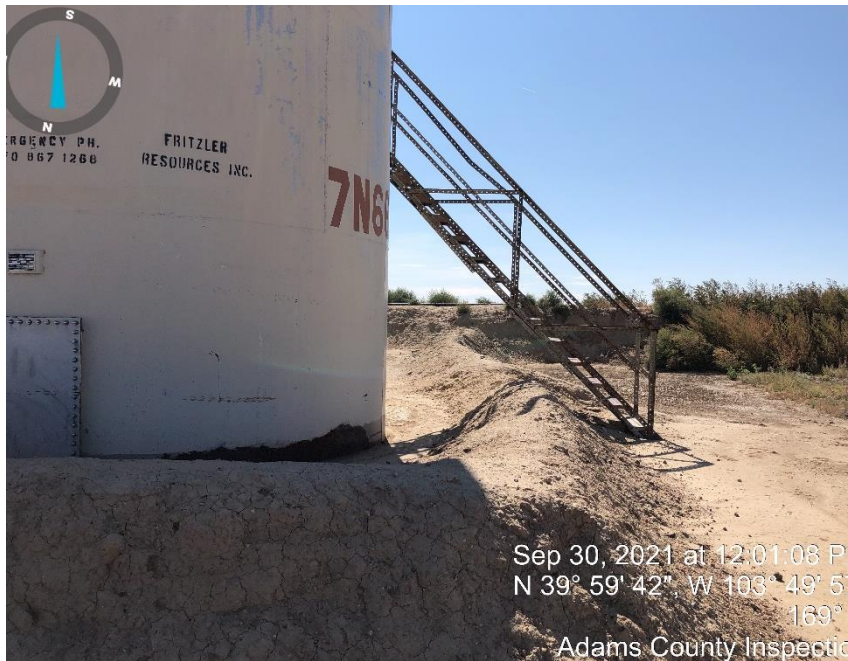
Photo #17 West side of unmaintained berm around tanks.

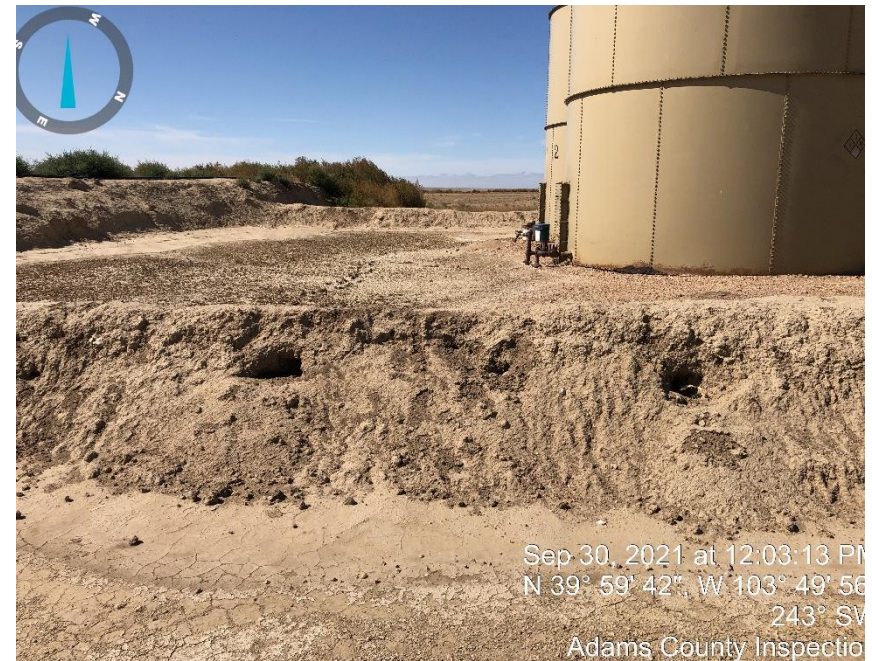
Photo #18 East side of unmaintained berm around tanks.

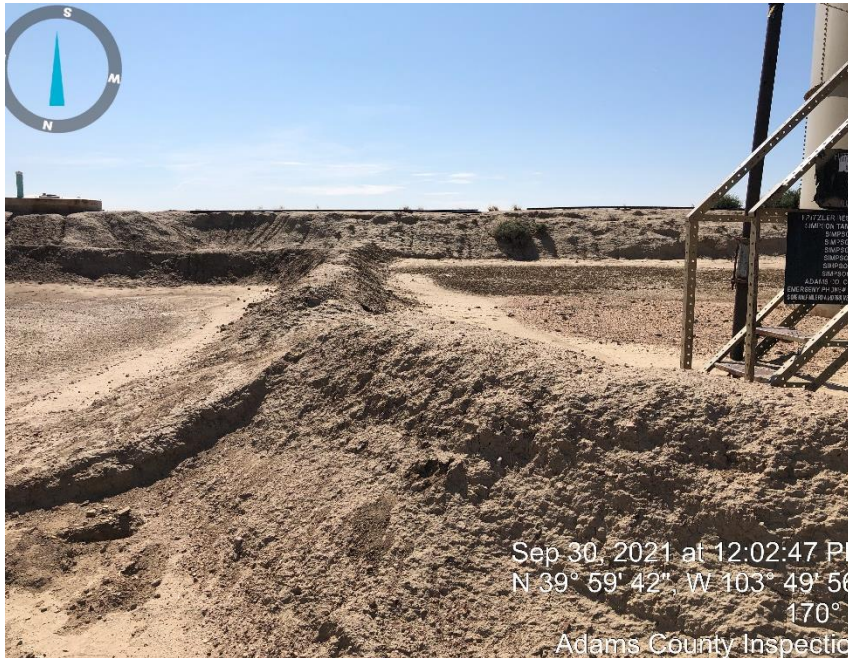
Photo #19 West side of unmaintained berm around tanks

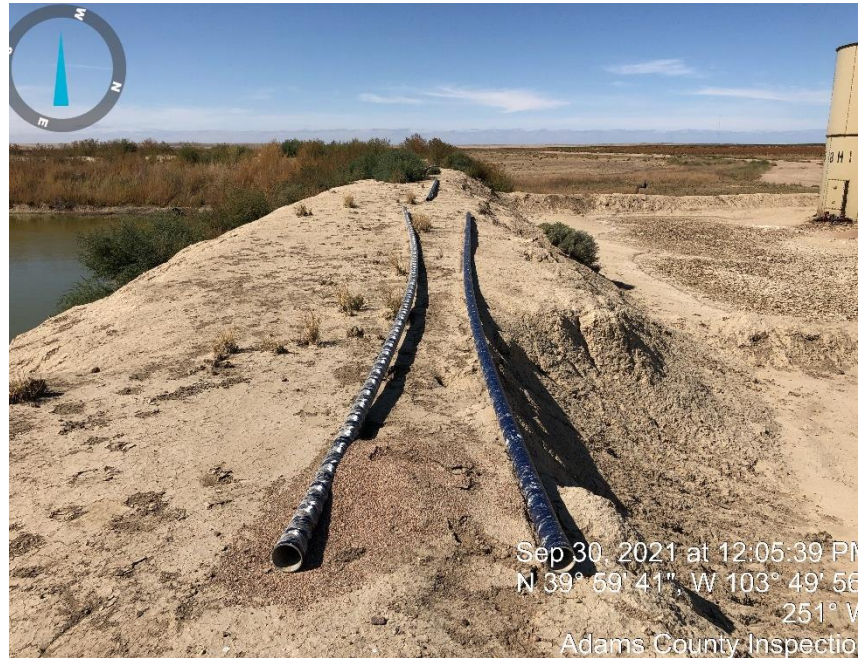
Photo #20 unused fiberglass pipe along pit.

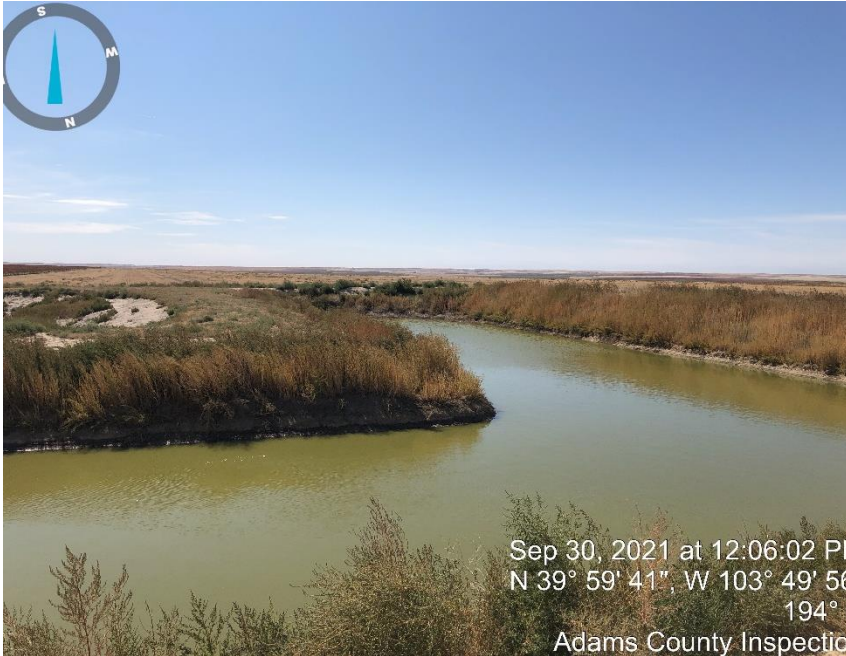
Photo #21 unmaintained pit .

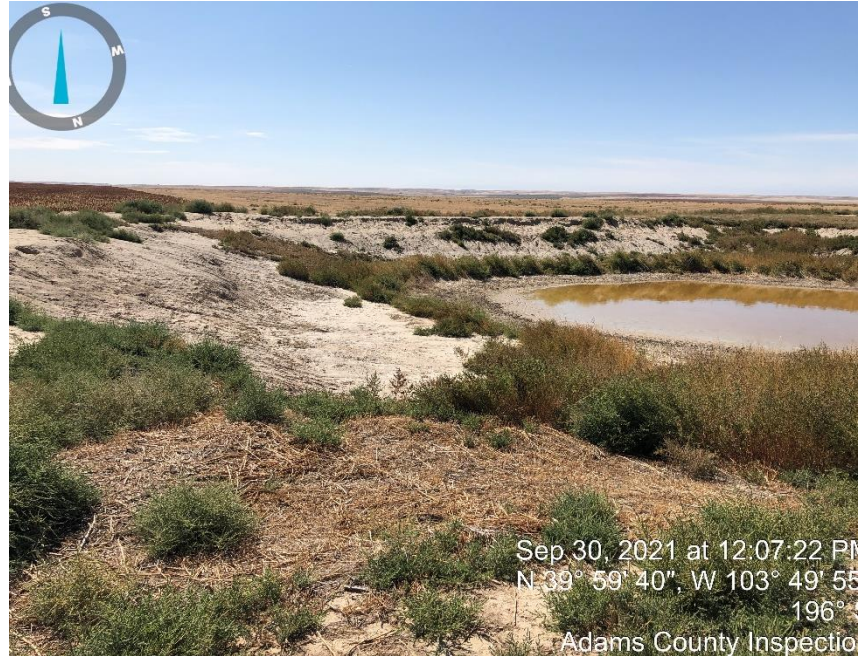
Photo #22 unmaintained pit.

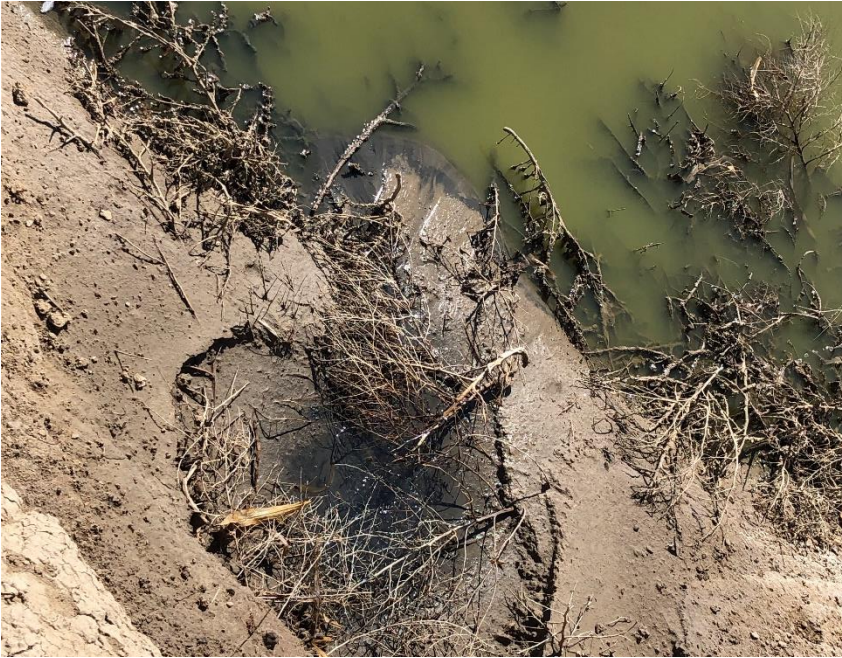
Photo #23 Hydrocarbons in pit below discharge tub.

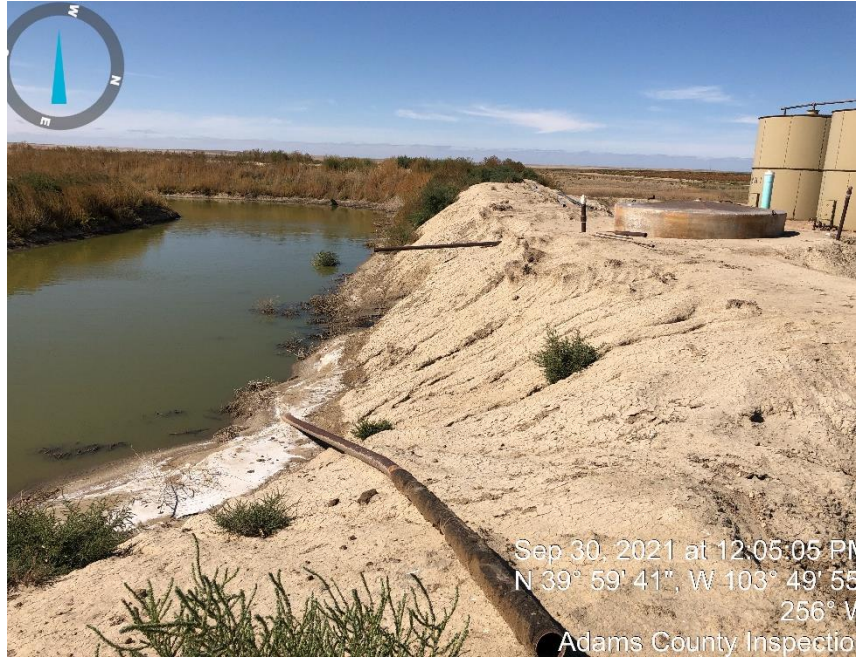
Photo #24 unmaintained pit.
