Inspection Photos
Location Name: Standley 5-2
Location ID: 335697

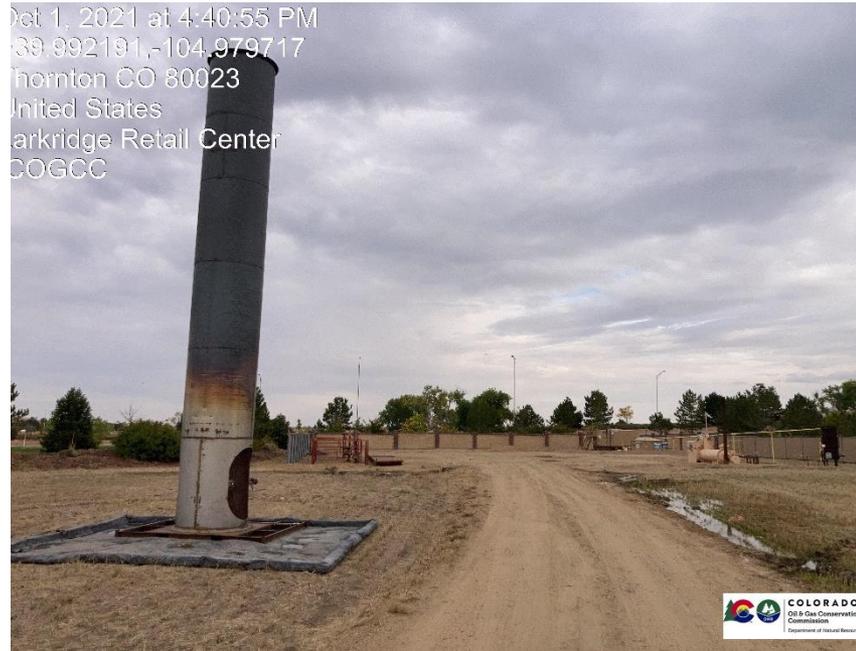
Pic 1 ECD not connected to well.

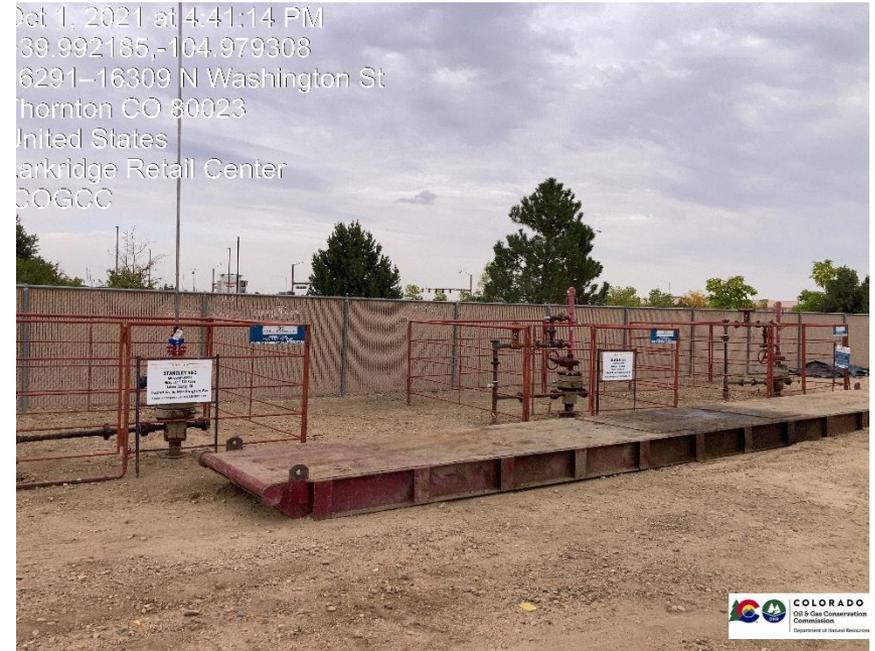
Pic 2 basebeam in front of well. Rods have been installed on first well, no rig on location.

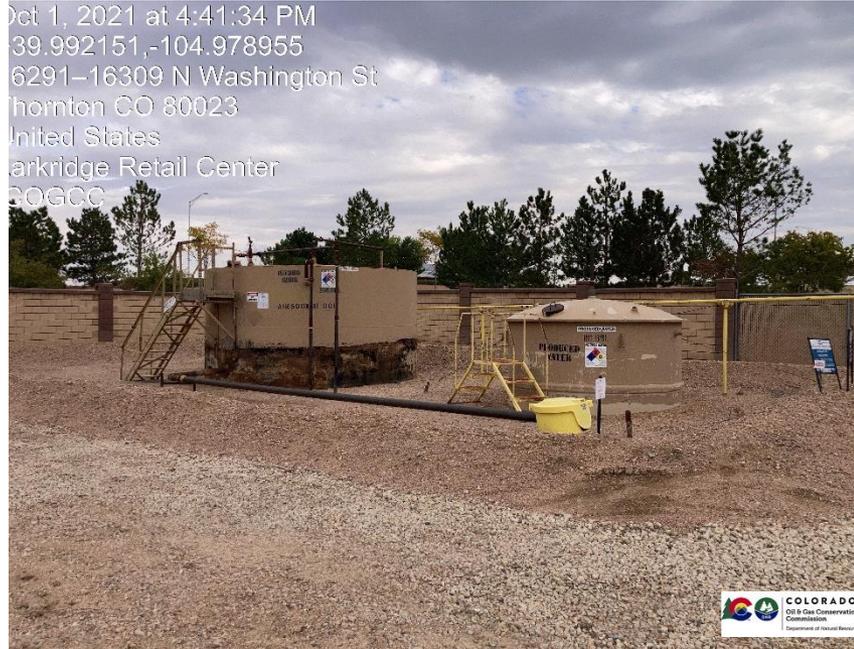
Pic 3 tanks.

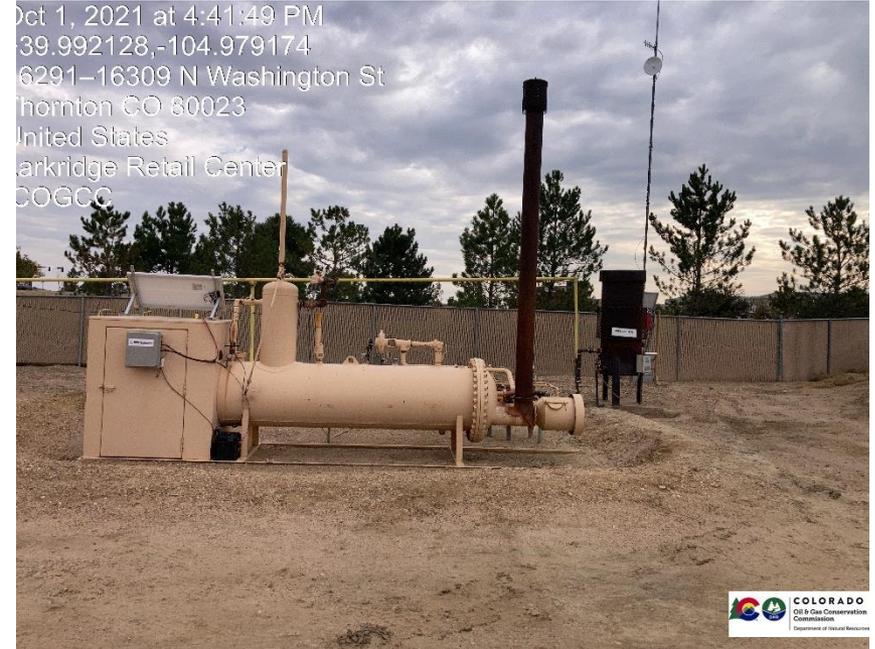
Pic 4 separator, ECD. Automation equipment.
