Inspection Photos
Operator: Arkoma
Facility: 067-09531
Date: 9/20/2021

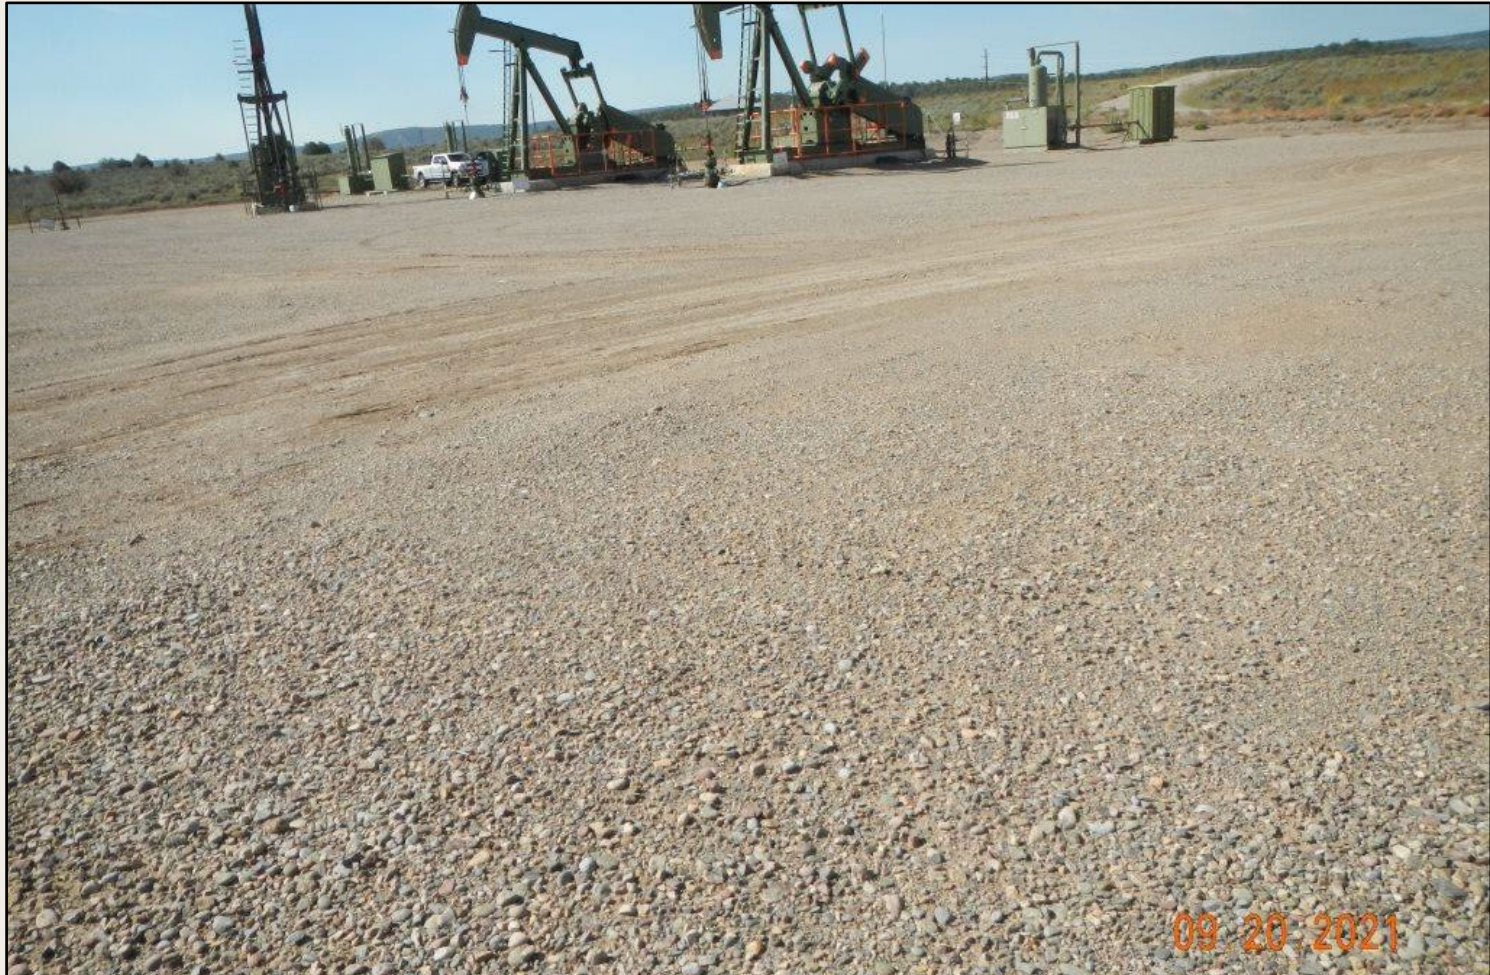
Photo 1. View of the project area from the northeastern corner facing center.

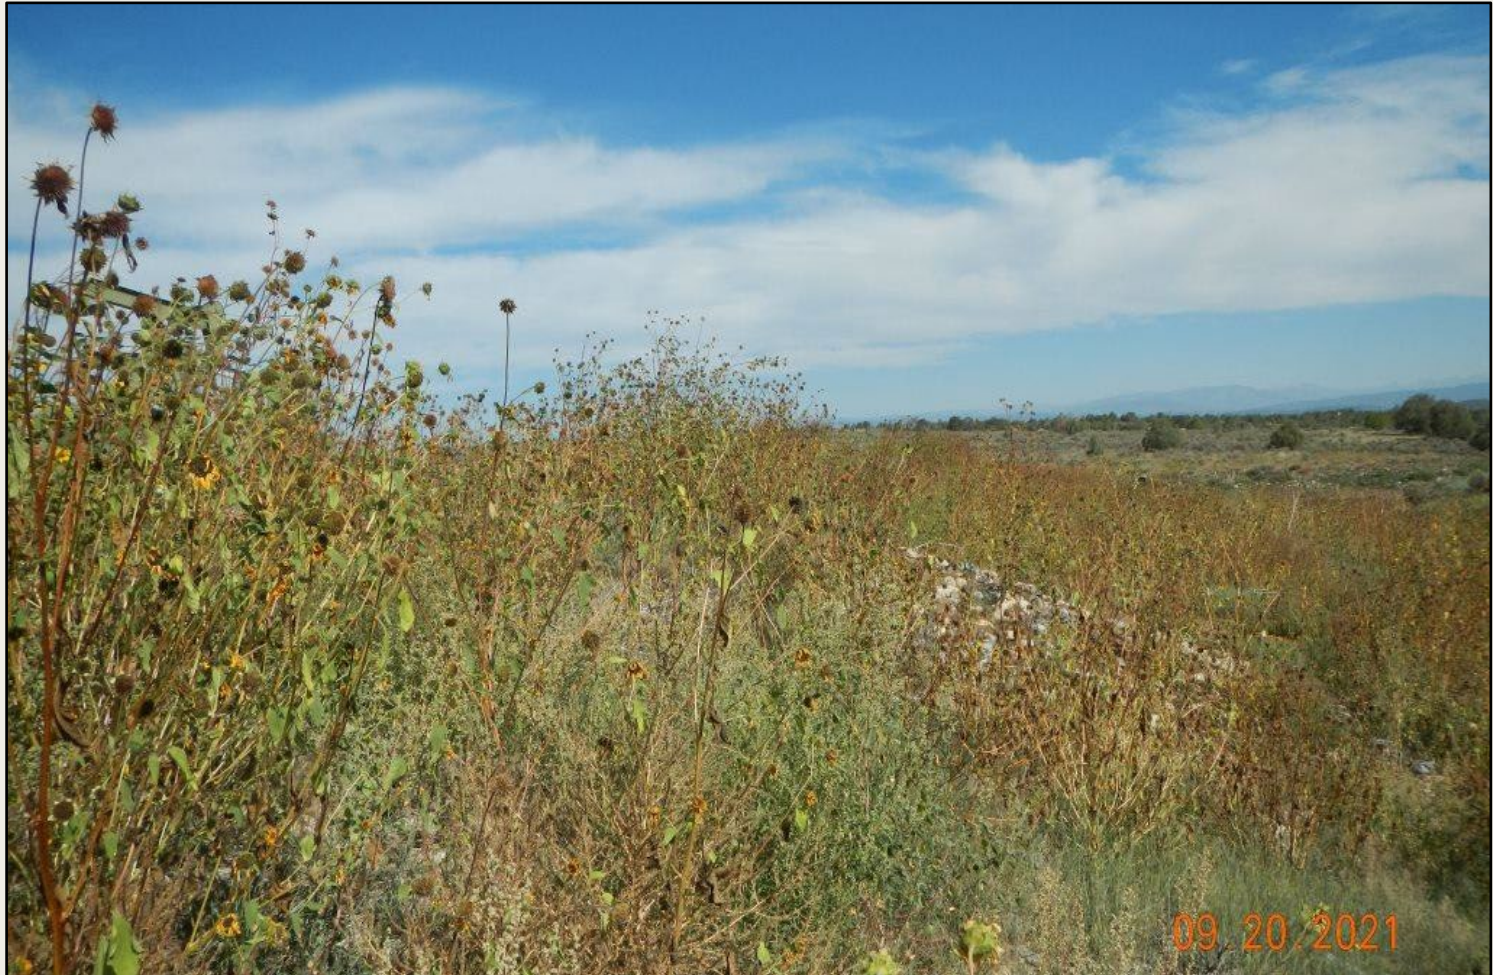
Photo 2. View of the eastern project area from the southeastern corner facing northward. Revegetation is progressing with smooth brome, western wheatgrass, and sunflowers.

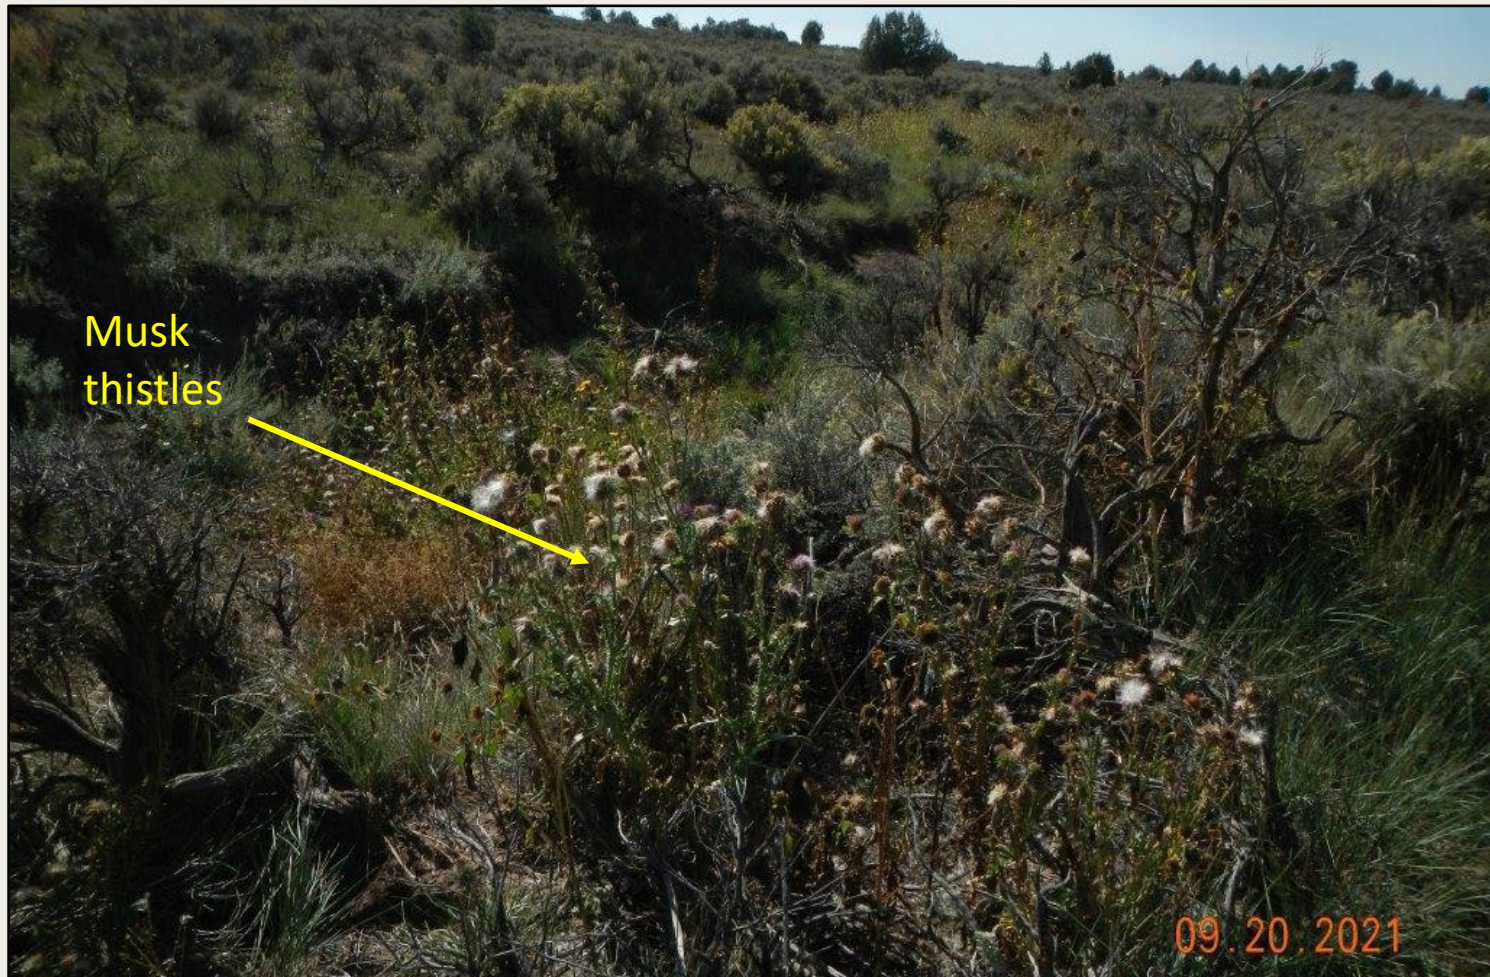
Photo 3. View of seeding musk thistles within the southern project area, need to be removed. Approximately 30 individuals observed.

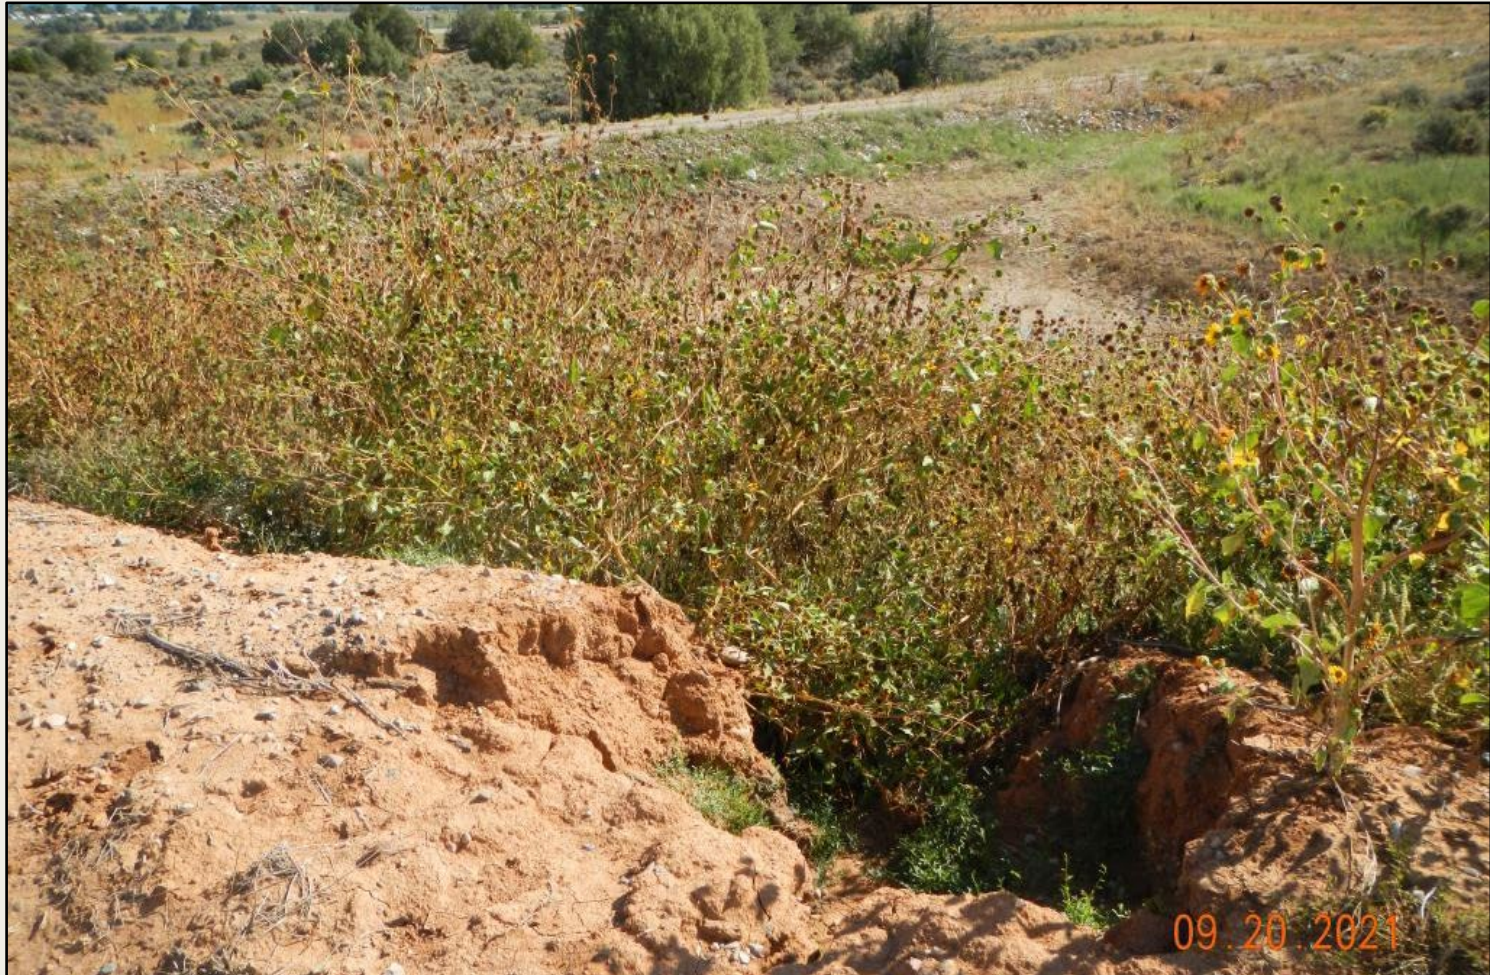
Photo 4. View of area in the eastern fill slope where stormwater erosion (approx. 3 ft wide and 2ft deep channel) is occurring due to oversaturation in the slope. Stabilization is needed here.

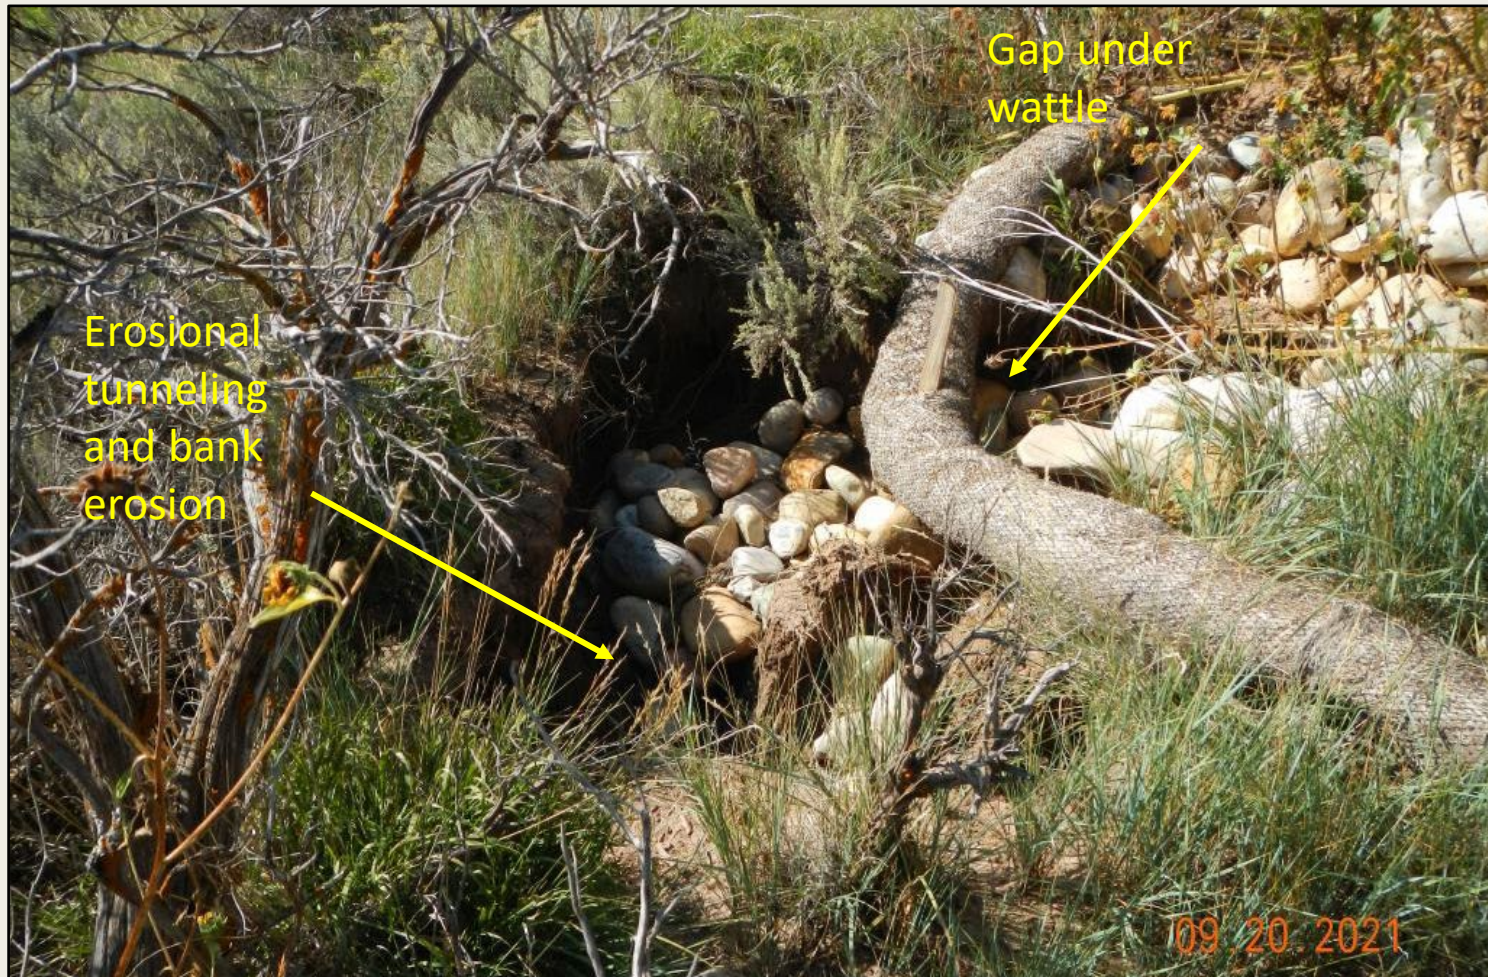
Photo 5. View of cobble BMP in southeastern well pad diversion. BMP needs repair and additional, more robust reinforcement to stabilize erosion here.

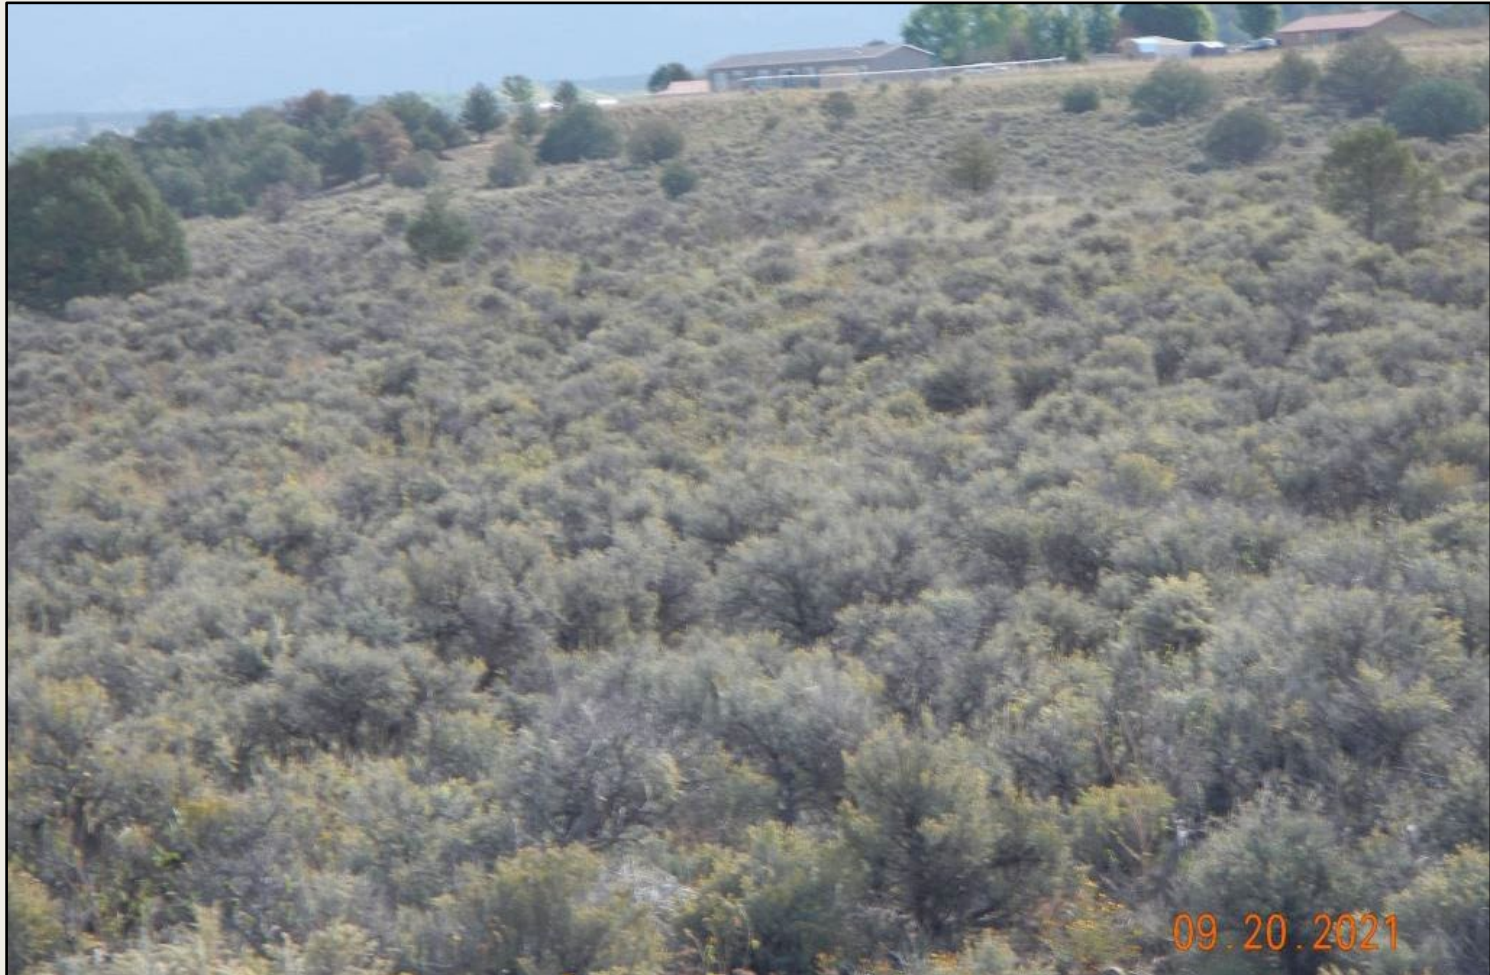
Photo 6. View of reference area comprised of sagebrush shrubland with snakeweed, James galleta, buckwheat, and penstemons in the understory.
