Inspection Photos
Operator: Logos
Facility: 067-05469
Date: 9/20/2021

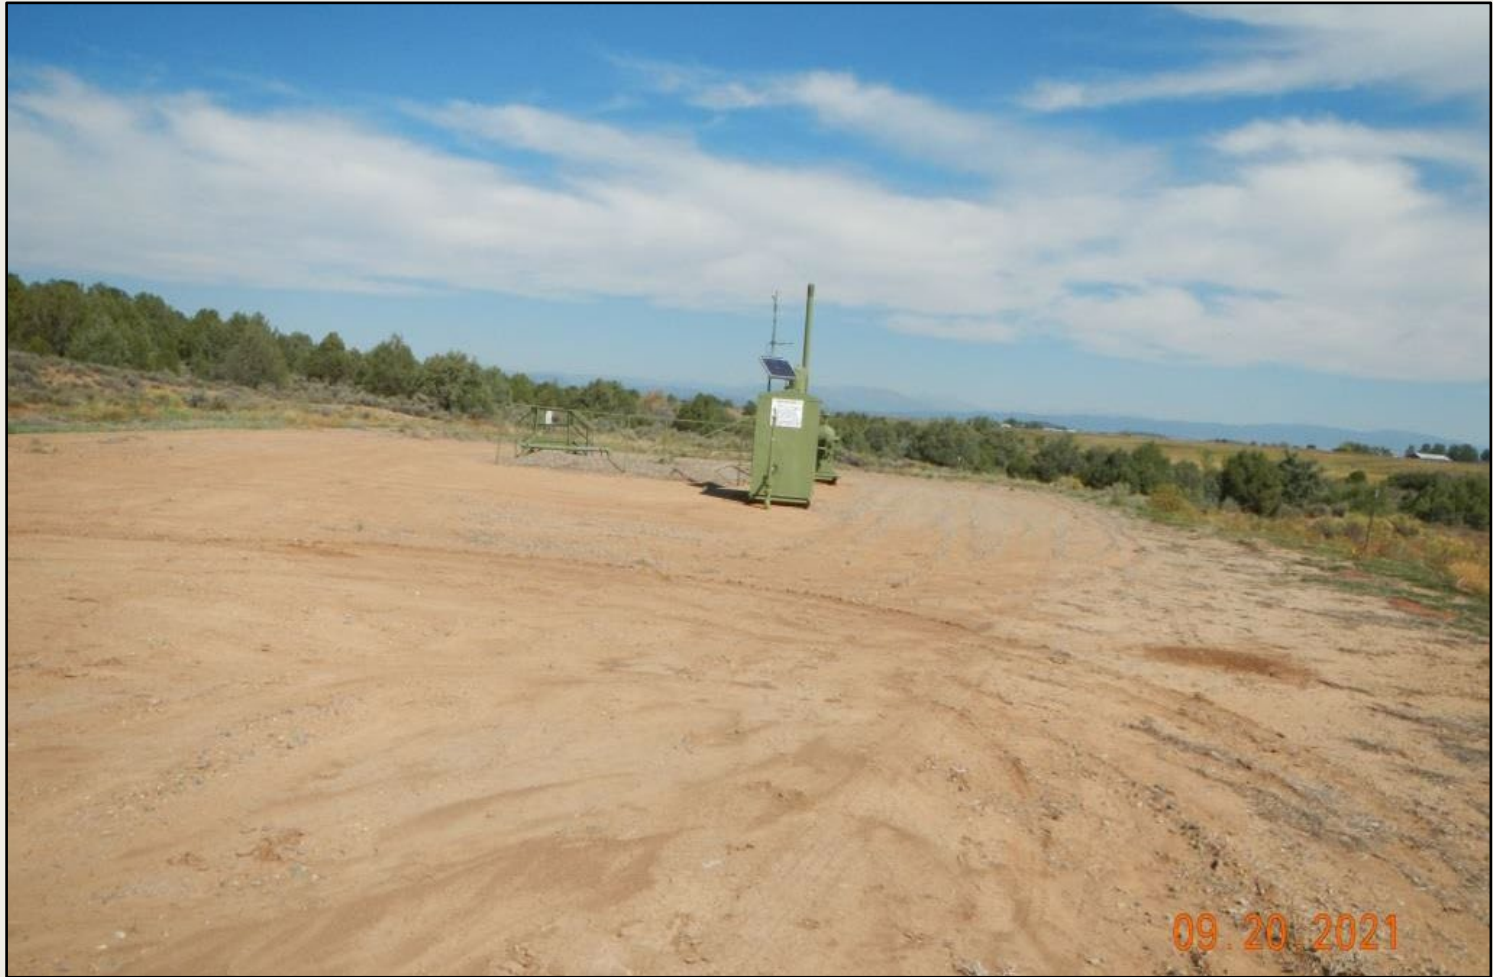
Photo 1. View of project area from the well pad entrance facing center.

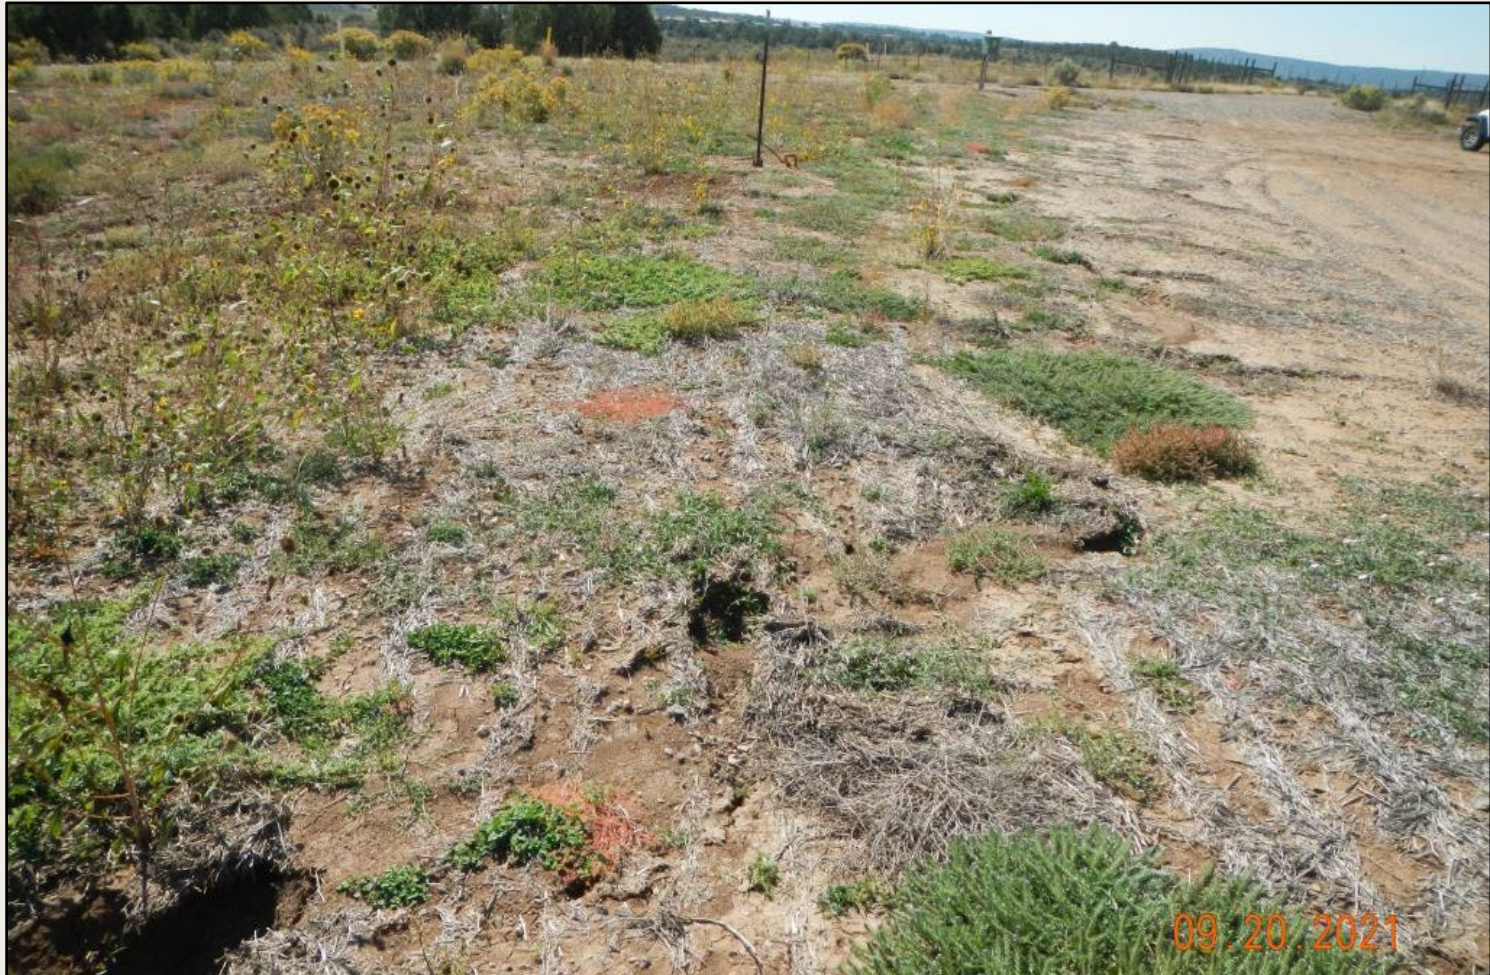
Photo 2. View of the eastern project area from the northeastern corner of the working area, facing southward. Seeding is conducted. Straw mulch and some seedlings observed. Mature vegetation remains weedy.

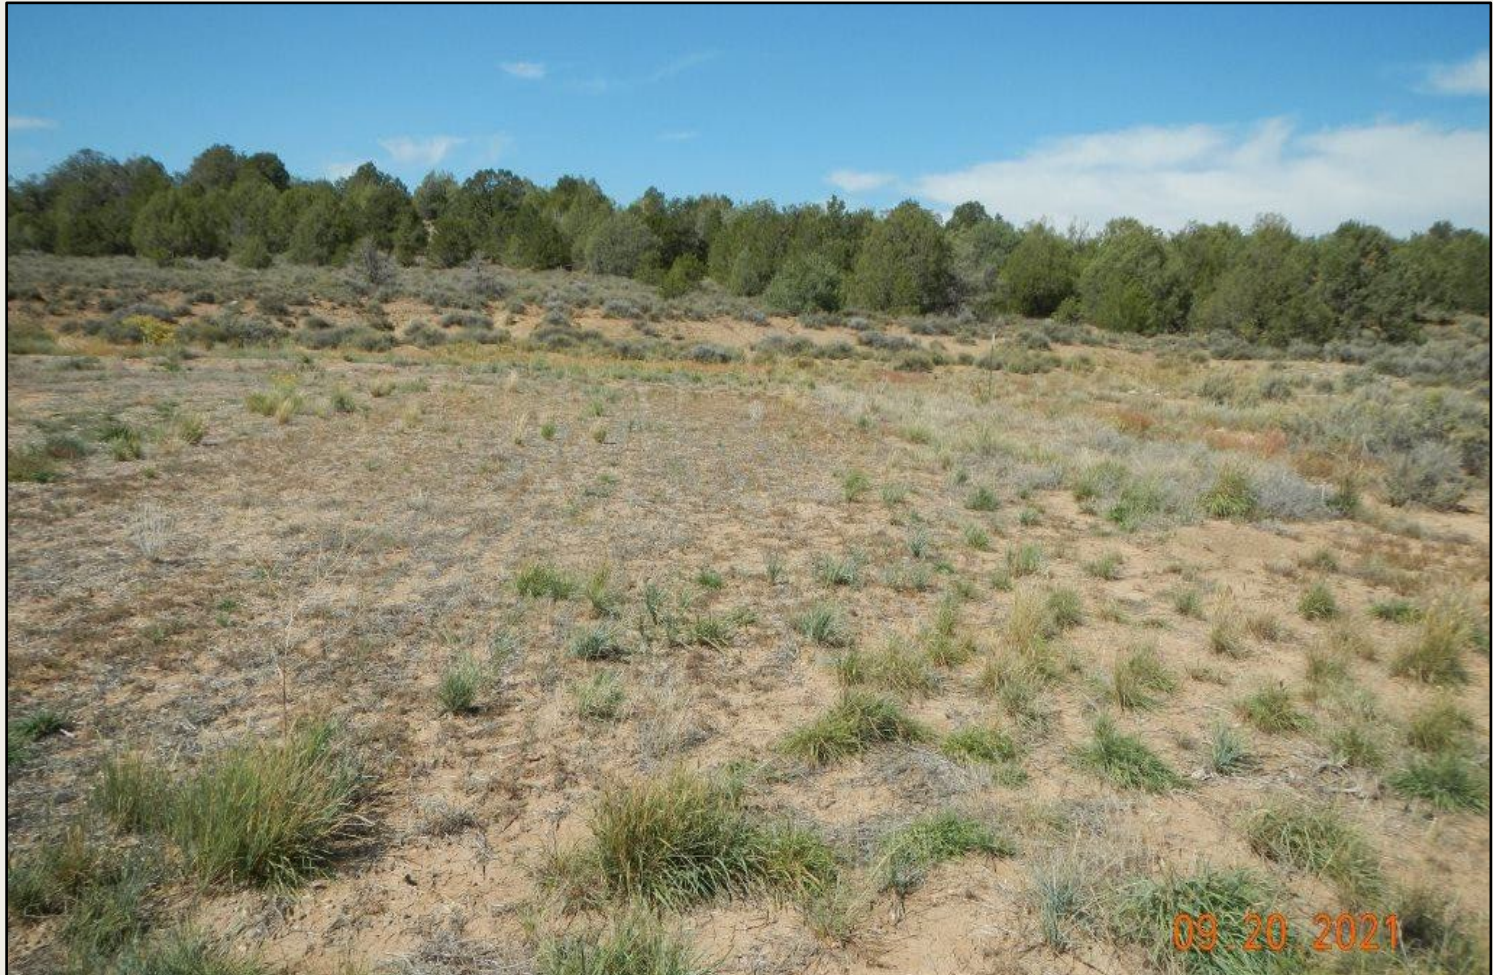
Photo 3. View of the northern project area from the northeastern corner facing westward.

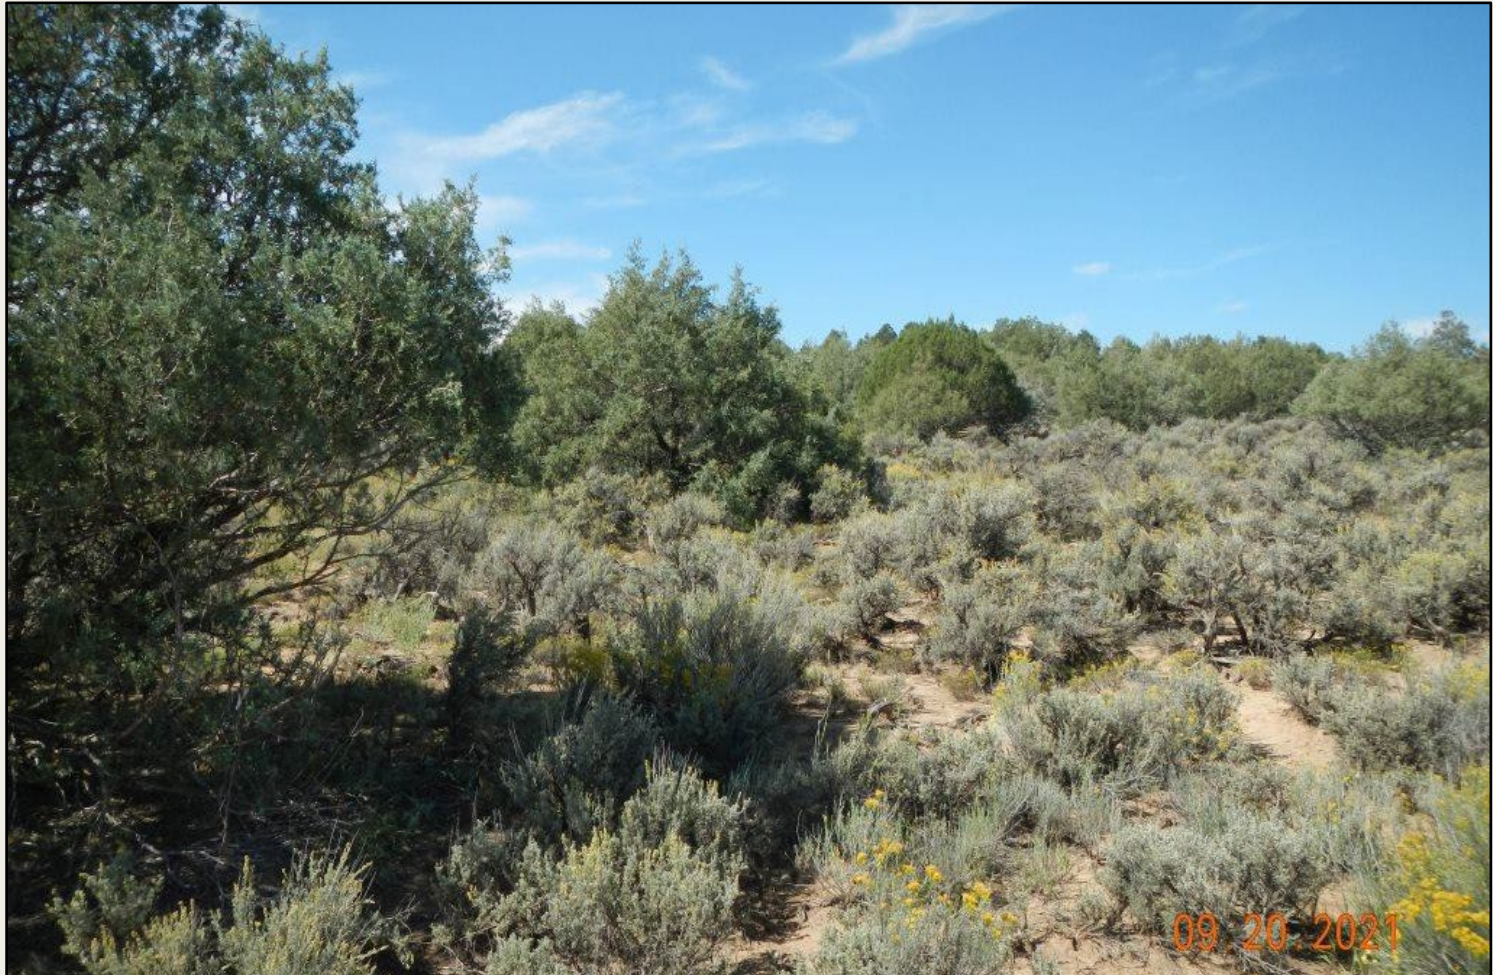
Photo 4. View of reference area comprised of sagebrush shrubland and pinyon/juniper woodland with James galleta, rubber rabbitbrush, snakeweed, Indian paintbrush, and squirreltail.
