Inspection Photos

API: 055-06283

Operator: EDWARDS ENERGY CORPORATION

Inspection Date: 10/5/2021

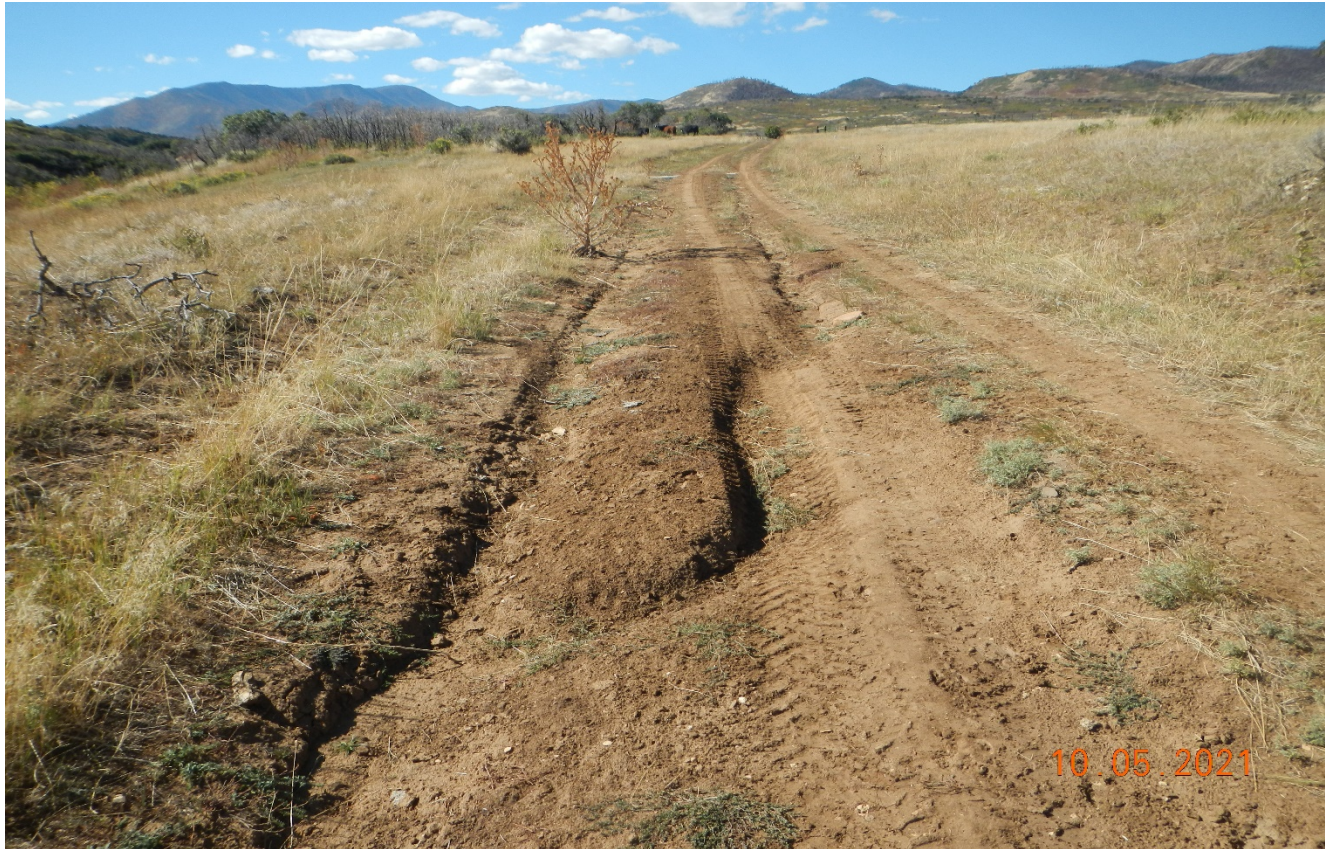
Photo 1. Facing southwest along the former access road which appears to be mostly pre-existing. There is erosion occurring along areas of the road which need to be stabilized. Previous corrective action was not performed.

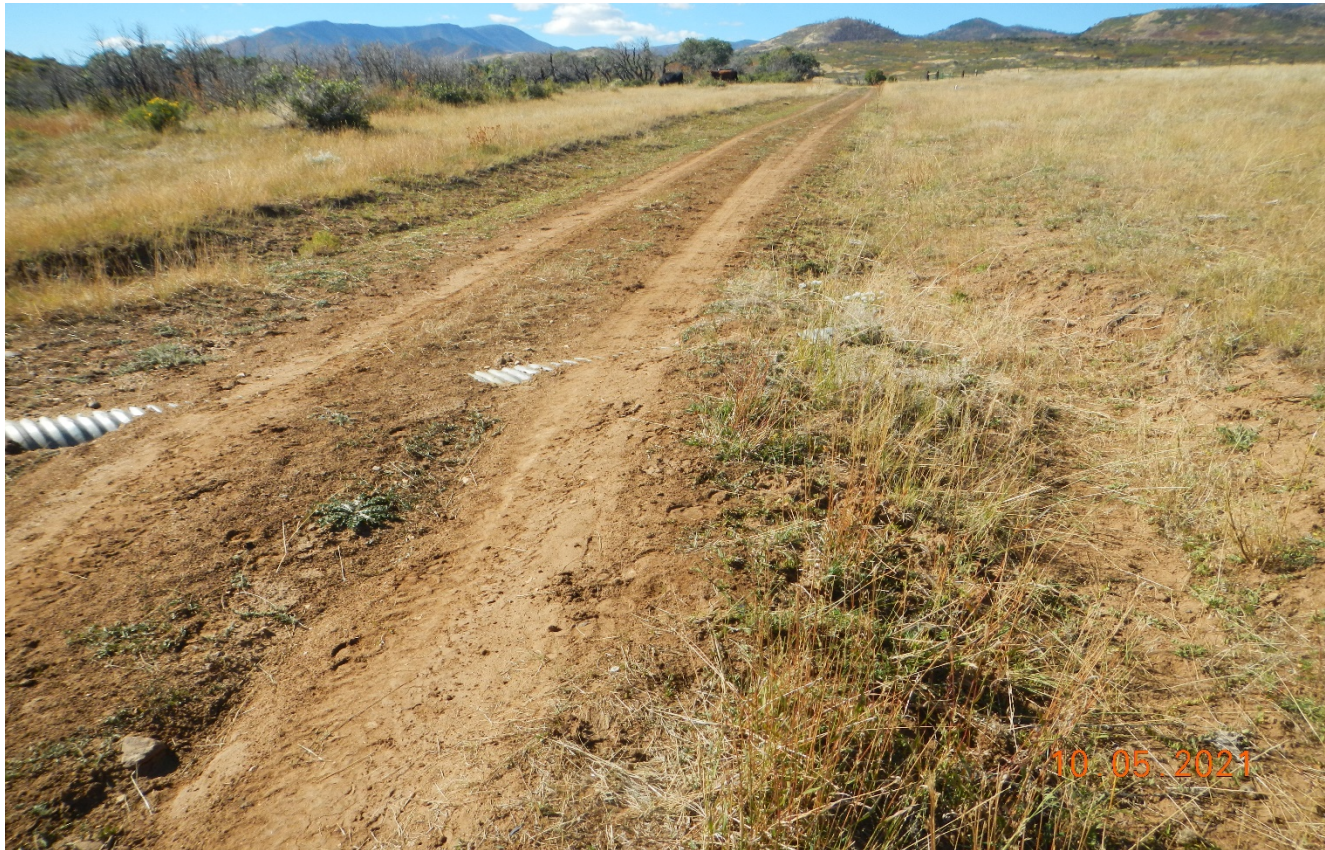
Photo 2. The culvert installed along the access road is not maintained and stormwater is bypassing the culvert. Lat/Long:37.50521,-105.07444.

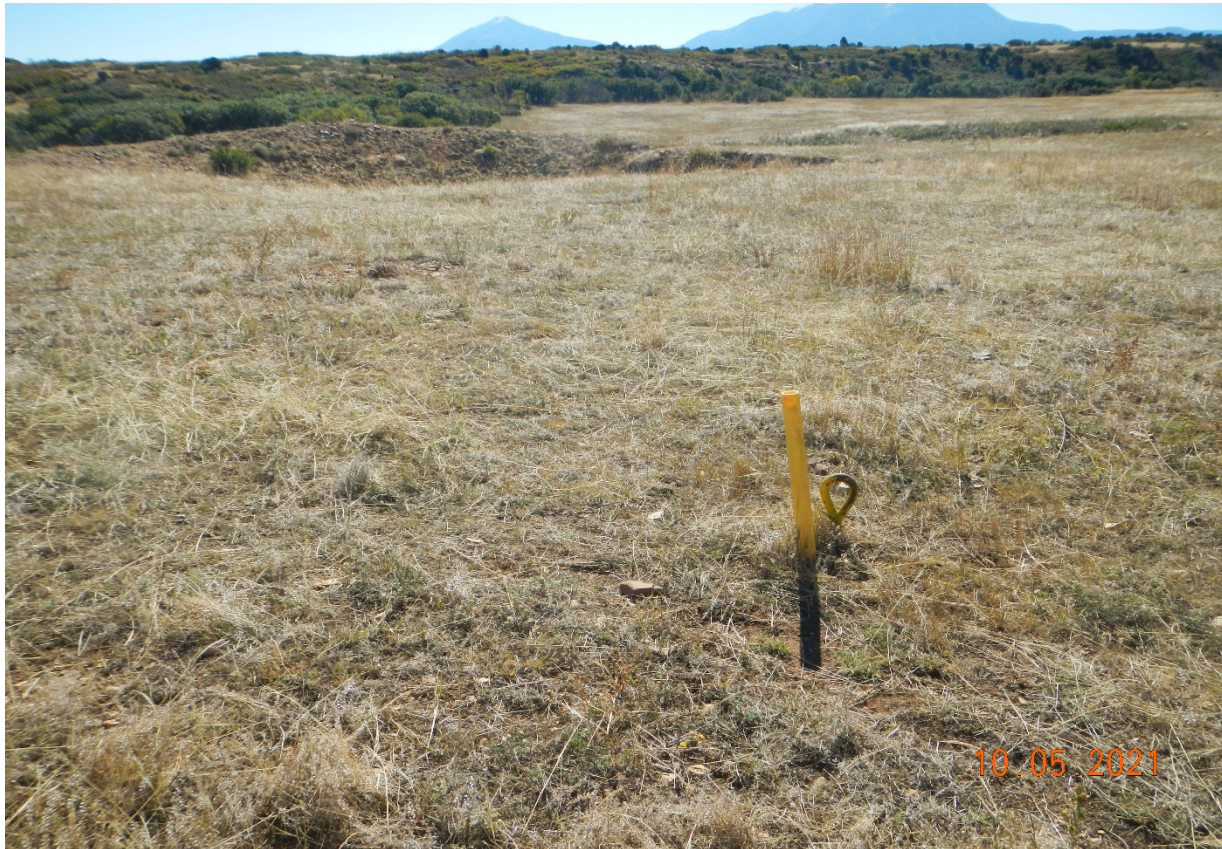
Photo 3. Facing southeast toward the location which was never recontoured and reclaimed per 1004 Rules. There are four guyline anchors that remain and the pit was not backfilled and reclaimed.

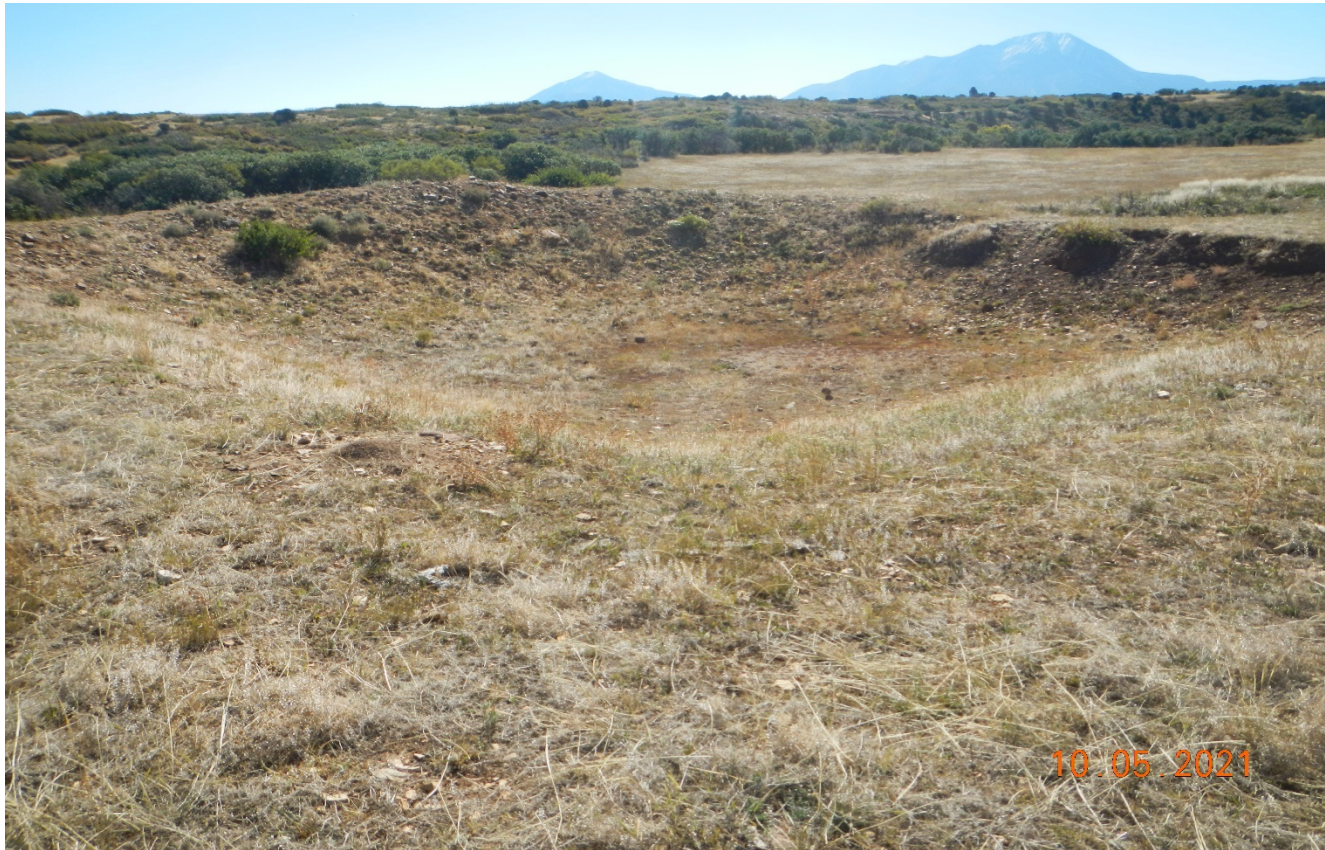
Photo 4. Facing southeast toward the pit which is approximately 100'x100' in size.

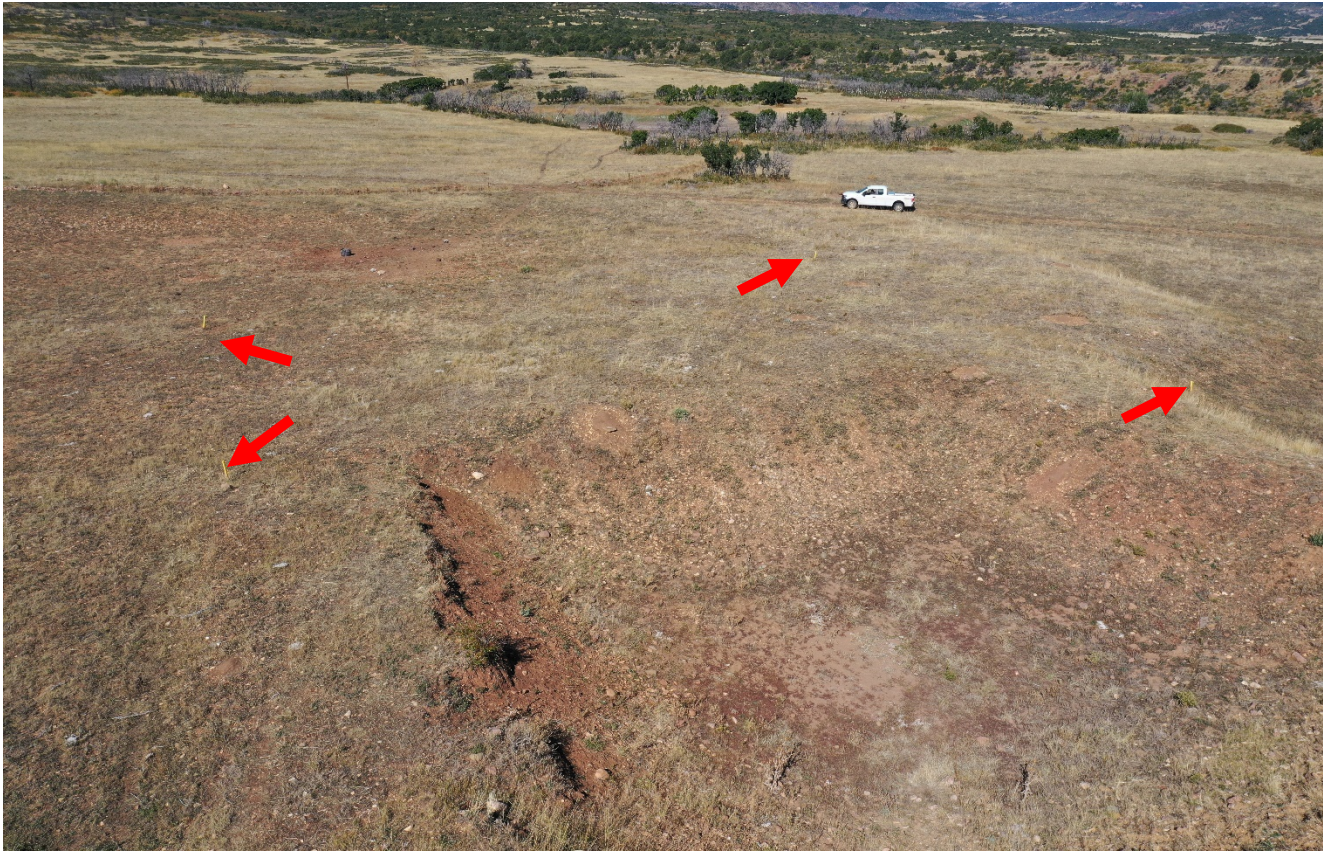
Photo 5. Drone aerial photo facing northwest. The red arrow points to the four guyline anchors that were never removed.
