Inspection Photos

API: 055-06101

Operator: MANZANO LLC

Inspection Date: 10/5/2021

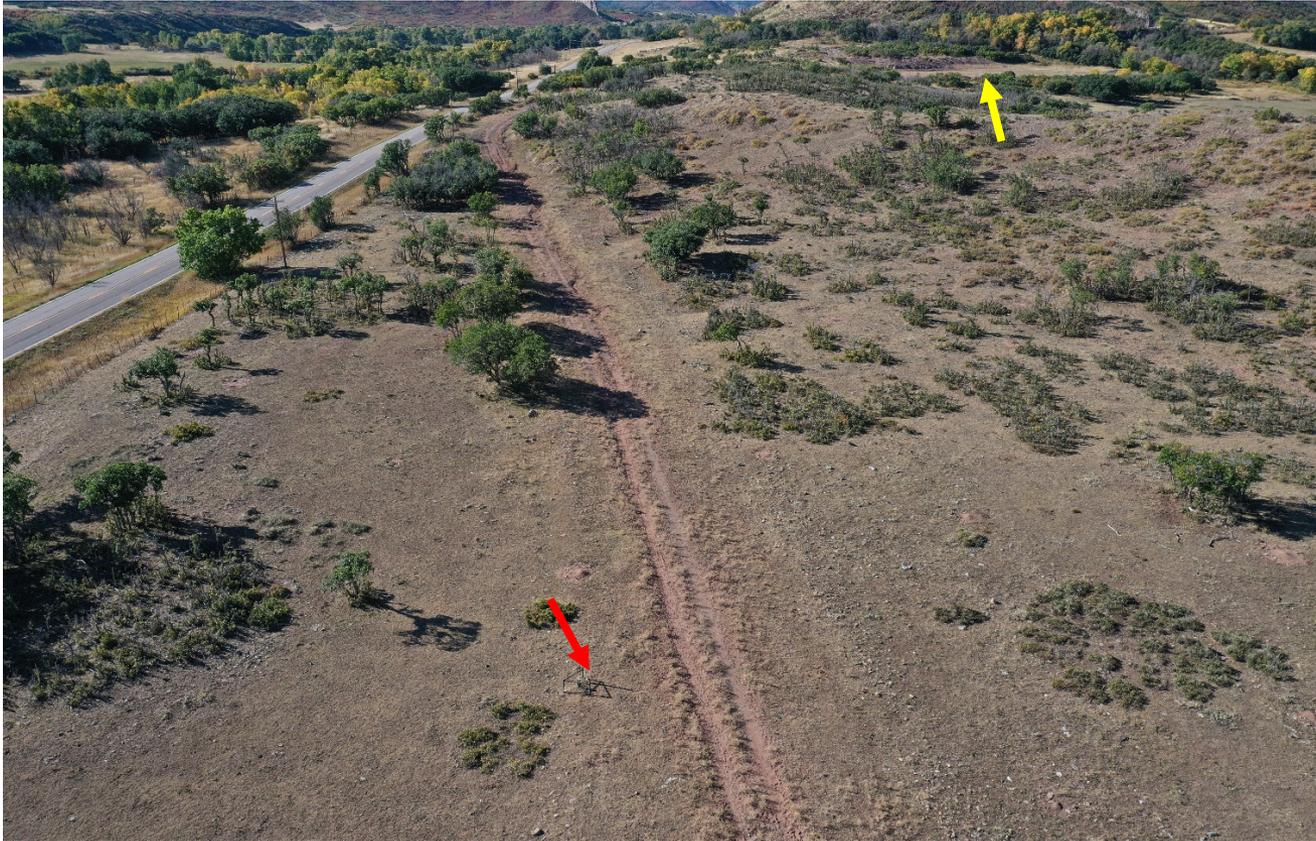
Photo 1. Drone aerial photo facing southwest along the access road. A pipe riser remains at the red arrow. The access road has not been reclaimed and the location is shown at the yellow arrow.

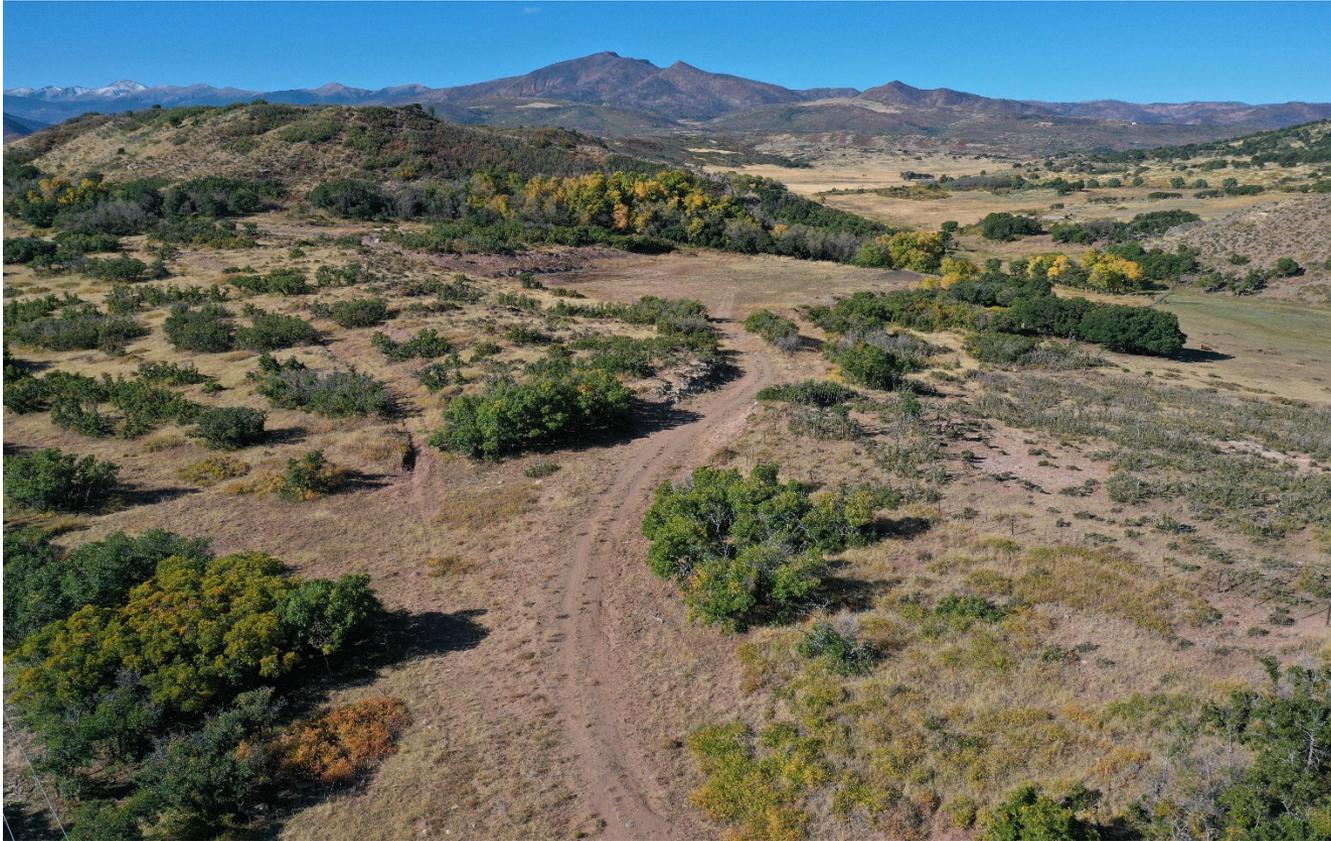
Photo 2. Drone aerial photo facing northwest along the access road toward the location.

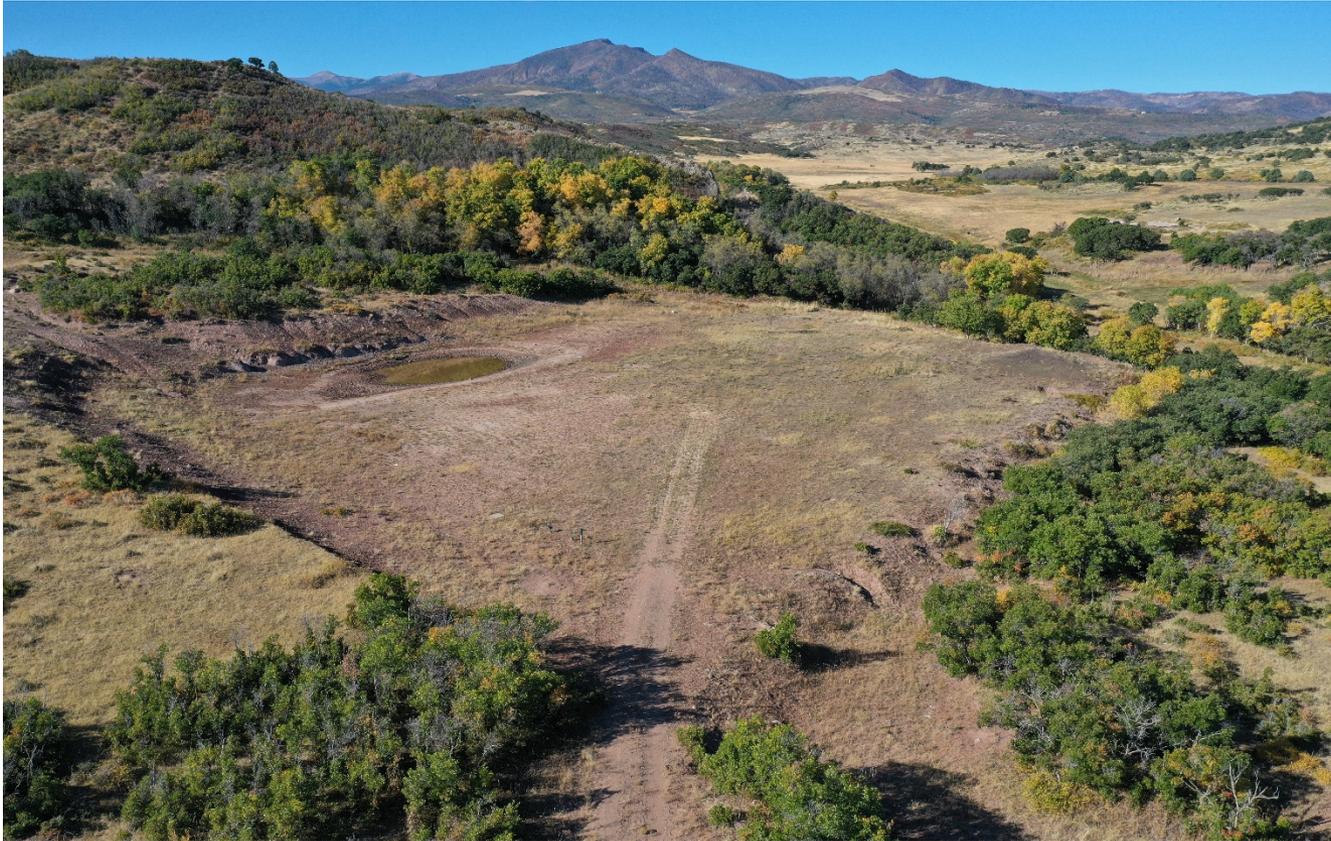
Photo 3. Aerial image of the location shows it has not been recontoured and reclaimed. The location disturbance is approximately 3.3 acres.

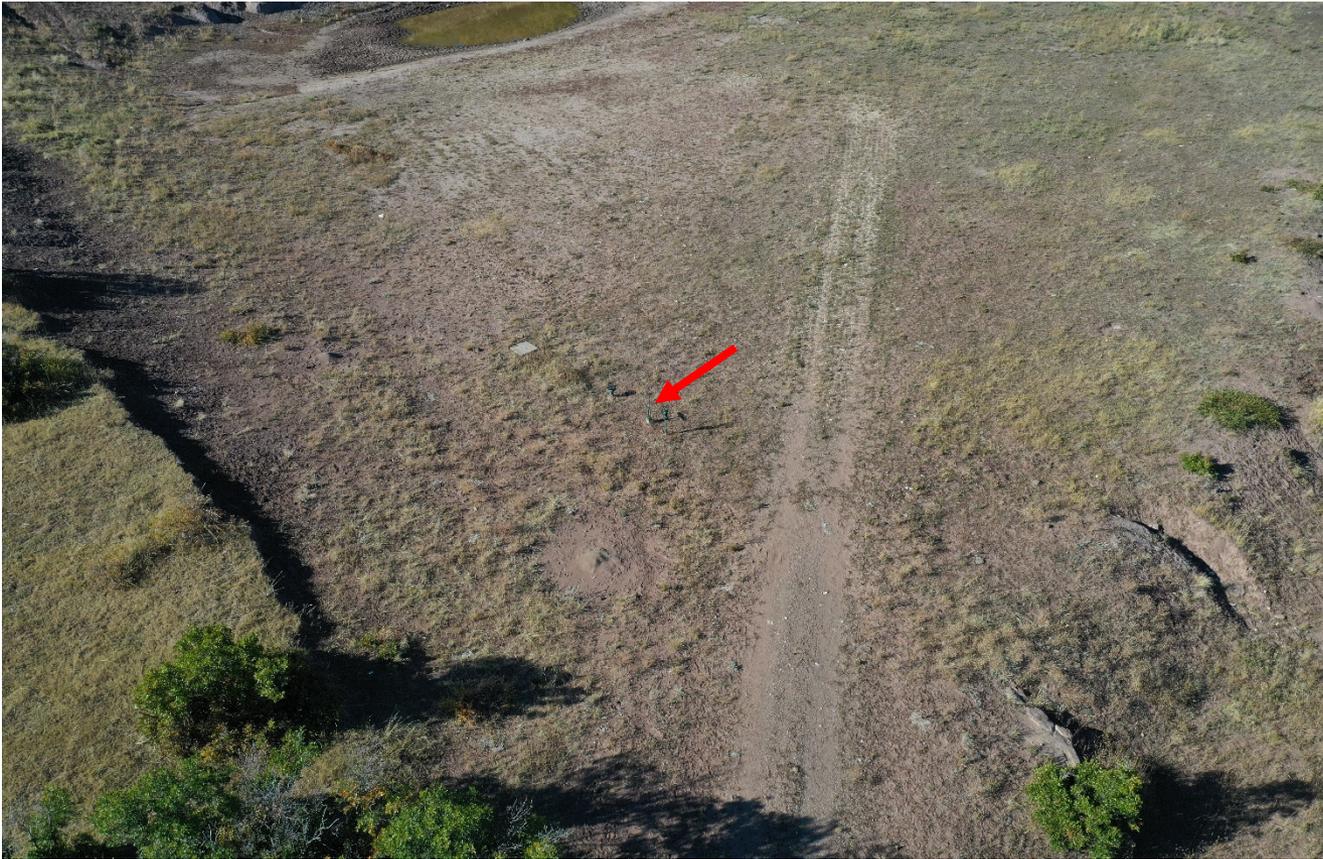
Photo 4. The pipeline risers still remain at the location shown at red arrow.

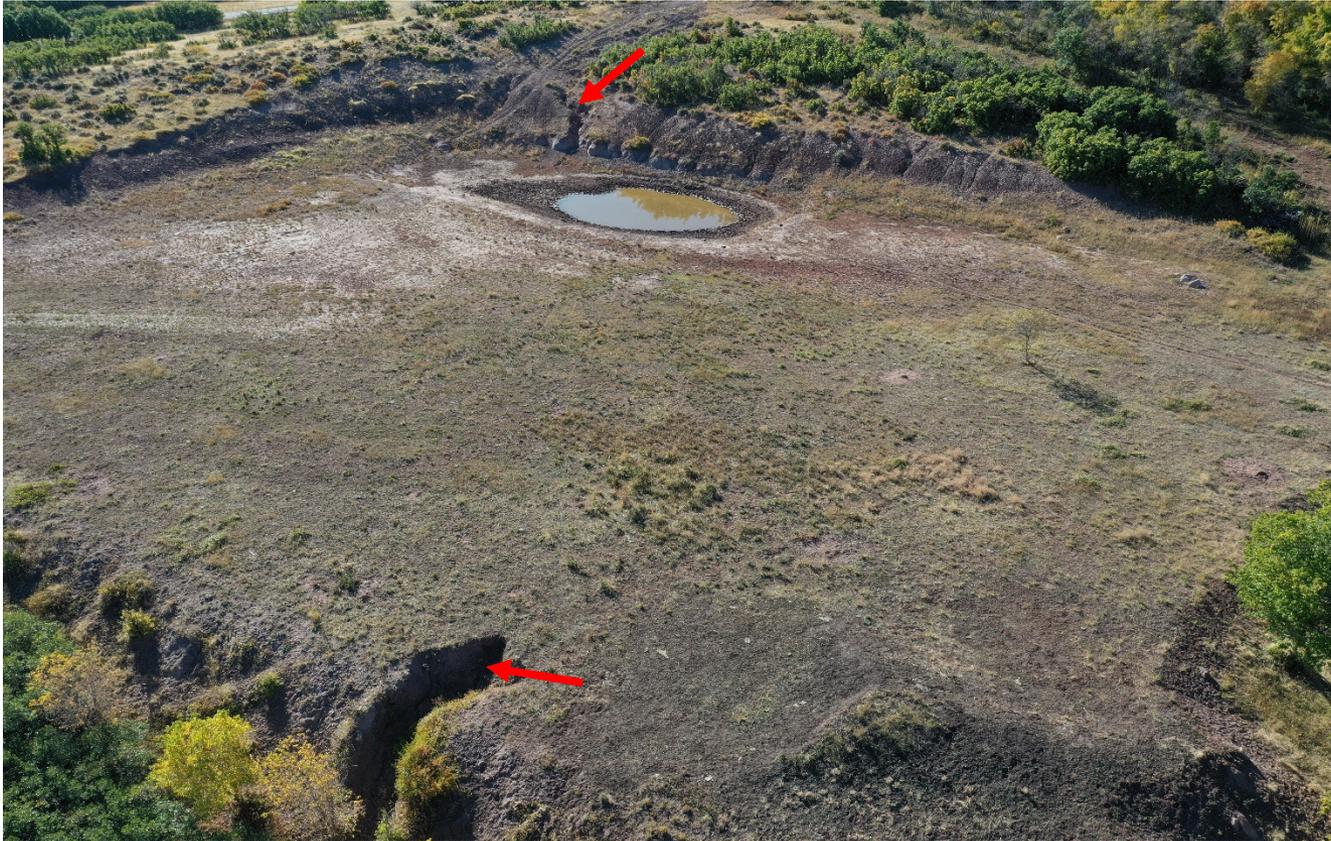
Photo 5. Facing southwest overlooking the location. There are multiple areas of erosion along the cut slope and fill slope shown at red arrows.

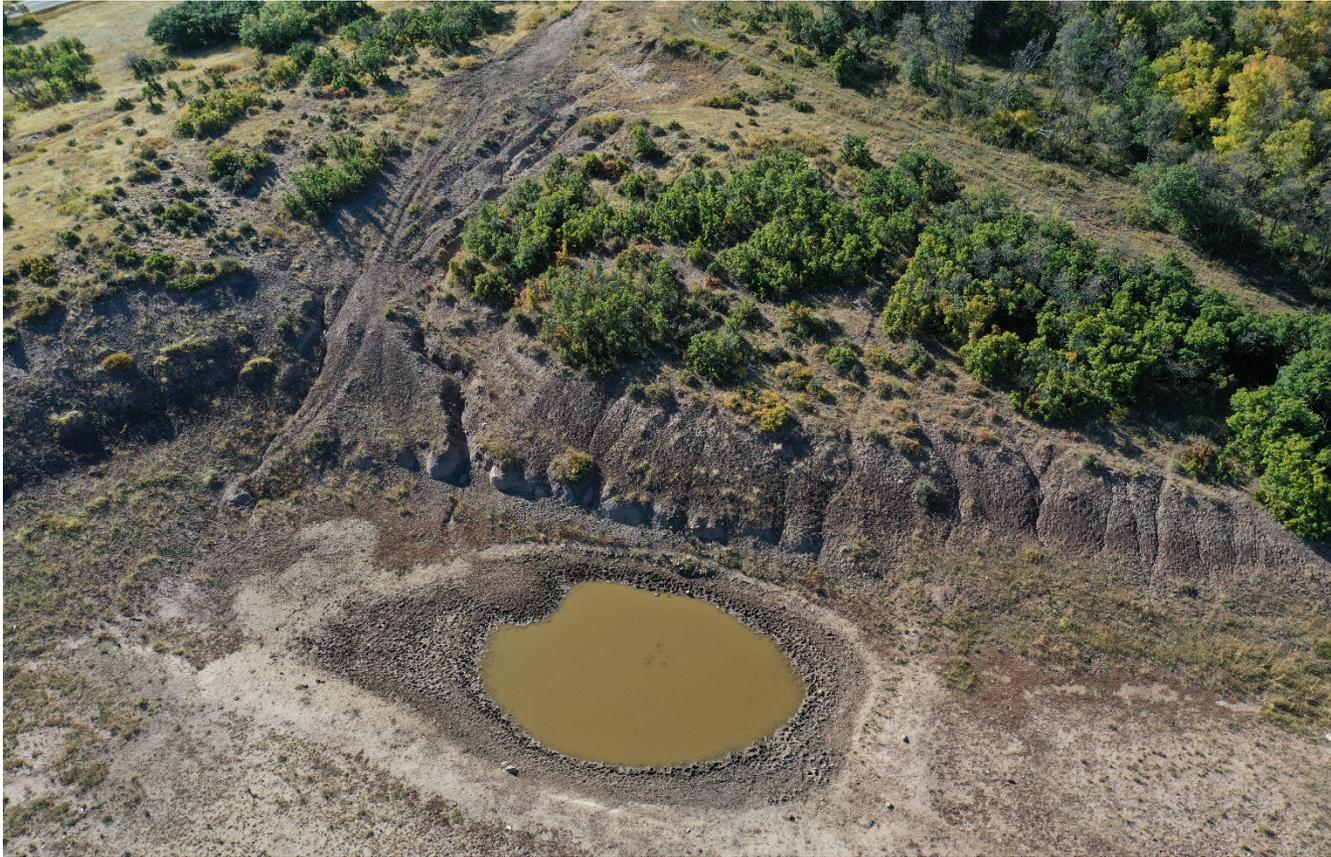
Photo 6. The pit remains and is filled in with stormwater. This photo shows the erosion along the cut slope.

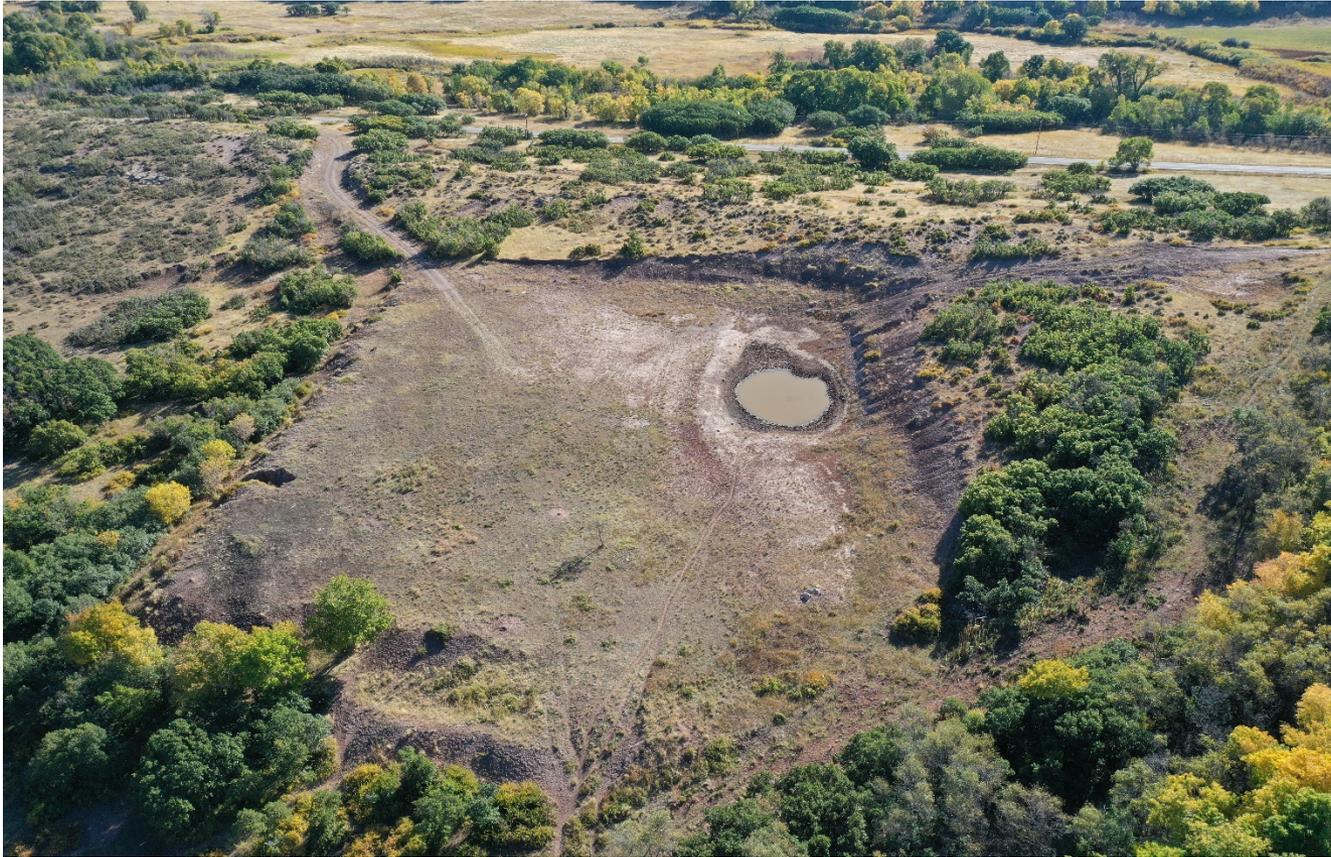
Photo 7. Facing southeast toward the location. The location disturbance is approximately 3.3 acres.
