Inspection Photos

Loc ID: 386769

Operator: EVERGREEN NATURAL RESOURCES

Inspection Date: 10/7/2021

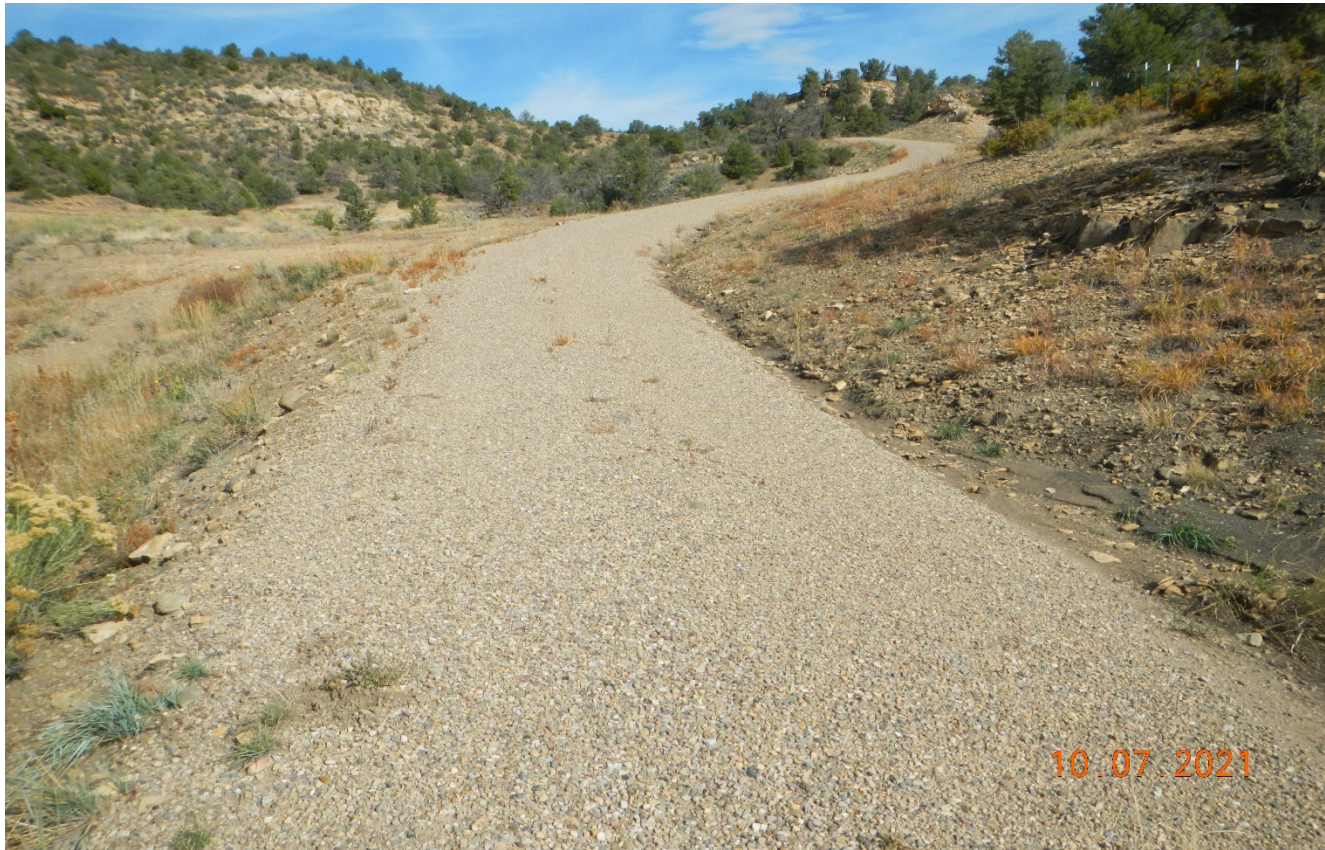
Photo 1. Facing north at the beginning of the access road. The road has not been recontoured and reclaimed.

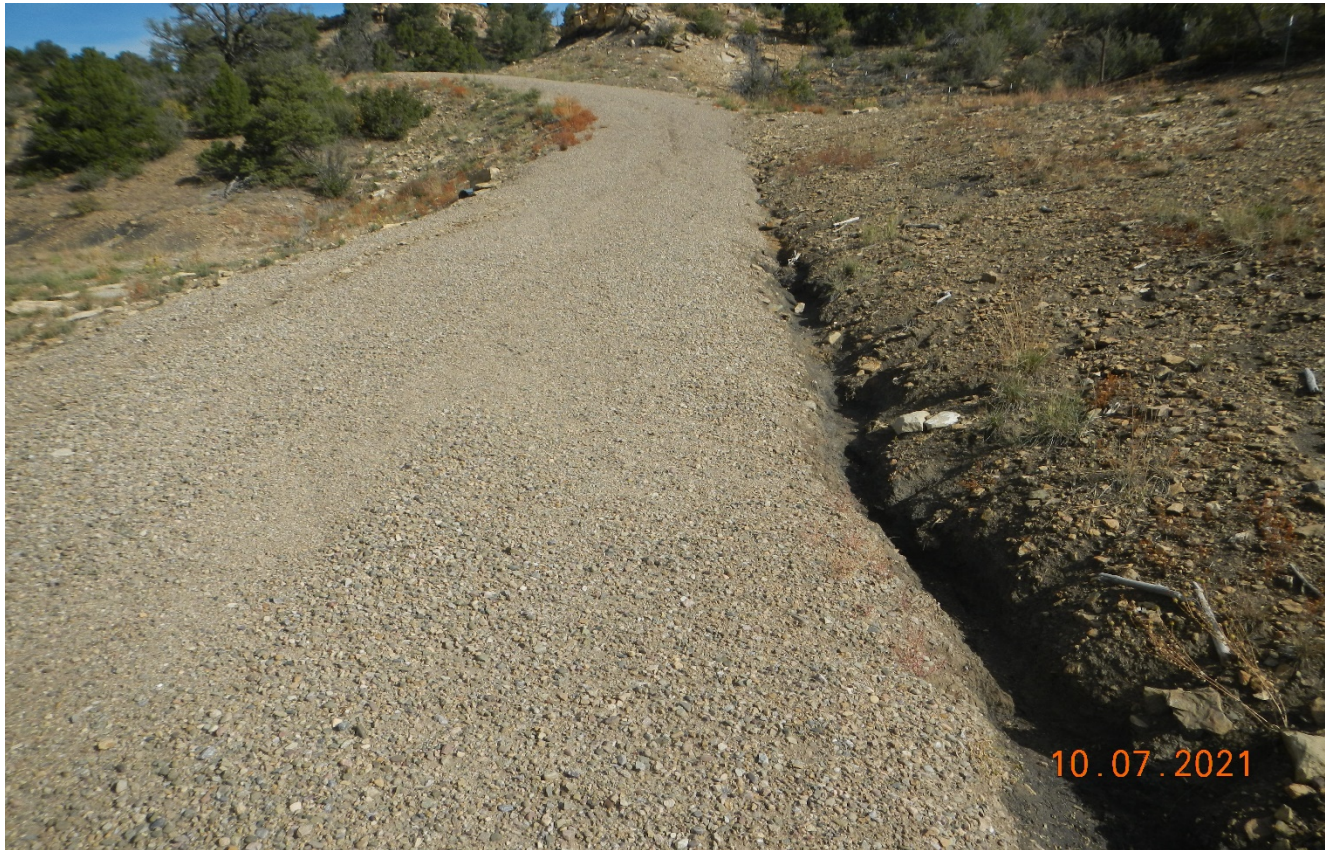
Photo 2. Facing northeast along the access road. The road has not been recontoured and reclaimed. There is an erosion channel developing along the roadside.

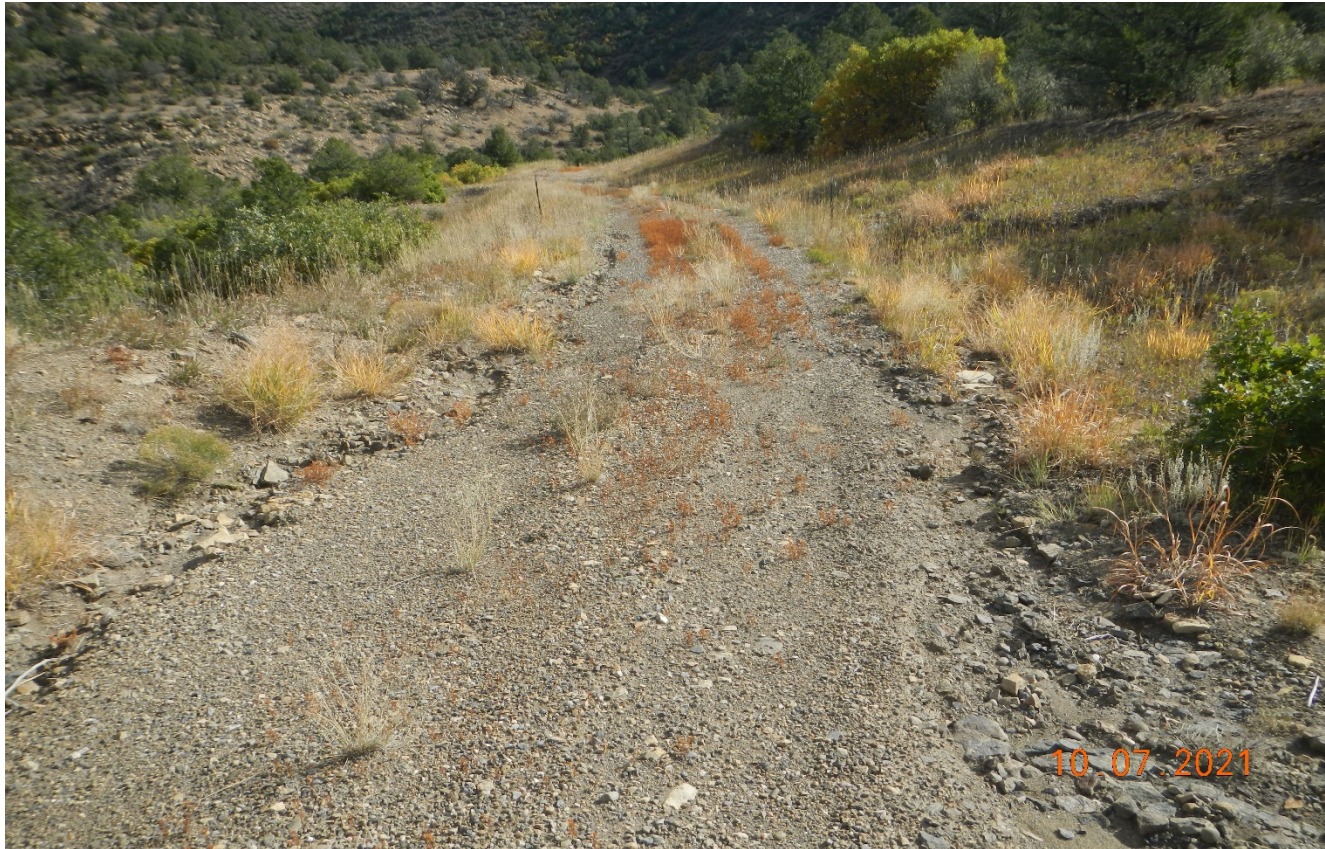
Photo 3. Facing east along the access road. There is erosion along this area of the road.

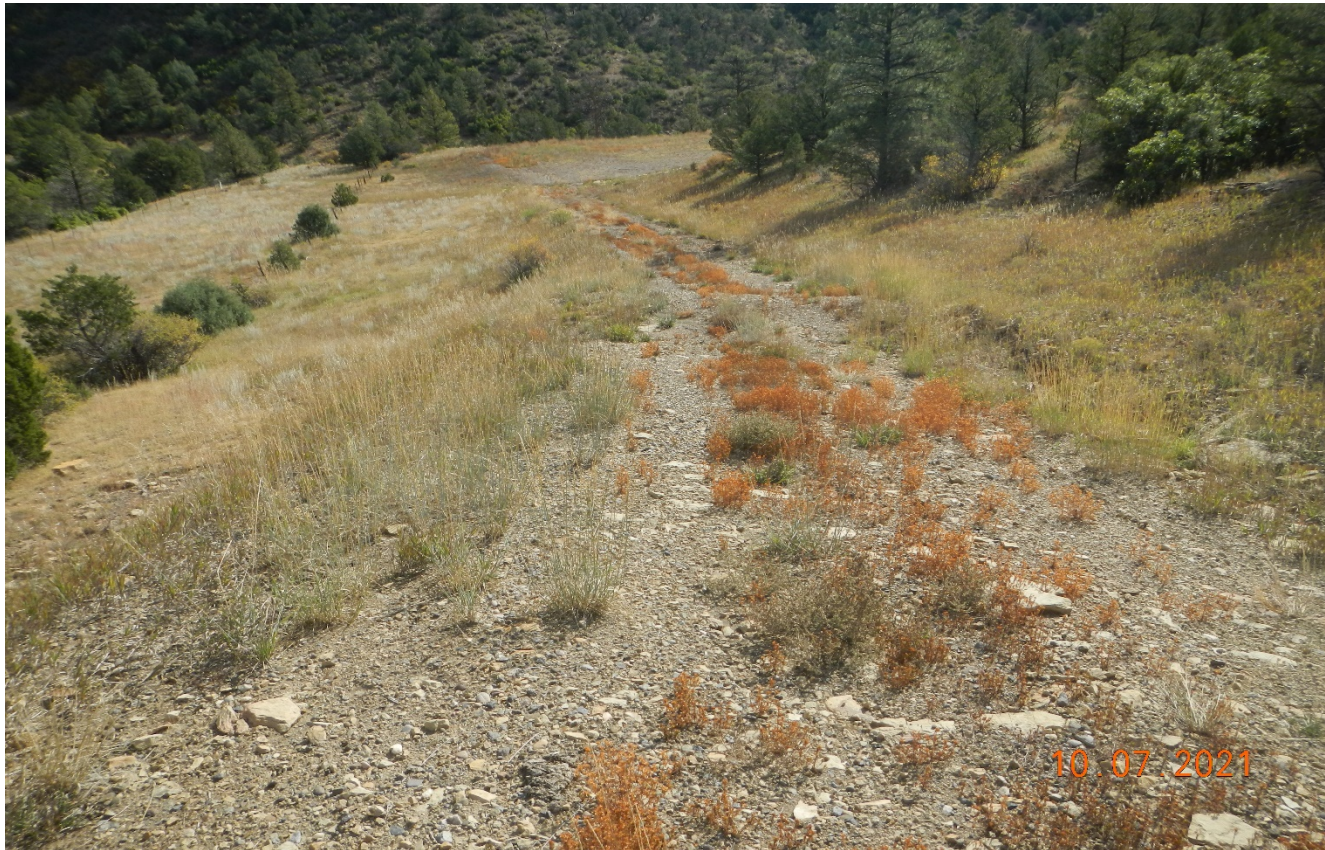
Photo 4. Facing east along the access road and toward the location.

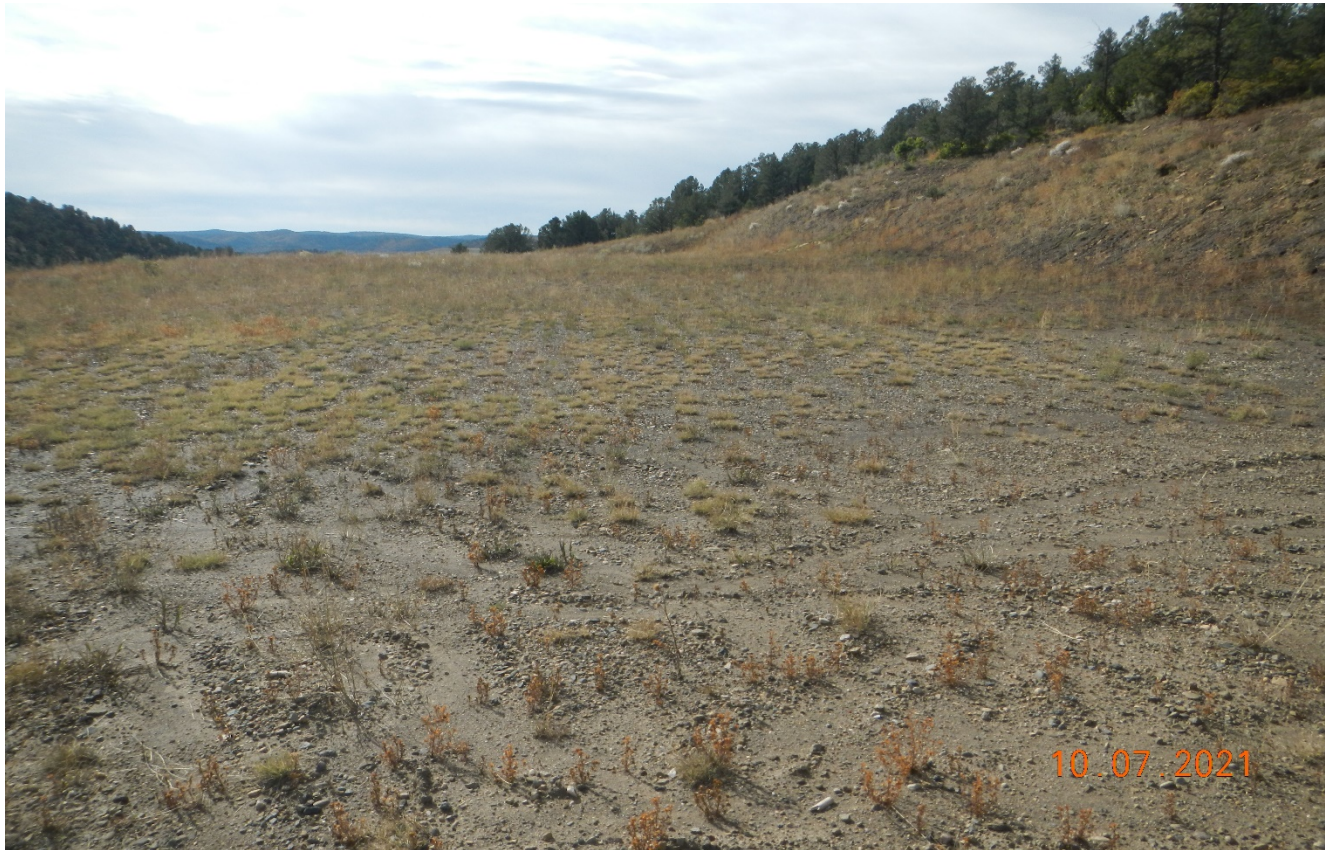
Photo 5. Facing south toward the location. The location has not been recontoured and reclaimed.

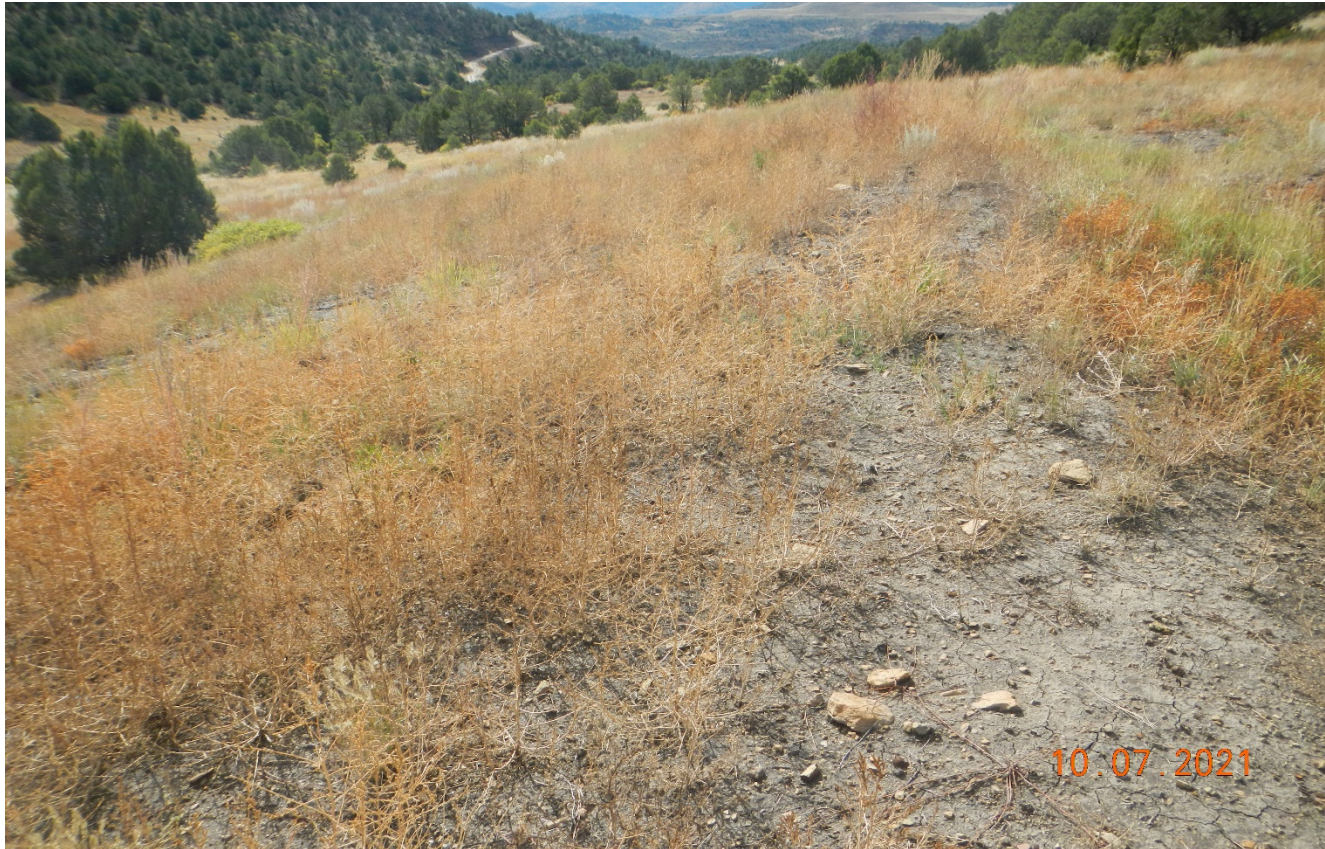
Photo 6. Facing southeast toward the fill slope of the location. There are mostly undesirable weeds (Russian thistle) growing along the fill slope.

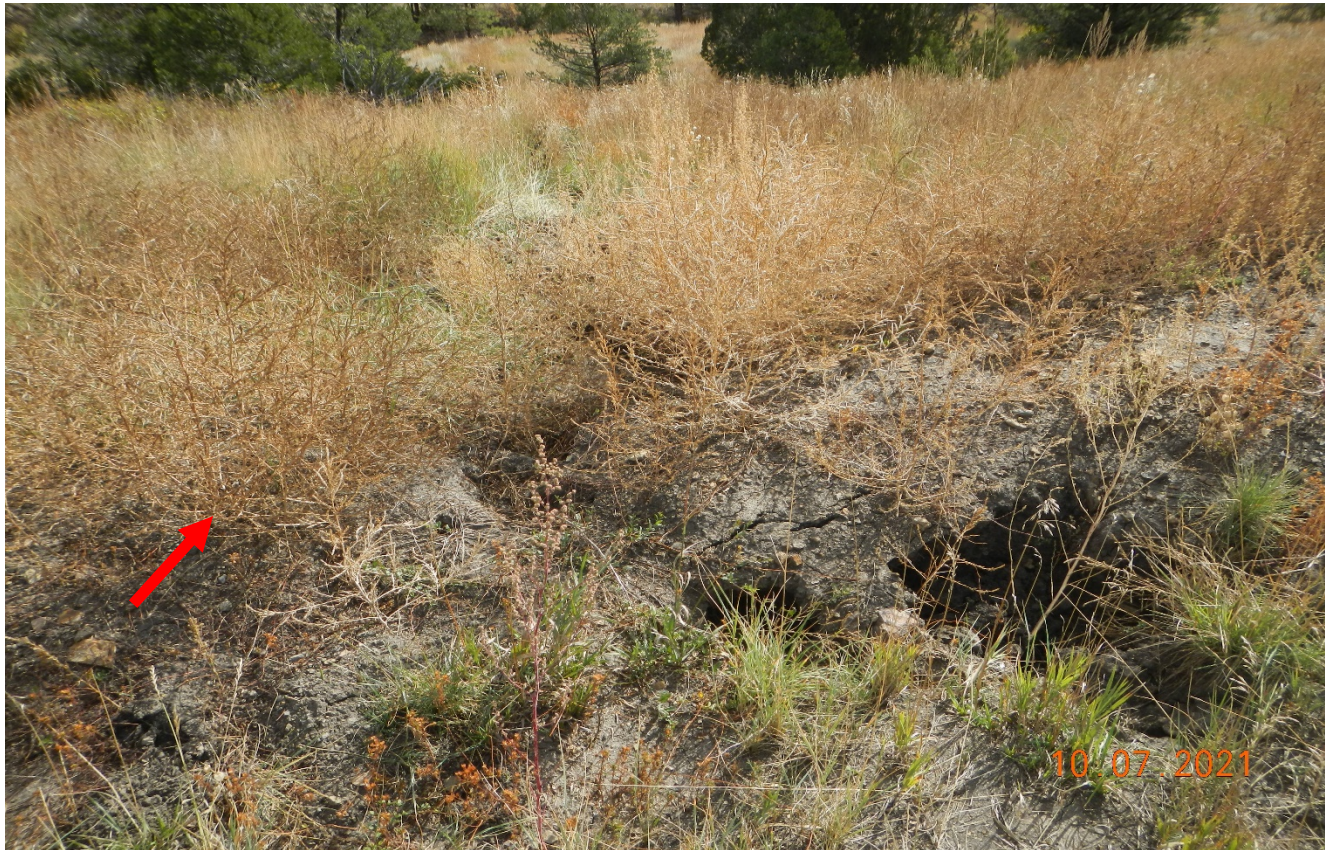
Photo 7. There are erosion channels along the fill slope which can be seen better in aerial imagery (photo 13). Arrow points to undesirable weeds, Russian thistle.

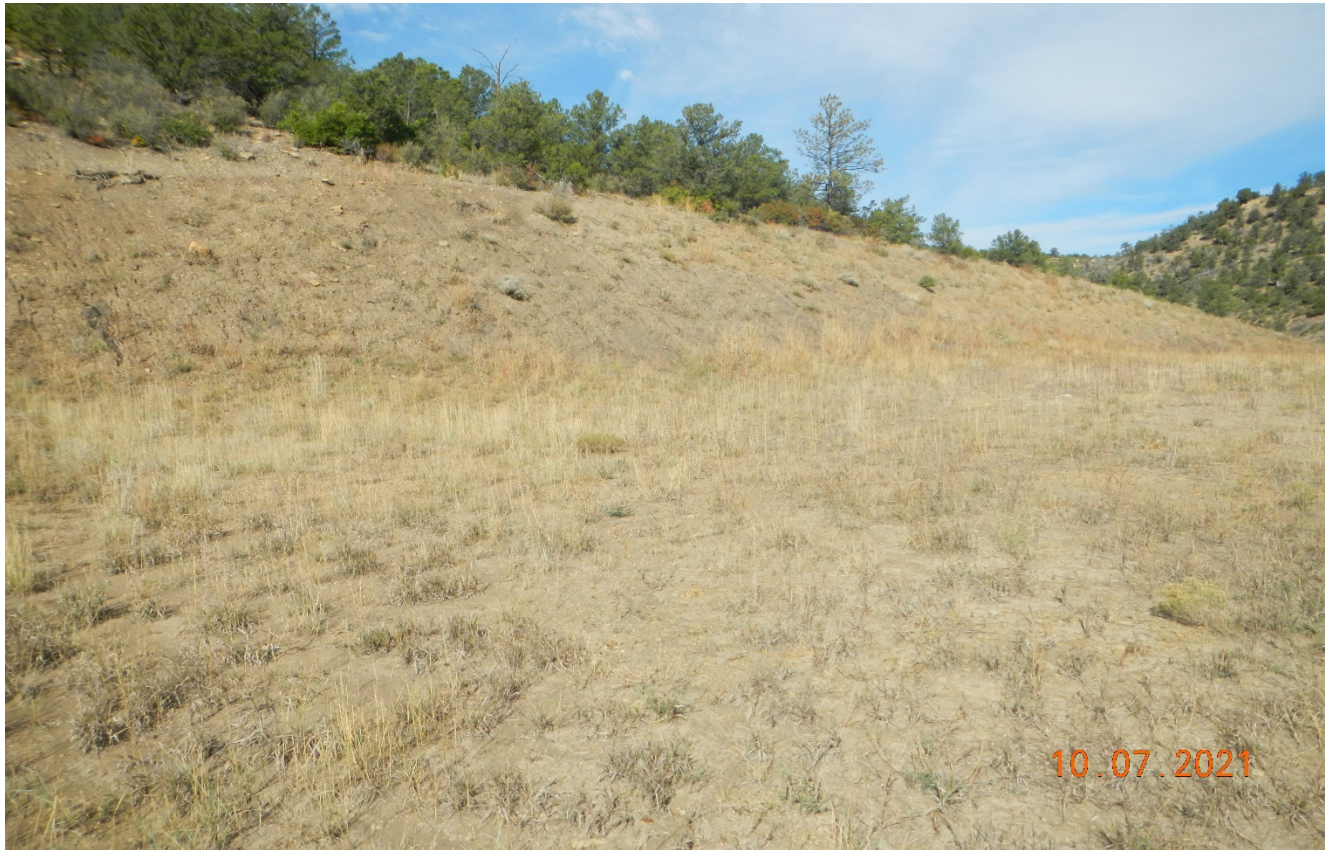
Photo 8. Facing northwest toward the cut slope.

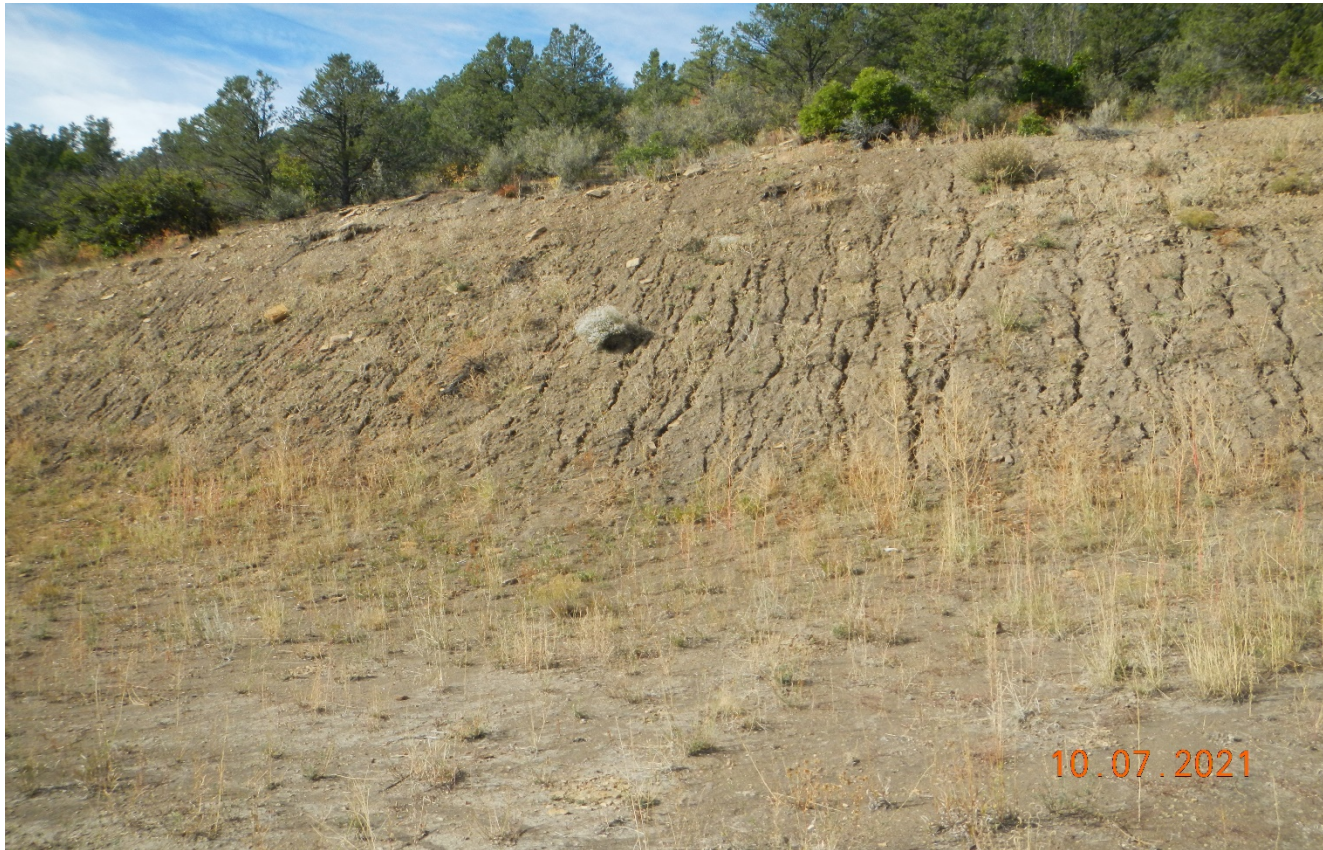
Photo 9. There are signs of erosion occurring off the cut slope.

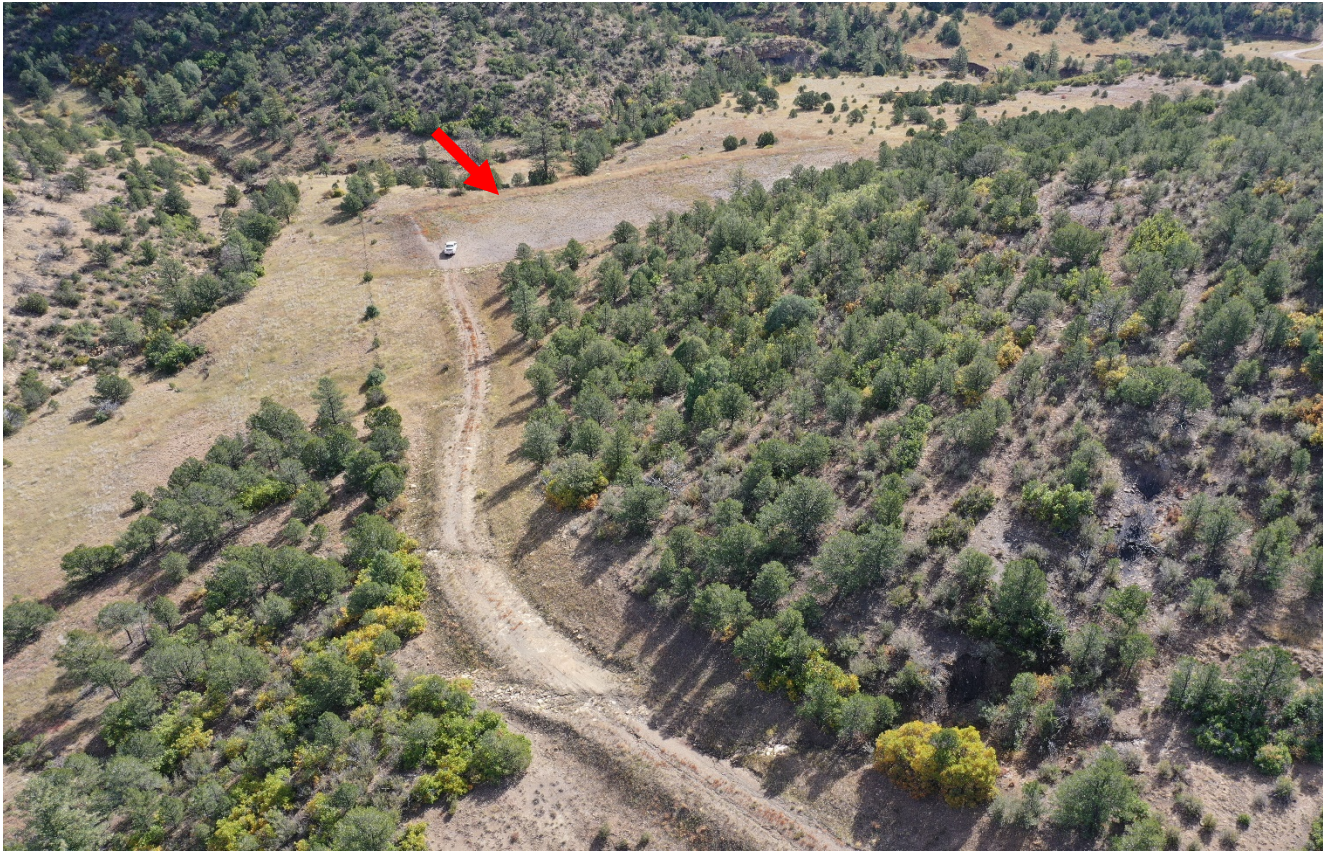
Photo 10. Drone aerial photo facing east toward the access road and location shown at red arrow.

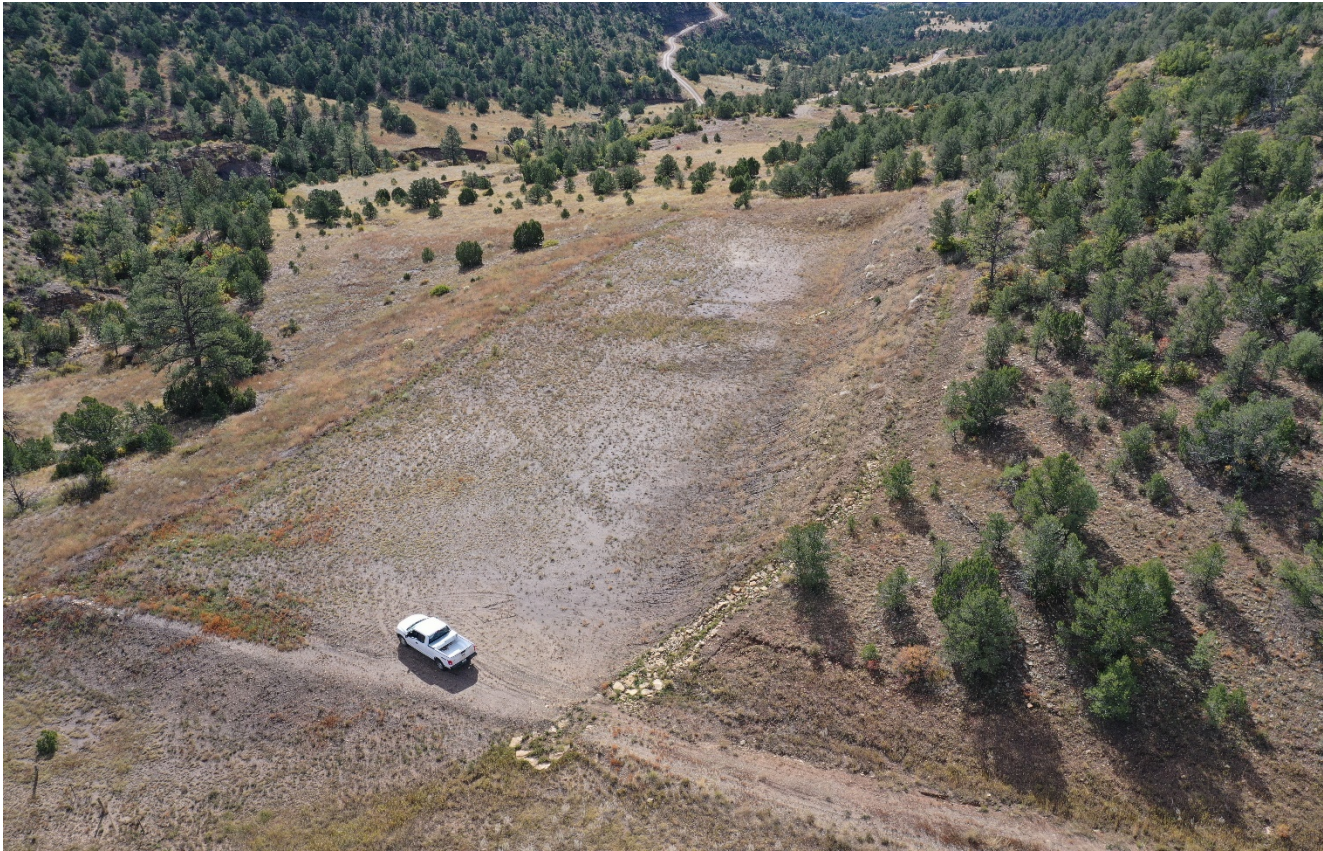
Photo 11. Drone photo facing southeast toward the location.

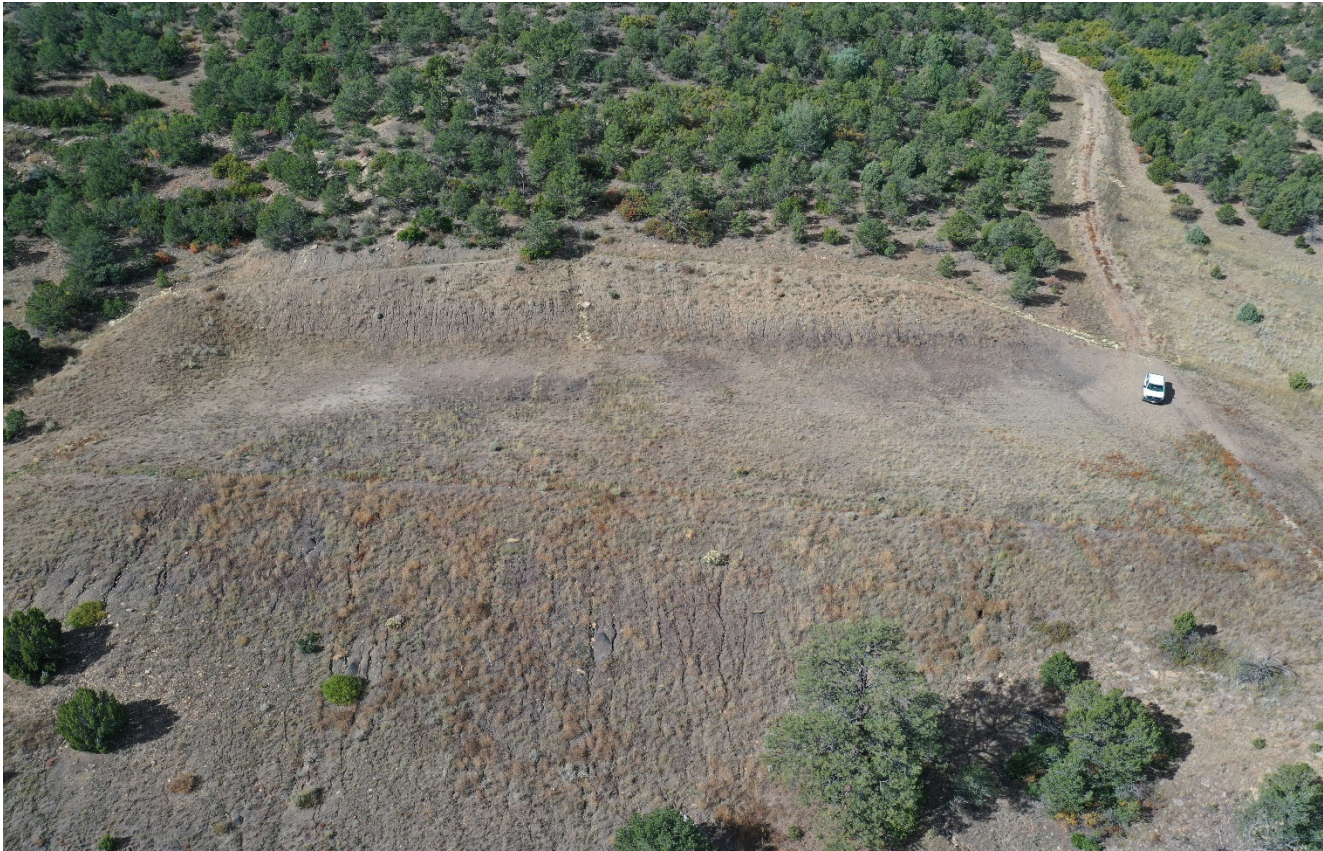
Photo 12. Drone photo facing west toward the location.

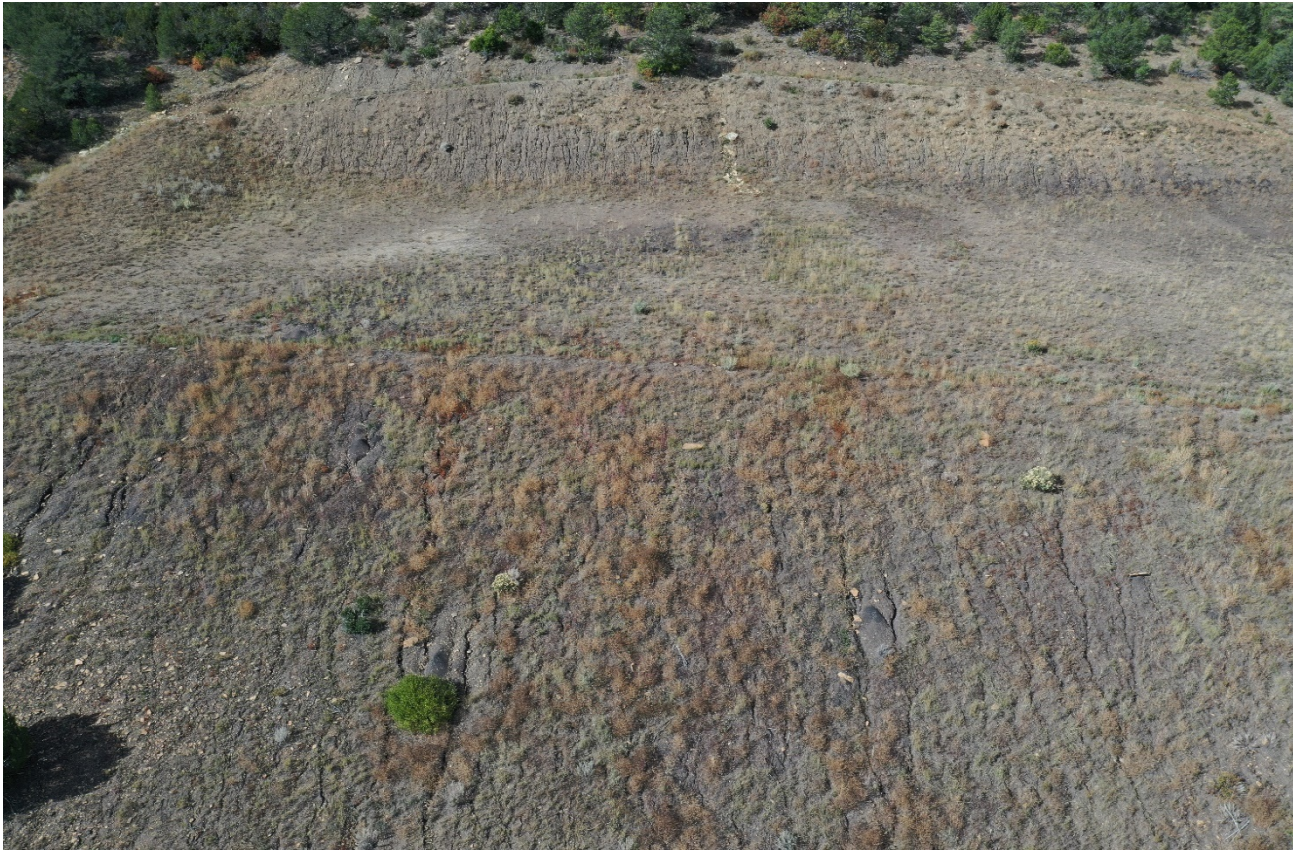
Photo 13. Facing down toward the location shows erosion along the fill slope.

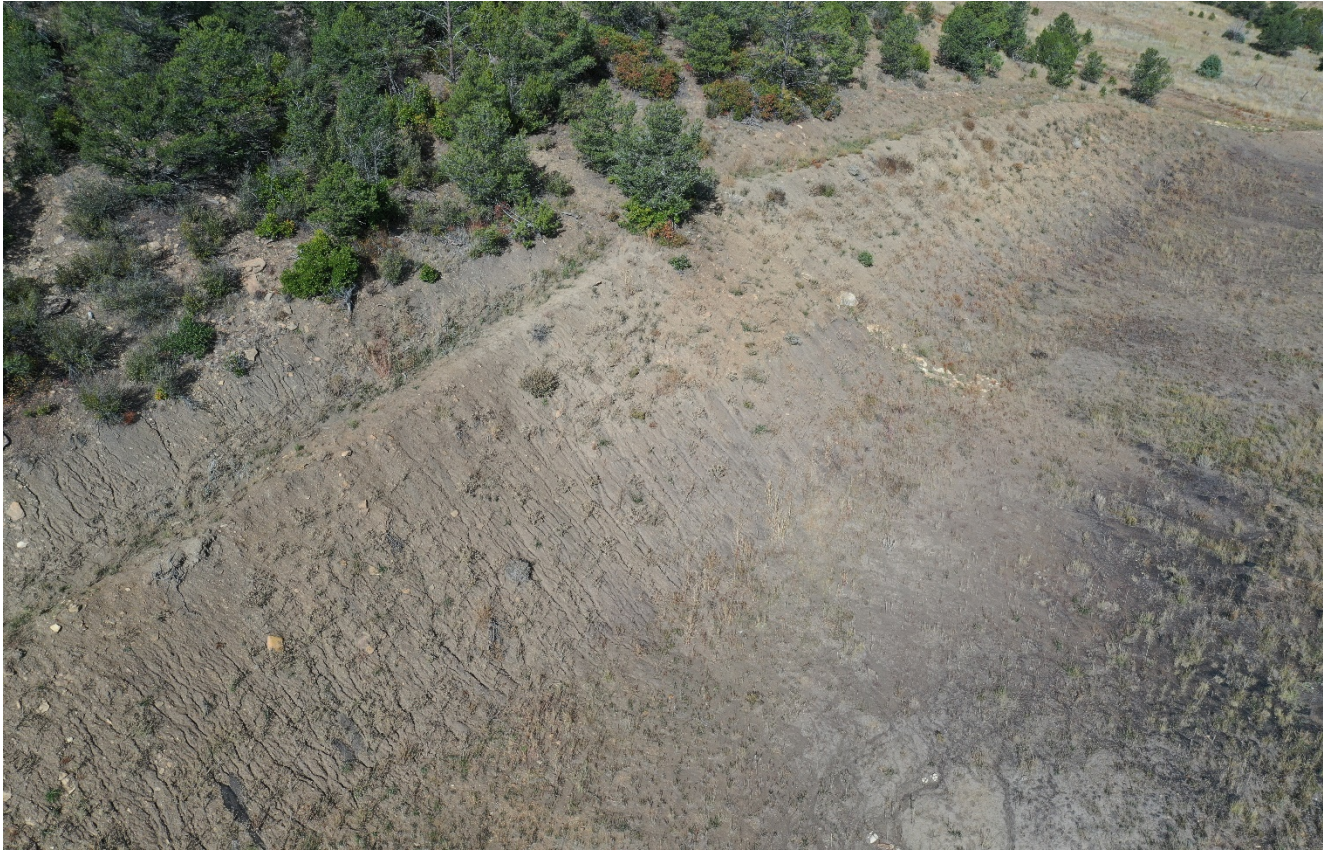
Photo 14. Facing down toward the cut slope of the location.

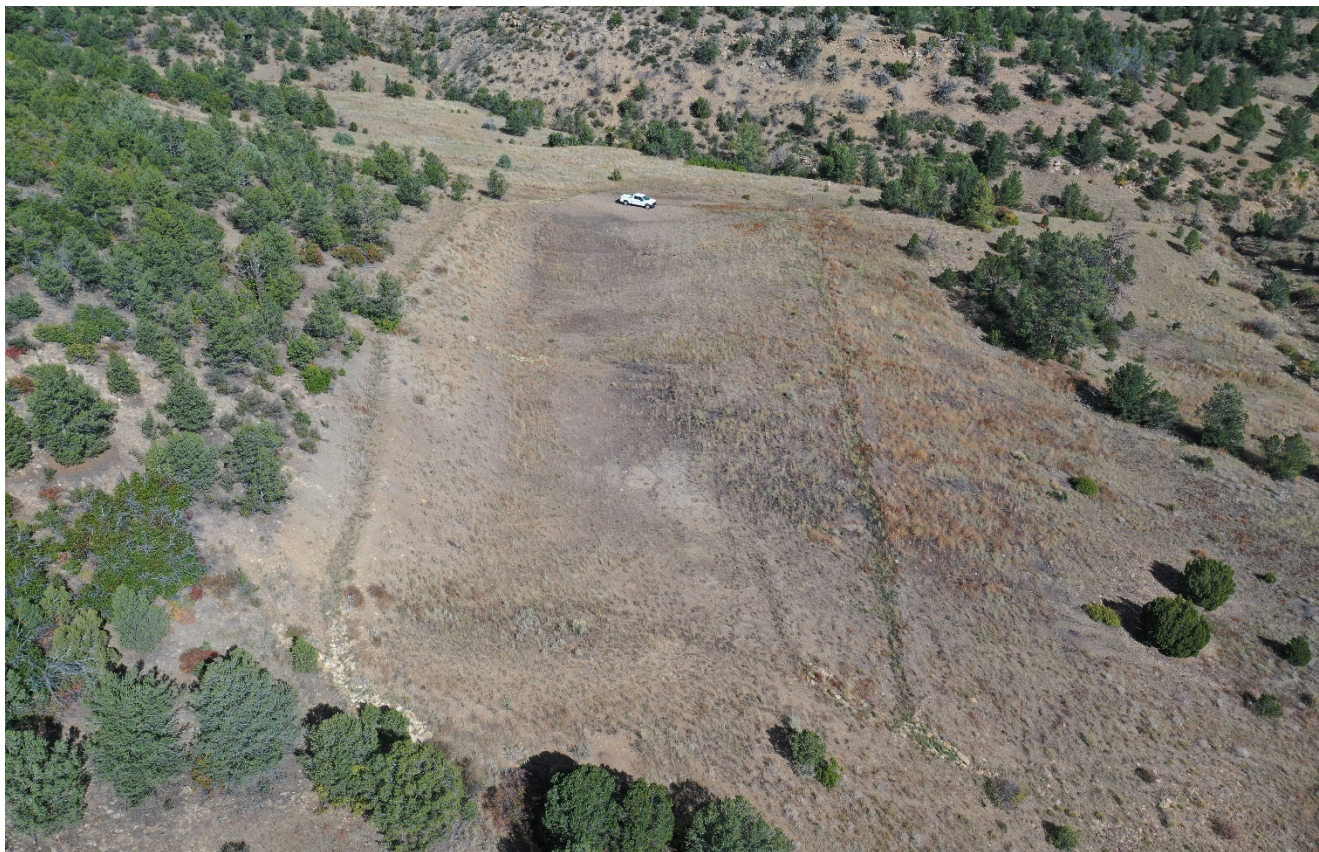
Photo 15. Drone photo facing north toward the location.
