Inspection Photos
Operator: Simcoe
Facility: 067-07464
Date: 10/6/2021

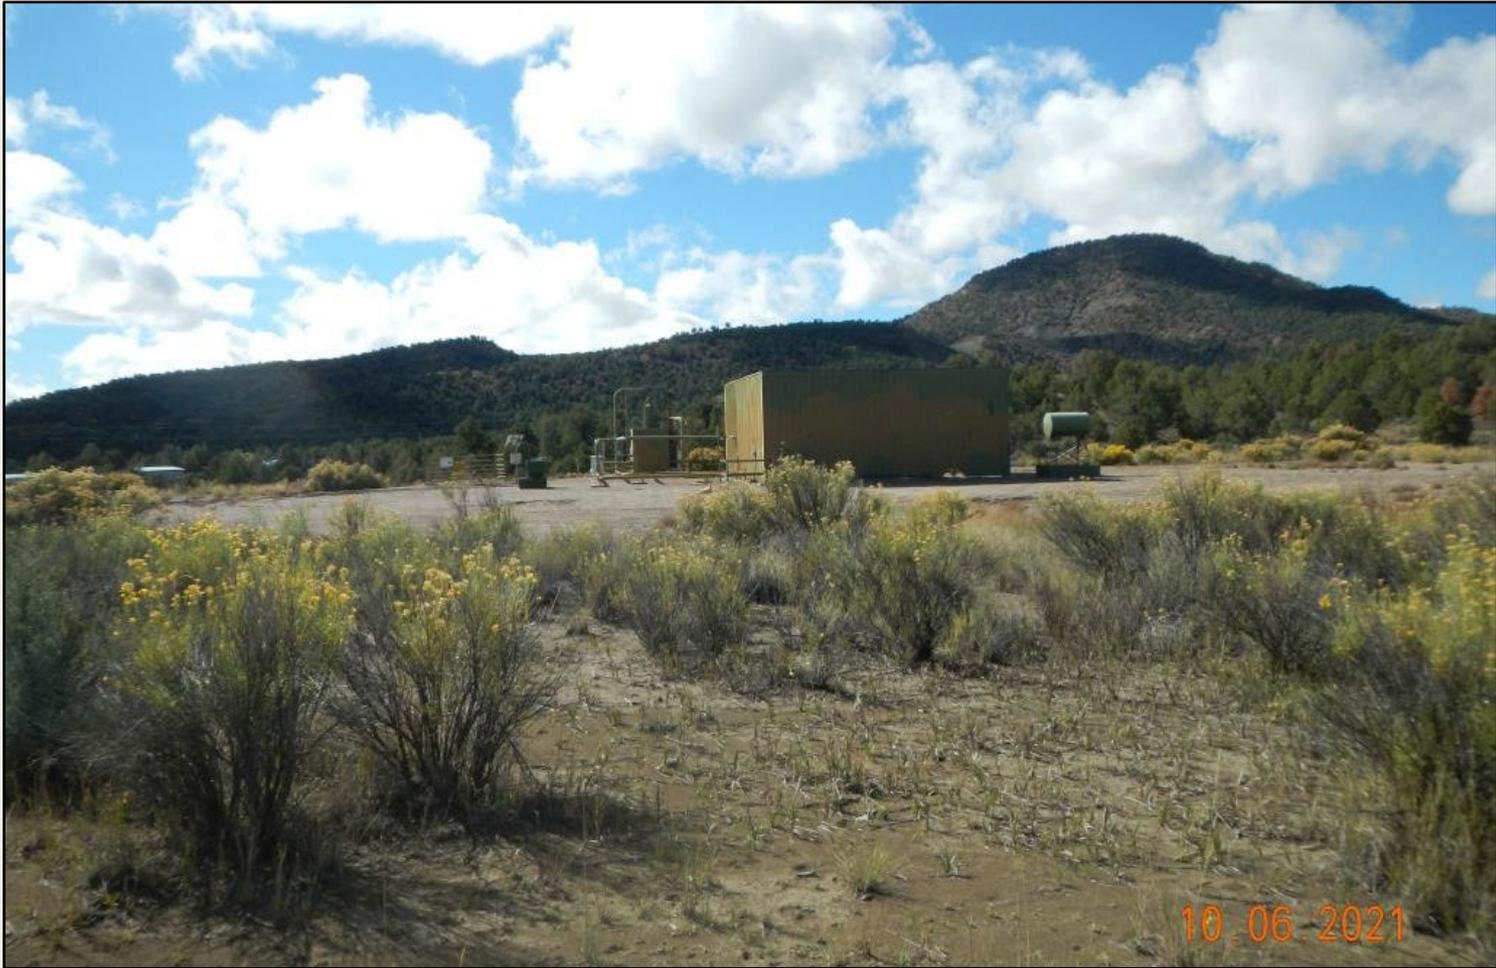
Photo 1. View of project area from the northeastern corner facing center.

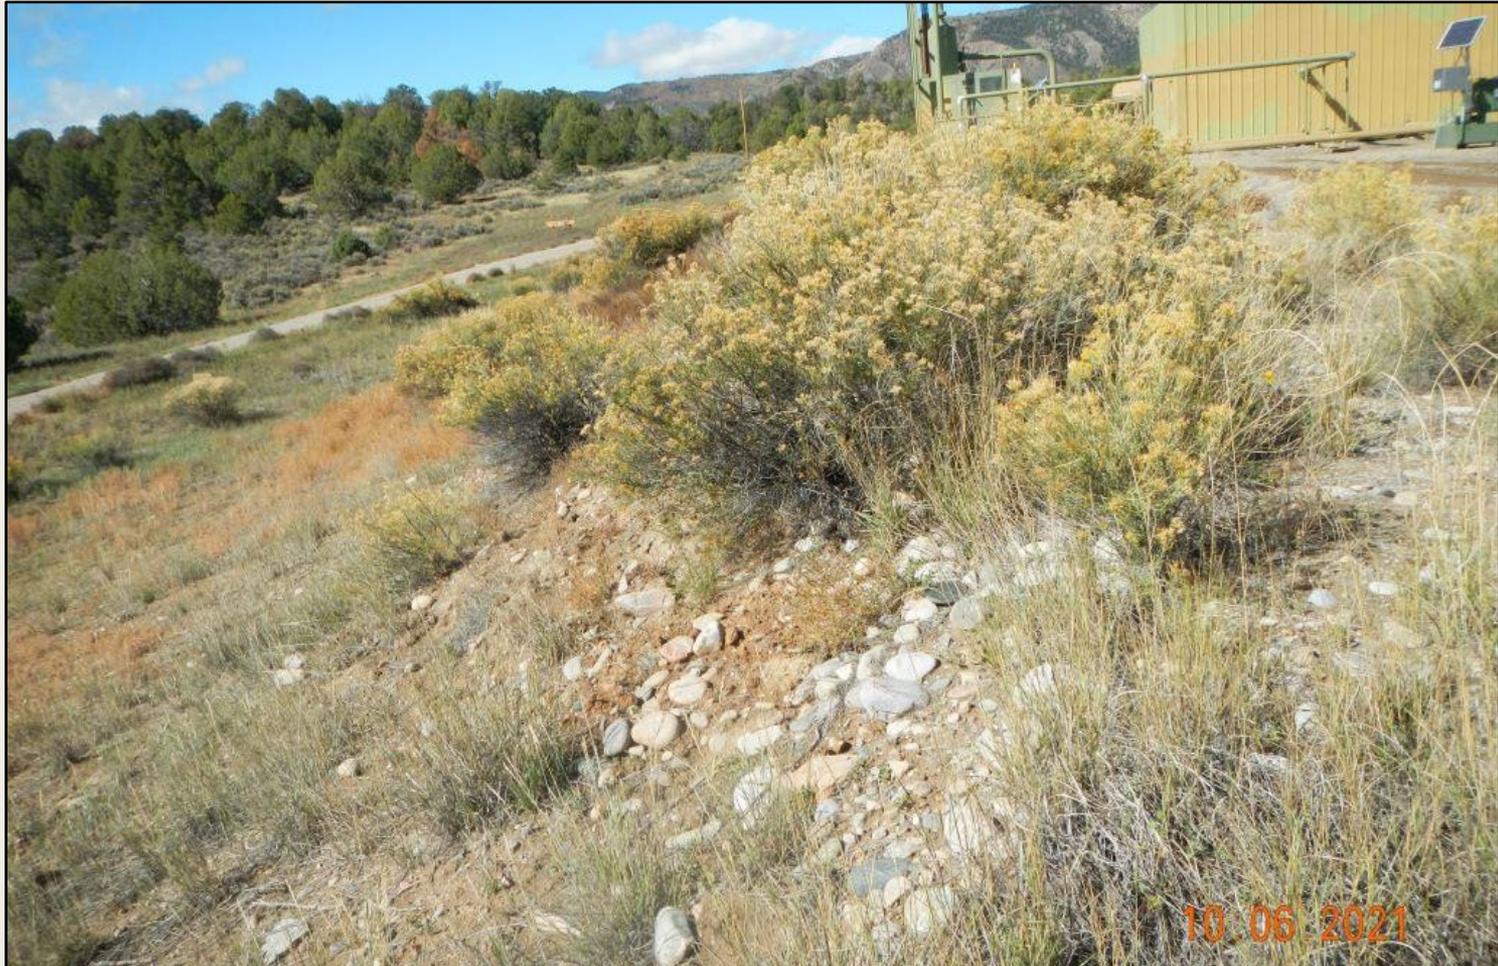
Photo 2. View of the southern project area from the southeastern corner facing westward. Revegetation is progressing here with rubber rabbitbrush, Intermediate wheatgrass, smooth brome, and sand dropseed.

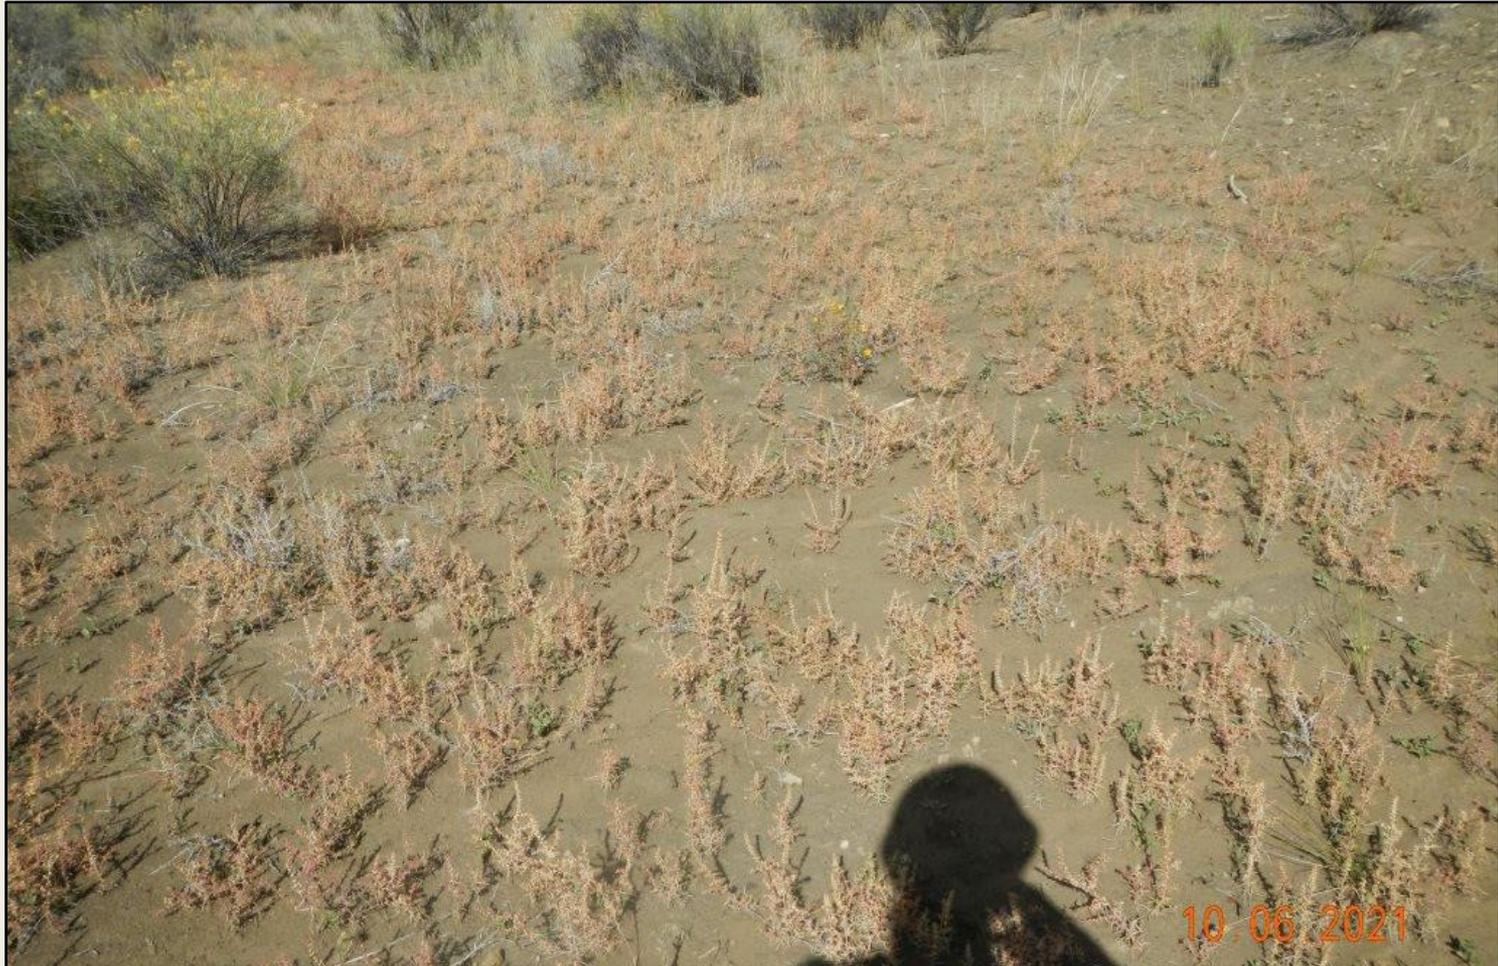
Photo 3. View of area (approx. 50x 75) in the northern project area where little desirable vegetation is growing (observable vegetation is weedy Russian thistle). It appears that sediment deposition from the cutslope is settling here and choking desirable vegetation.

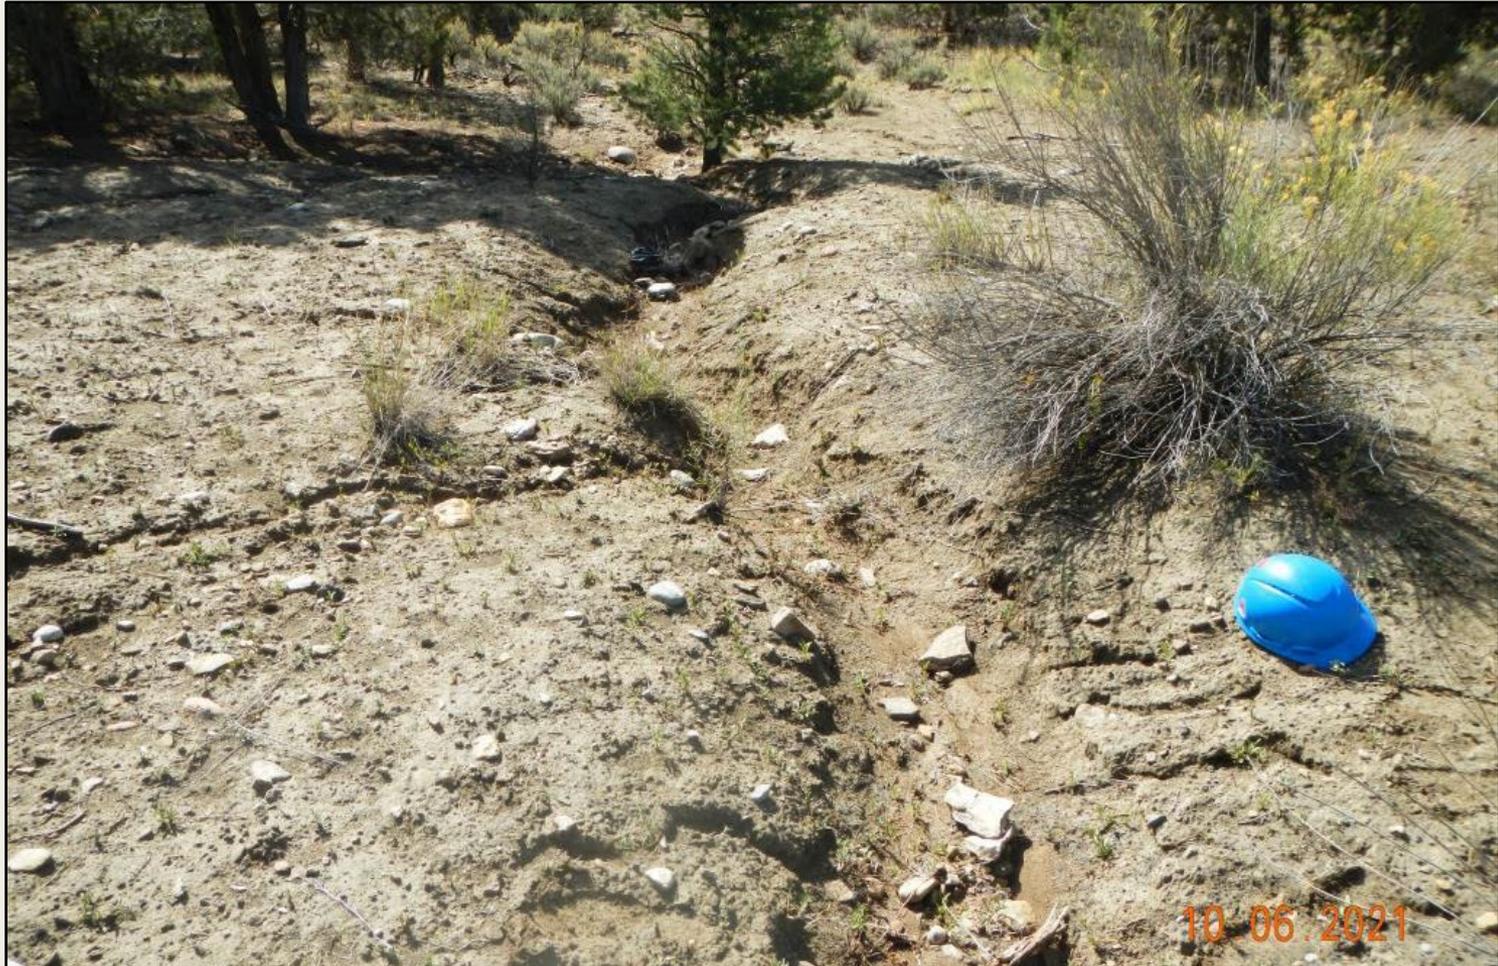
Photo 4. View of erosional channel (approx. 2-3 feet wide and 2 feet deep) within the northeastern corner of the project area.

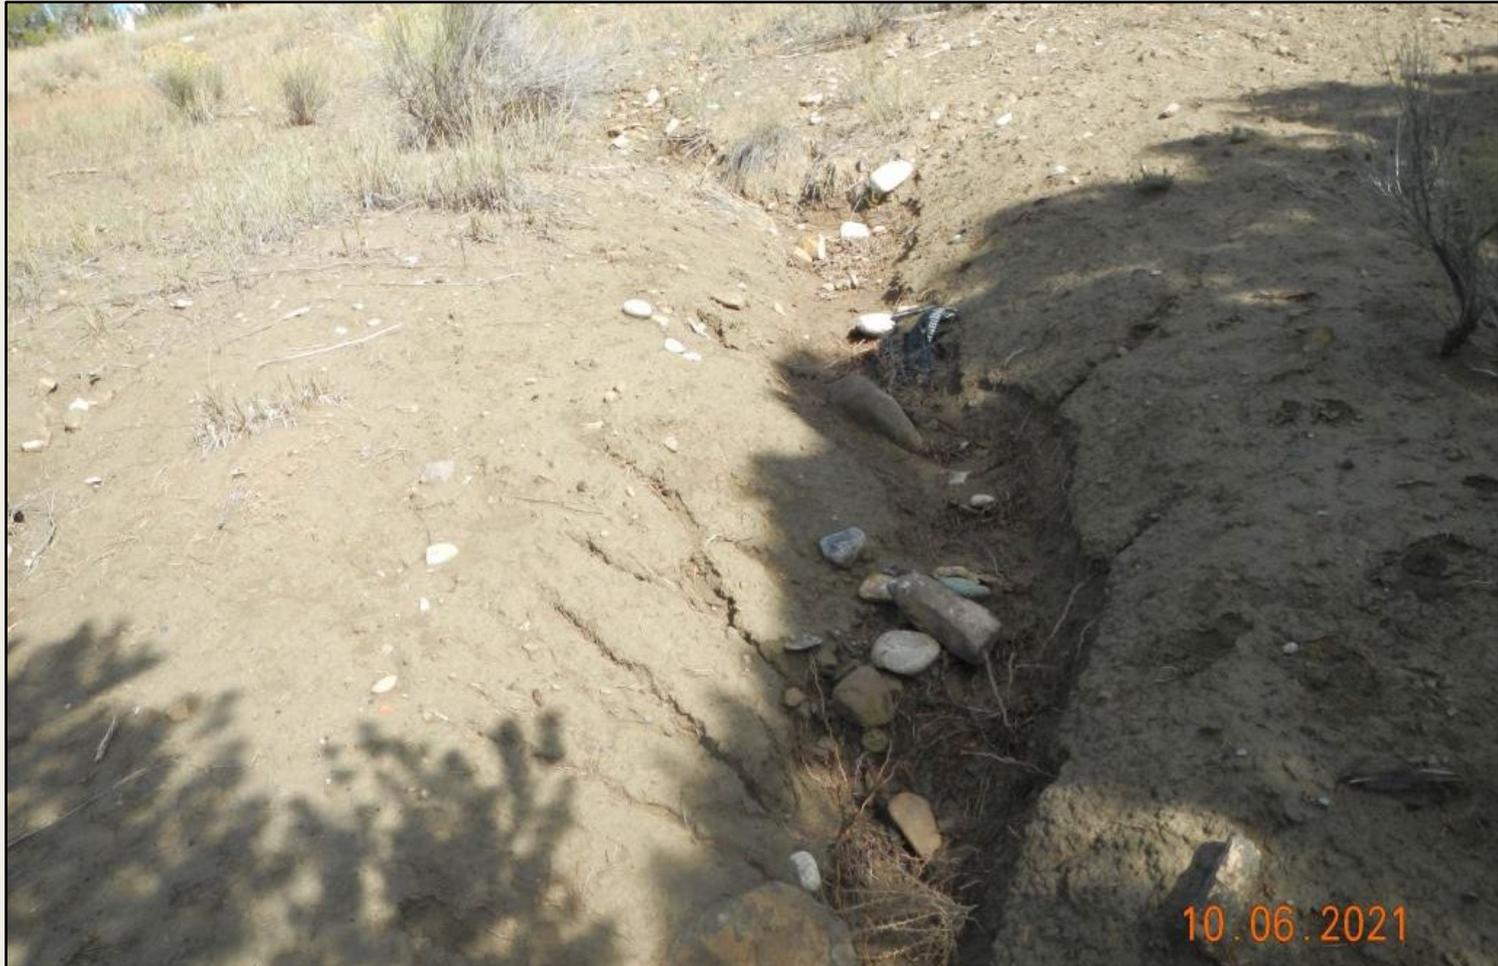
Photo 5. View of erosional channeling and rilling within the eastern project area. Multiple erosional rills in the eastern project area.

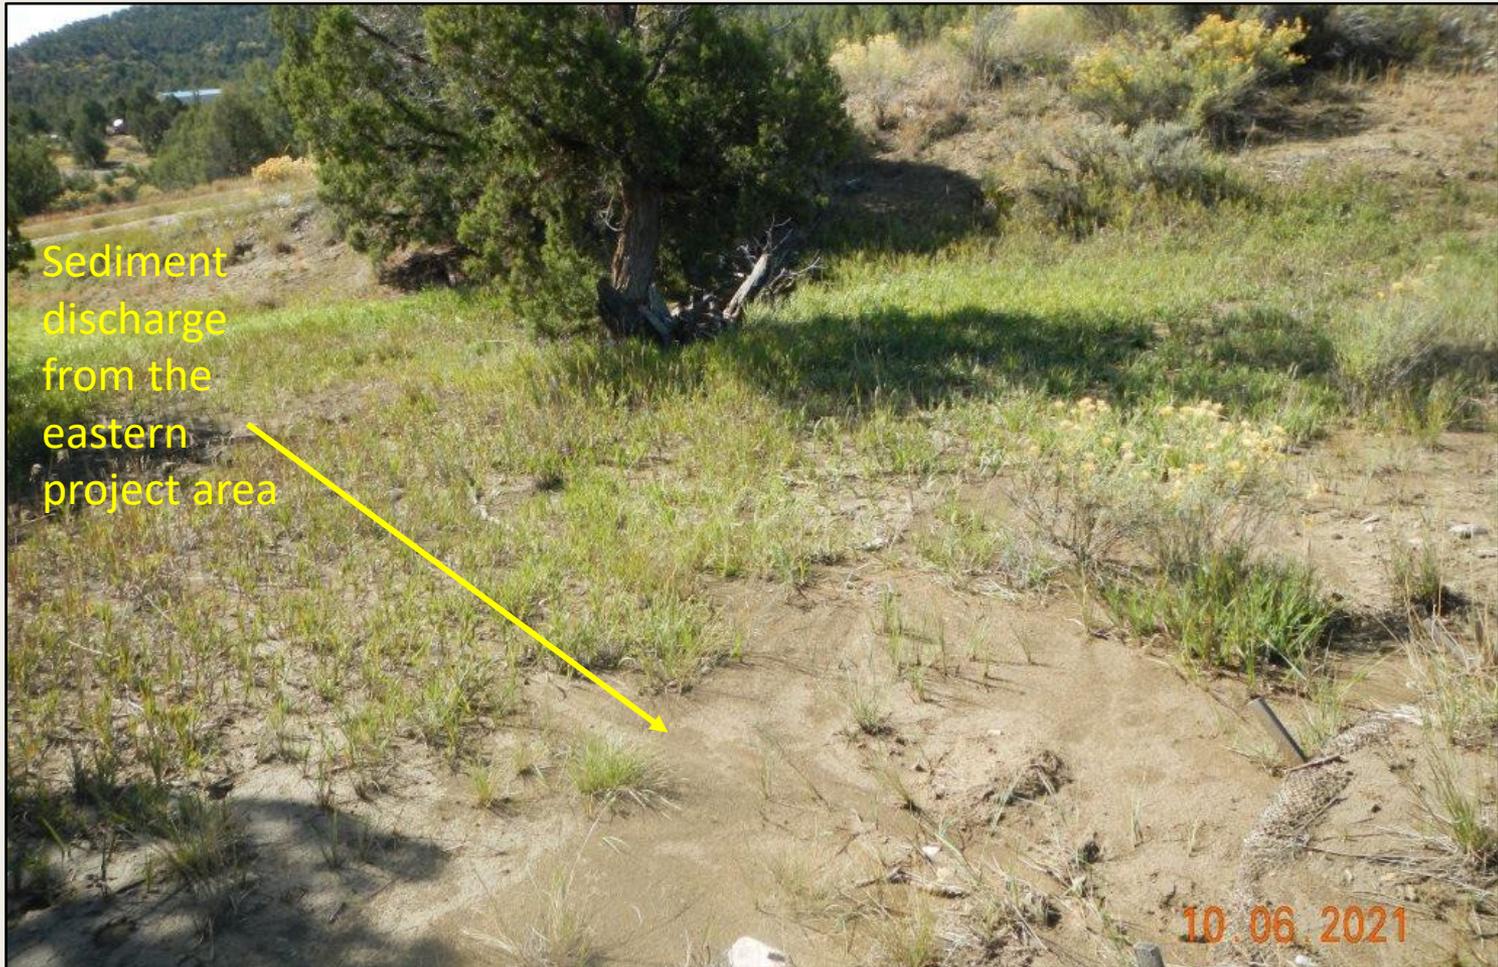
Photo 6. View of reference area (in background) comprised of irrigated grass field with western wheatgrass and mixed pasture grasses.

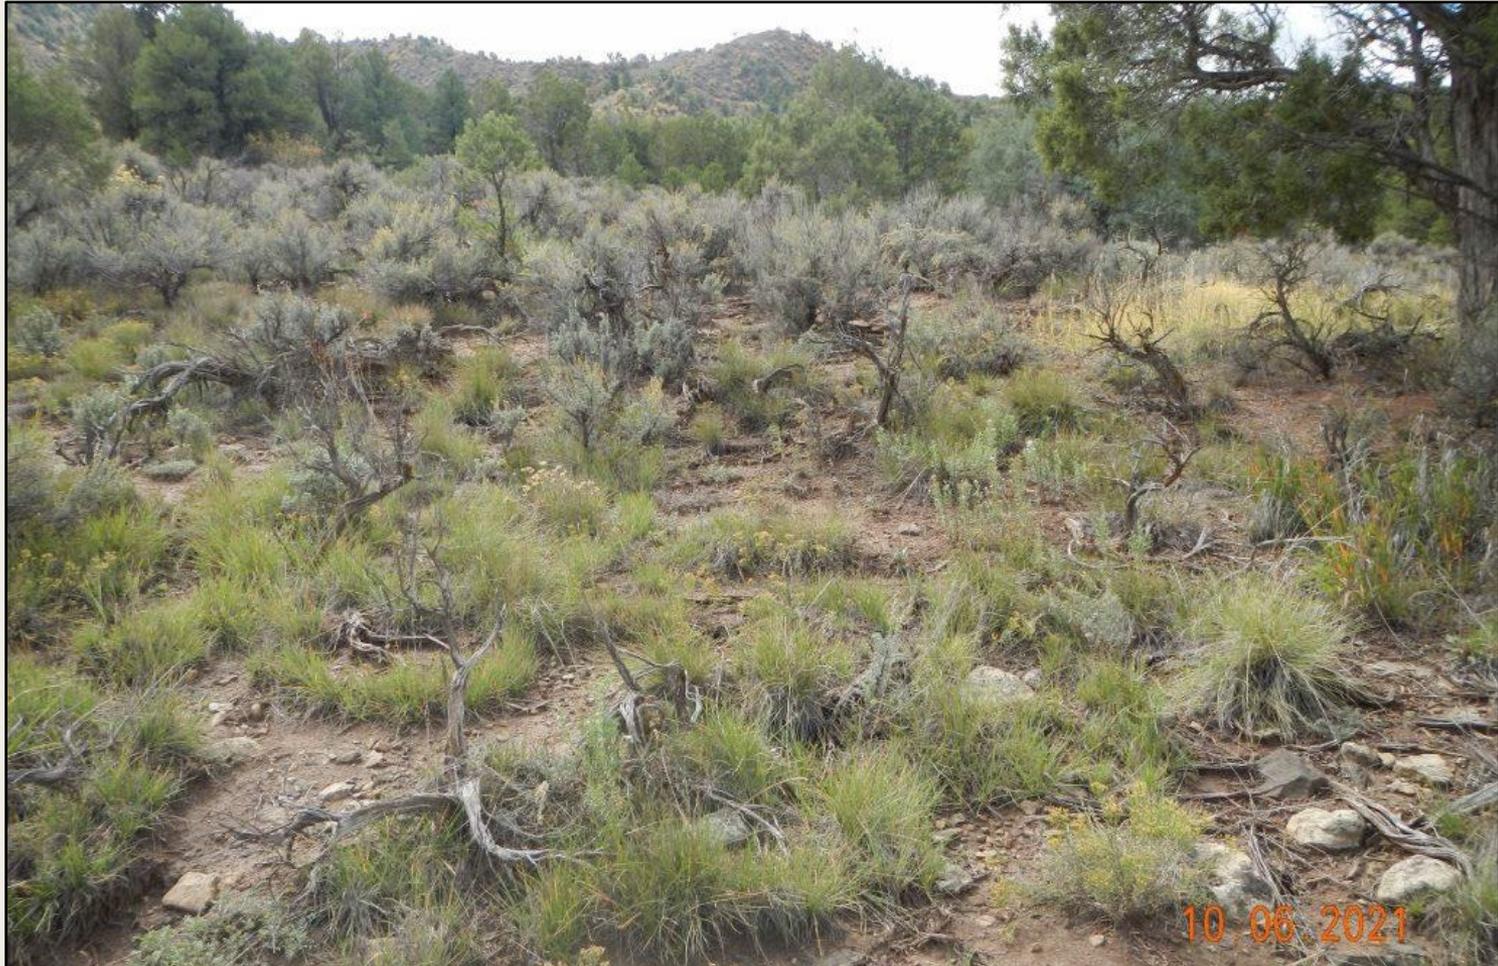
Photo 8. View of reference area comprised of sagebrush shrubland and pinyon-juniper woodland with James galleta, western wheatgrass, matt penstemon, and sticky rabbitbrush.
