Inspection Photos

Operator: Logos Operating
API: 067-05589
Date: 10/6/2021

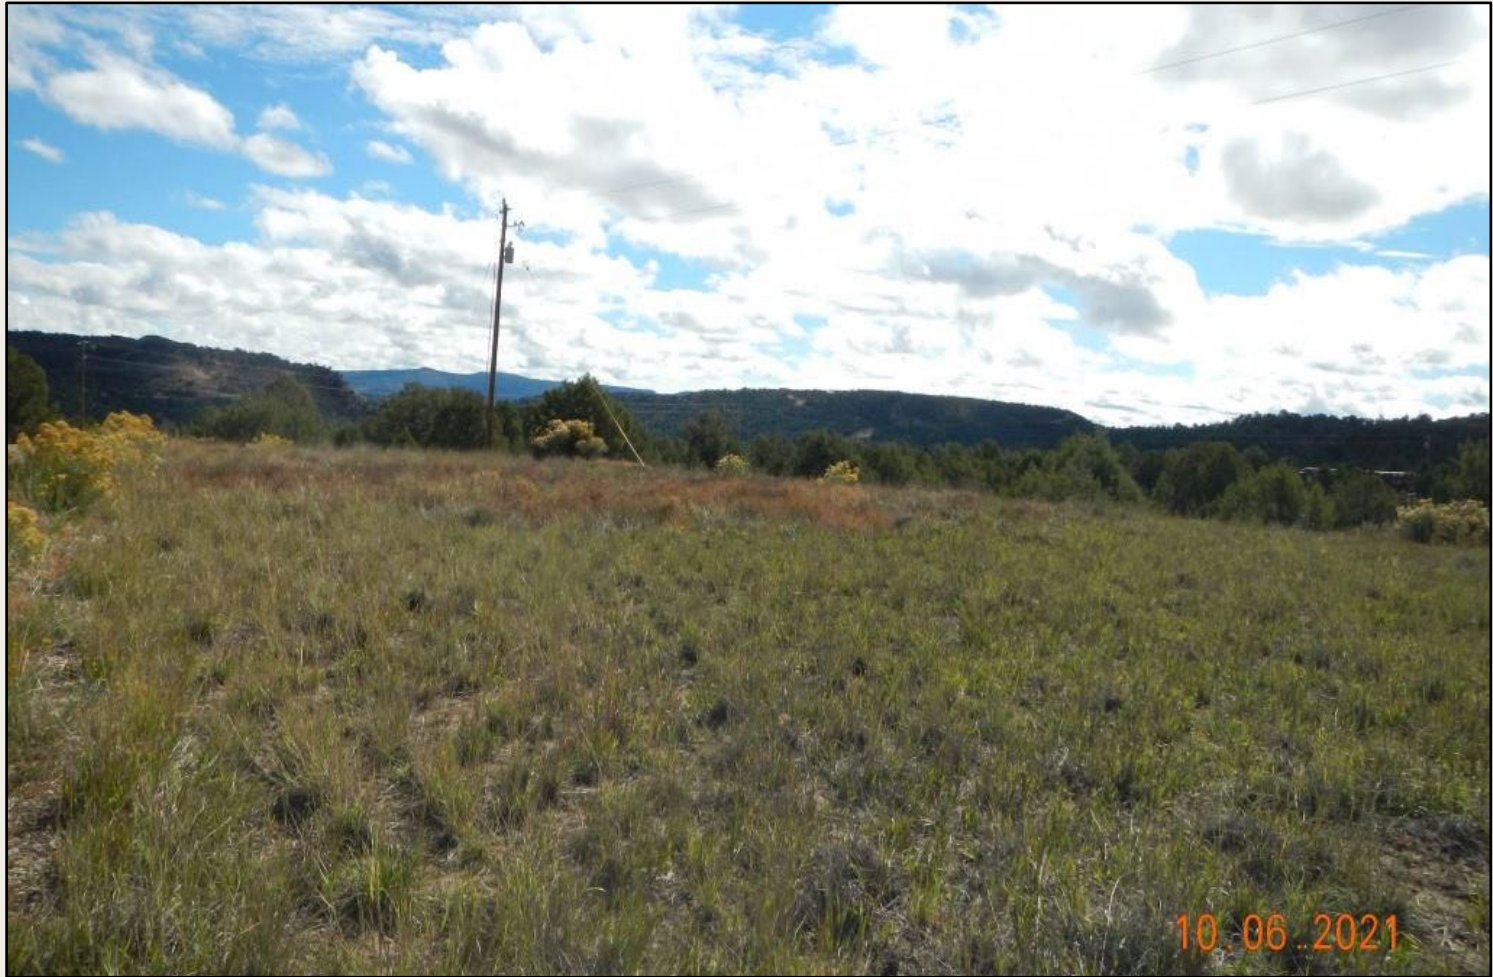
Photo 1. View of project area from the northwestern corner facing center. Revegetation is progressing here with smooth brome and crested wheatgrass.

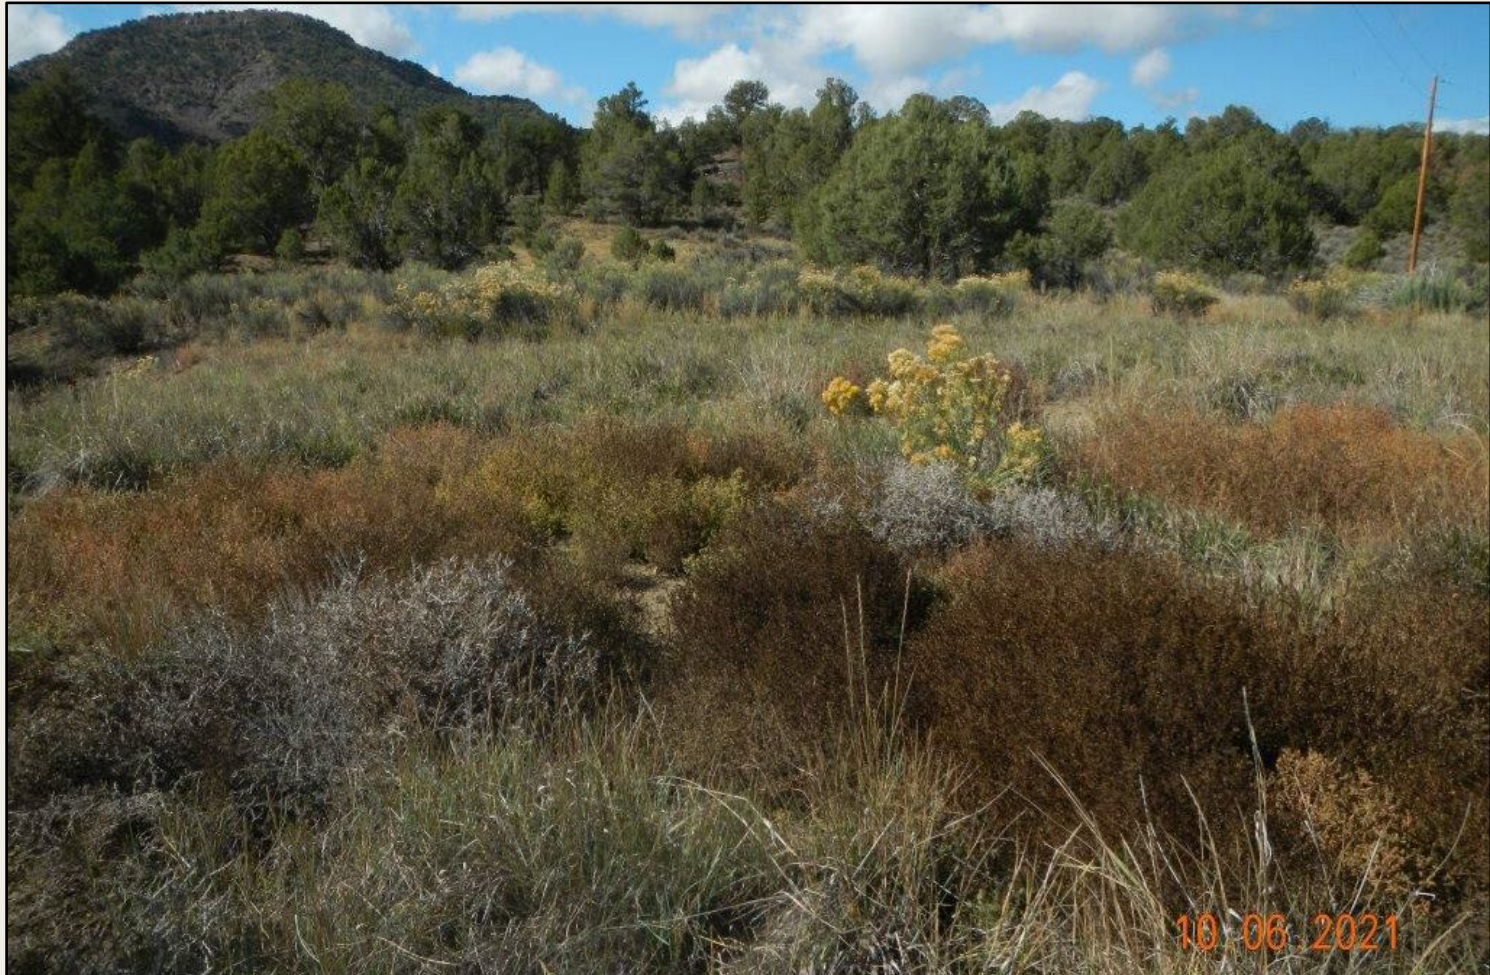
Photo 2. View of Russian thistle debris on the well pad, in former facilities area. Revegetation success needs to be assessed here.

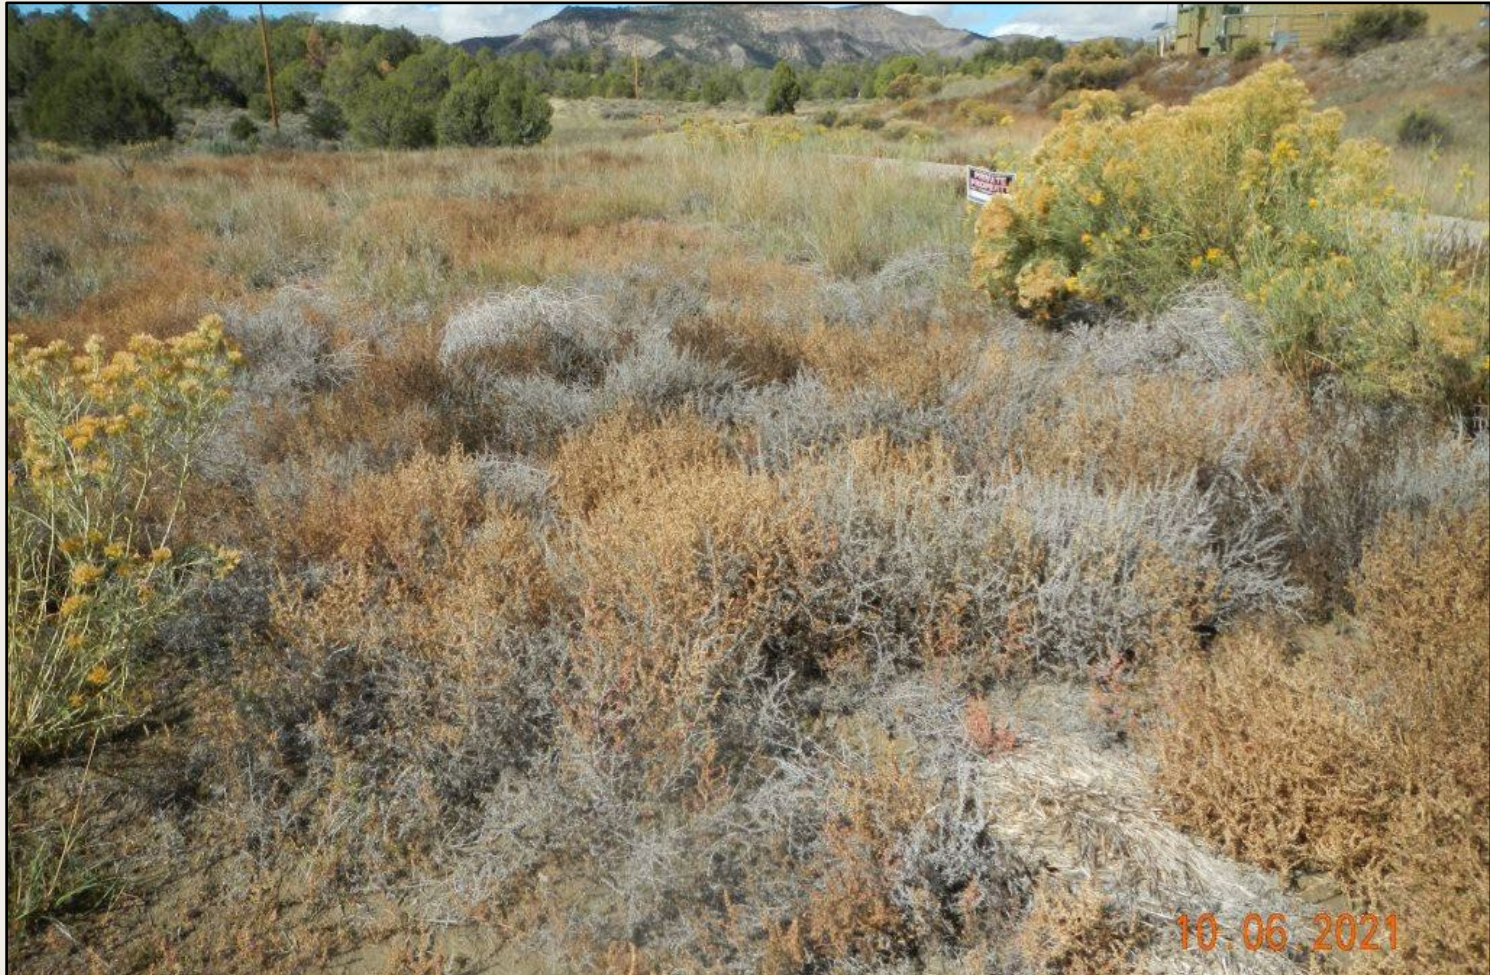
Photo 3. View of more Russian thistle debris on the well pad along former access road area.

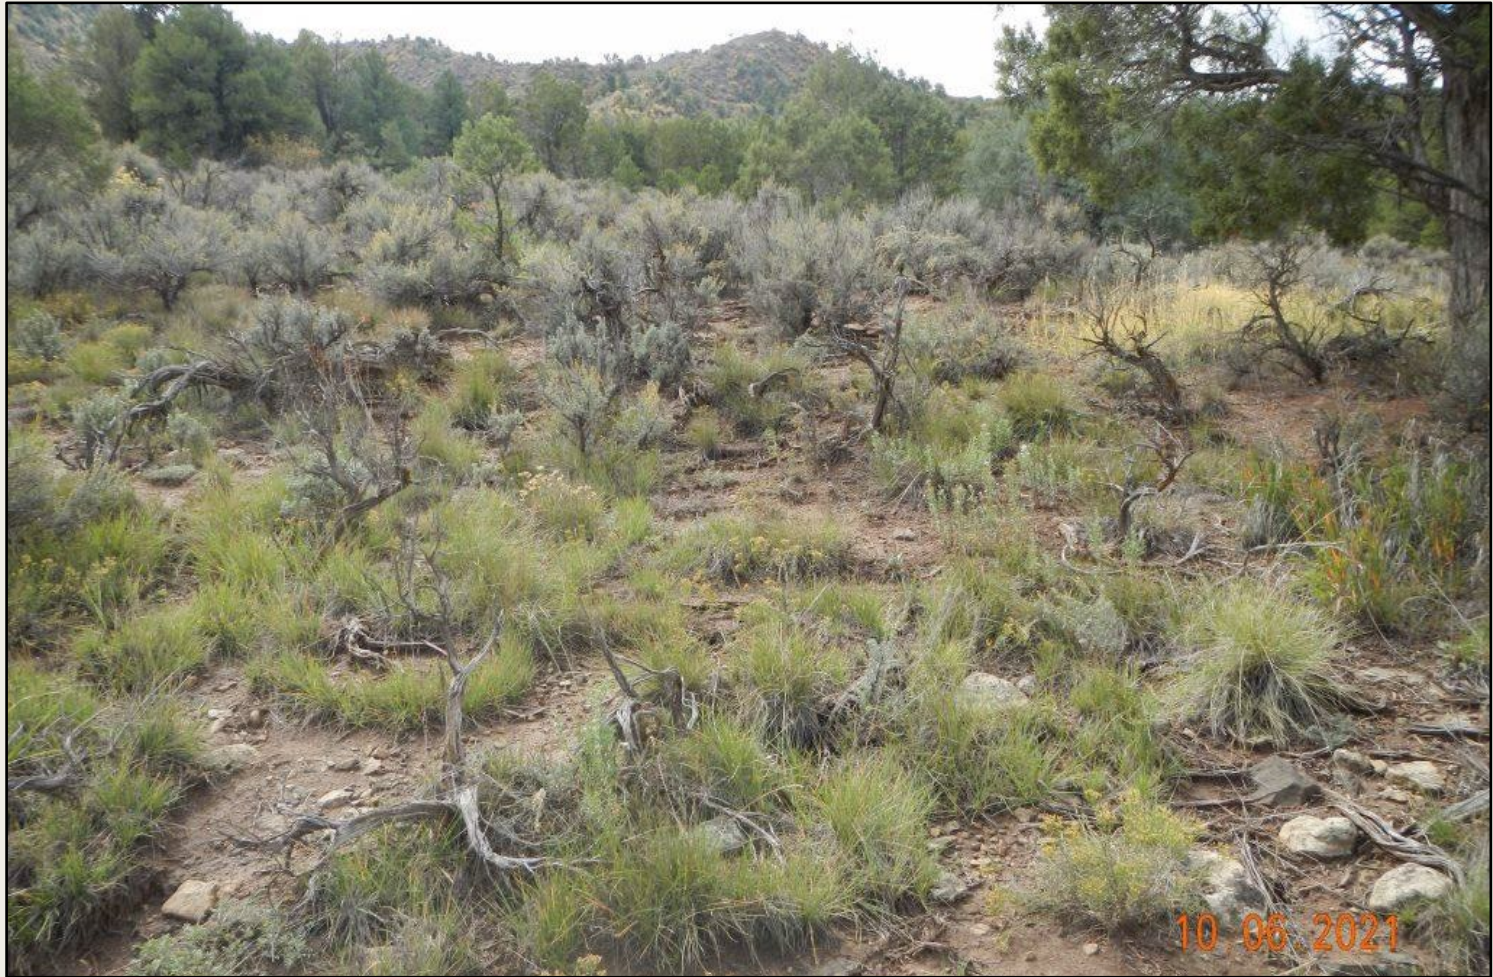
Photo 4. View of reference area comprised of sagebrush shrubland and pinyon-juniper woodland with James galleta, western wheatgrass, matte penstemon, and sticky rabbitbrush.
