Inspection Photos
Operator: Logos
API: 067-05565
Date: 10/6/2021

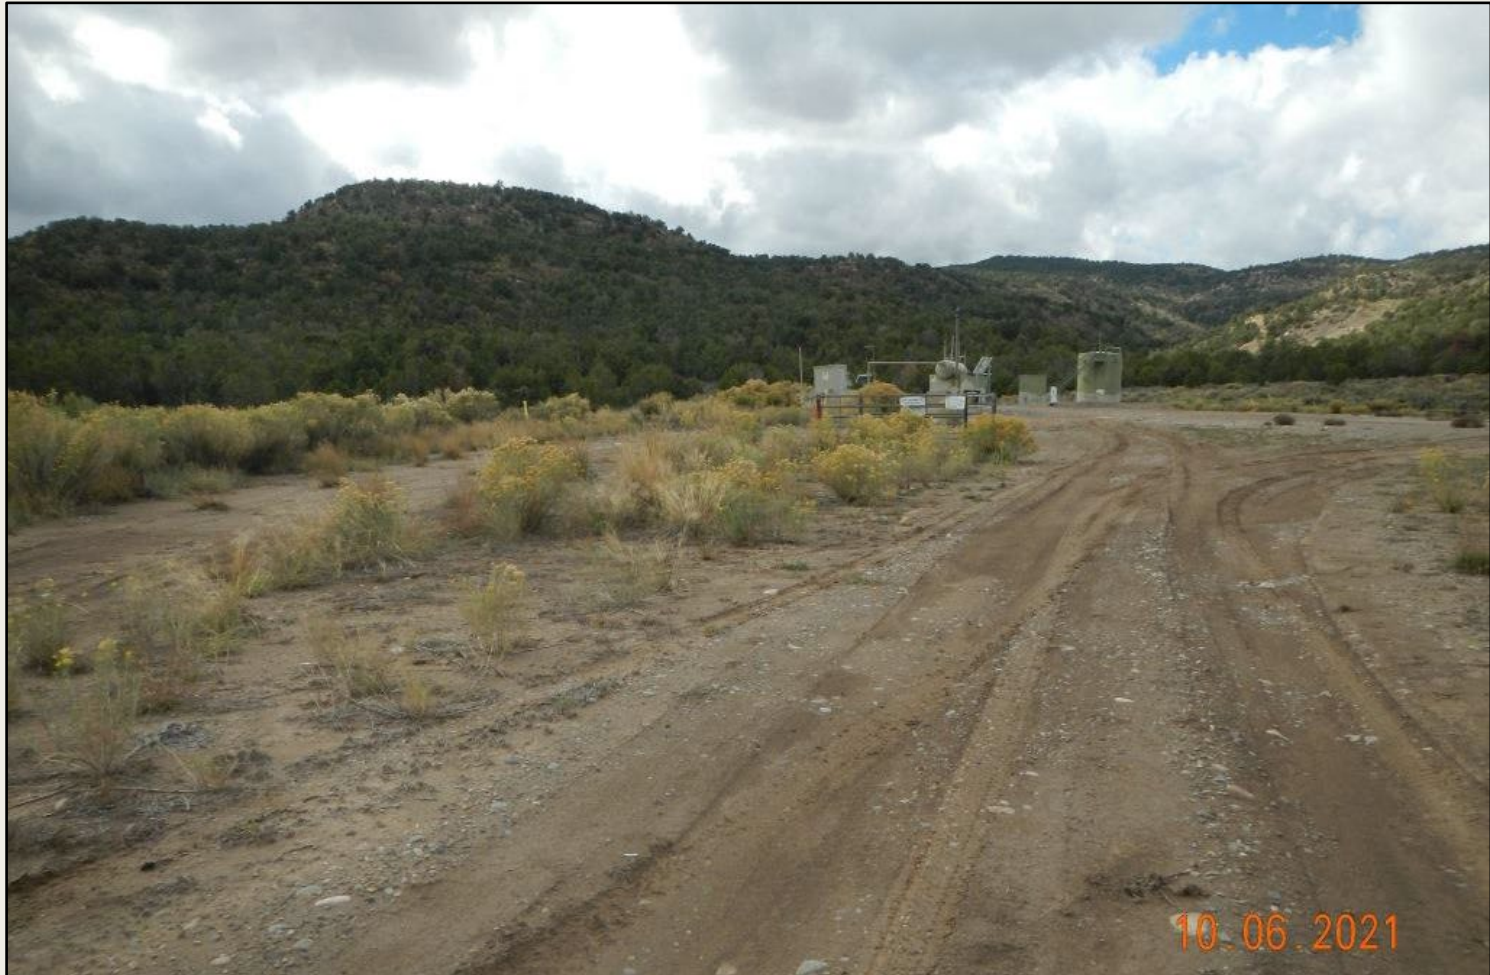
Photo 1. View of project area from the well pad entrance facing center.

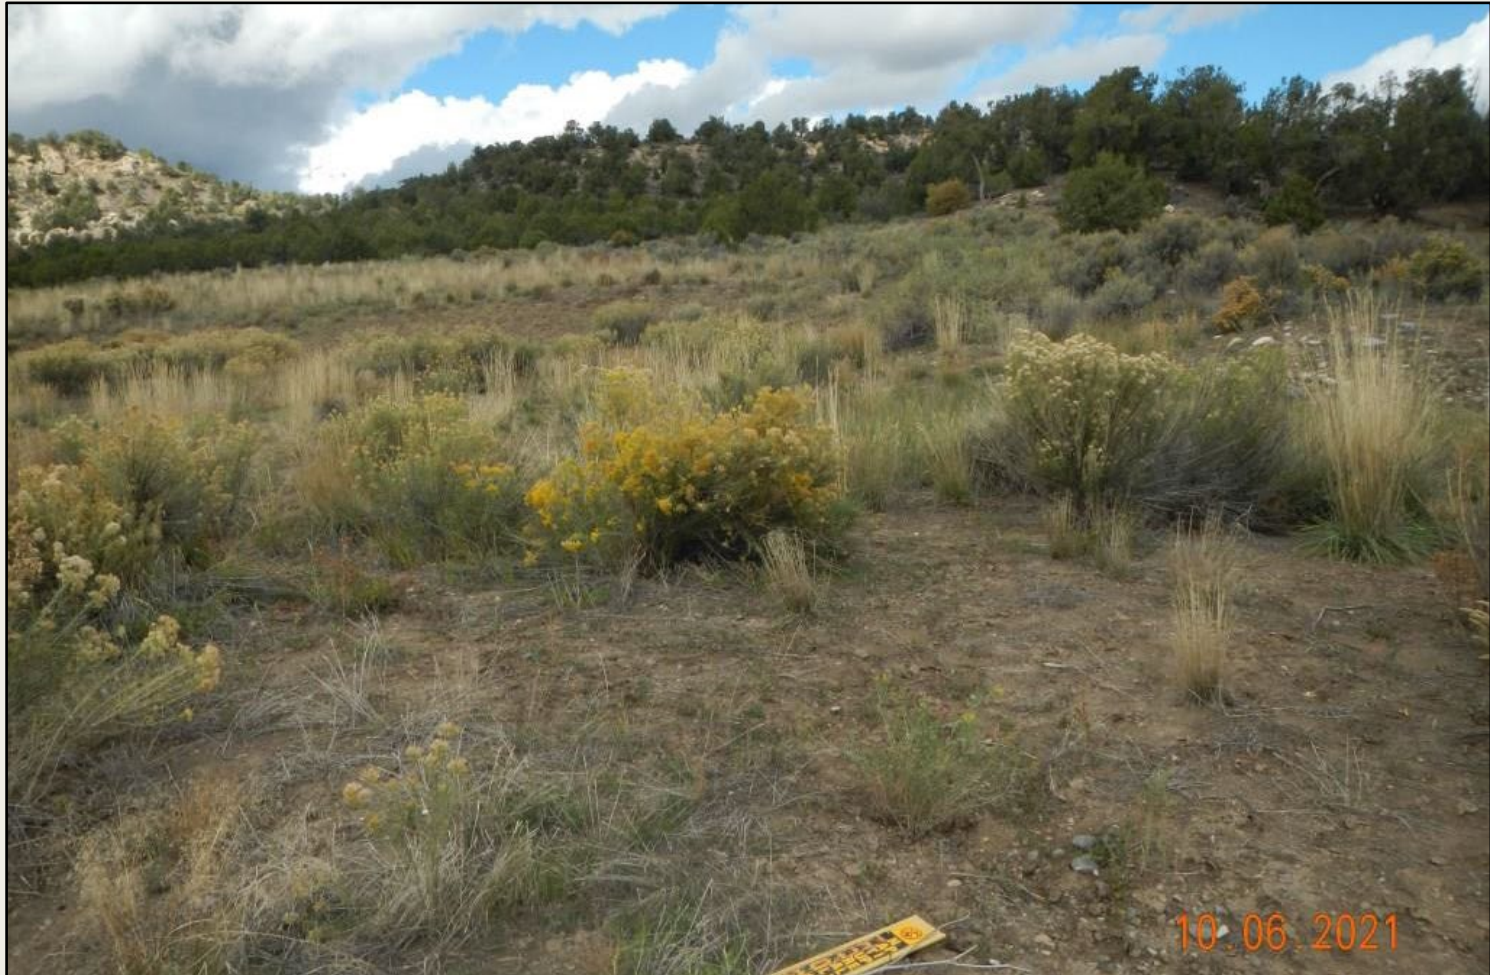
Photo 2. View of the northern project area facing eastward. Revegetation is progressing with western wheatgrass, intermediate wheatgrass, and smooth brome.

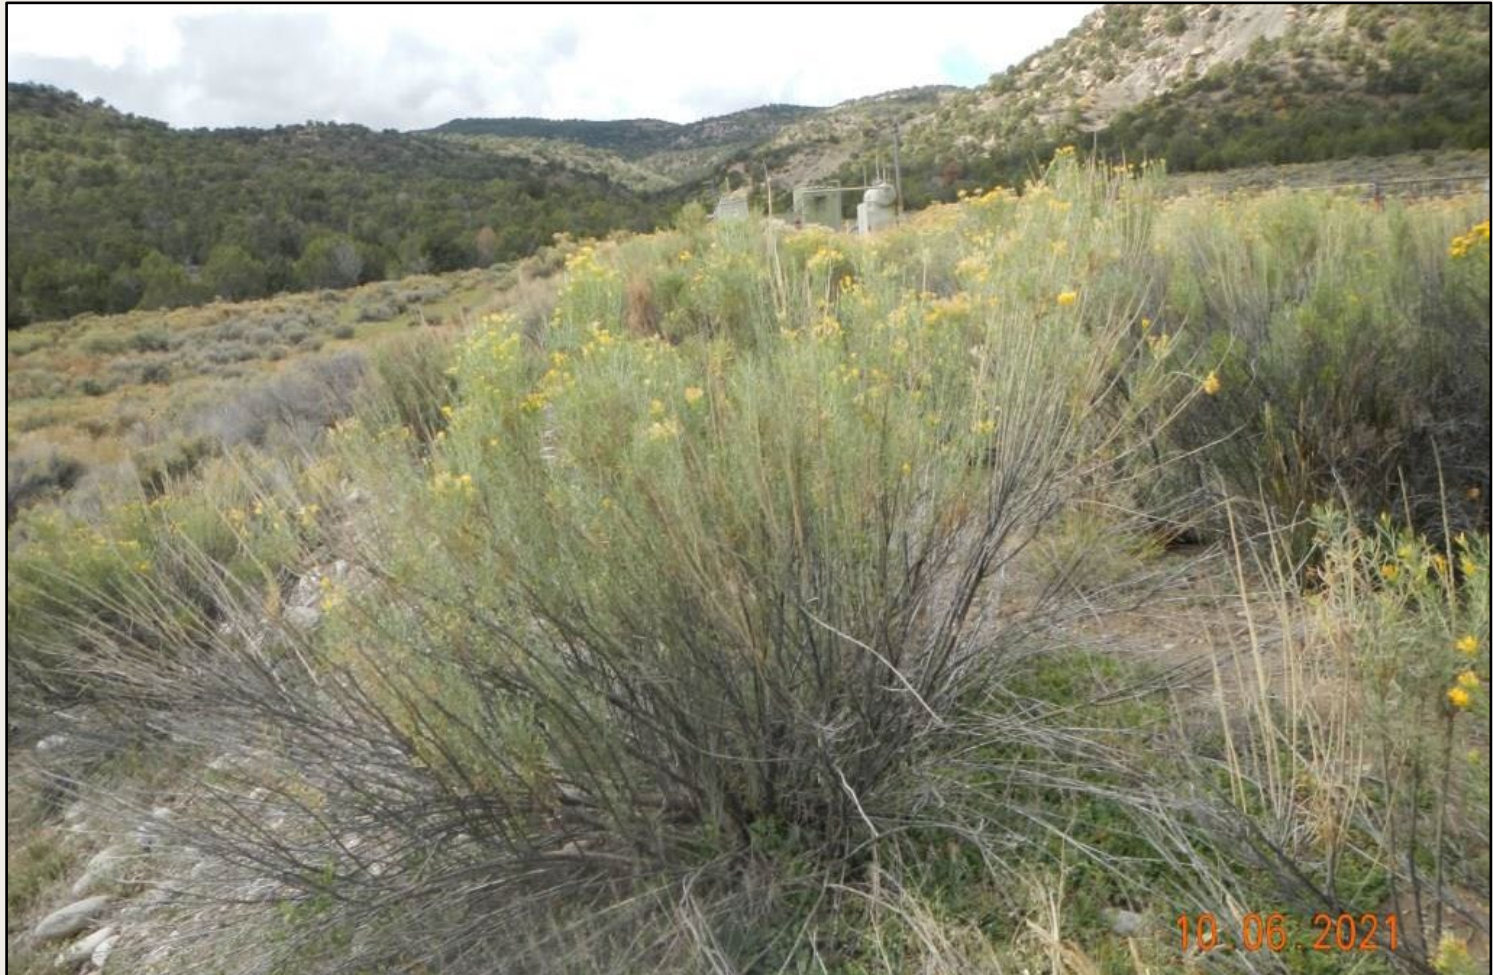
Photo 3. View of the southern fill slope from the southeastern corner facing westward.

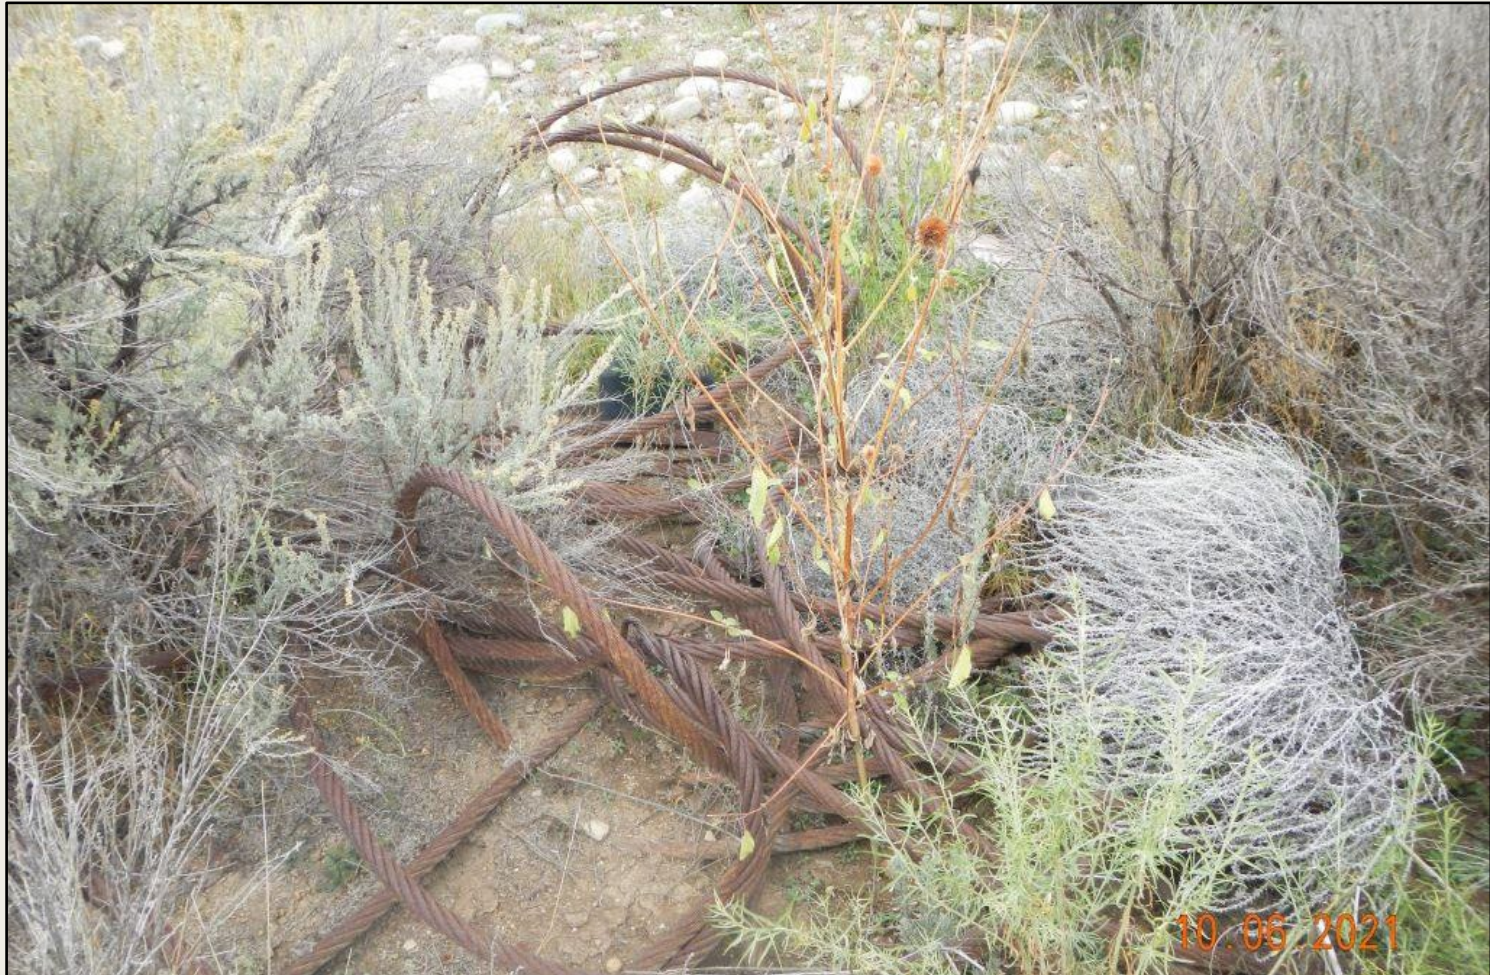
Photo 4. View of cable debris in the southern project area.

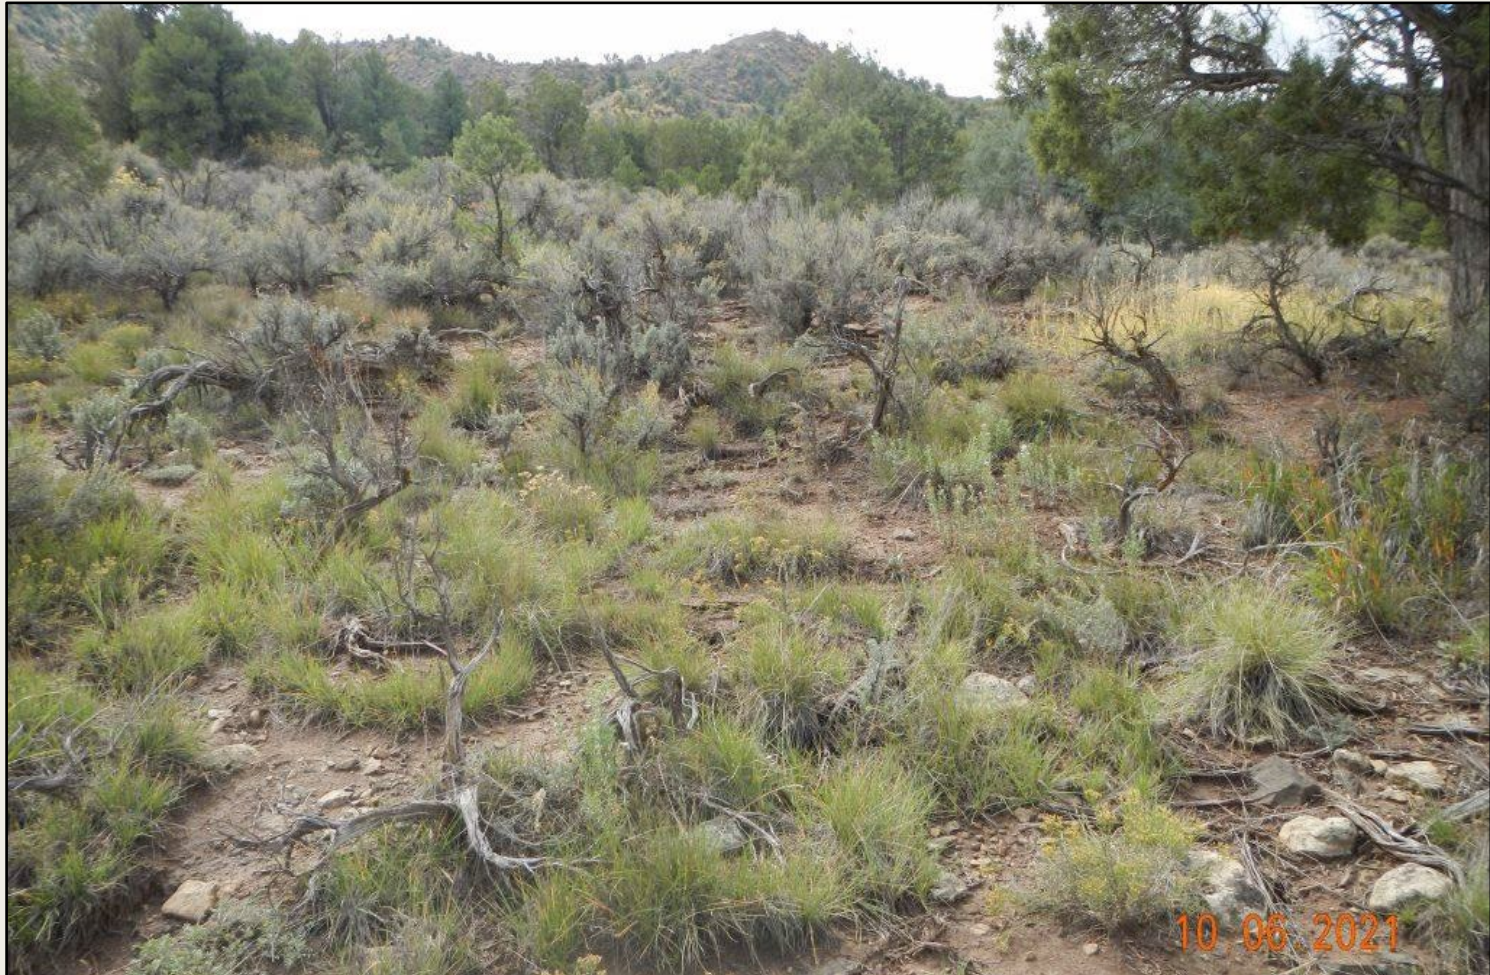
Photo 5. View of reference area comprised of sagebrush shrubland and pinyon-juniper woodland with James galleta, western wheatgrass, matte penstemon, and sticky rabbitbrush.
