Inspection Photos
Operator: Simcoe
API: 067-07509
Date: 10/6/2021

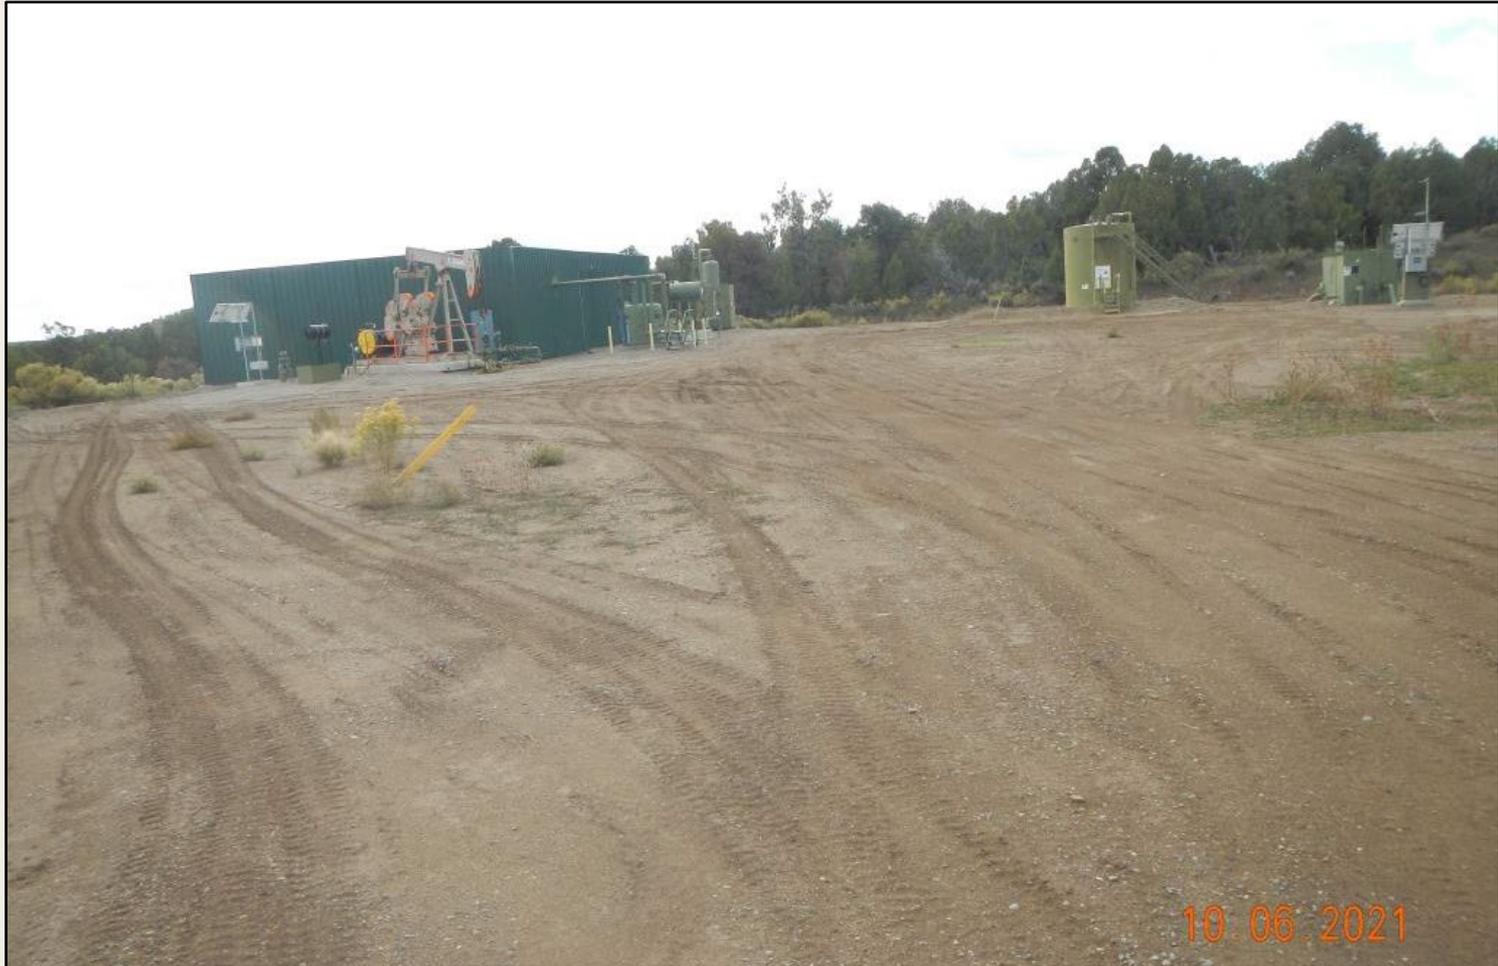
Photo 1. View of project area from the well pad entrance facing center.

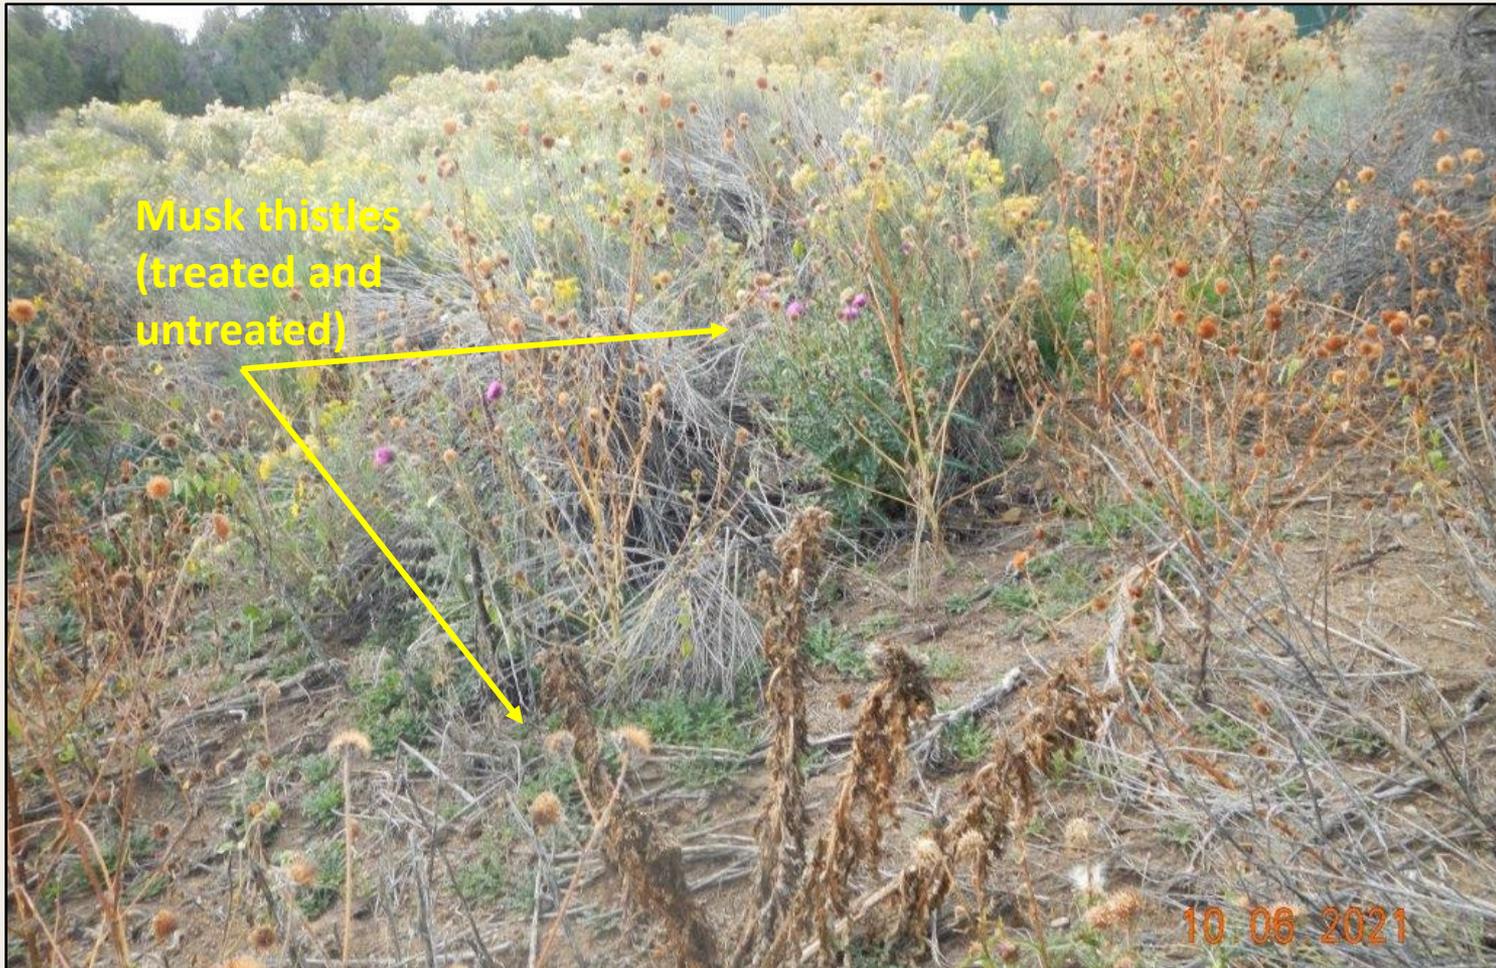
Photo 2. View of the eastern fill slope facing southward. Revegetation is progressing with crested wheatgrass, smooth brome, and rubber rabbitbrush. Musk thistles are partially treated. However, approximately 50 surviving individuals observed. Many in flowering condition.

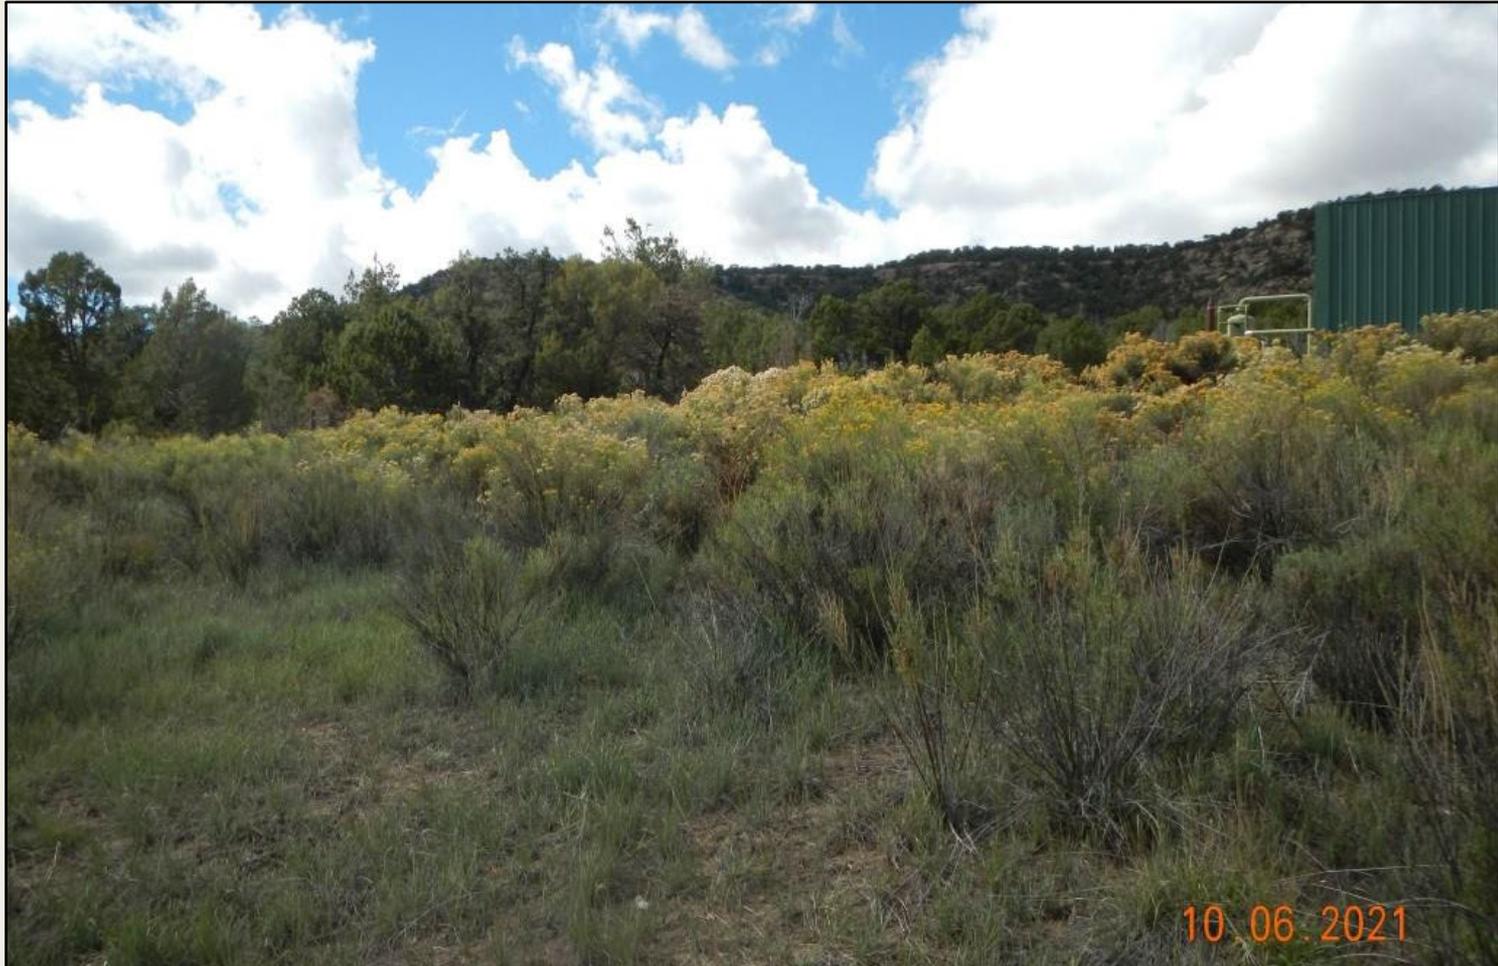
Photo 3. View of the southern project area from the southeastern corner facing westward.

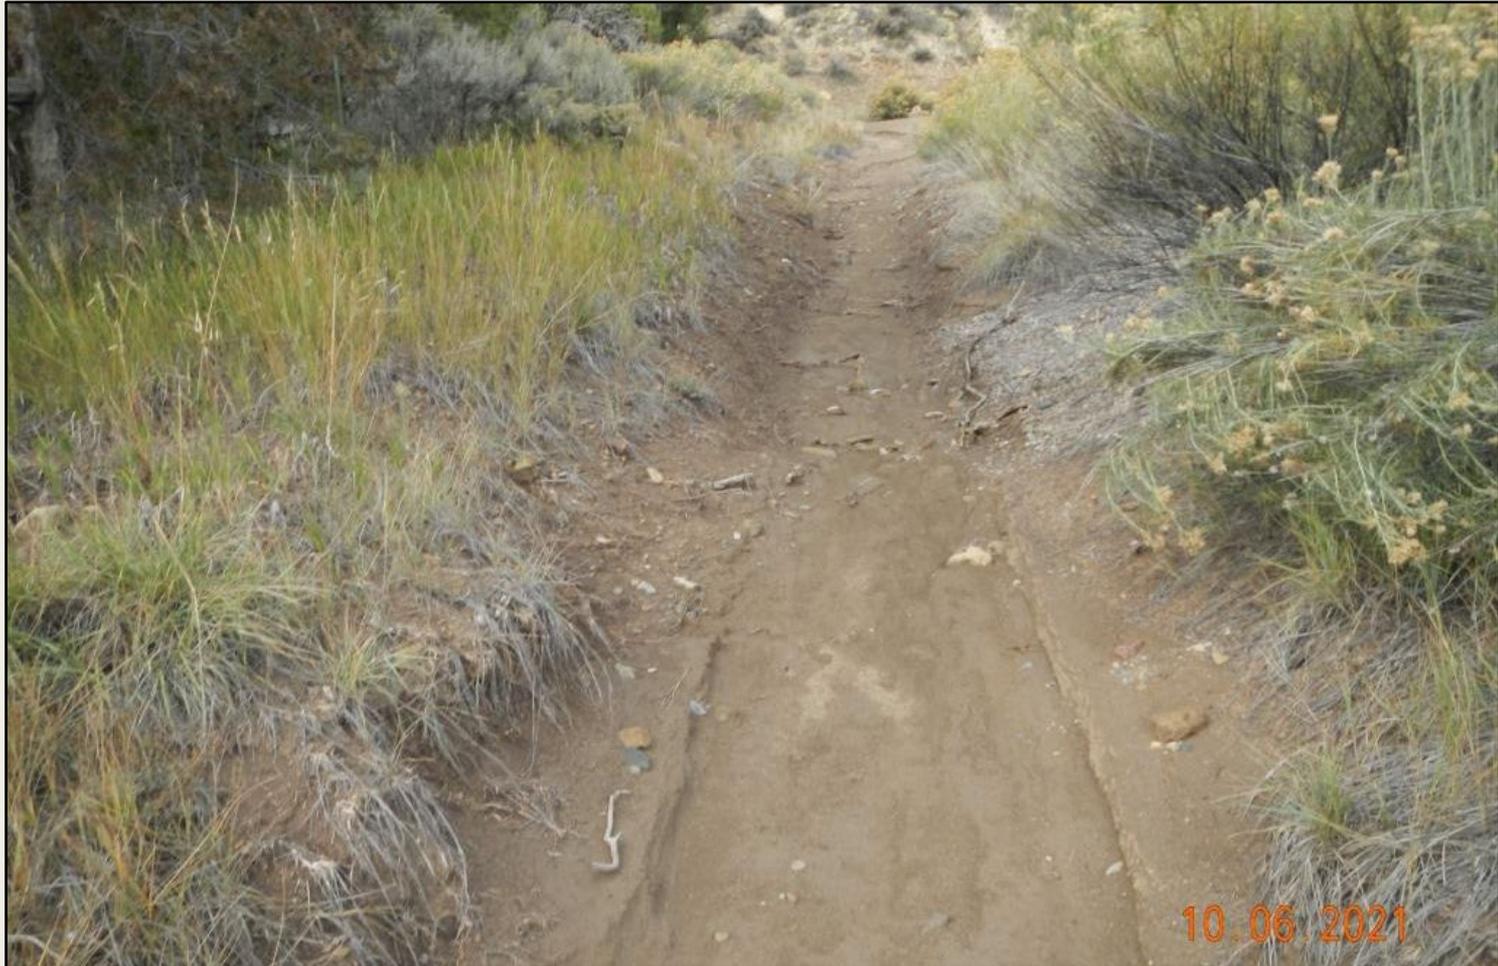
Photo 4. View of southern diversion channel, largely full of sediment and eroding. BMPs need to de-energize channel where velocities are high, and sediment needs to be contained.

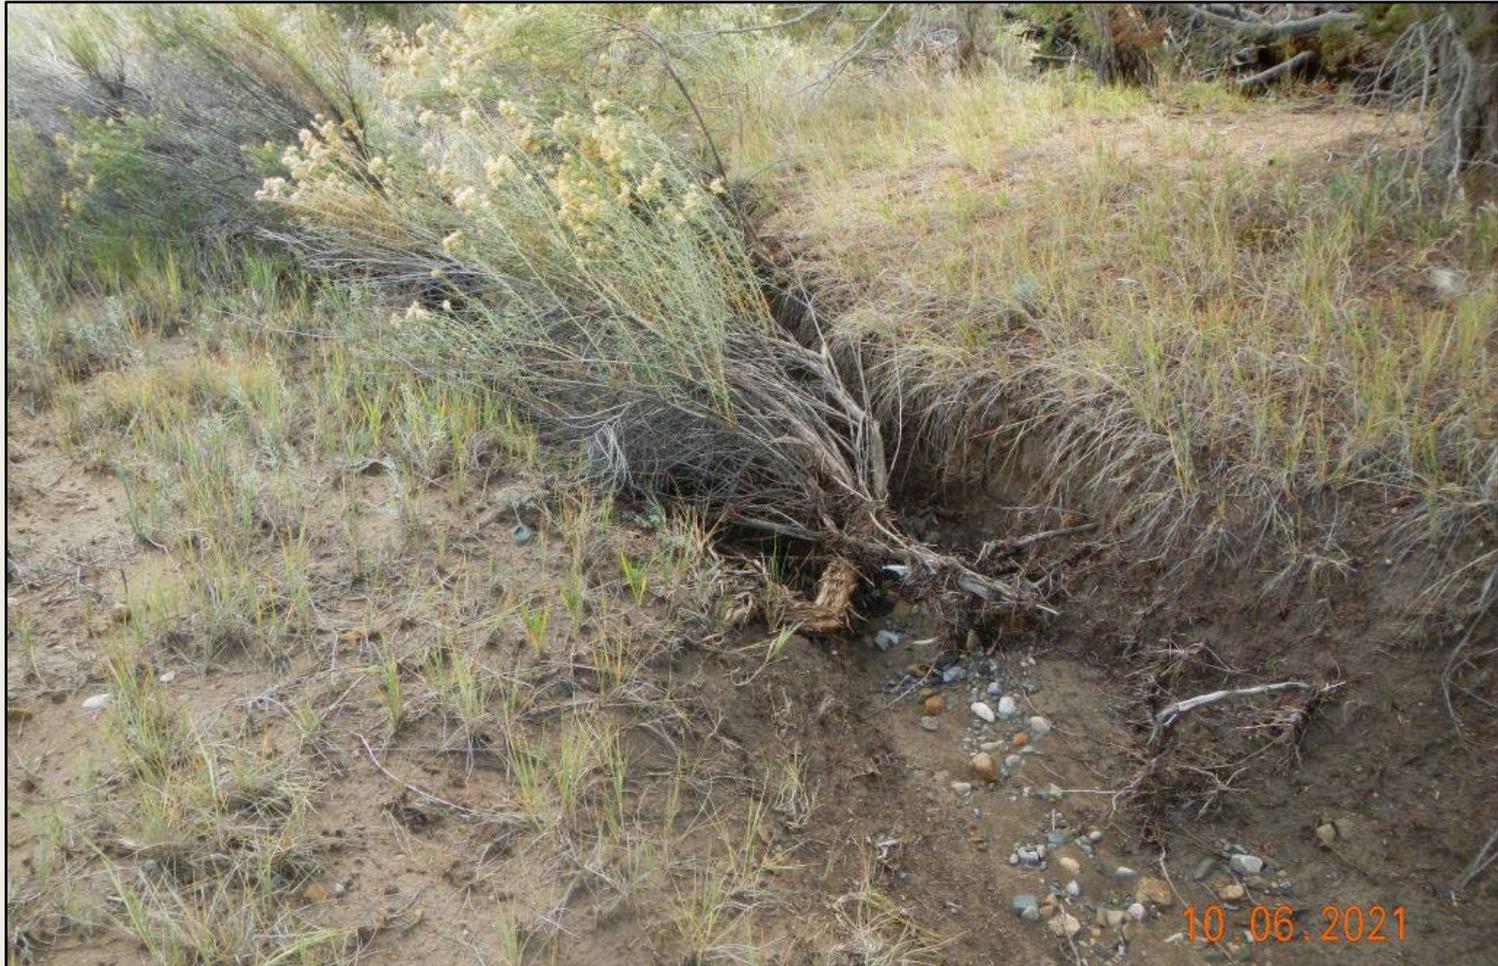
Photo 5. View of erosional channel (approx. 2-3ft wide and deep) in the southeastern project area where it flows off of the well pad, facing downstream. Downcutting is occurring.

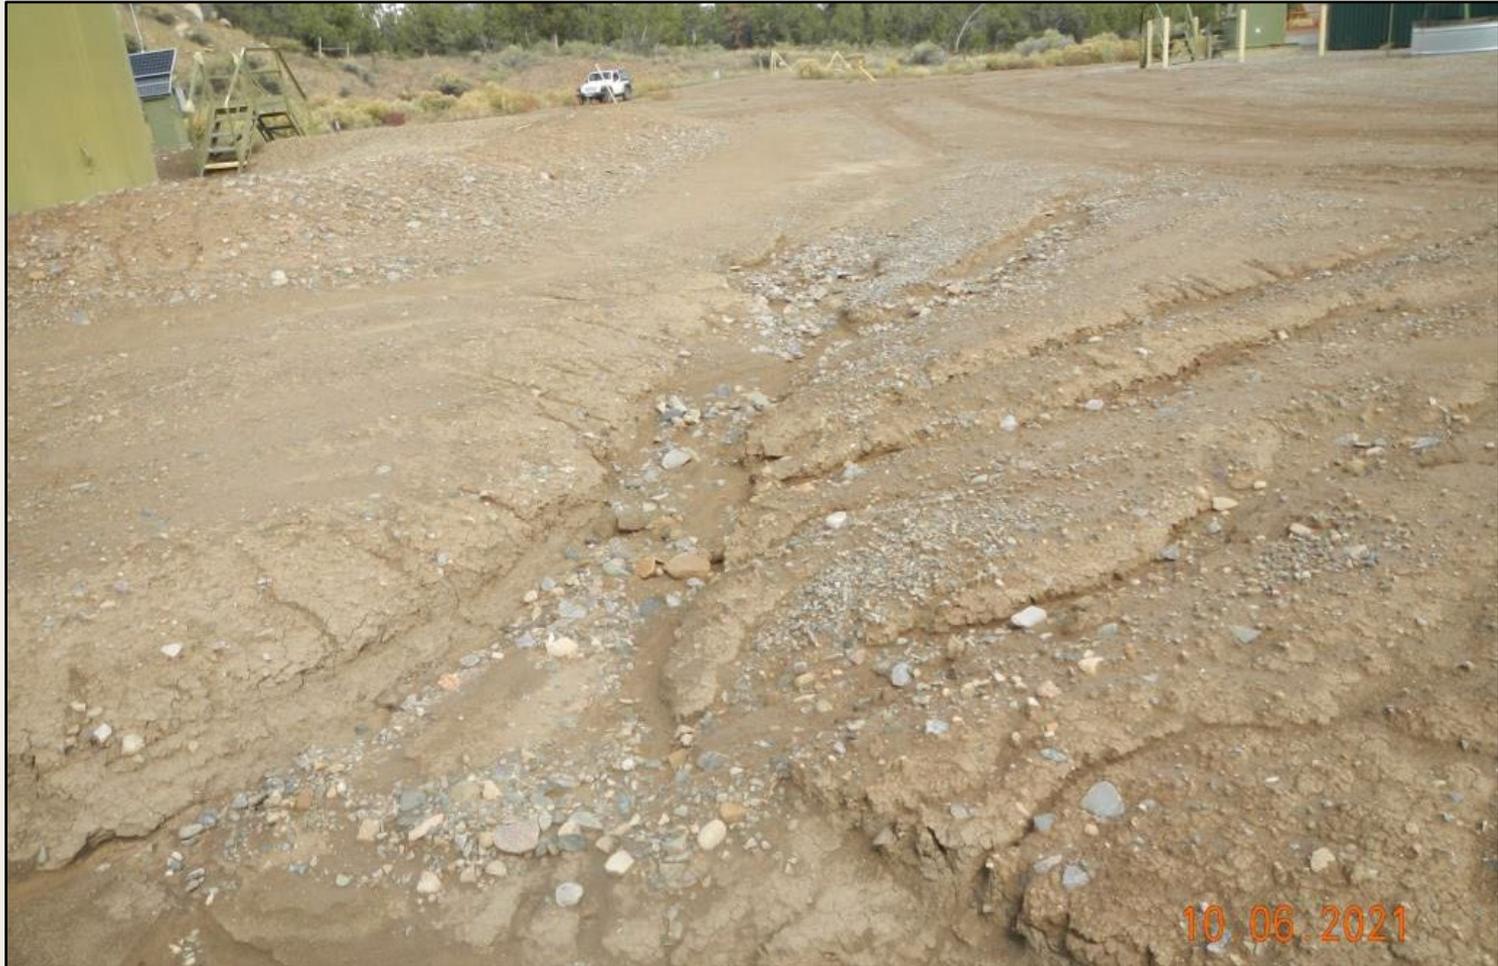
Photo 6. View of area on the southern well pad where stormwater flows off of the well pad toward diversion in photos 4 and 5.

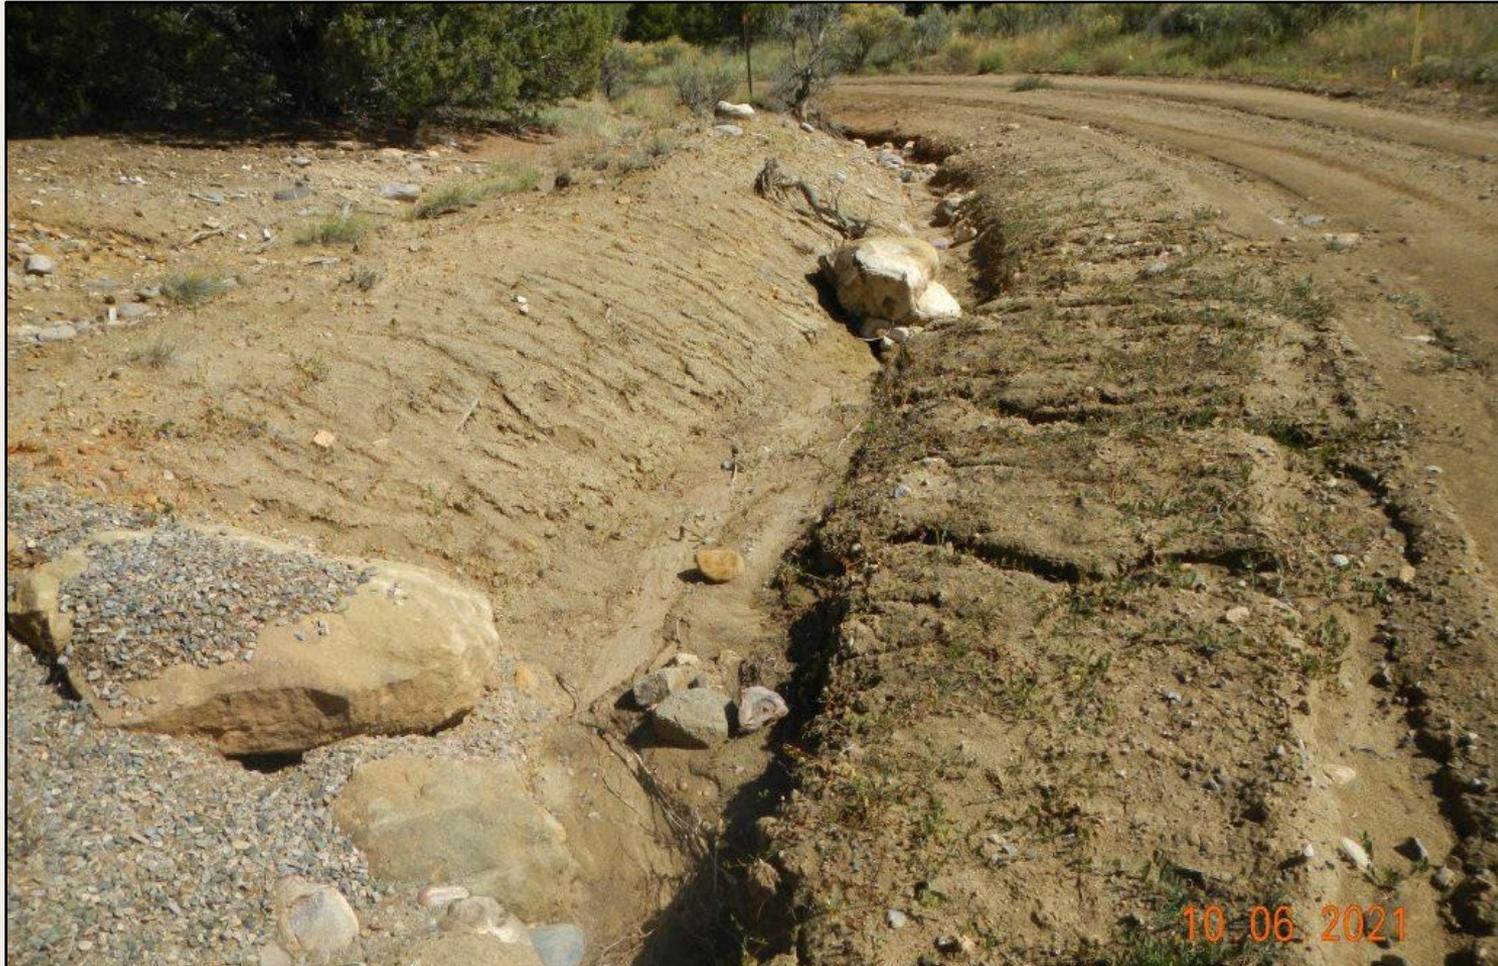
Photo 7. View of erosional channel along the access road. Stabilization is needed on the bed and banks of roadside diversions.
