Inspection Photos
Location Name: MDM 33-14
Location ID: 331806

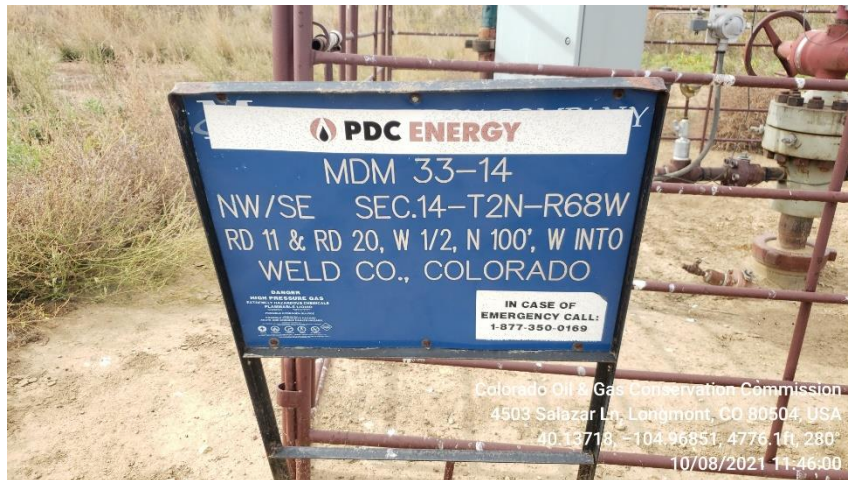
Photo 1 WH sign

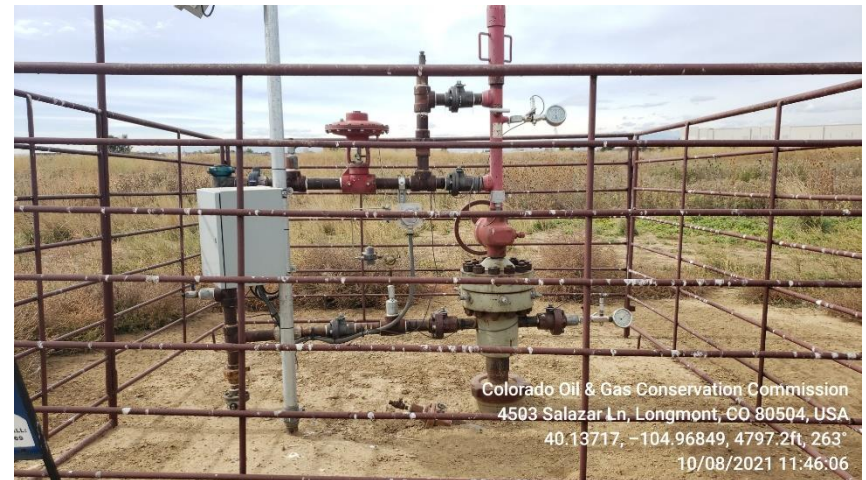
Photo 2 WH

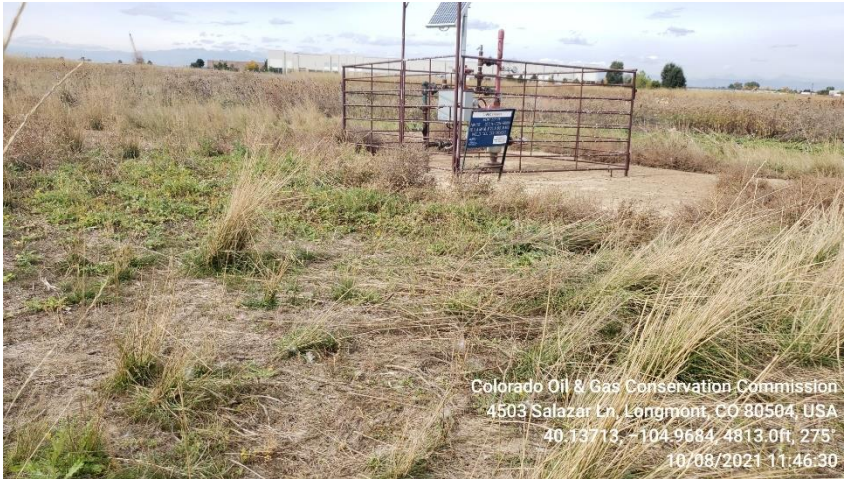
Photo 3 Weeds growing all around location ROW

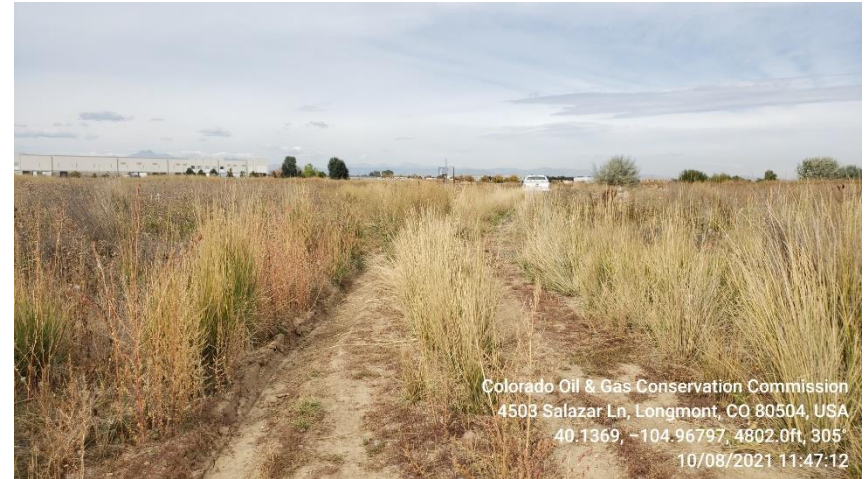
Photo 4 Weeds growing along access road

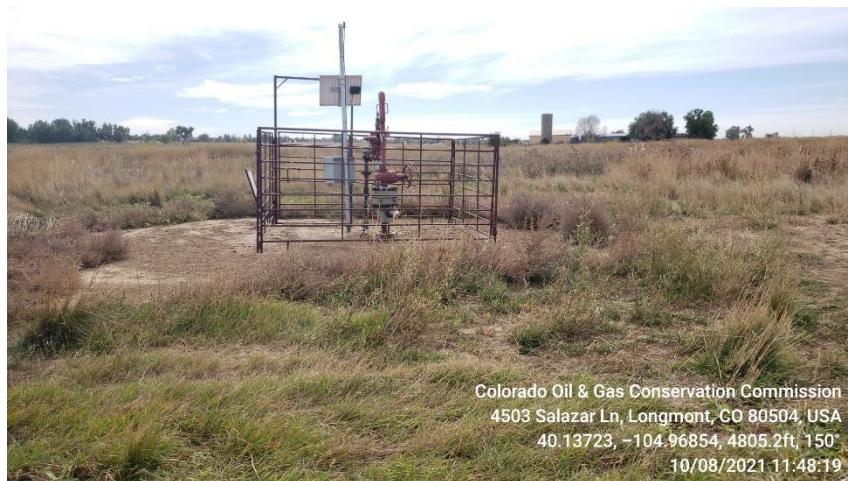
Photo 5 Weeds growing all around location ROW

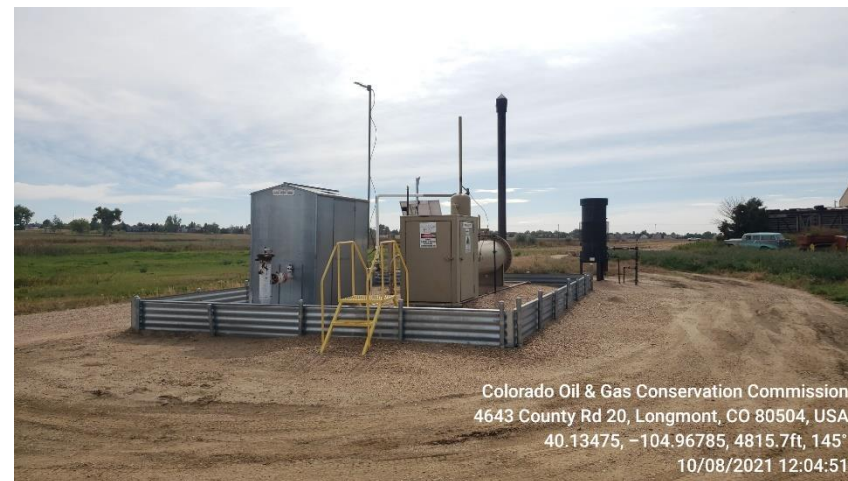
Photo 6 ECD, Horiz. Heated Sep.

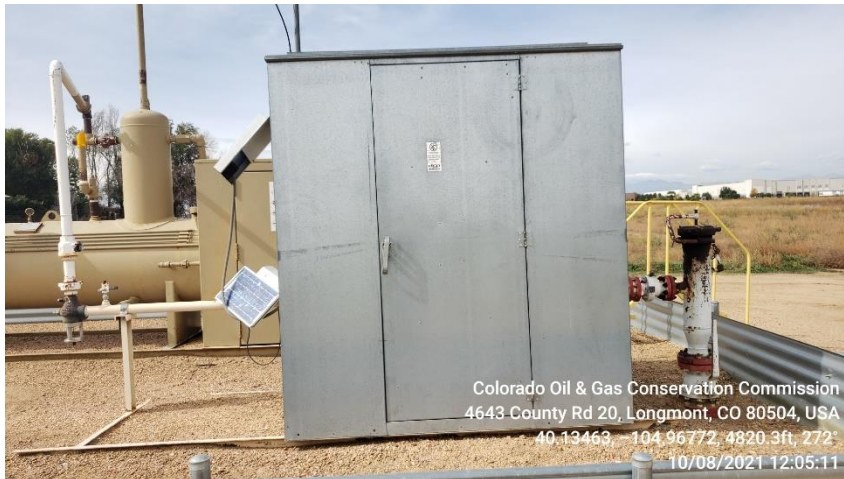
Photo 7 Gas Meter Run

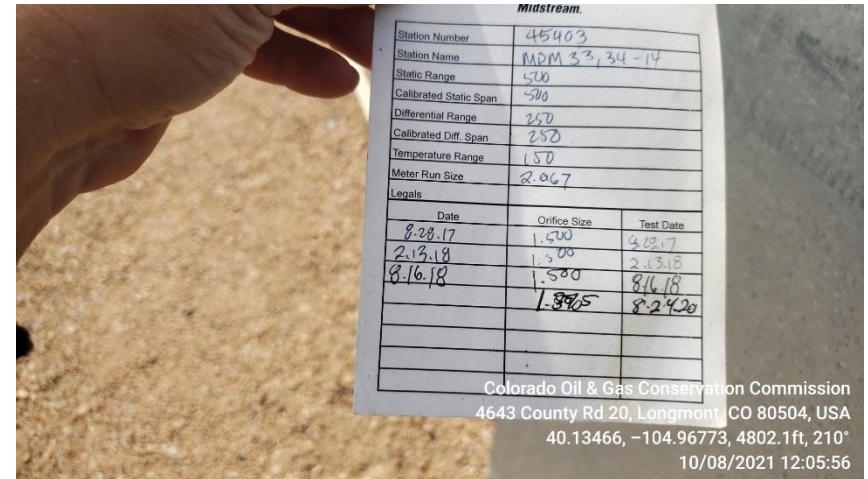
Photo 8 Card in meter house indicates that calibration is not current

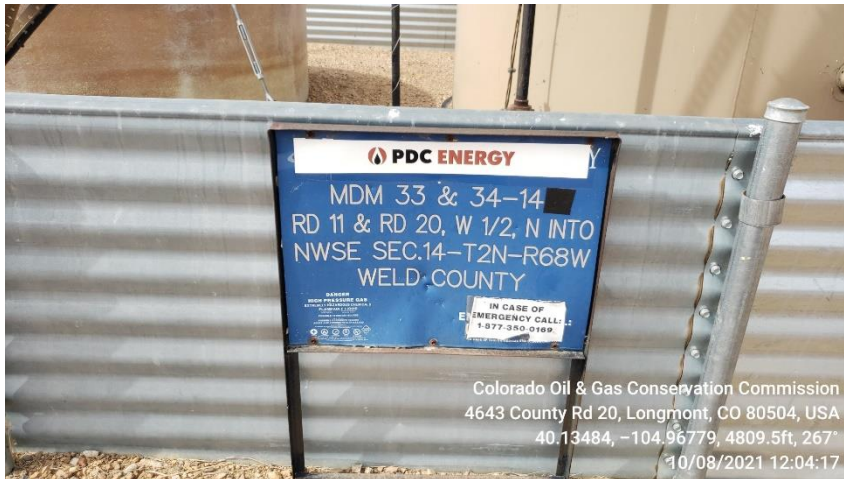
Photo 9 TB sign

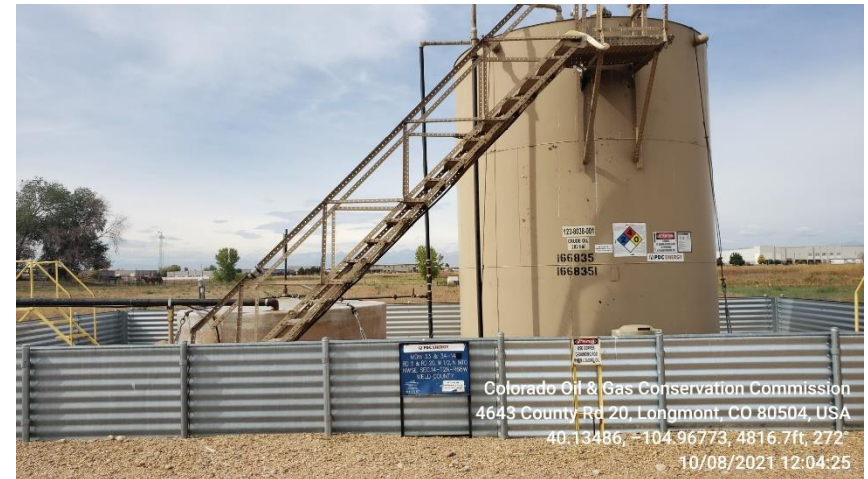
Photo 10 TB
