Caerus Piceance LLC
K28NW
Location # 335428

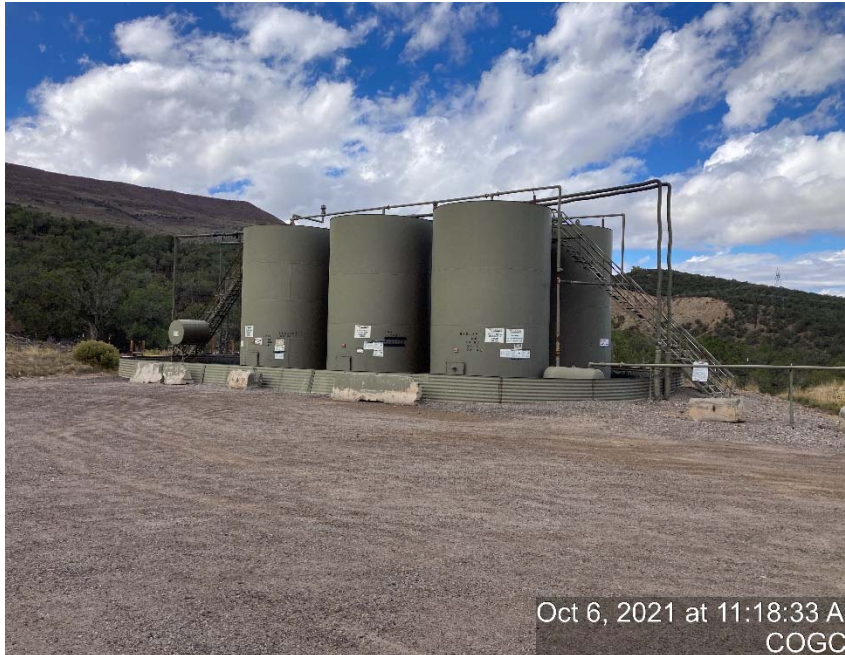
Location/ lack of battery signage

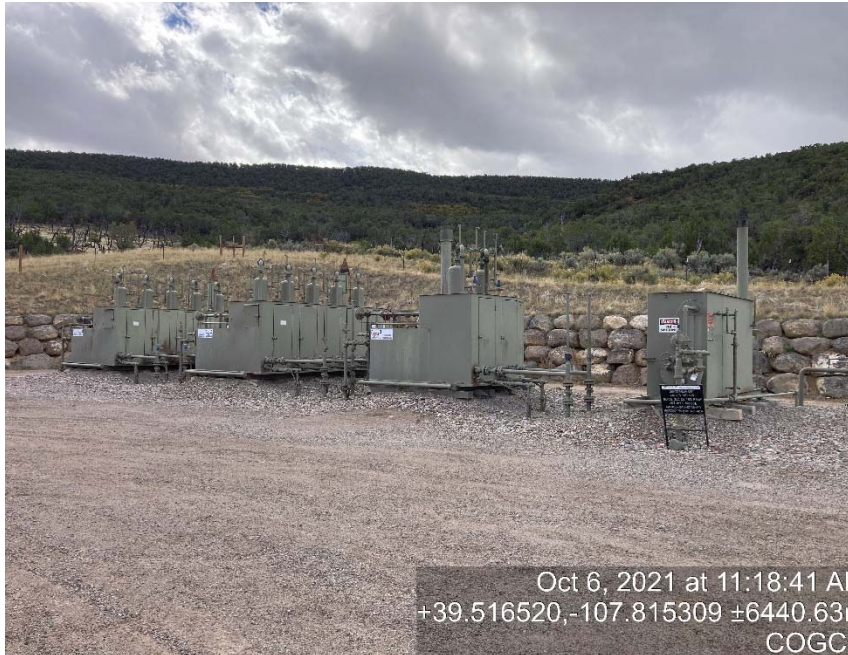
Location/ lack of labeling on glycol vessels

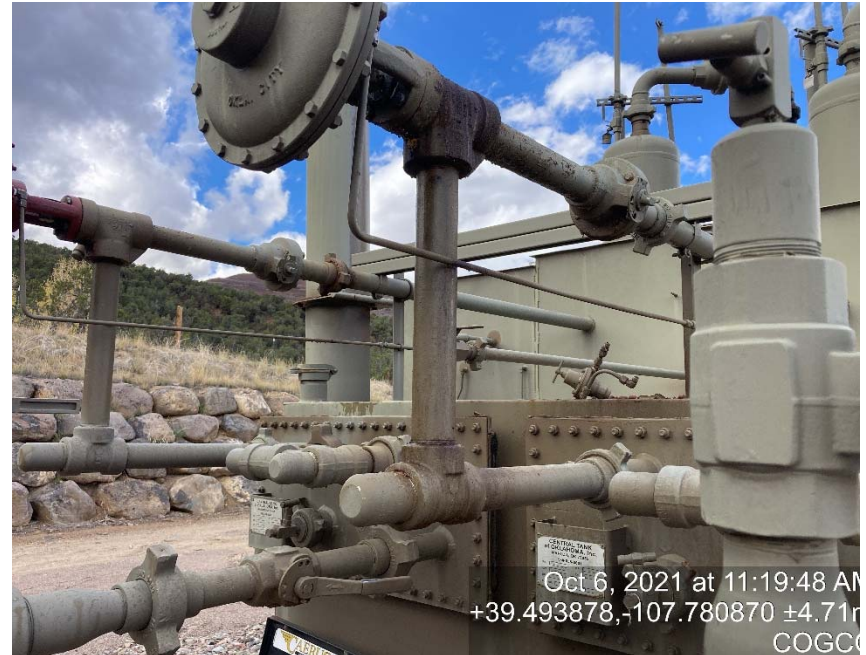
Leaking A-valve or angle body

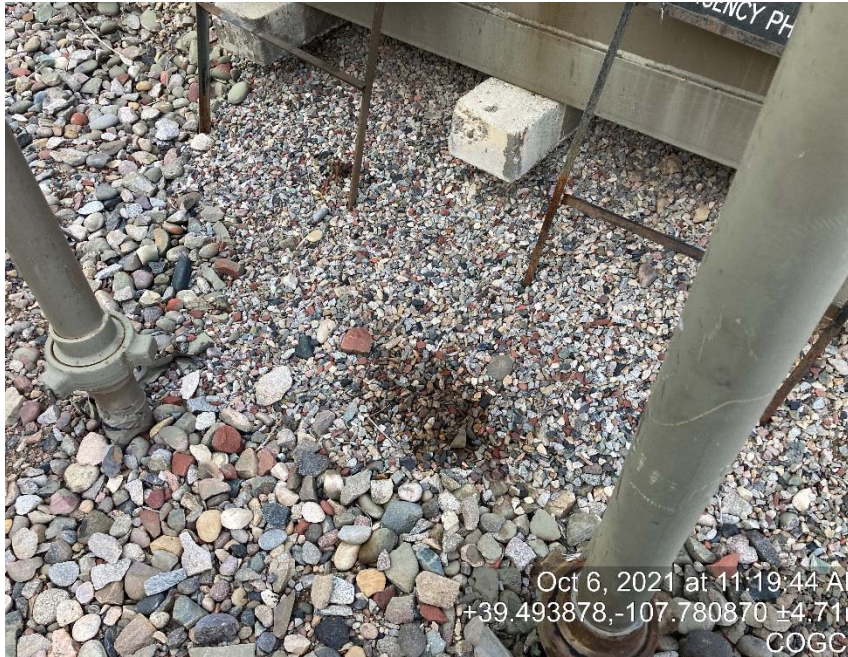
Staining under leaking A-valve

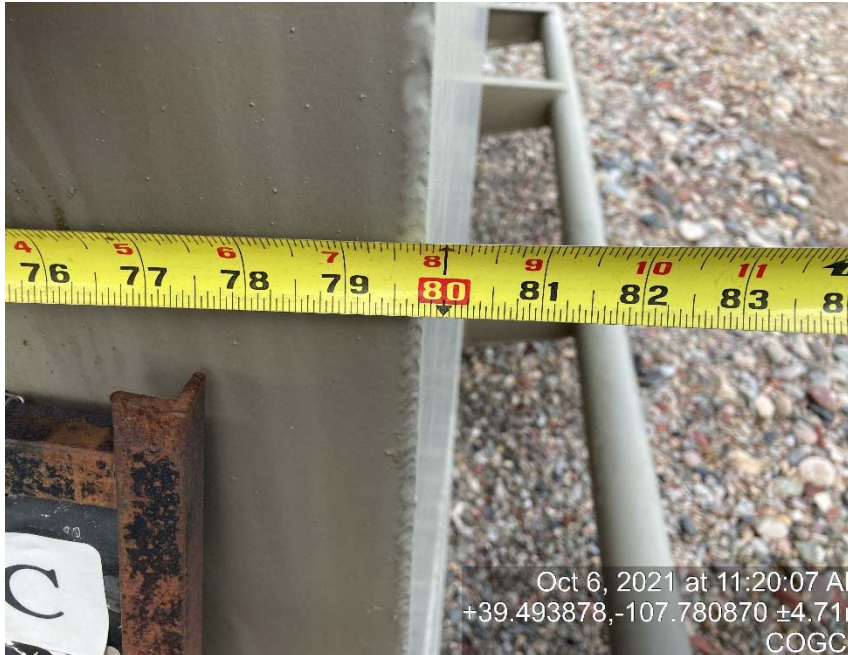
Glycol vessel dimensions

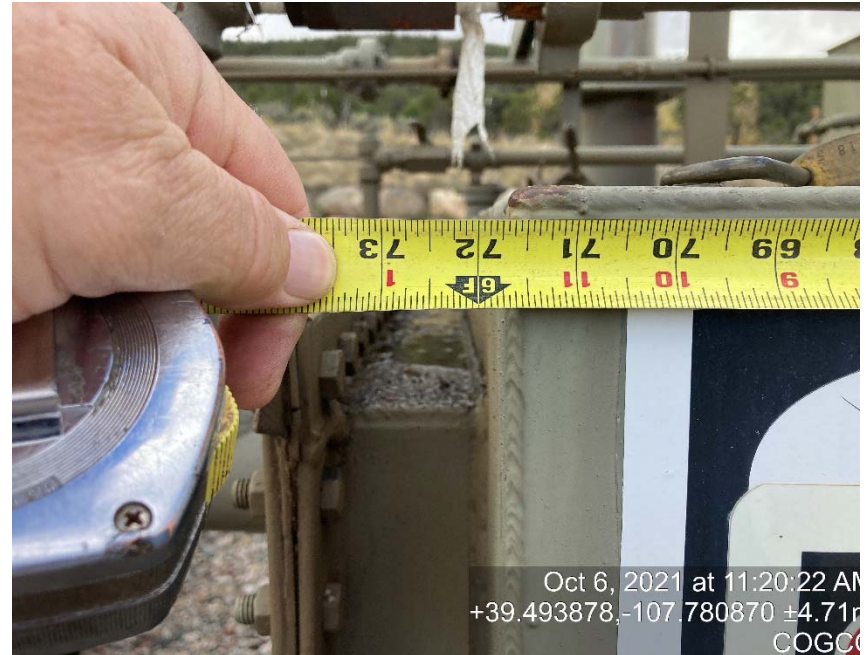
Glycol vessel dimensions

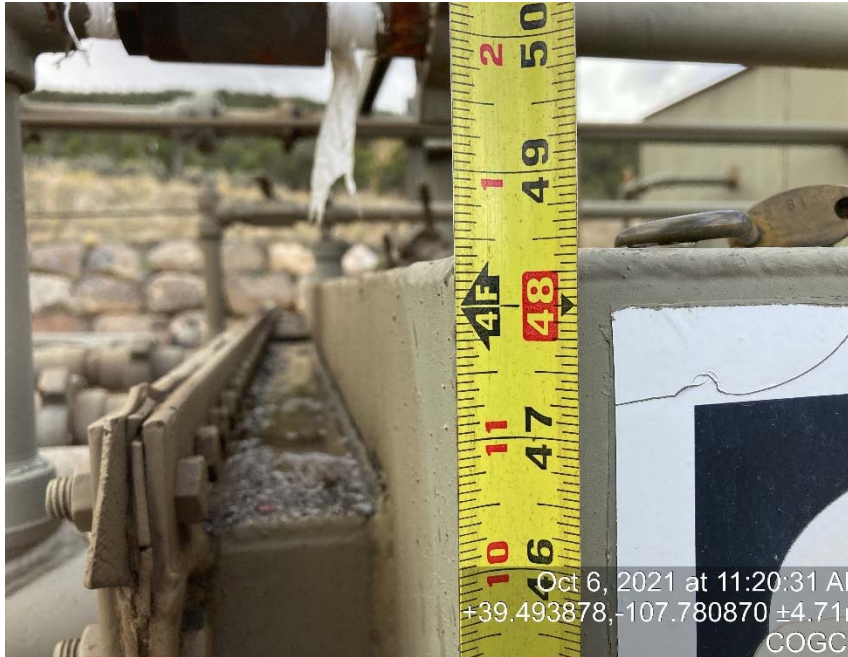
Glycol vessel dimensions

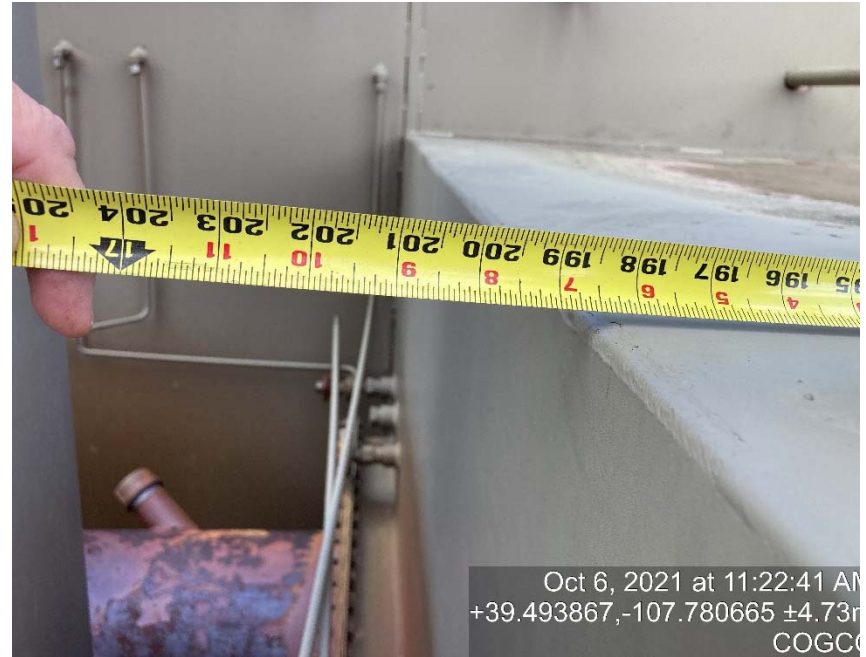
Glycol vessel dimensions

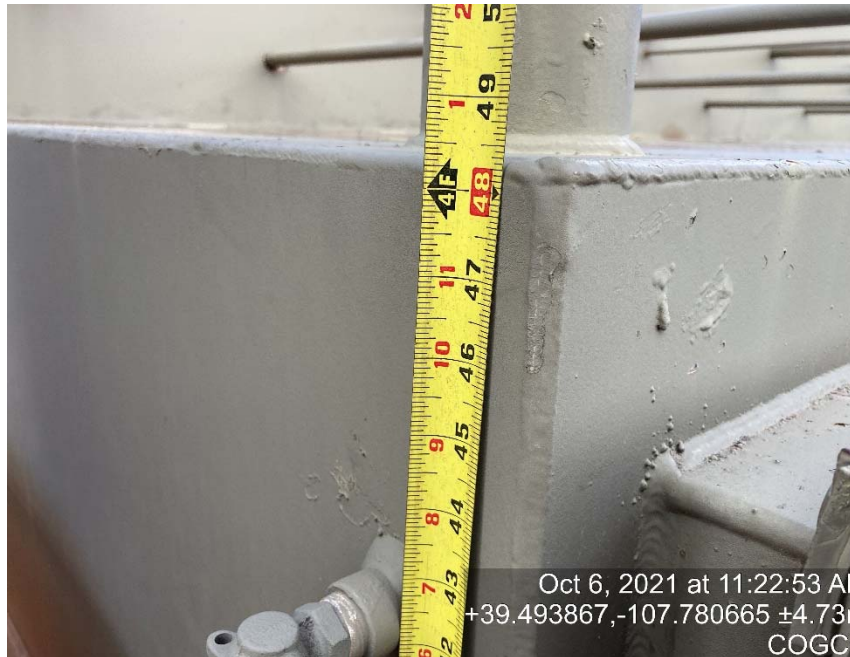
Glycol vessel dimensions

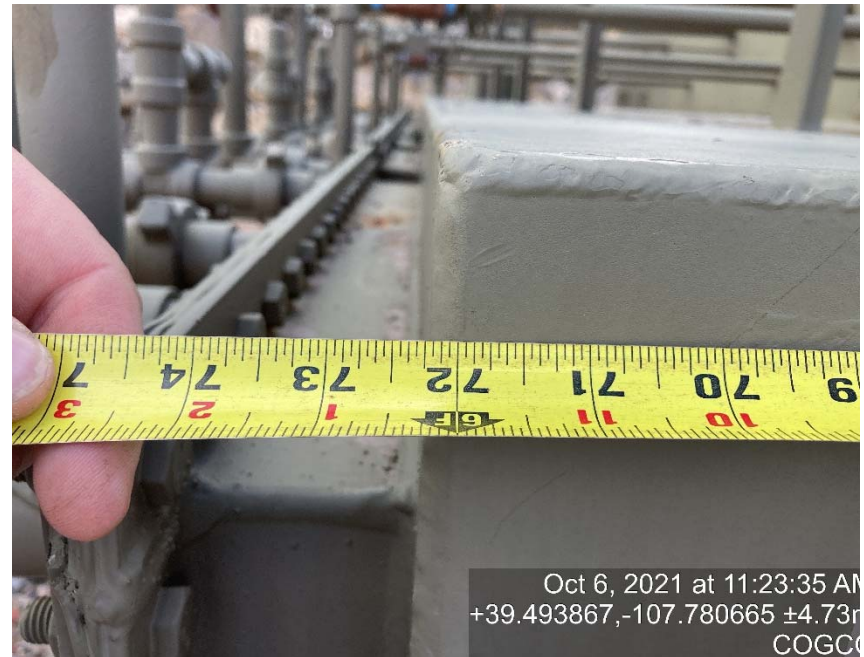
Glycol vessel dimensions
