Inspection Photos

Location Name: CAERUS PICEANCE LLC DAYBREAK FEDERAL-67S95W /30SWNE

Location ID: 334657

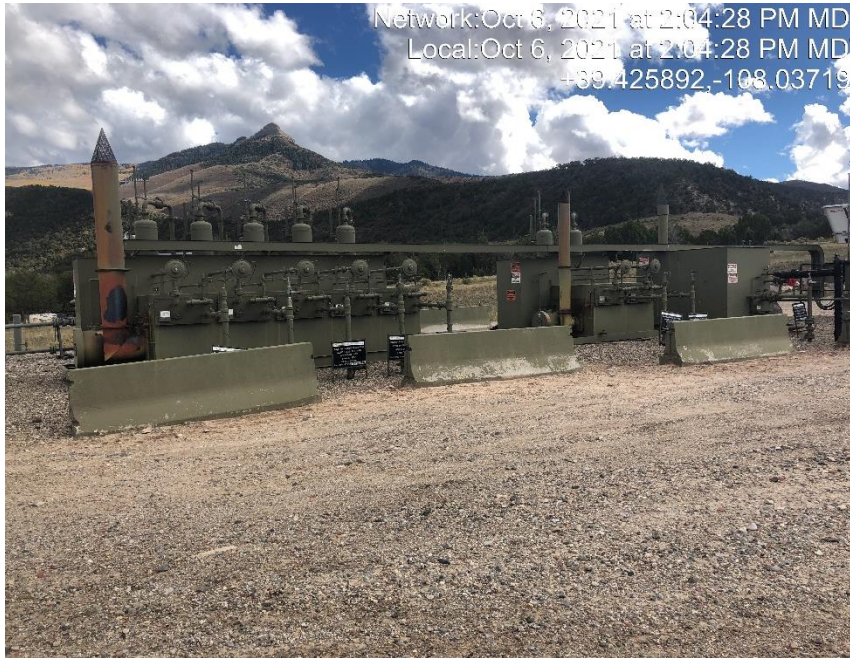
Photo #5021 from entrance to location.

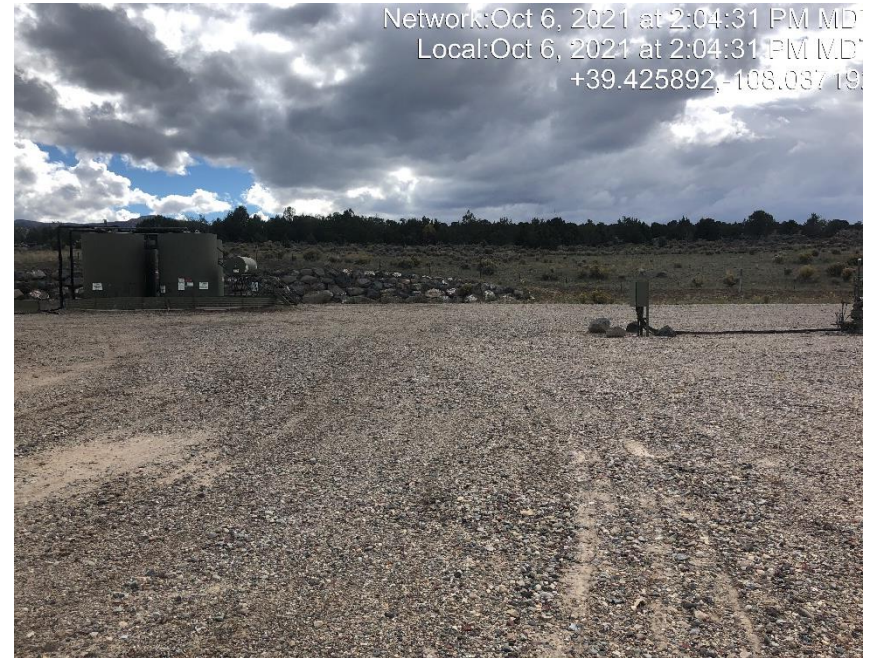
Photo #5022 from entrance to location.

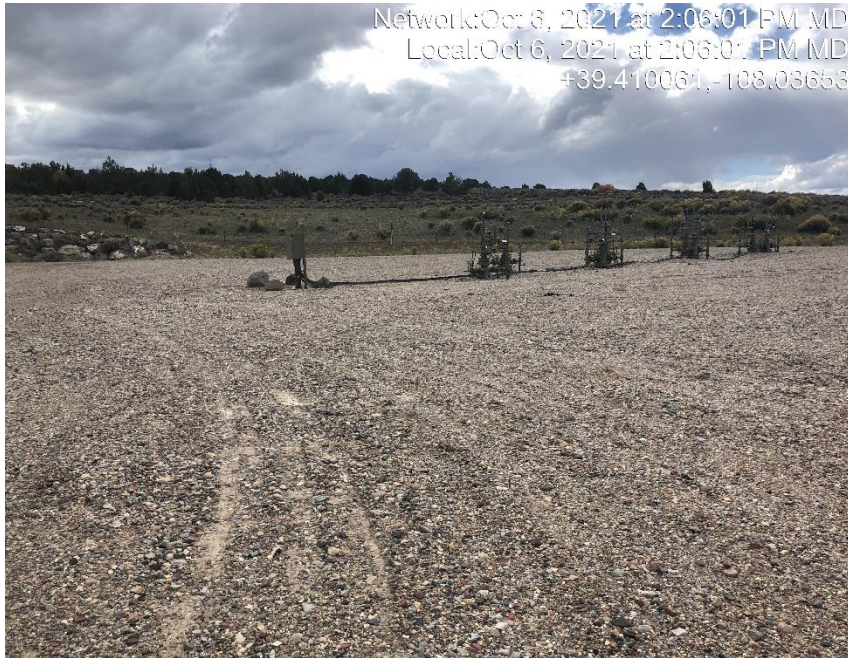
Photo #5023 from entrance to location.

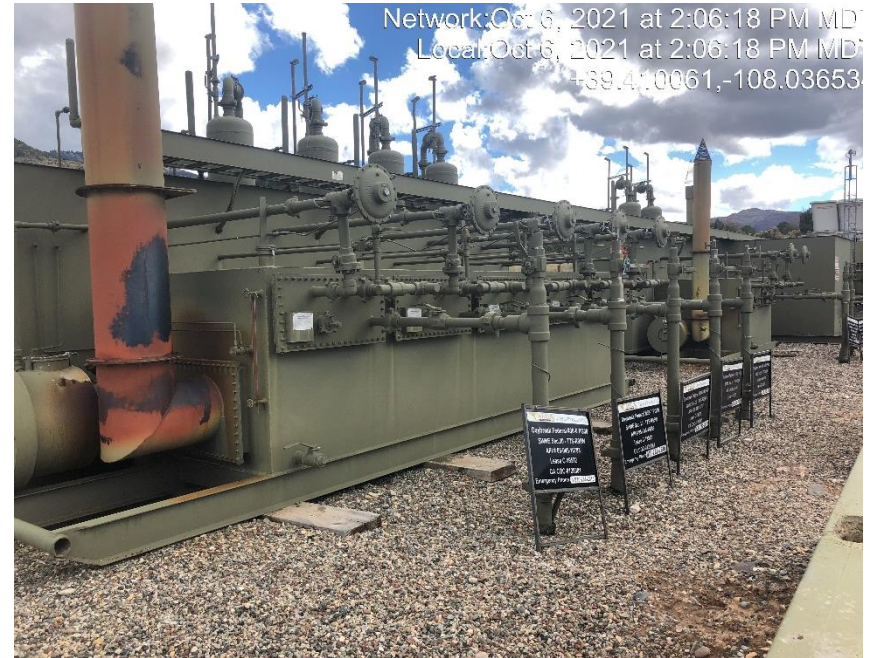
Photo #5024 Glycol storage tank missing required information.

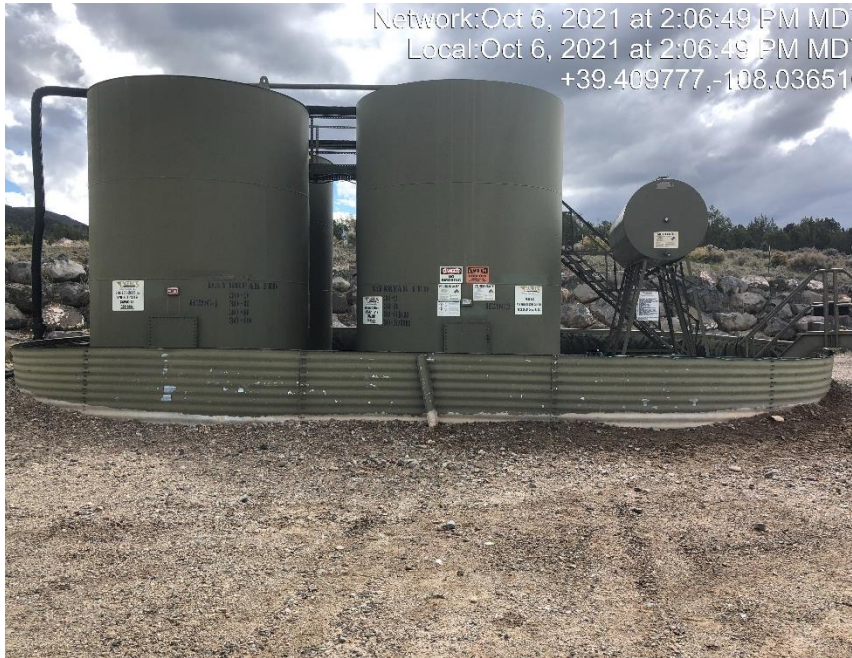
Photo #5025 No battery sign located at the tank battery.

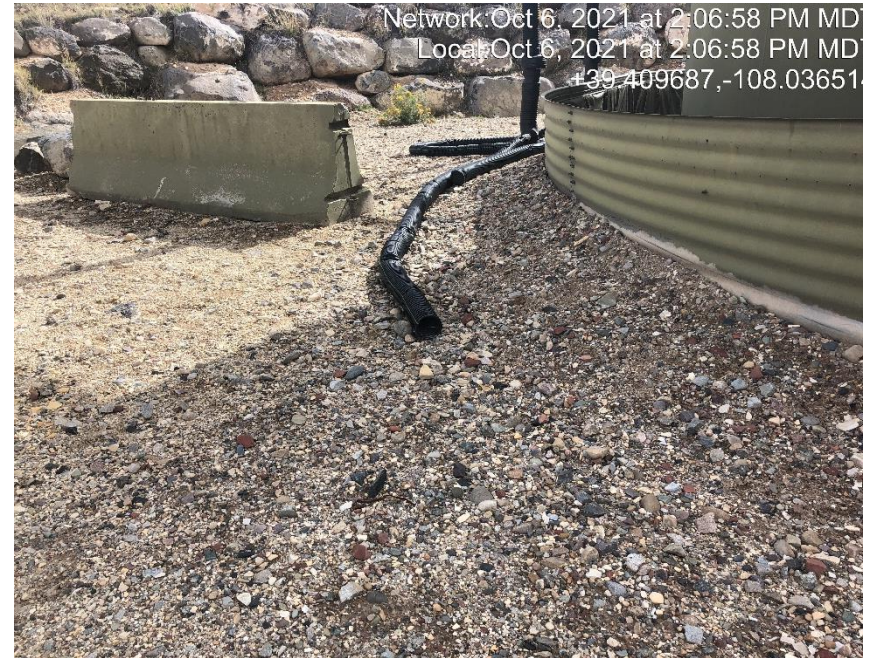
Photo #5026 Flowline heating insulation open ended and not capped.
