Inspection Photos  
Location Name: MSSU 30-7  
API #069-06095

**Form 21**

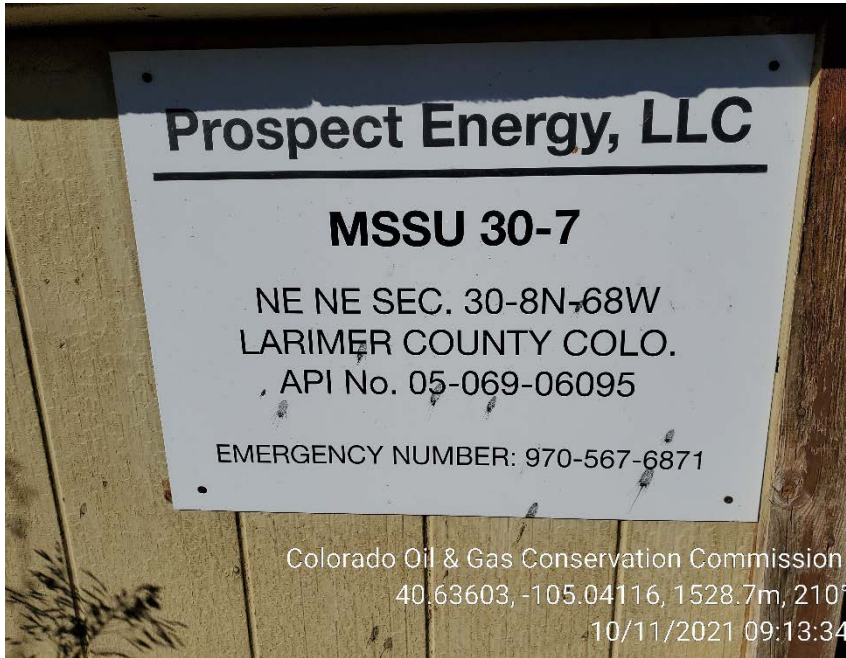
Wellhead sign

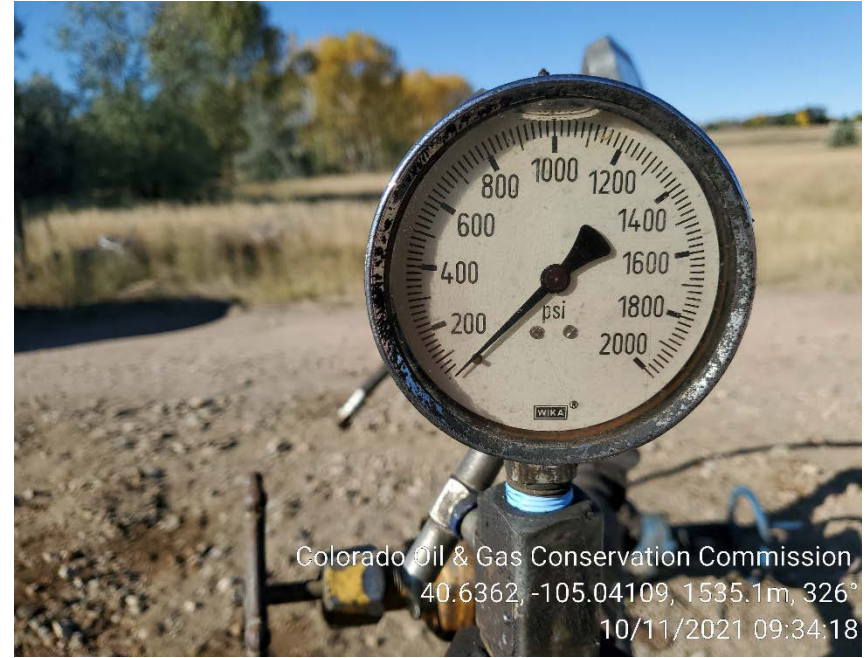
Initial tubing pressure

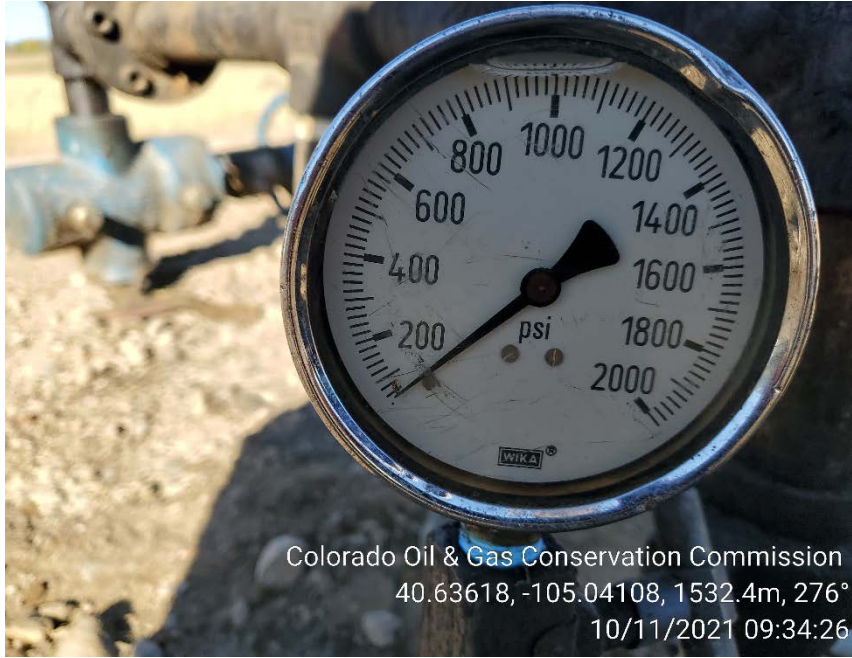
Initial casing pressure

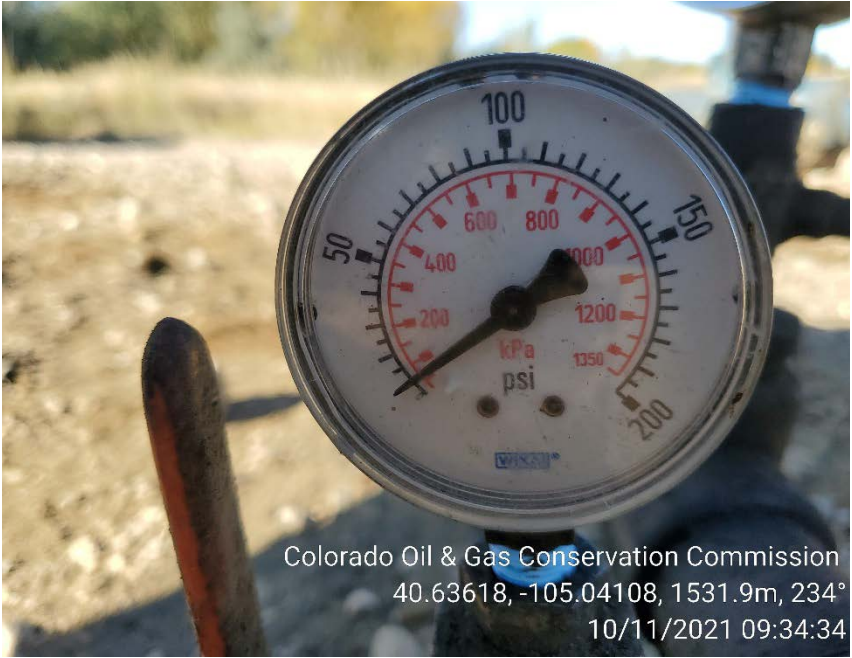
Initial Bradenhead pressure

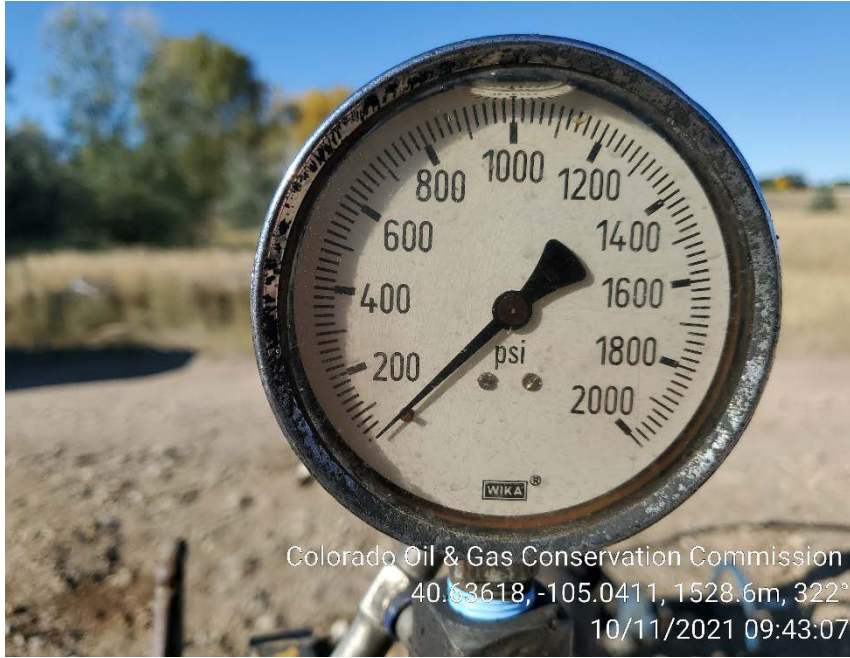
5 minute tubing pressure

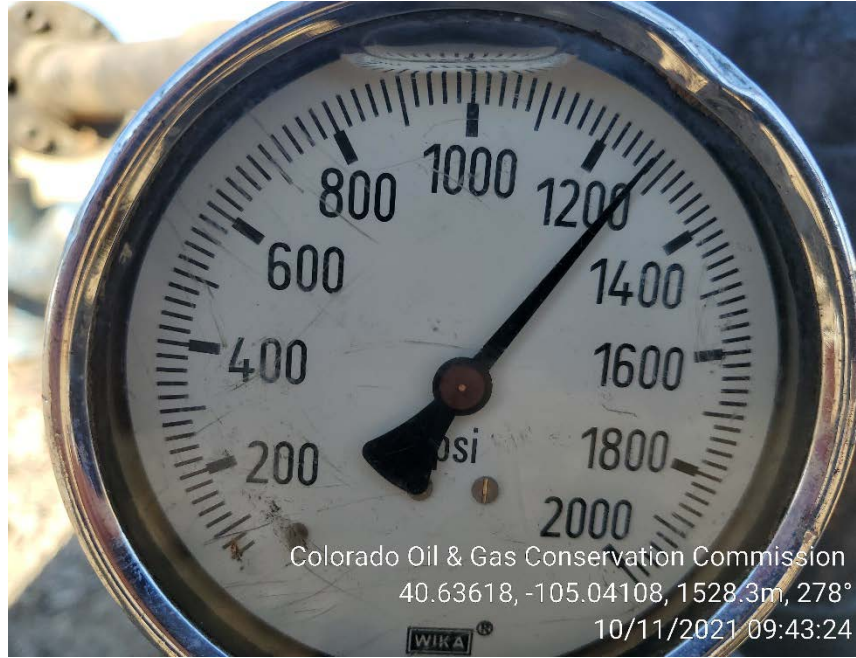
5 minute casing pressure

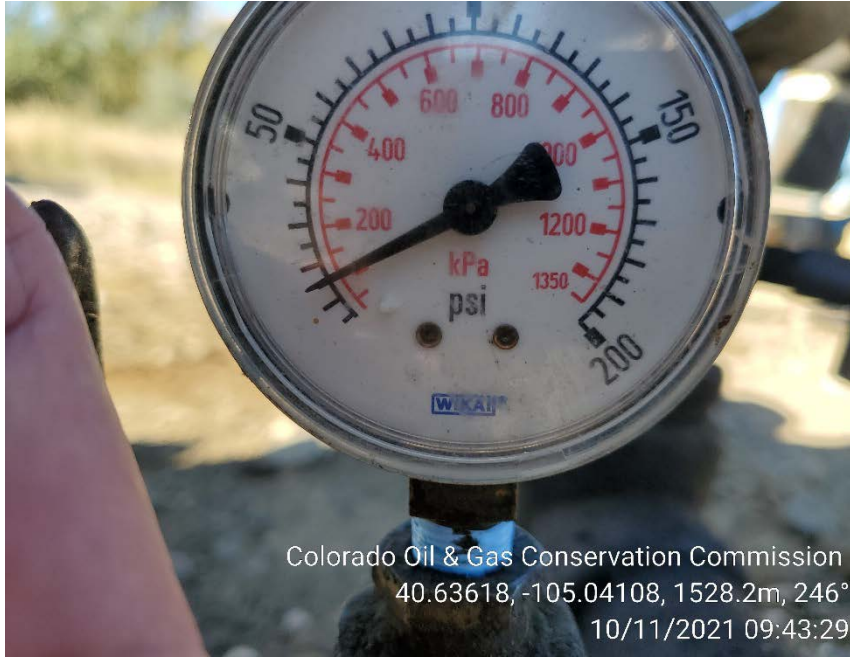
**5 minute Bradenhead pressure**

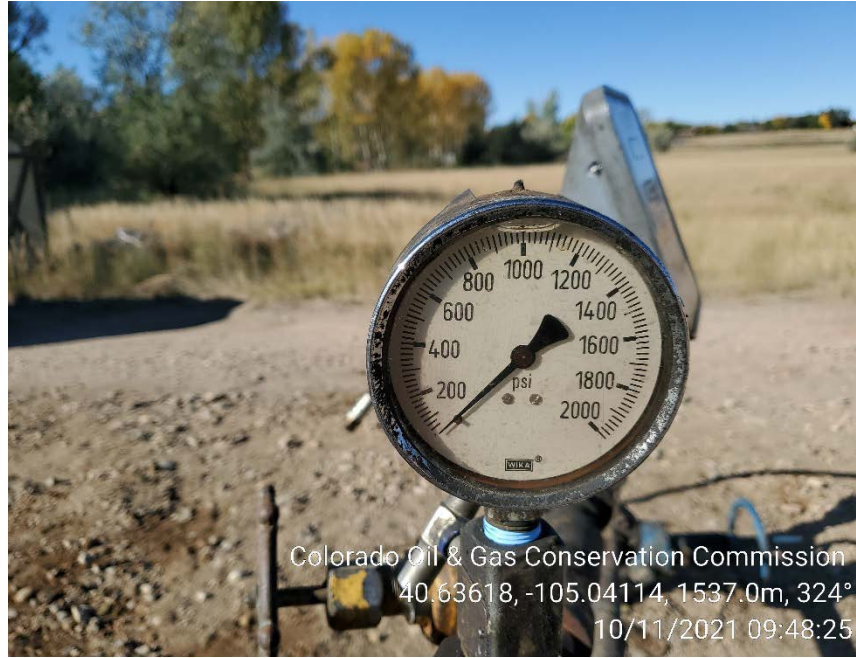
**10 minute tubing pressure**

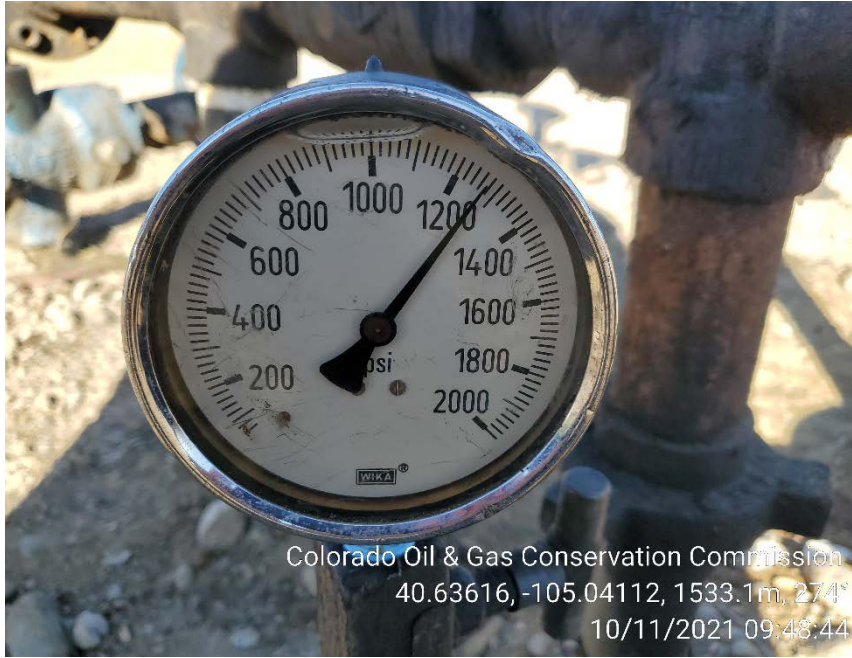
**10 minute casing pressure**

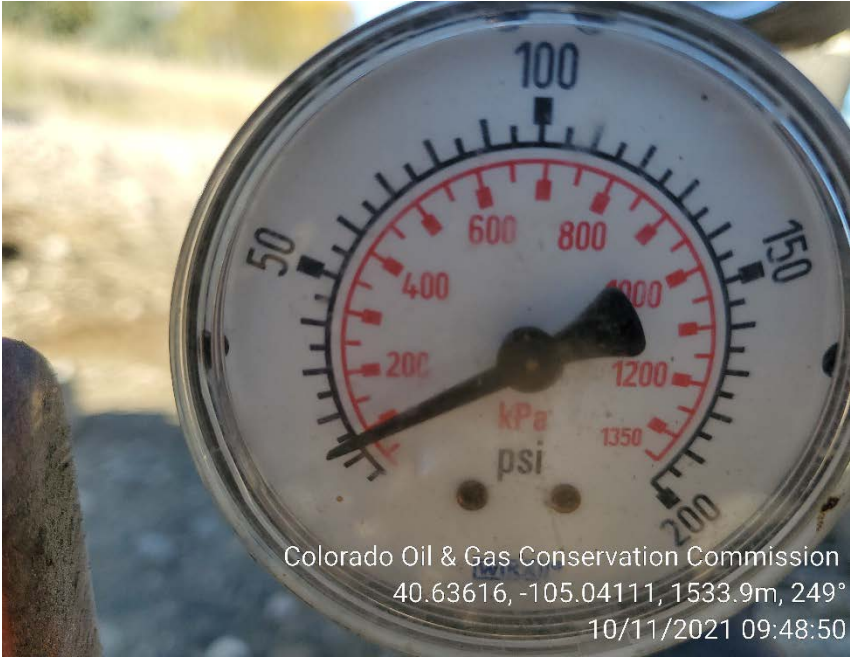
**10 minute Bradenhead pressure**

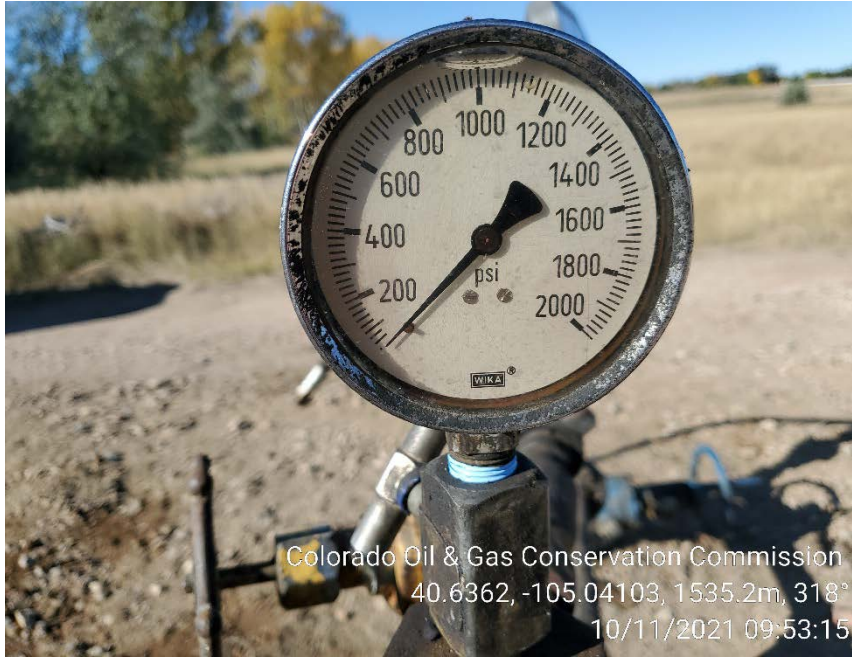
**15 minute tubing pressure**

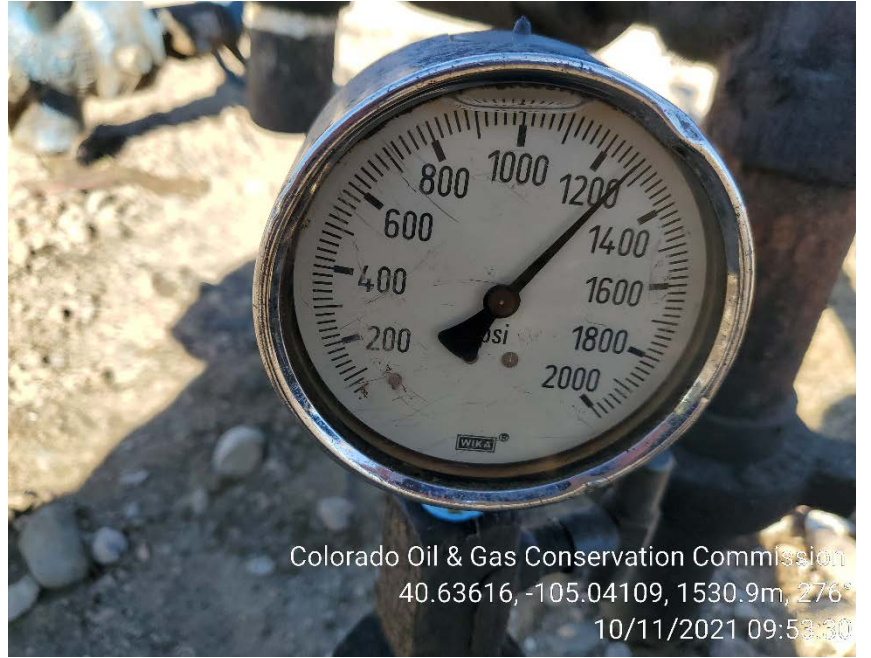
**15 minute casing pressure**

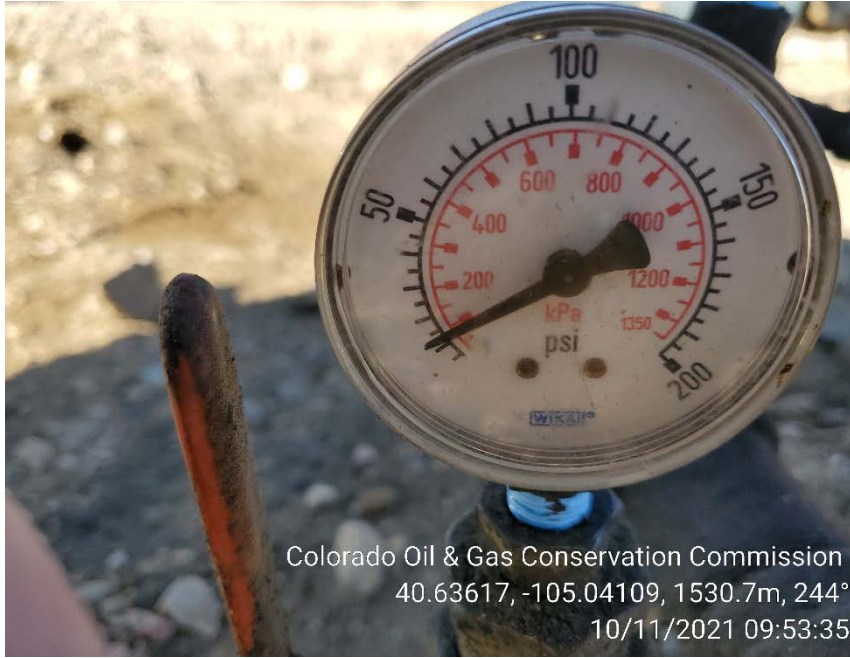
**15 minute Bradenhead pressure**
