# Construction and Stormwater Inspection

Operator: MORNING GUN EXPLORATION LLC #10656

Location ID: 465272

Inspection Document #: 697503330

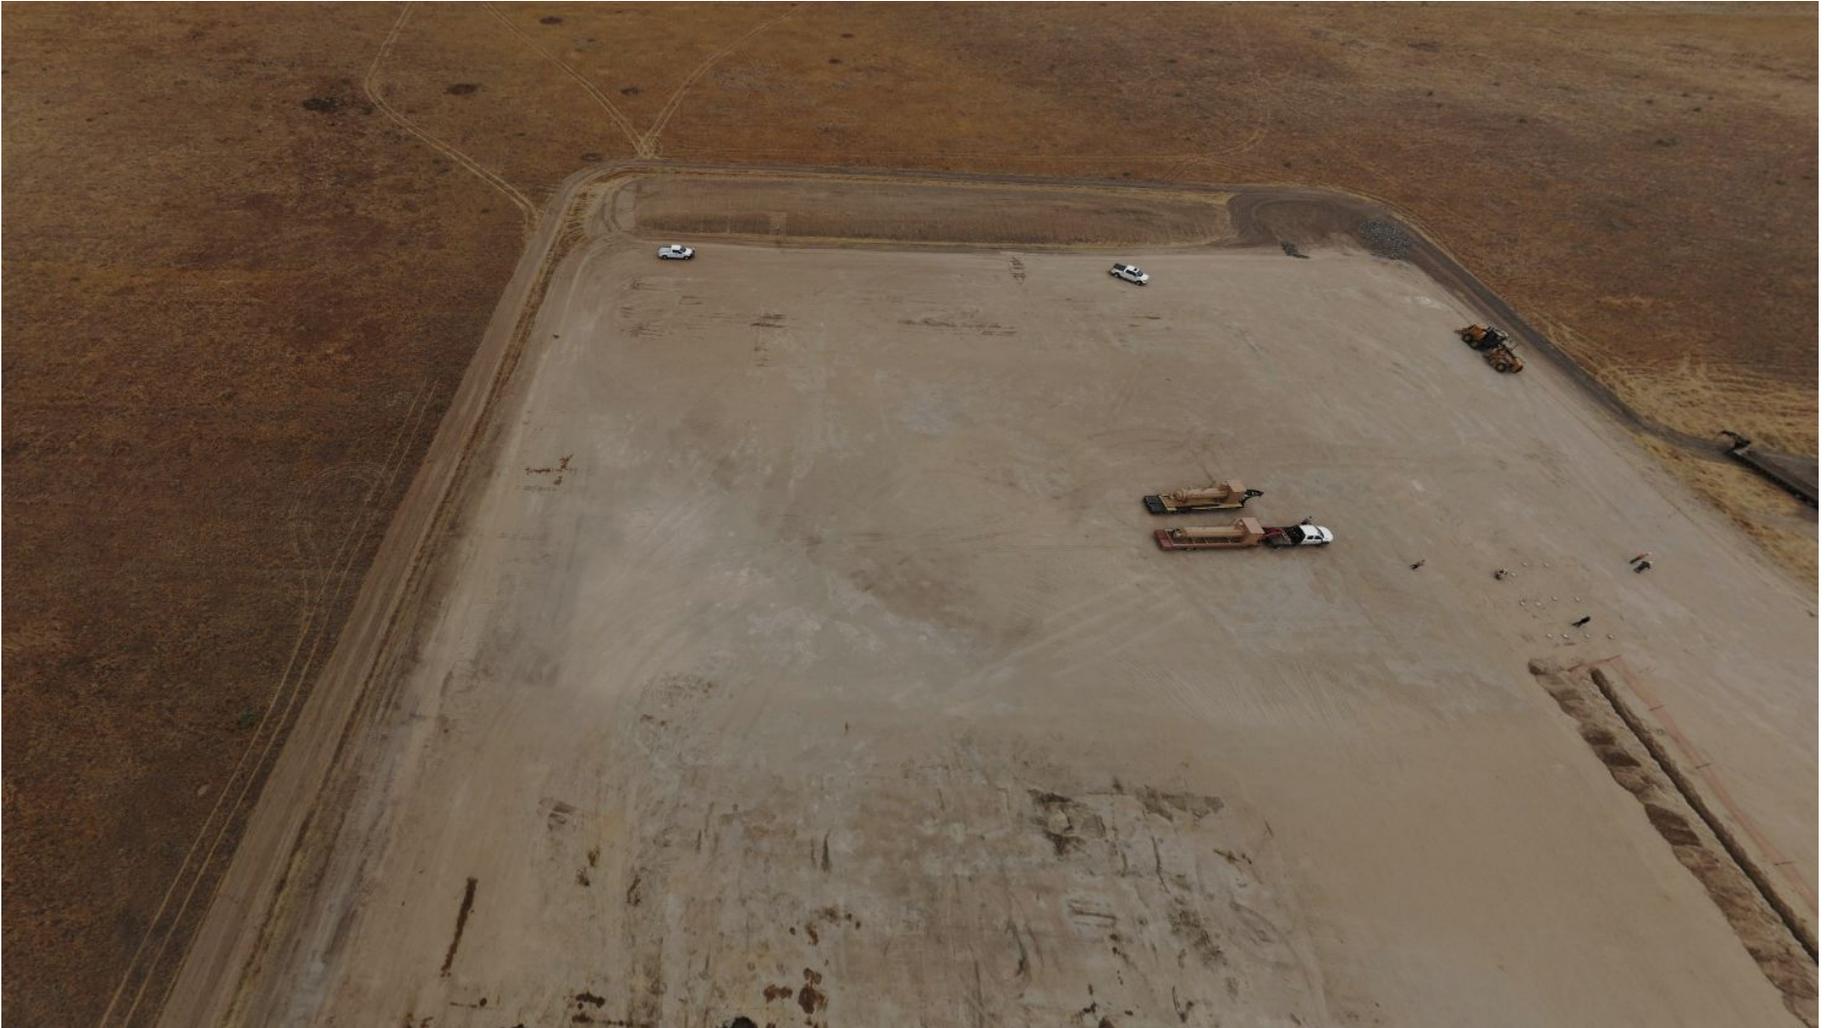
**Photo 2.** Drone aerial imagery taken from location, facing North. Photo illustrates the topsoil stockpile and northeast sediment trap.

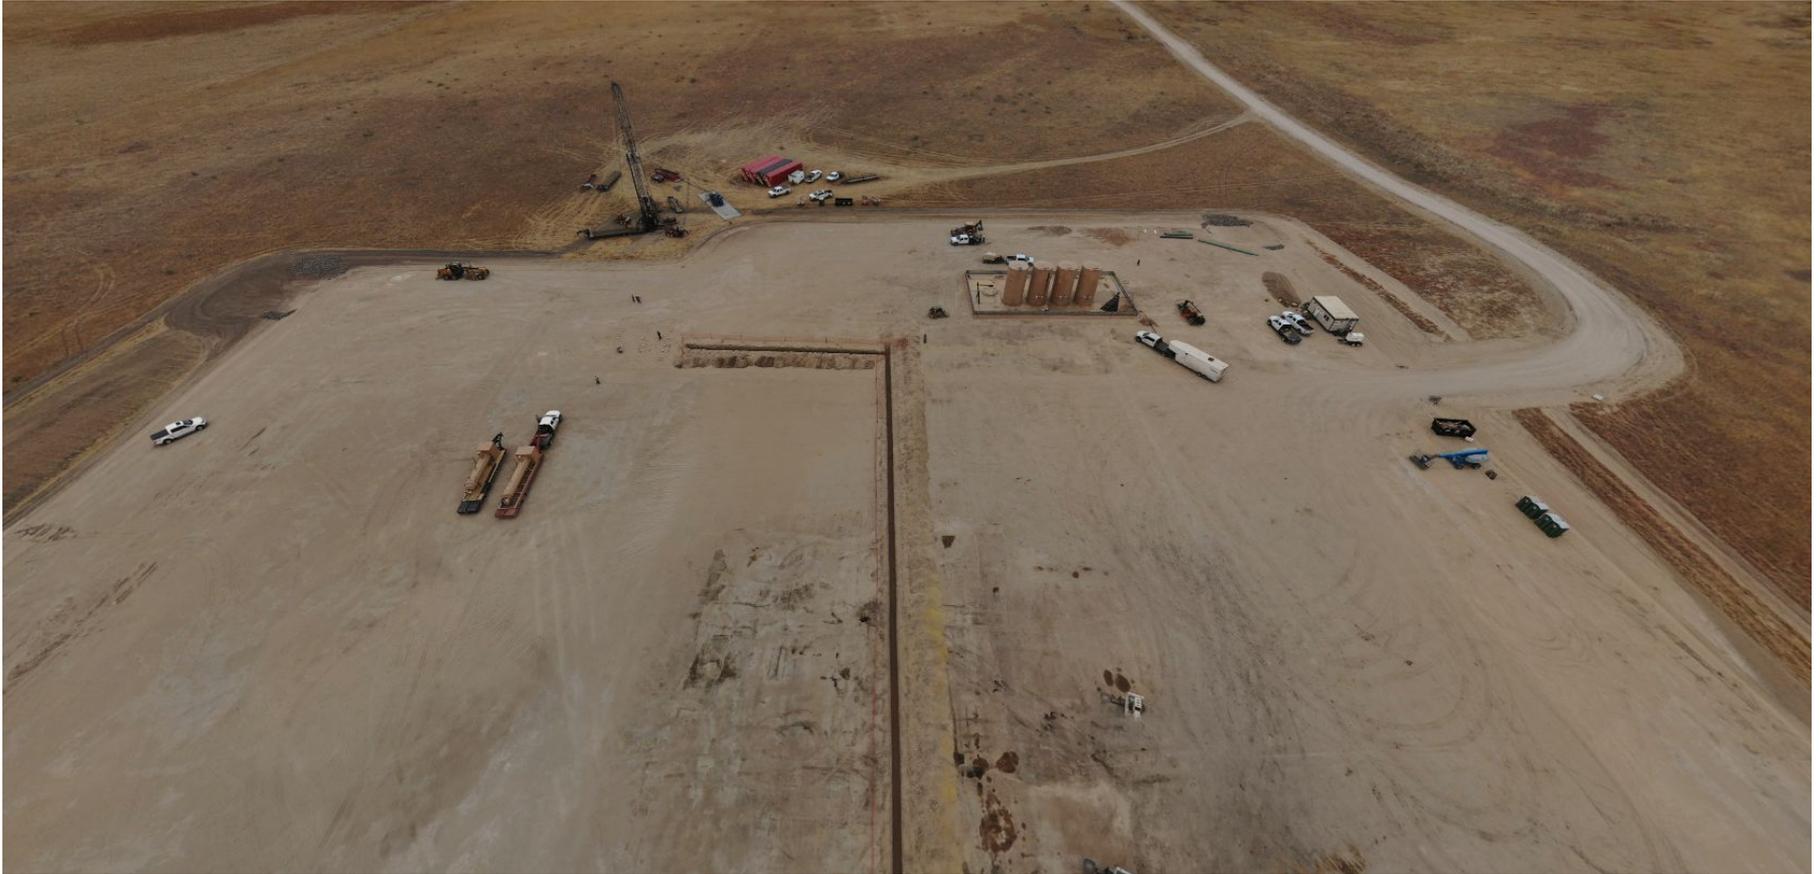
**Photo 3.** Drone aerial imagery taken from location, facing East. Photo illustrates construction of facilities, plugging operations at an adjacent Tindall well, and the southeast sediment trap.

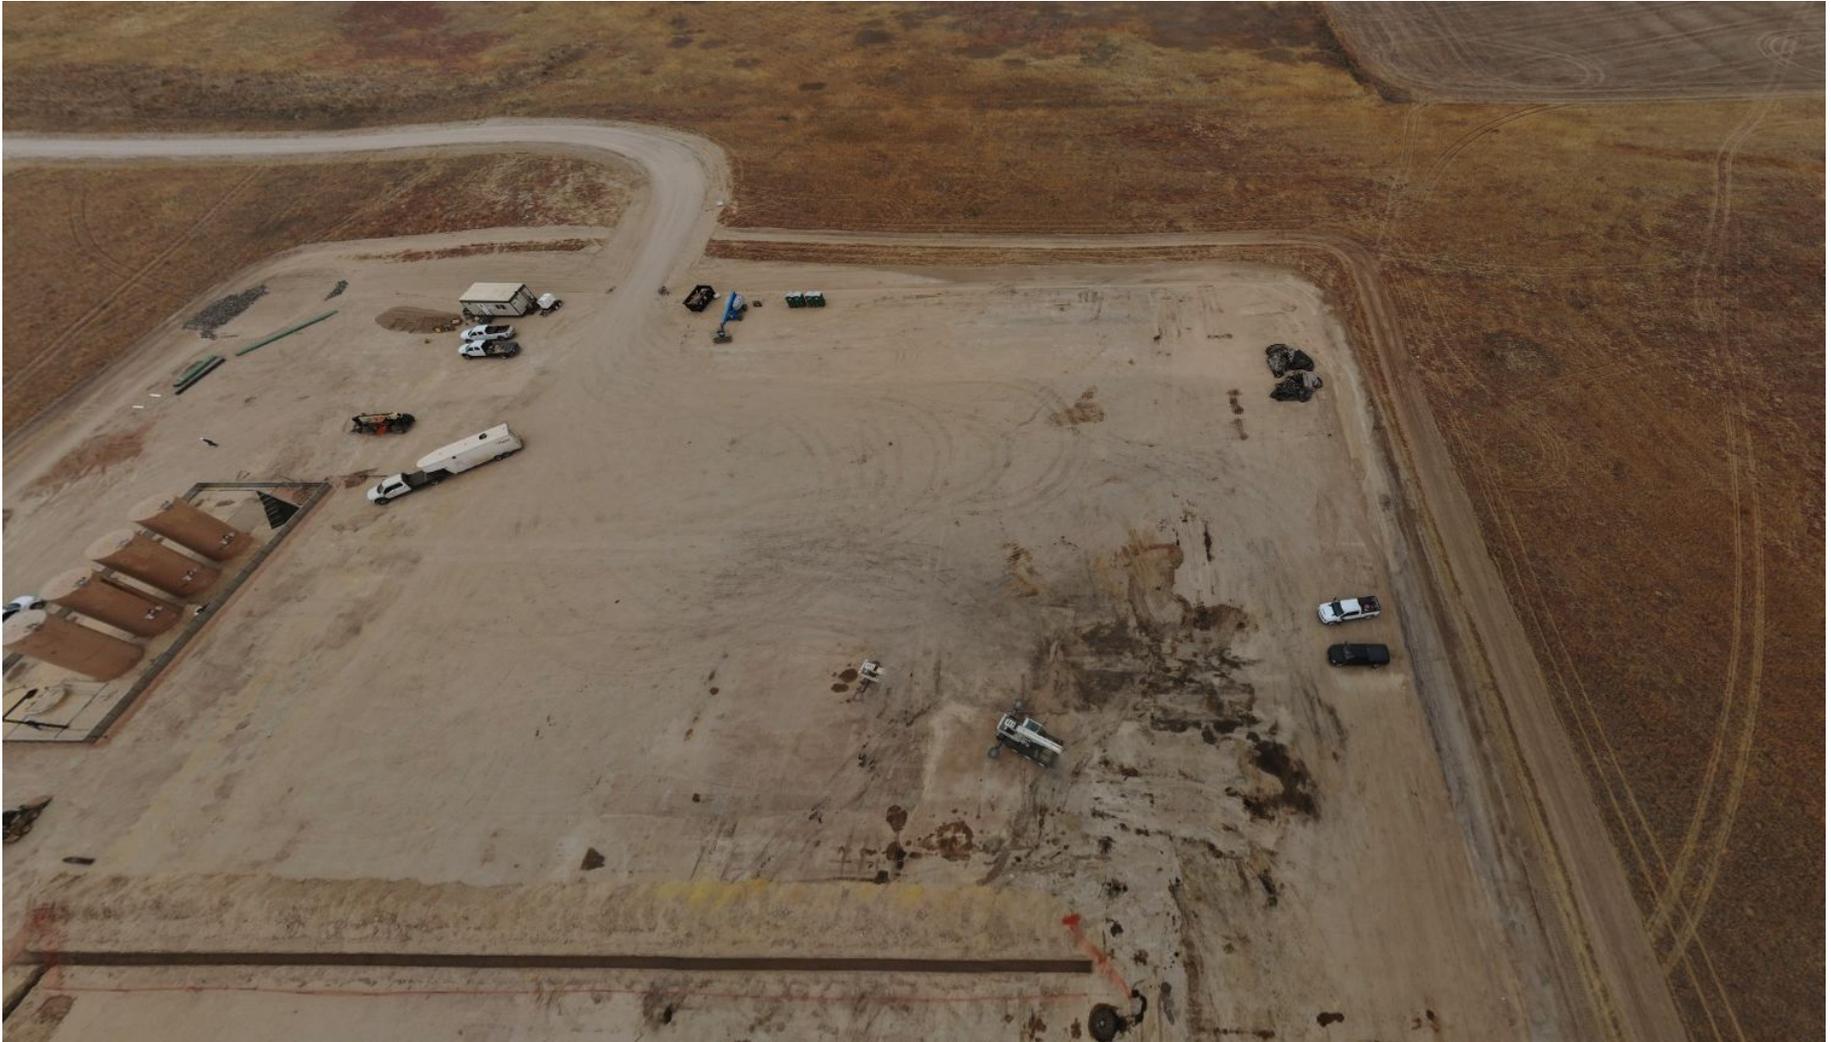
**Photo 4.** Drone aerial imagery taken from location, facing South. Photo illustrates construction of facilities and the location entrance.

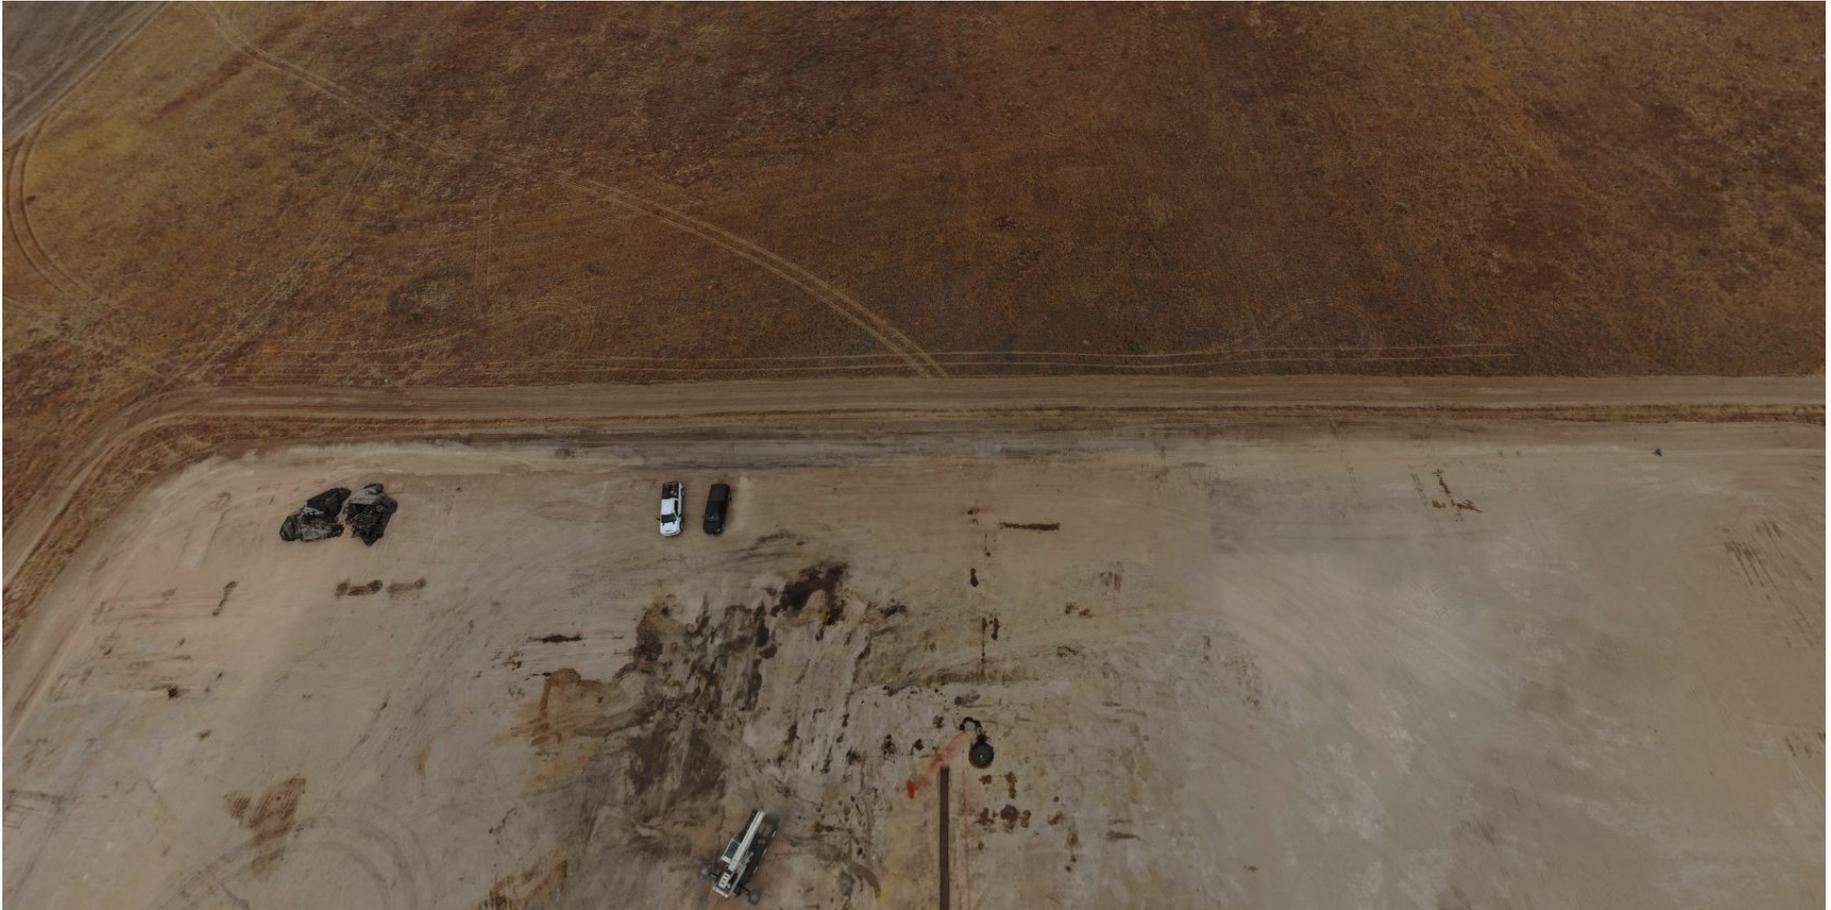
**Photo 5.** Drone aerial imagery taken from location, facing West. Photo illustrates the one well that has been spud.

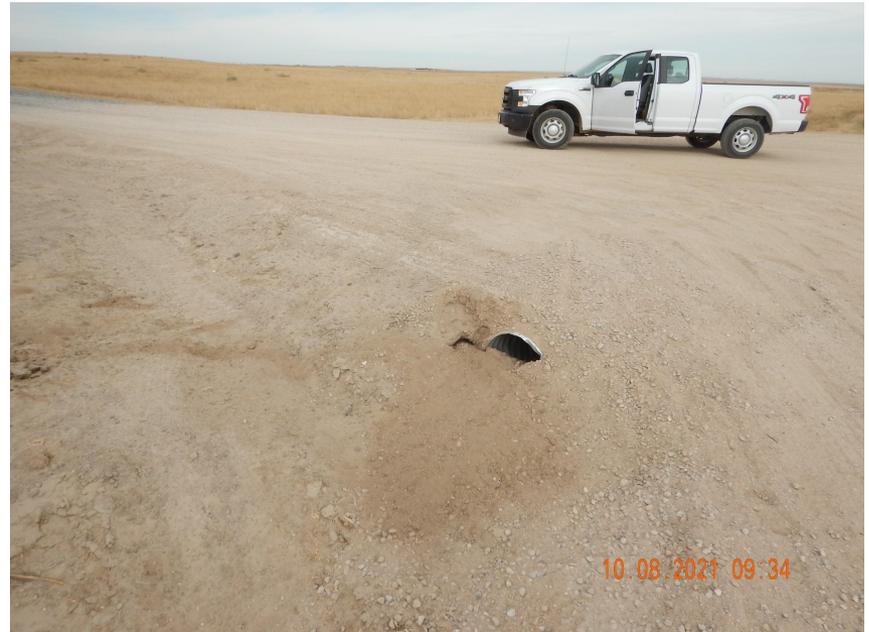
**Photo 7.** Photo taken from the entrance of location off CR 121, facing North. Photo illustrates culvert needs maintenance, as it is currently blocked with gravel.

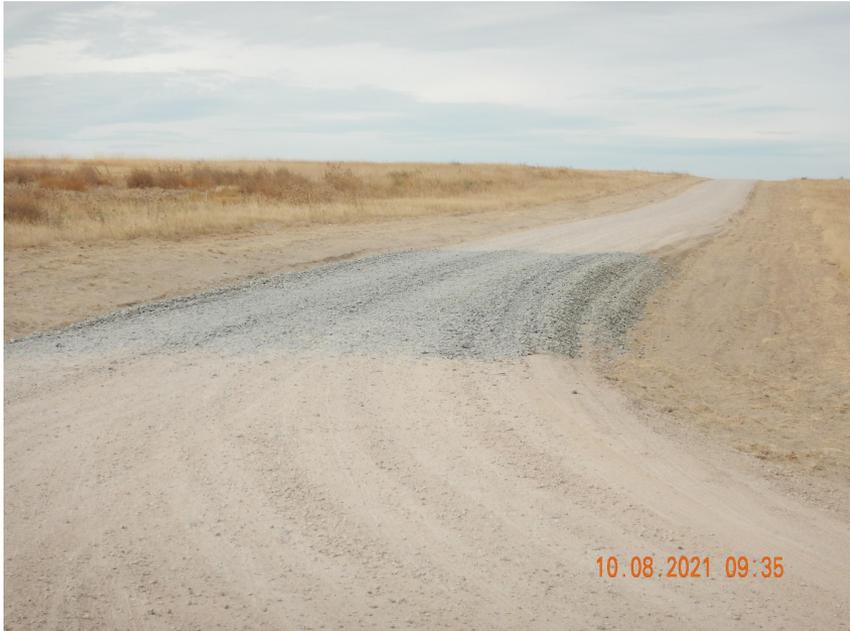
**Photo 8.** Photo taken from the entrance of location off CR 121, facing West. Photo illustrates a vehicle tracking device BMP.

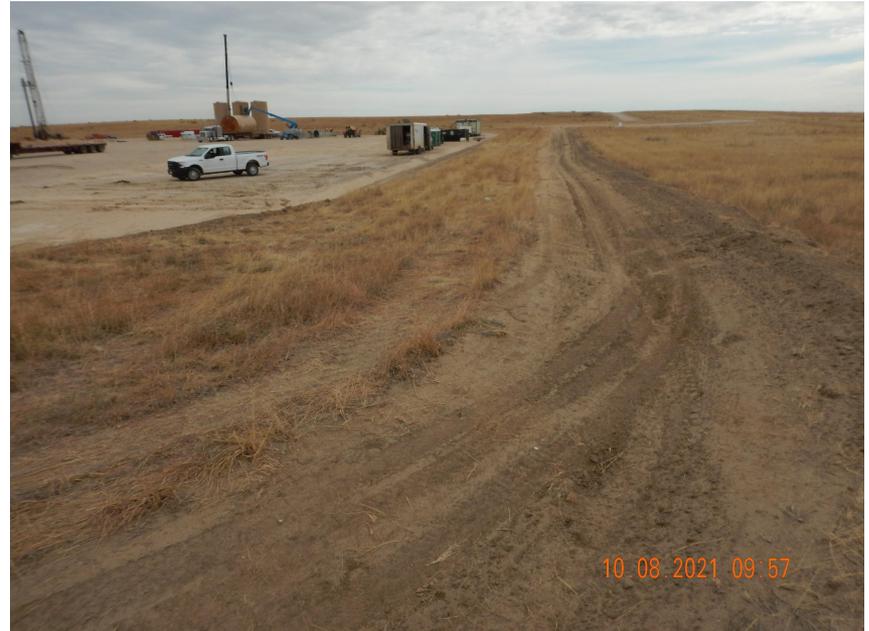
**Photo 9.** Photo taken from the southeastern location, facing North. Photo illustrates the perimeter ditch and berm BMP.

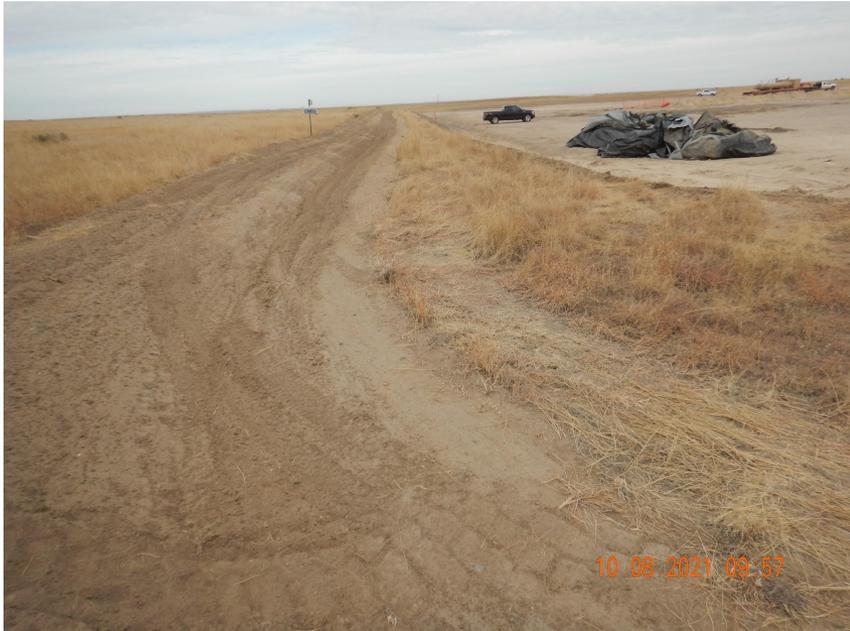
**Photo 10.** Photo taken from the southwestern location, facing North. See comments under Photo 9.

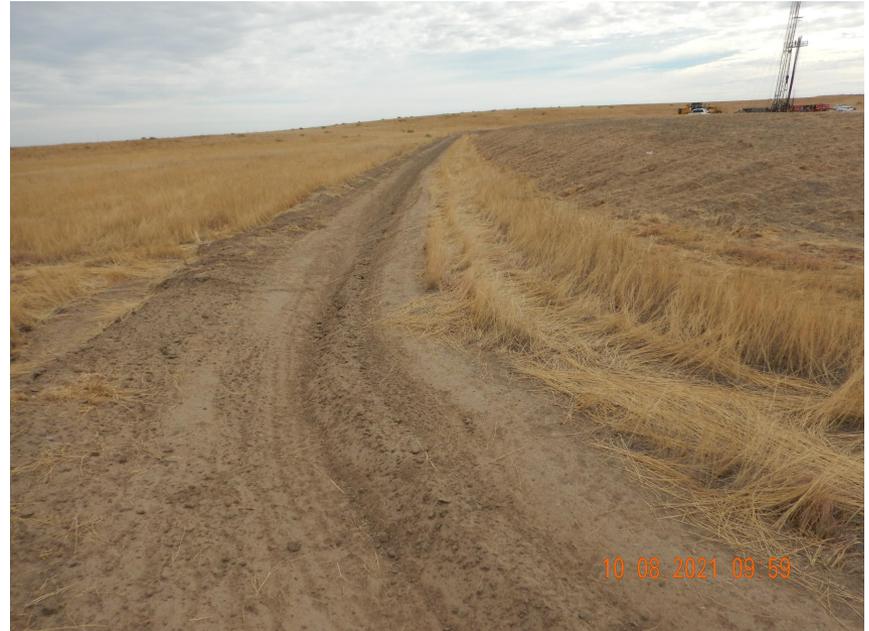
**Photo 11.** Photo taken from the northeastern location, facing East. See comments under Photo 9.

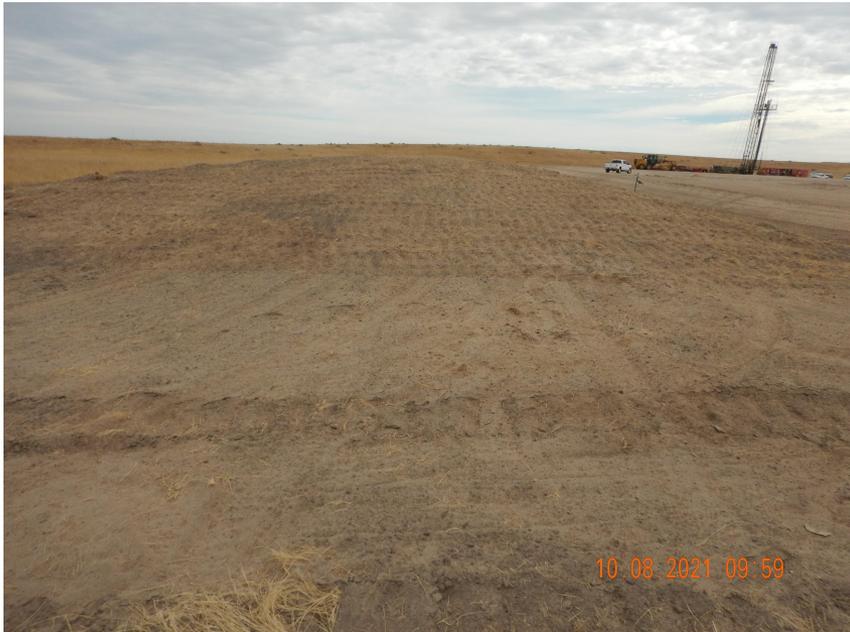
**Photo 12.** Photo taken from the western topsoil stockpile, facing East. Photo illustrates the stockpile has been temporarily stabilized.

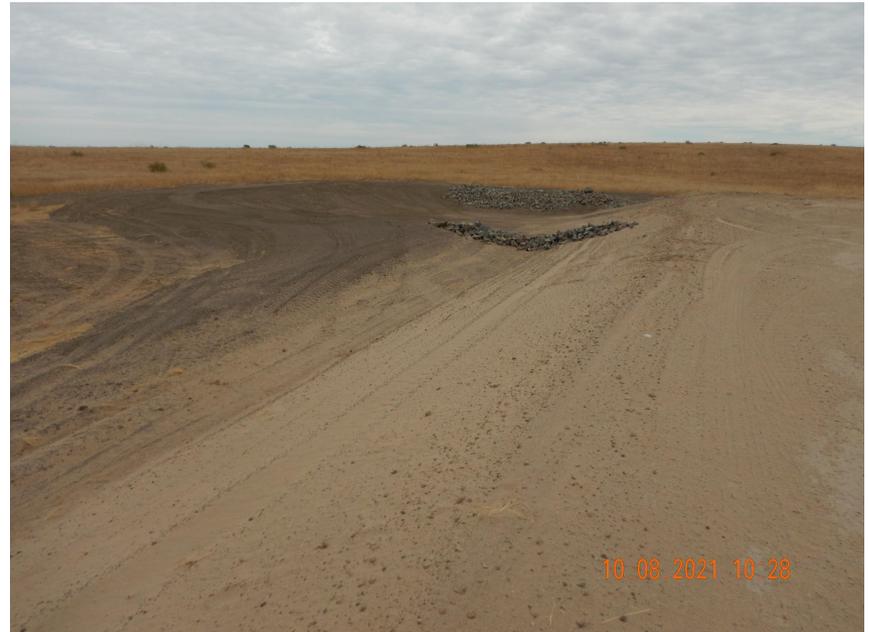
**Photo 13.** Photo taken of the northwest sediment trap, facing East.

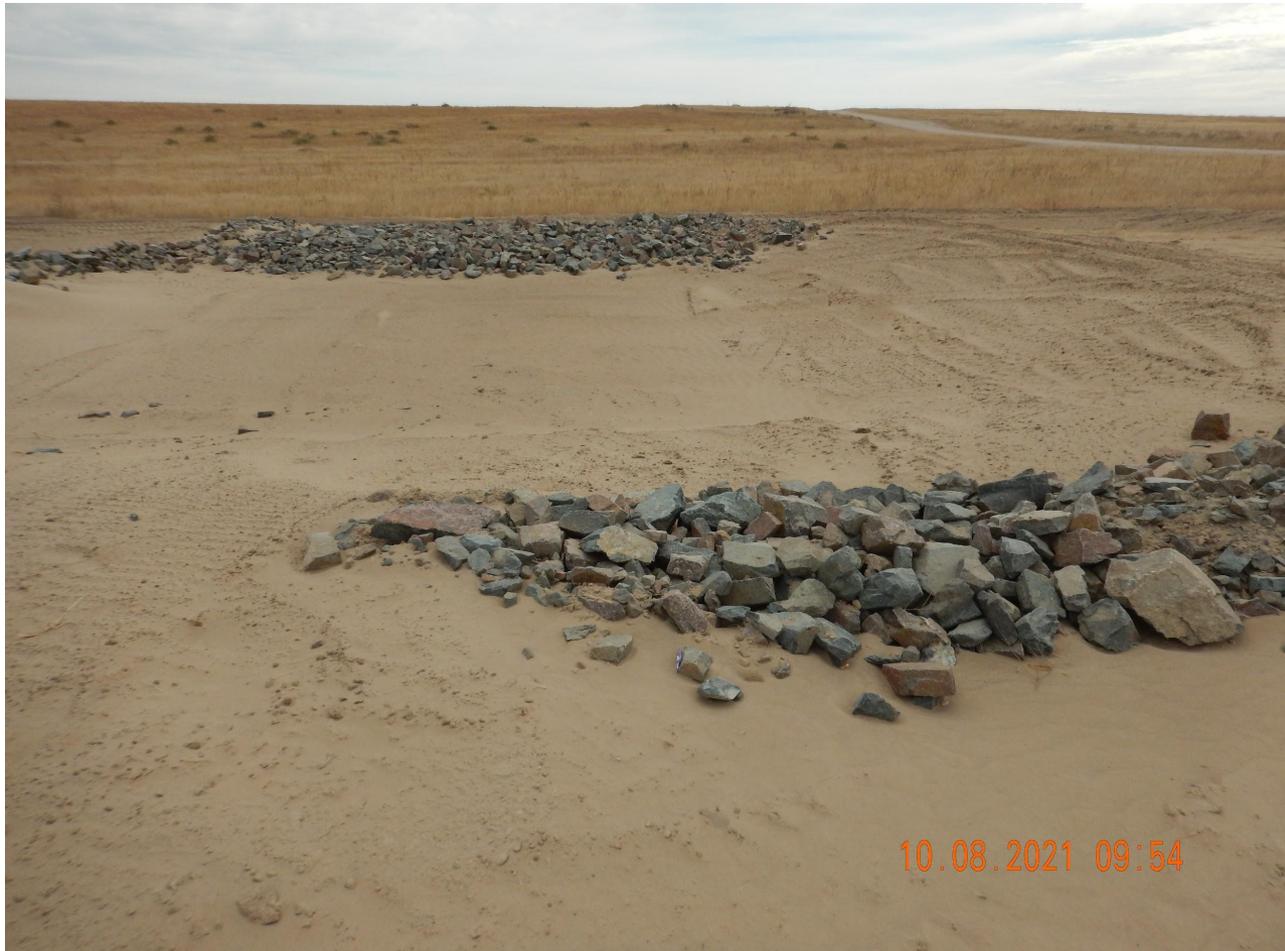
**Photo 14.** Photo taken of the southwest sediment trap, facing East. Photo illustrates sediment accumulation from unconsolidated soil material from the well location due to wind erosion. The well location has not been properly stabilized.

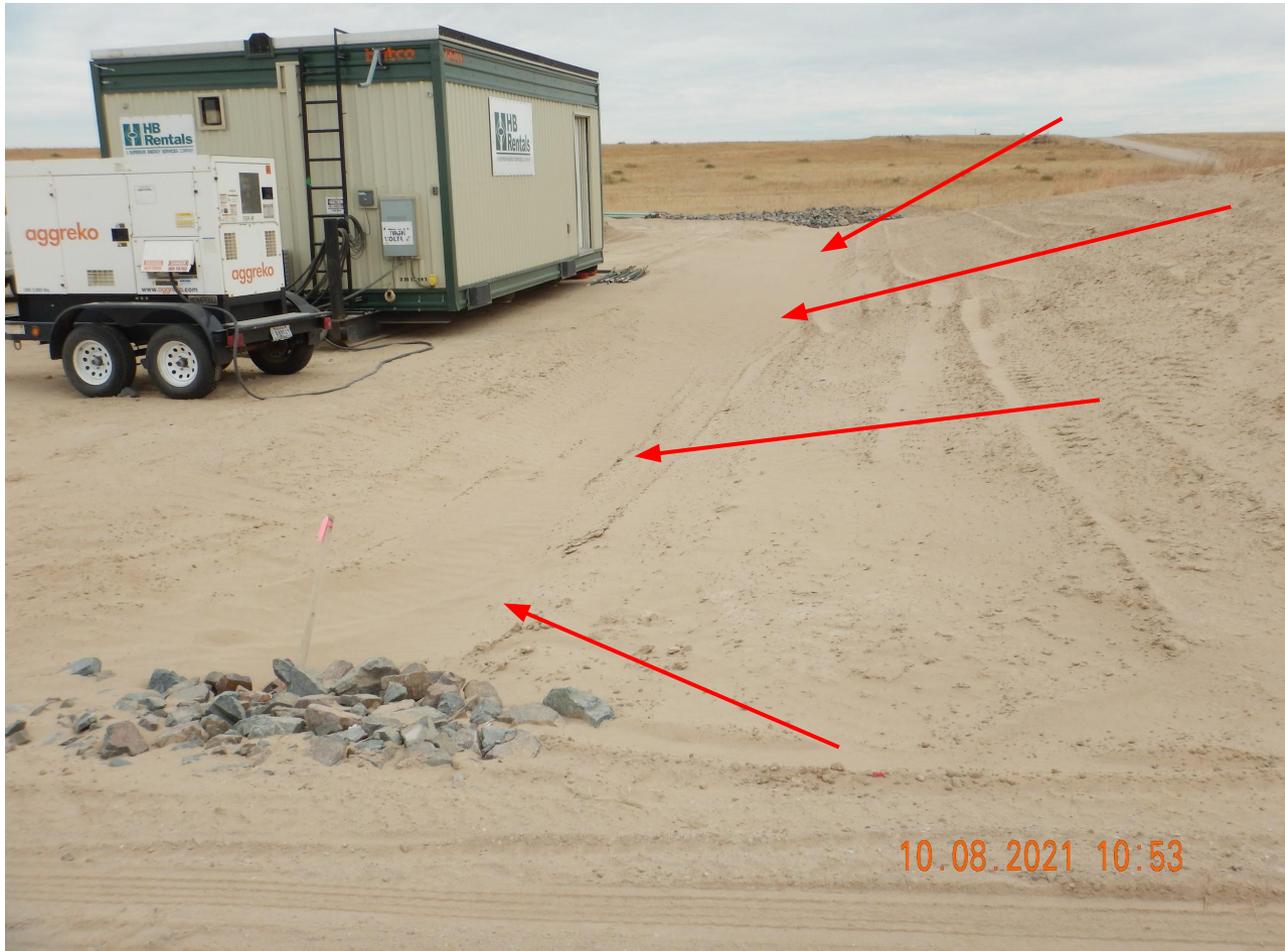
**Photo 15.** Photo taken of the southeastern ditch BMP, facing East. Photo illustrates sediment accumulation from unconsolidated soil material from the well location due to wind erosion. The well location has not been properly stabilized.
