APACHE CANYON 04-04 API# 05-071-09632 – OGRIS OPERATING
OGCC OPERATOR NUMBER 10758 - DATE: SEPTEMBER 17, 2021
CORRECTIVE ACTIONS COMPLETED REGARDING COGCC FIR DOCUMENT # 695104834

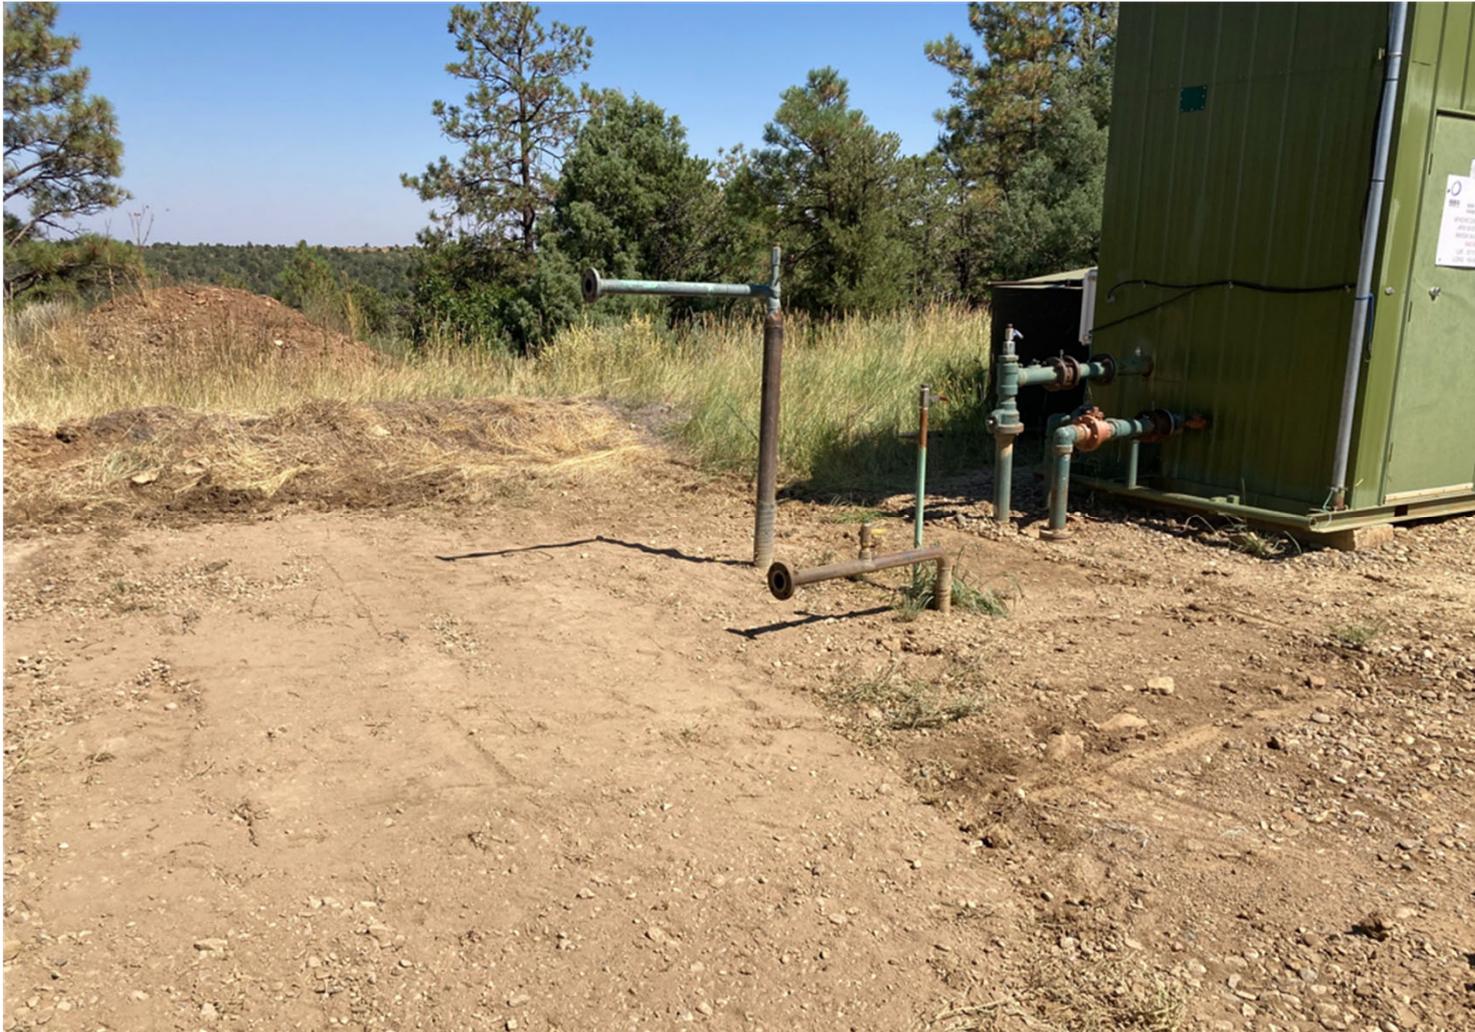
PHOTO 3: THE COMPRESSOR WAS MOVED TO INSPECT THE SOIL UNDER THE SKID. IT WAS DISCOVERED THAT THE SOIL UNDER THE SKID WAS NOT IMPACTED. THE COGCC AREA EPS WAS CONTACTED BY PHONE. THE INITIAL FORM 19 COULD NOT BE SUBMITTED VIA E-FORM ON 09/17/21 DUE TO IT ISSUES WITH THE WEBSITE. THE FORM WAS SUBMITTED 9/20/21.
