## Inspection Photos

### Martin J Schaefer #2 Flowline – Spill #2

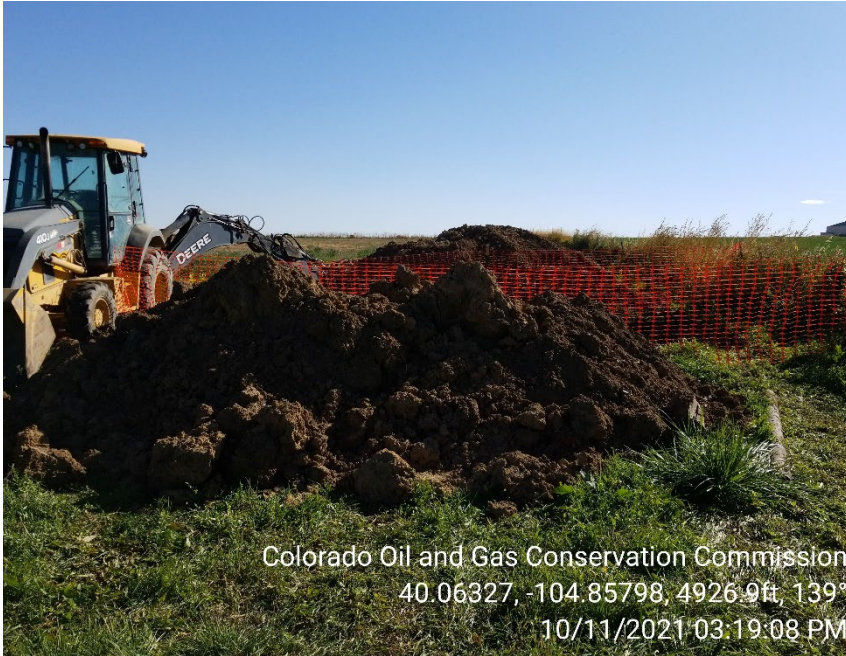
**Photo 1 – Spill location.**

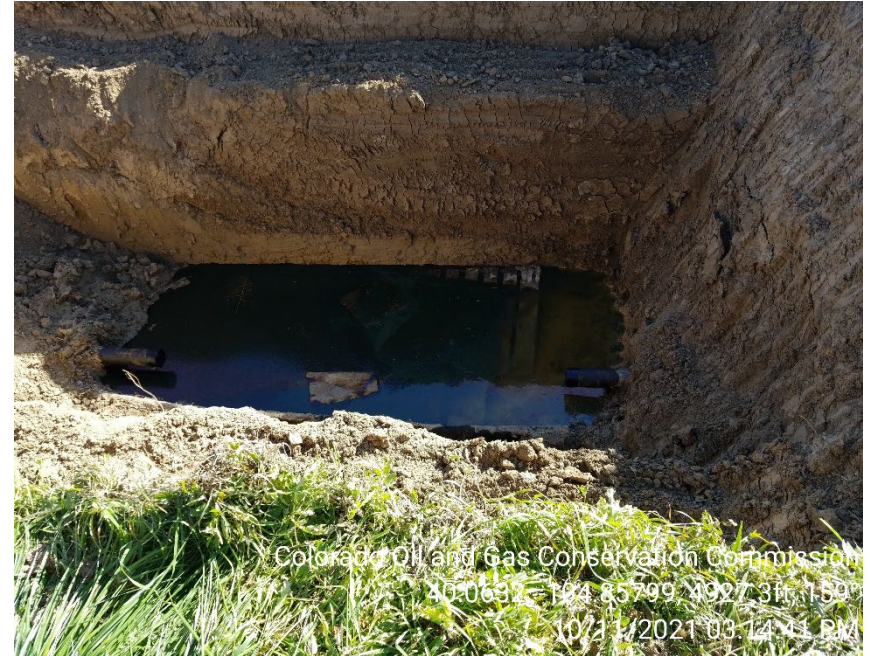
**Photo 2 – Spill excavation. Free product observed on groundwater.**

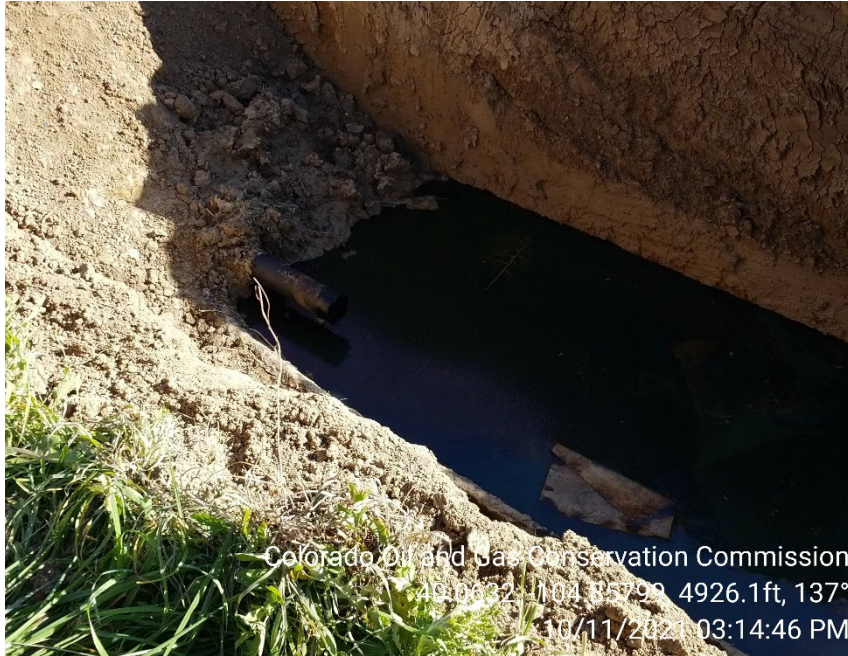
**Photo 3 – Spill excavation. Tape placed over cut end of flowline.**

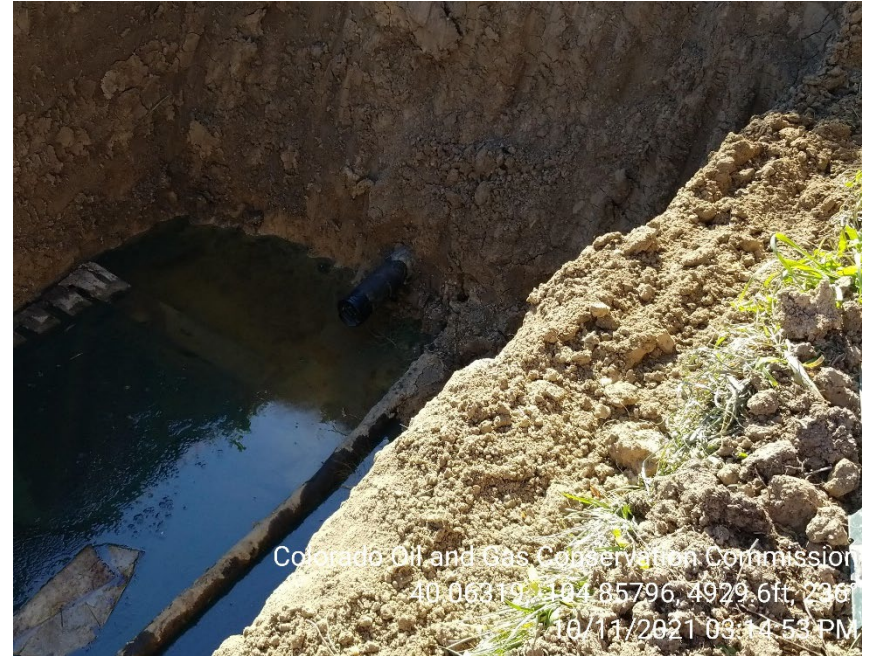
**Photo 4 – Spill excavation. Tape placed over cut end of flowline. Leak observed from western end of cut flowline.**

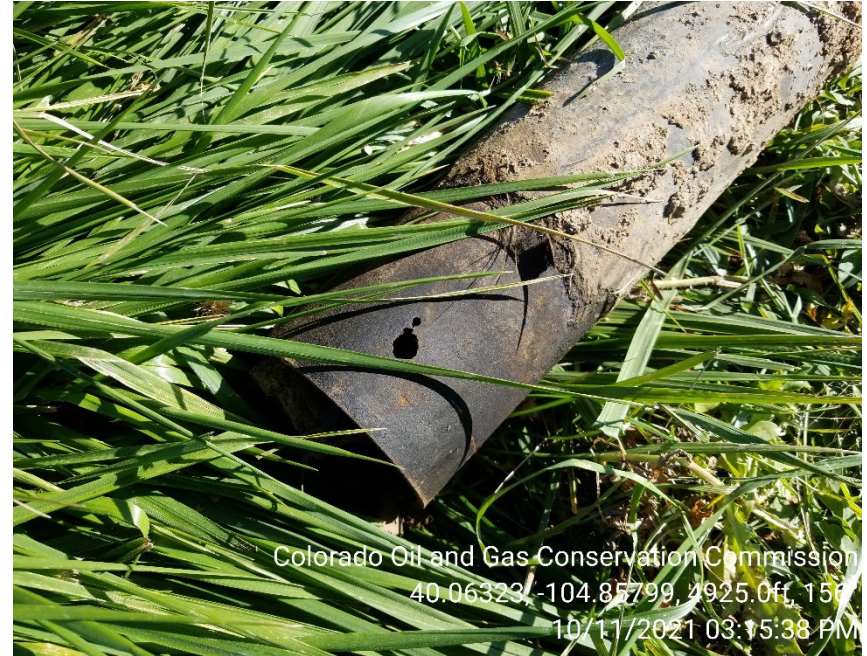
**Photo 6 – Hole observed in removed portion of flowline.**

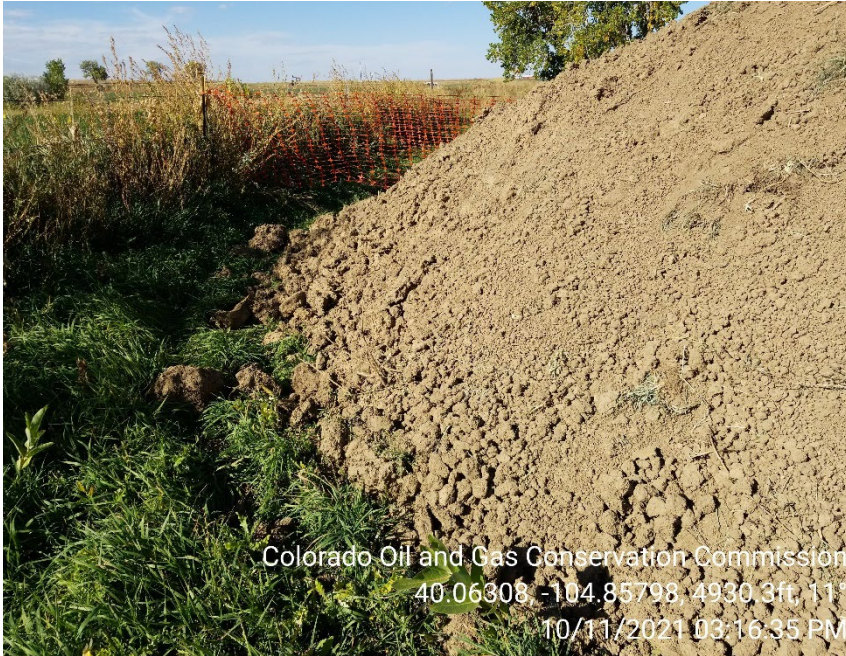
**Photo 7 – Soil stored on location. No stormwater BMPs or lining present beneath soils pile. Excavated soils were dry.**

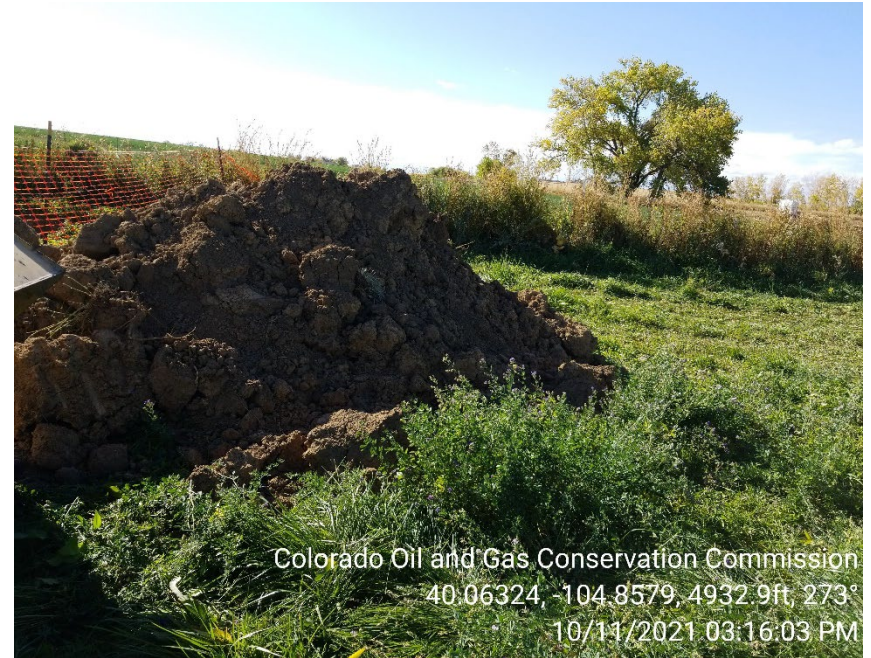
**Photo 8 – Soil stored on location. No stormwater BMPs or lining present beneath soils pile. Excavated soils were dry.**

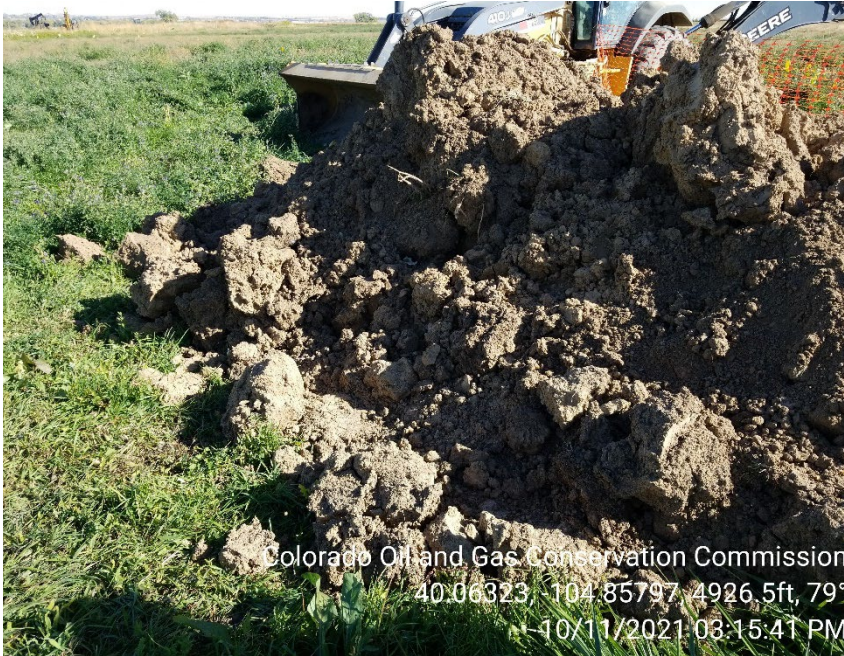
**Photo 9 – Soil stored on location. No stormwater BMPs or lining present beneath soils pile. Excavated soils were dry.**

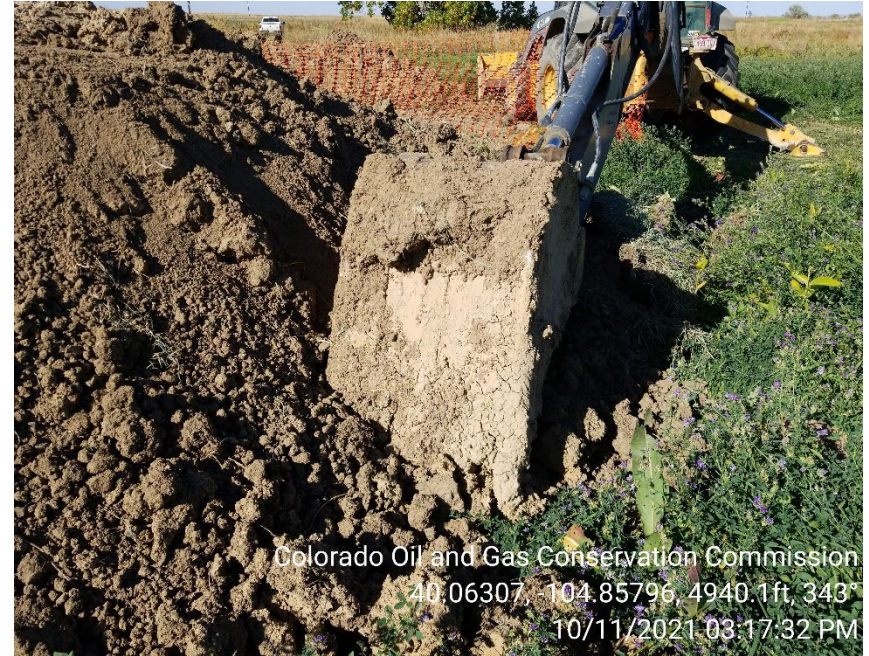
**Photo 10 – Soil stored on location. No stormwater BMPs or lining present beneath soils pile. Excavated soils were dry.**

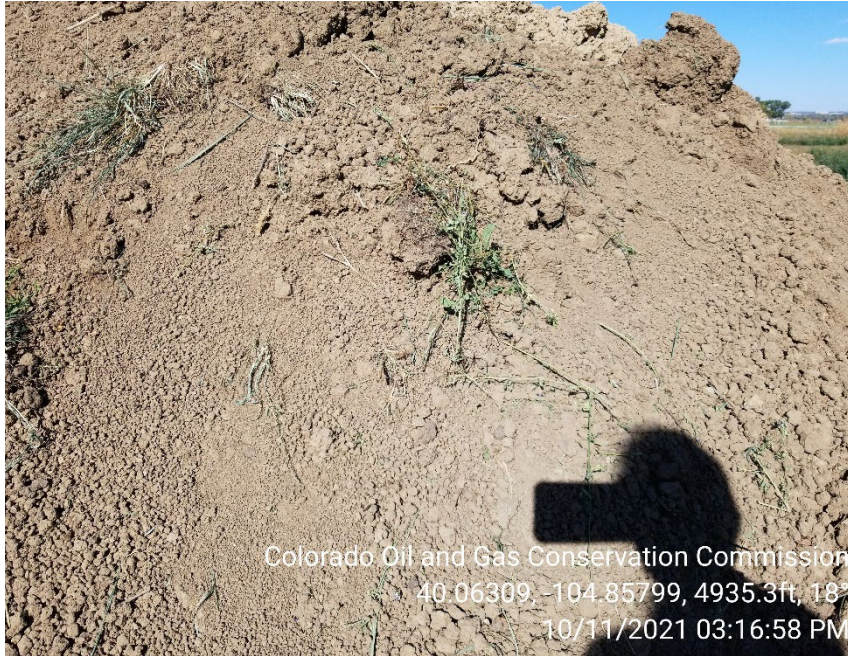
**Photo 11 – Dry vegetation on soils pile.**

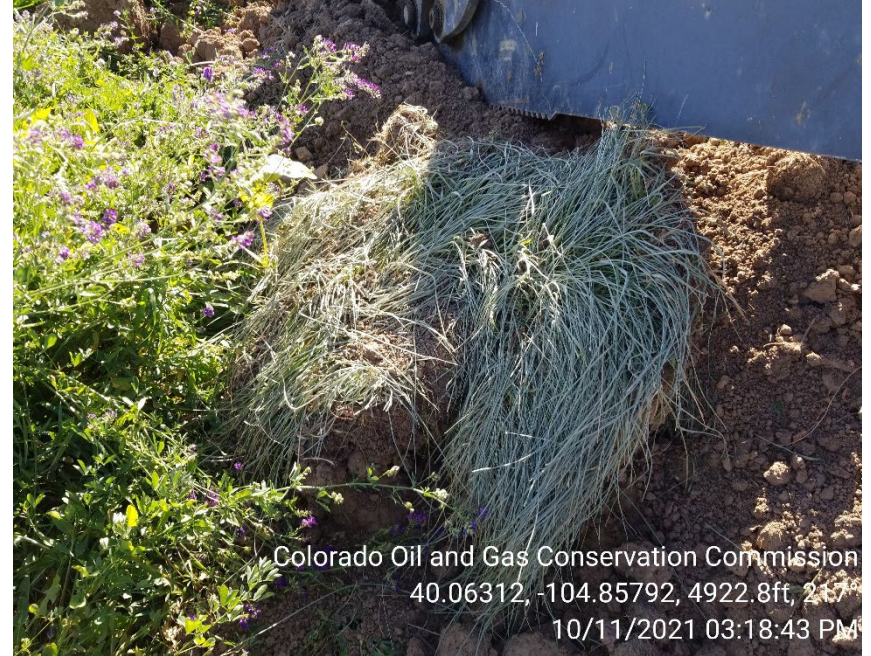
**Photo 12 – Dried scraped vegetation.**
