Inspection Photos
Location Name: Dyer 2
Location ID: 313119

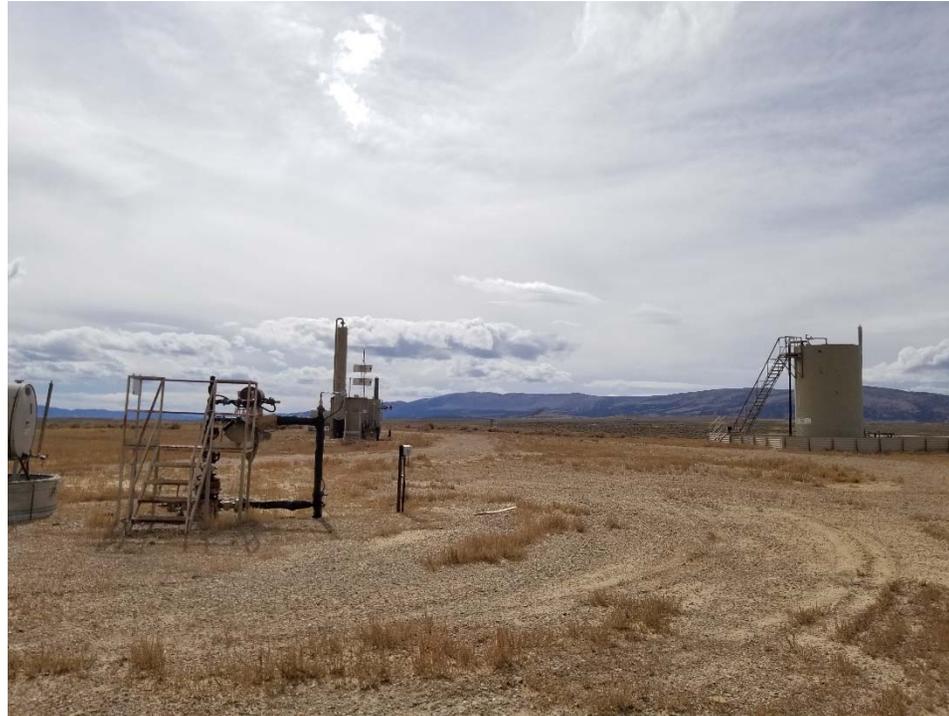
Photo 1. Overview of location taken facing south. Annual weeds drying on location.
