Inspection Photos

API: 071-08105

Operator: EVERGREEN NATURAL RESOURCES

Inspection Date: 10/12/2021

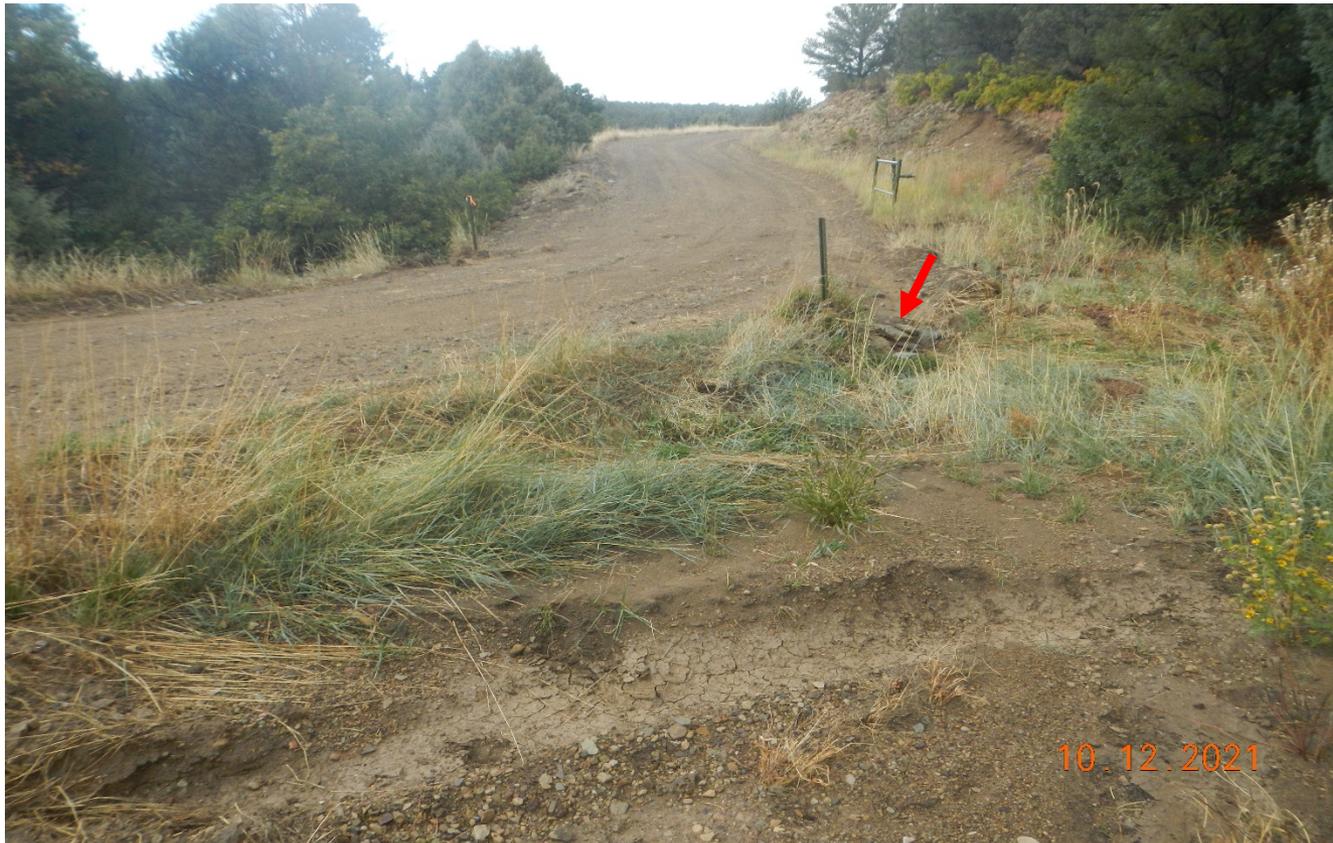
Photo 1. Facing northeast toward the access road. The culvert shown at red arrow is filled in with sediment. Stormwater flowed across the road in this area. The culvert will need to be repaired and proper drainage to the culvert needs to be repaired.

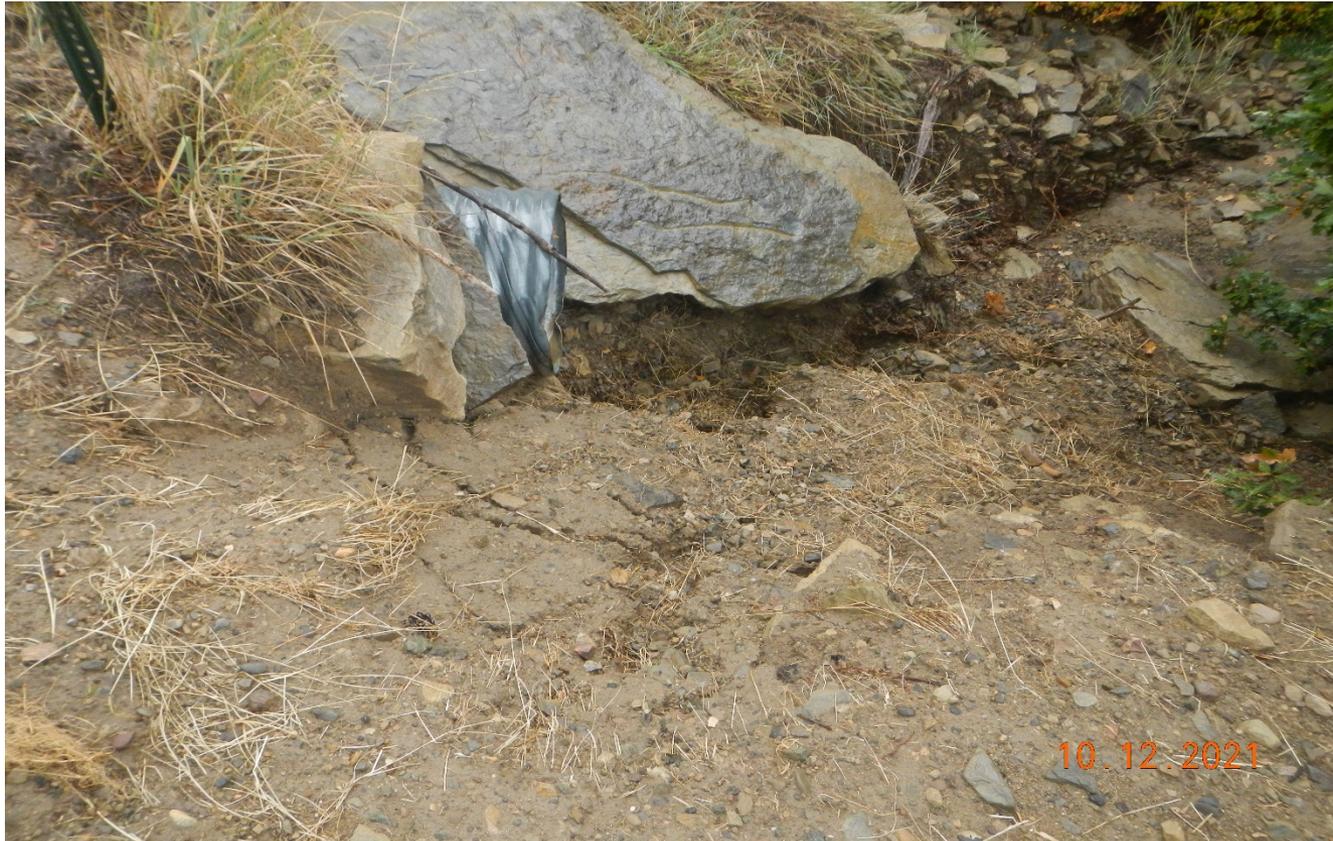
Photo 2. The pipeline has been covered with soil however this is not stabilized. Outlet protection at the culvert is needed.

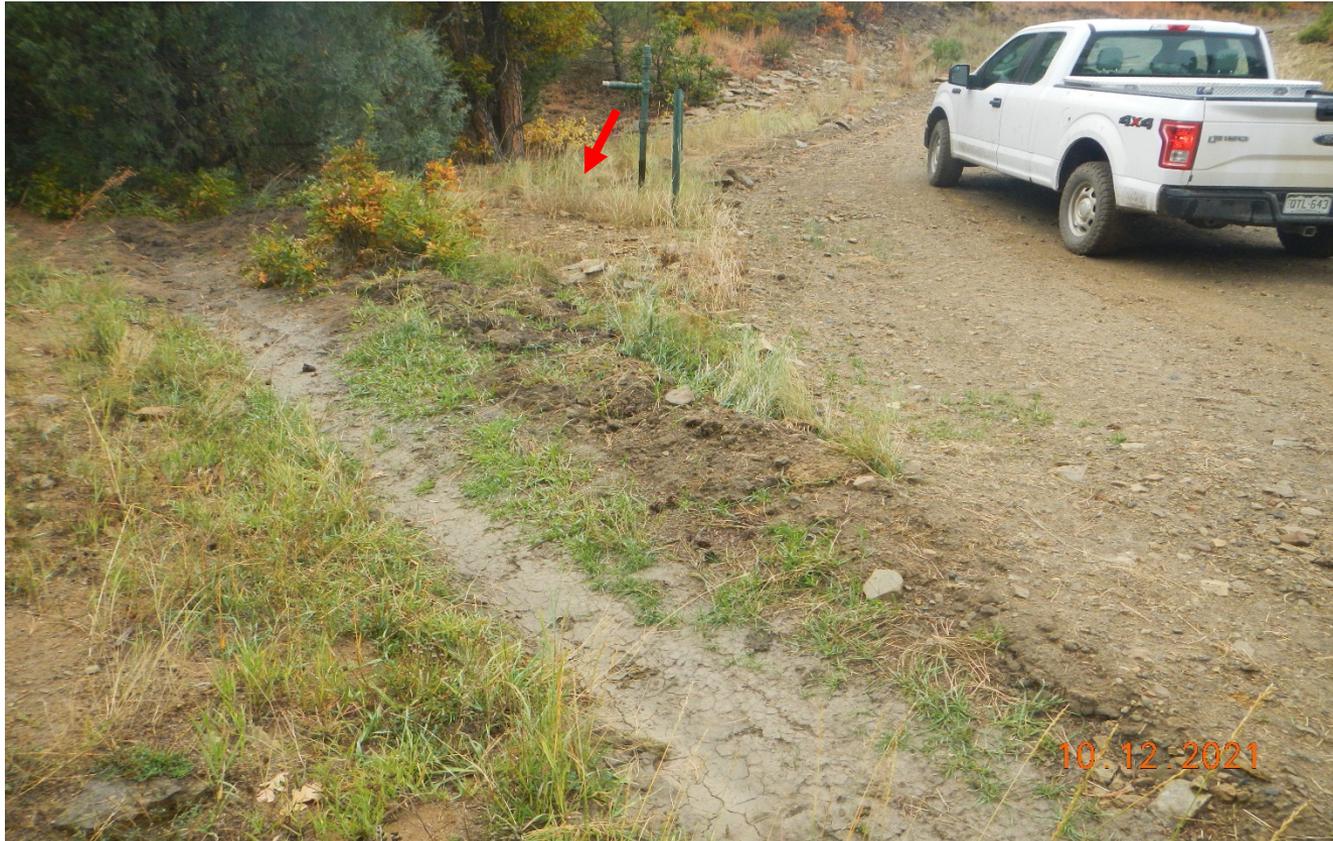
Photo 3. Facing toward the culvert further along the road. Drainage toward the culvert was not corrected. The culvert is shown at the red arrow which to be repaired to allow proper drainage.
