# TANK BATTERY DECOMMISSIONING FORM

<b>SITE NAME:</b> Poudre 10,14,15,19,23,25-28 Tank Battery Decommissioning							<b>DATE:</b> 7/14/2021	<b>REM. PROJECT #:</b> 90379413	<b>WEATHER:</b> Overcast 72		
<b>SITE DIRECTIONS:</b> WCR 17 & WCR 62, N. to New Liberty Rd., E@ 1st roundabout to center roundabout, N 1/10, NE into							<b>CLIENT:</b> Oxy				
<b>LEGALS AND LAT/LONG:</b> 40.453382, -104.900155							<b>TASMAN PERSONNEL:</b> Colette Ramey				
<b>SOIL TYPES:</b> Poorly Graded Gravel - GW beneath PW, Sandy Clay beneath ASTs and SEPs							<b>SURFACE GRADIENT:</b> West				
SOIL SAMPLING							FACILITY INFRASTRUCTURE				
Date/Time	Soil Sample ID	PID (ppm)	Visual	Olfactory	Photo?	Grab or Lab Sample?	EQUIPMENT		Quantity		
							Above Ground Storage Tank (AST)		4		
7/14/2021 11:20	PW-B01@5'	5.5	No Staining	No Odor	Yes	Lab	Buried or Partially Buried Vessel		1		
7/14/2021 11:25	PW-N01@3'	6.5	No Staining	No Odor	Yes	N/A	Separator		2		
7/14/2021 11:30	PW-S01@3'	7.8	No Staining	No Odor	Yes	N/A	Emission Control Device (ECD)		1

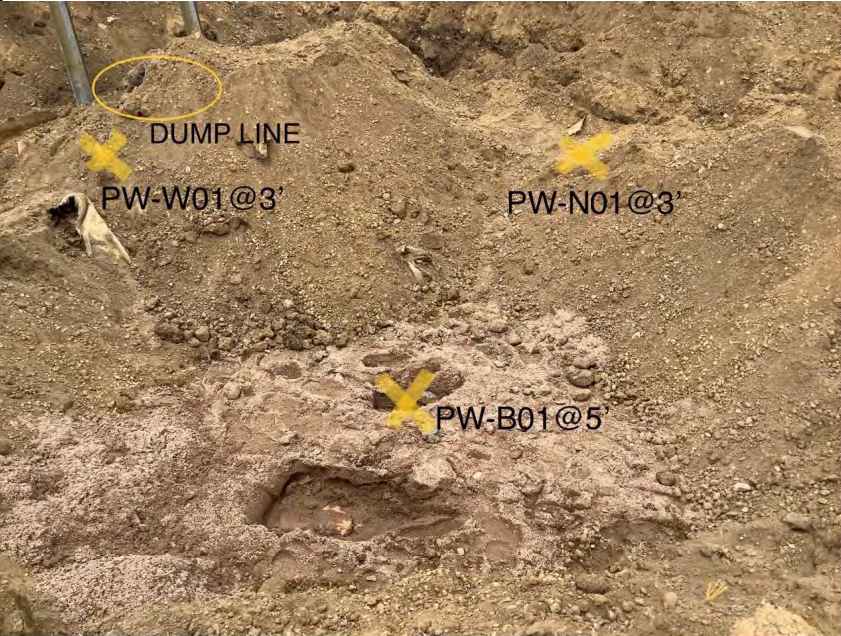
Equipment ID:		Equipment Type:		Equipment ID:		Equipment Type:					
Material:		Volume:		Contents:		Material:		Volume:		Contents:	
Notes/Conditions: PW-B01@5', PW-N01@3', PW-W01@3' FACING NORTH WEST						Notes/Conditions: PW-B01@5', PW-S01@3', PW-E01@3' FACING SOUTH EAST

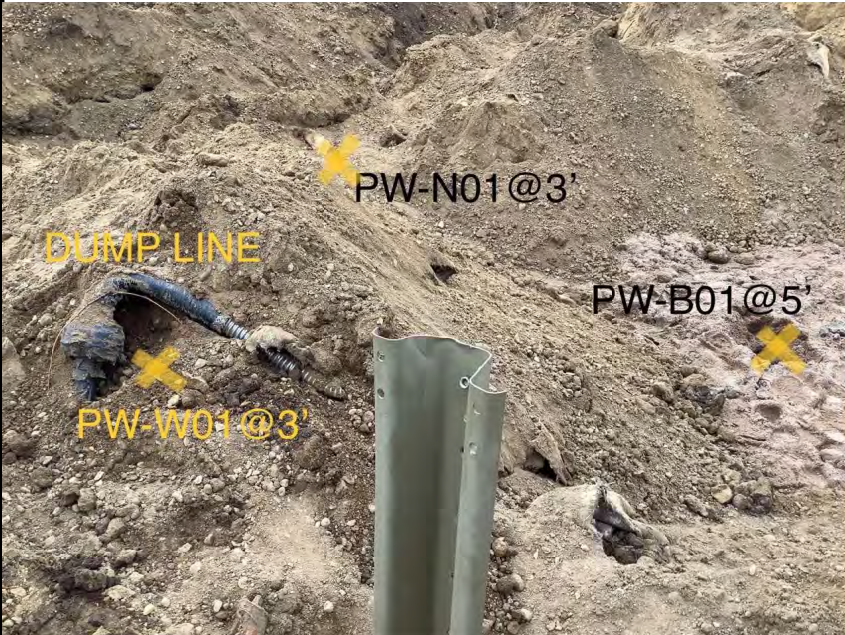
Equipment ID:		Equipment Type:	Equipment ID:		Equipment Type:
Material:	Volume:	Contents:	Material:	Volume:	Contents:
Notes/Conditions: PW-B01@5', PW-N01@3', PW-W01@3' SHOWING DUMPLINE JOINT FACING NORTH EAST			Notes/Conditions: BG-01@3', BG-01@5' FACING SOUTH

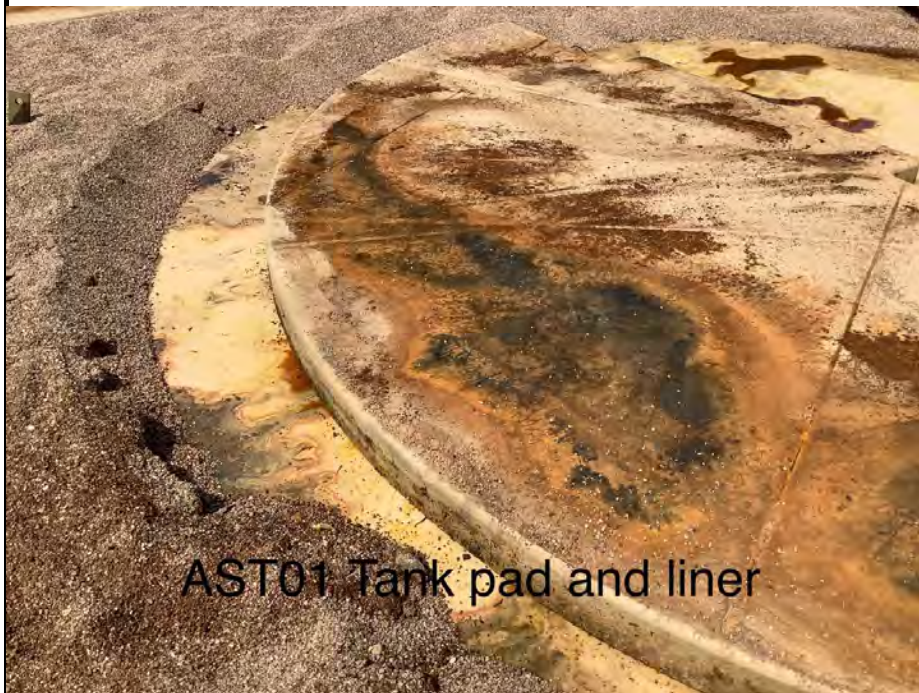
<p>AST01 Tank pad and liner</p>

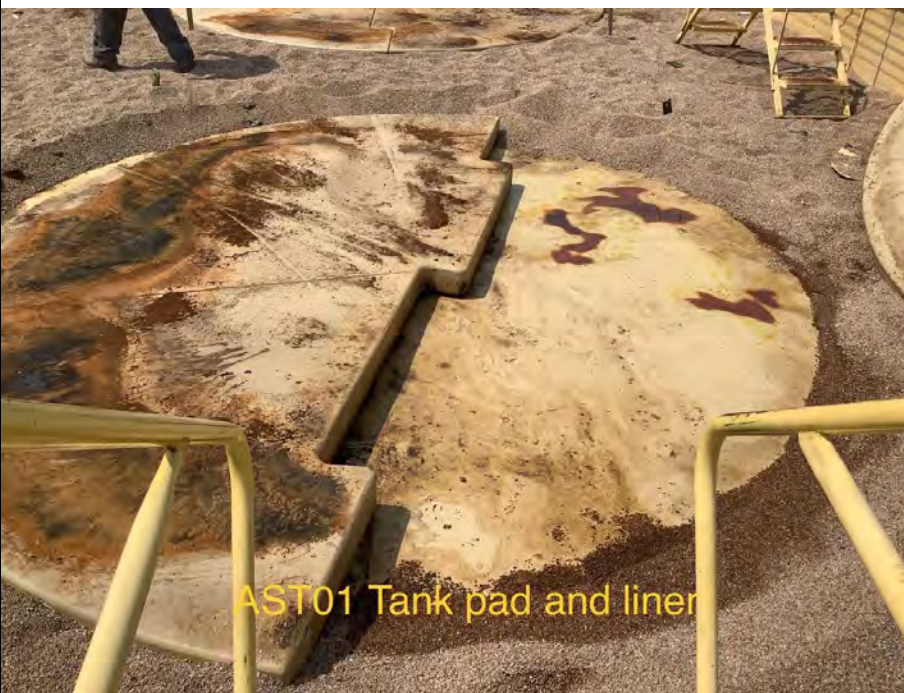
<p>AST01 Tank pad and liner</p>				
<b>Equipment ID:</b>		<b>Equipment Type:</b>		<b>Equipment ID:</b>		<b>Equipment Type:</b>	
<b>Material:</b>	<b>Volume:</b>	<b>Contents:</b>		<b>Material:</b>	<b>Volume:</b>	<b>Contents:</b>	
<b>Notes/Conditions:</b> AST01 TANK PAD AND LINER BENEATH				<b>Notes/Conditions:</b> AST01 TANK PAD AND LINER BENEATH

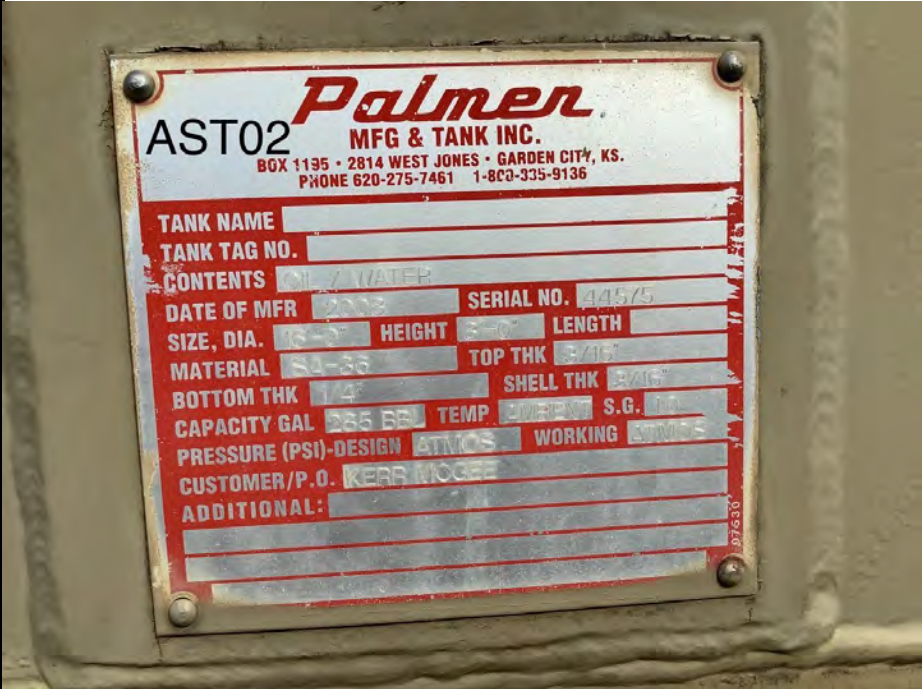
Equipment ID:		Equipment Type:		Equipment ID:		Equipment Type:	
Material:	Volume:	Contents:	Material:	Volume:	Contents:		
Notes/Conditions: AST02 ID plate			Notes/Conditions: AST02 showing hatch and connection - each tank had four connection points

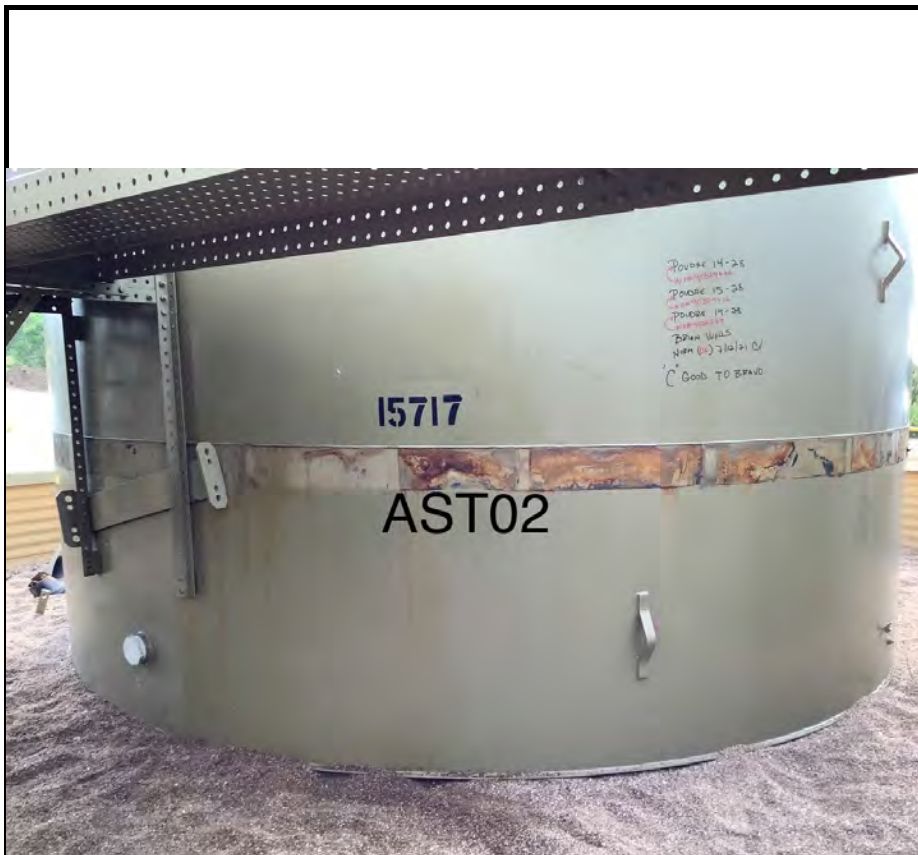
<b>Equipment ID:</b>		<b>Equipment Type:</b>	
<b>Material:</b>	<b>Volume:</b>	<b>Contents:</b>	
<b>Notes/Conditions:</b> AST02 TANK SIDE and well head connection information

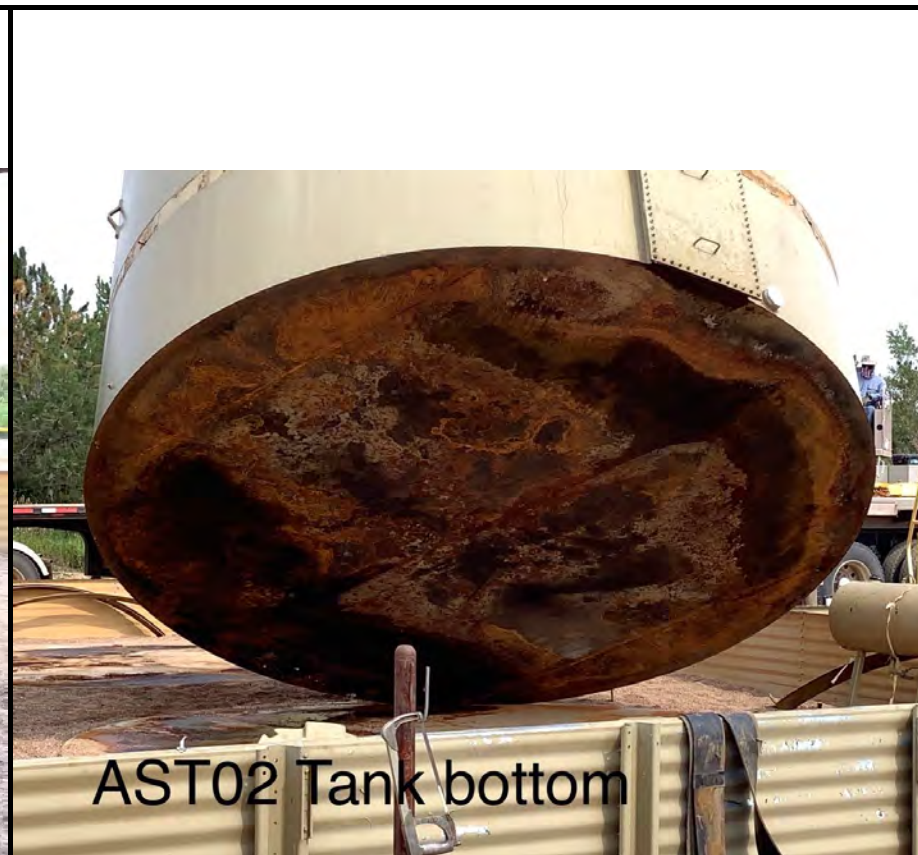
<b>Equipment ID:</b>		<b>Equipment Type:</b>	
<b>Material:</b>	<b>Volume:</b>	<b>Contents:</b>	
<b>Notes/Conditions:</b> AST02 TANK BOTTOM

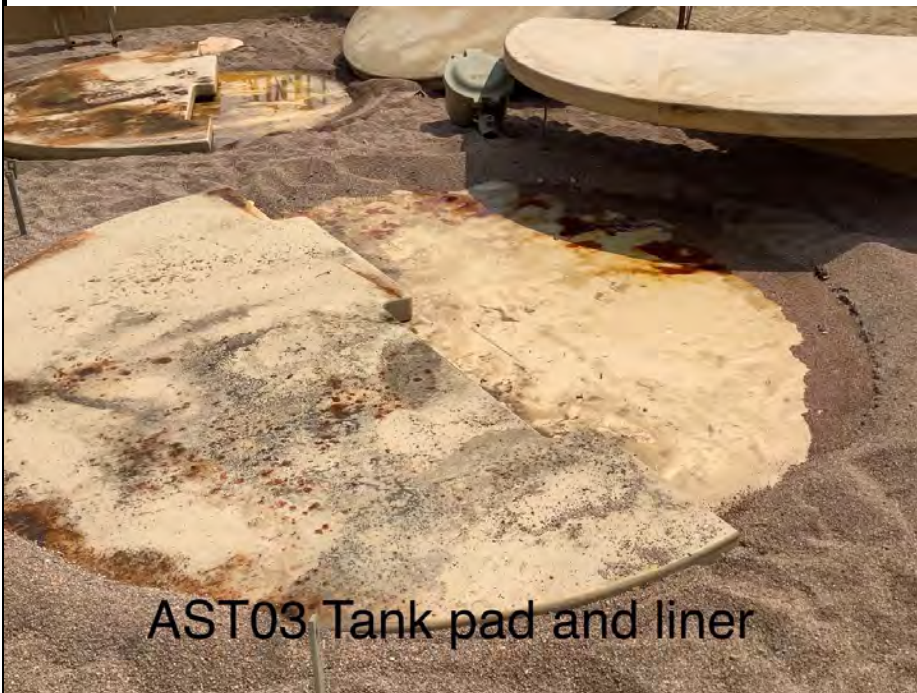
<p>AST03 Tank pad and liner</p>

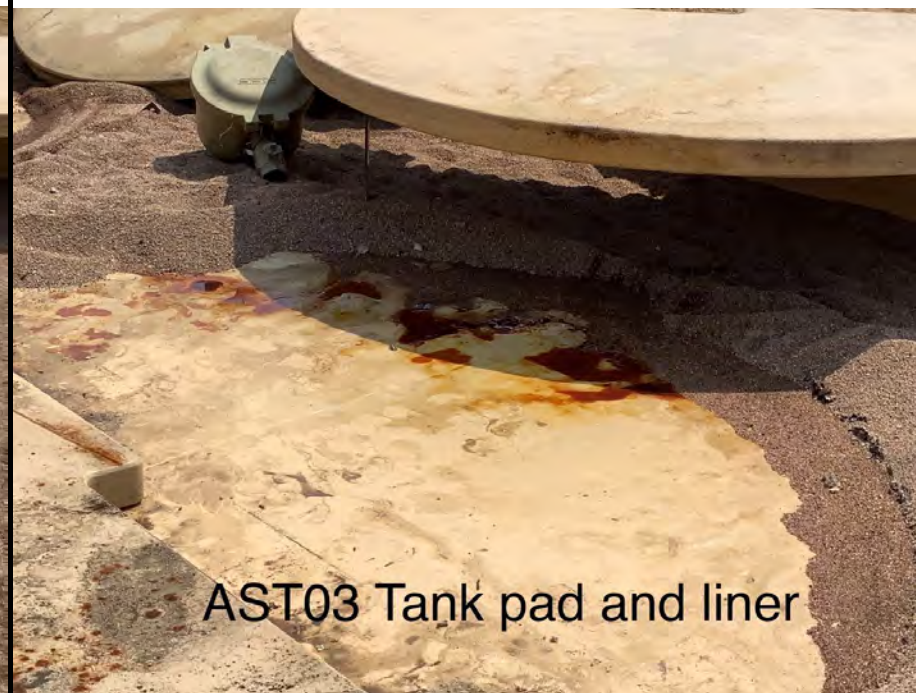
<p>AST03 Tank pad and liner</p>				
<b>Equipment ID:</b>		<b>Equipment Type:</b>		<b>Equipment ID:</b>		<b>Equipment Type:</b>	
<b>Material:</b>		<b>Volume:</b>		<b>Material:</b>		<b>Volume:</b>	
		<b>Contents:</b>				<b>Contents:</b>	
<b>Notes/Conditions:</b> AST03 showing pad and liner beneath tank				<b>Notes/Conditions:</b> AST03 showing pad and liner beneath tank

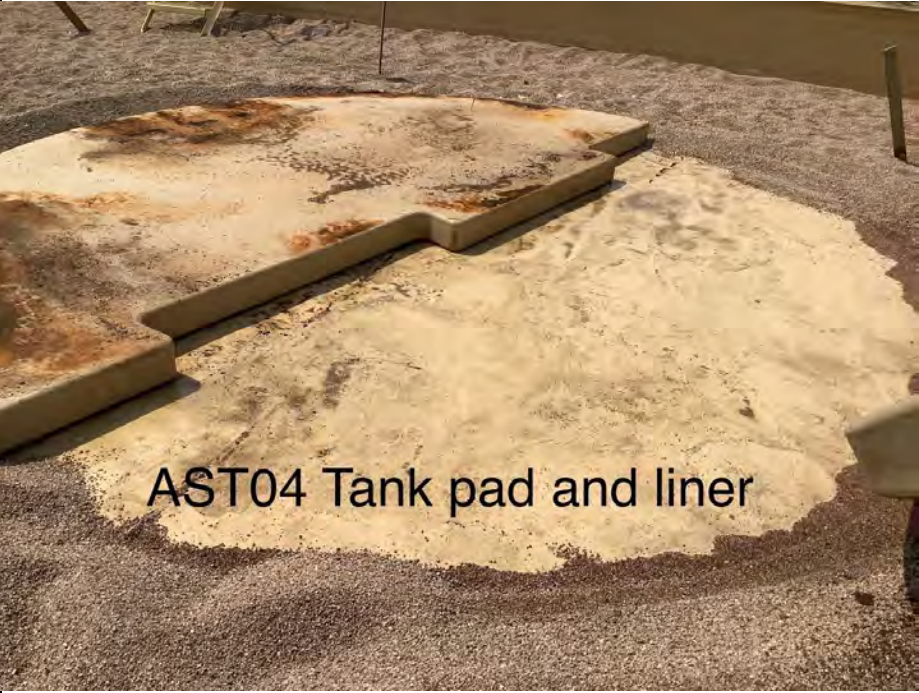
<p>AST04 Tank pad and liner</p>

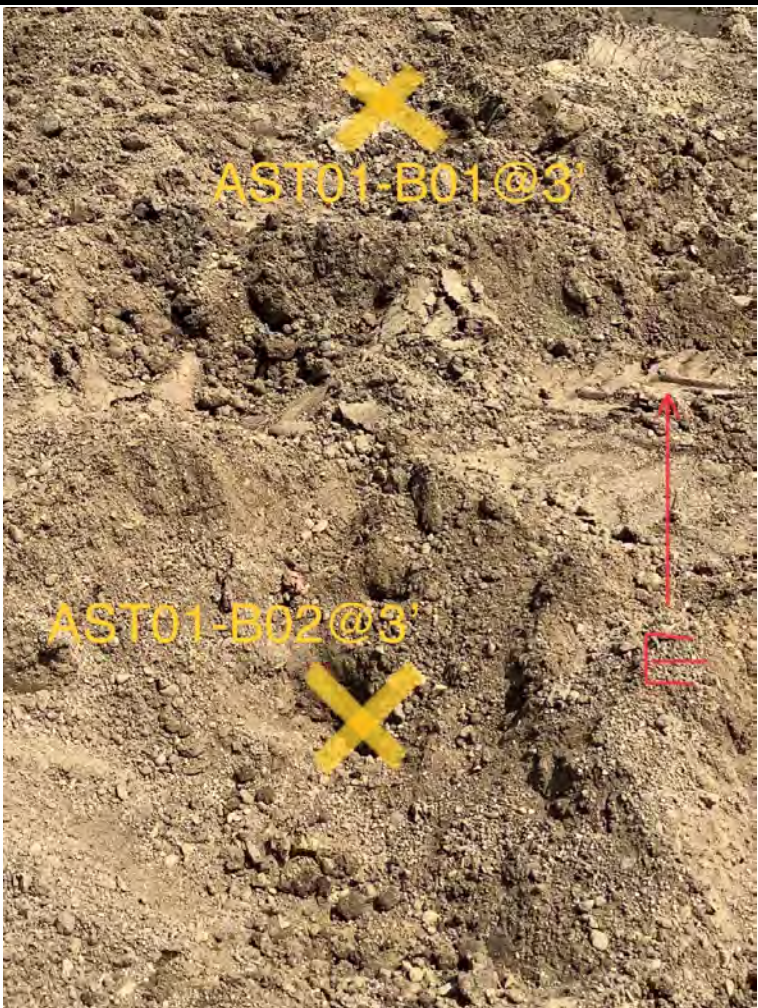
<p>AST01-B01@3'</p> <p>AST01-B02@3'</p>				
<b>Equipment ID:</b>		<b>Equipment Type:</b>		<b>Equipment ID:</b>		<b>Equipment Type:</b>	
<b>Material:</b>	<b>Volume:</b>	<b>Contents:</b>	<b>Material:</b>	<b>Volume:</b>	<b>Contents:</b>		
<b>Notes/Conditions:</b> AST04 showing pad and liner beneath tank			<b>Notes/Conditions:</b> AST01-B01@3' and AST01-B02@3' samples collected after removal of liner #1 @1' and liner #2 @3'

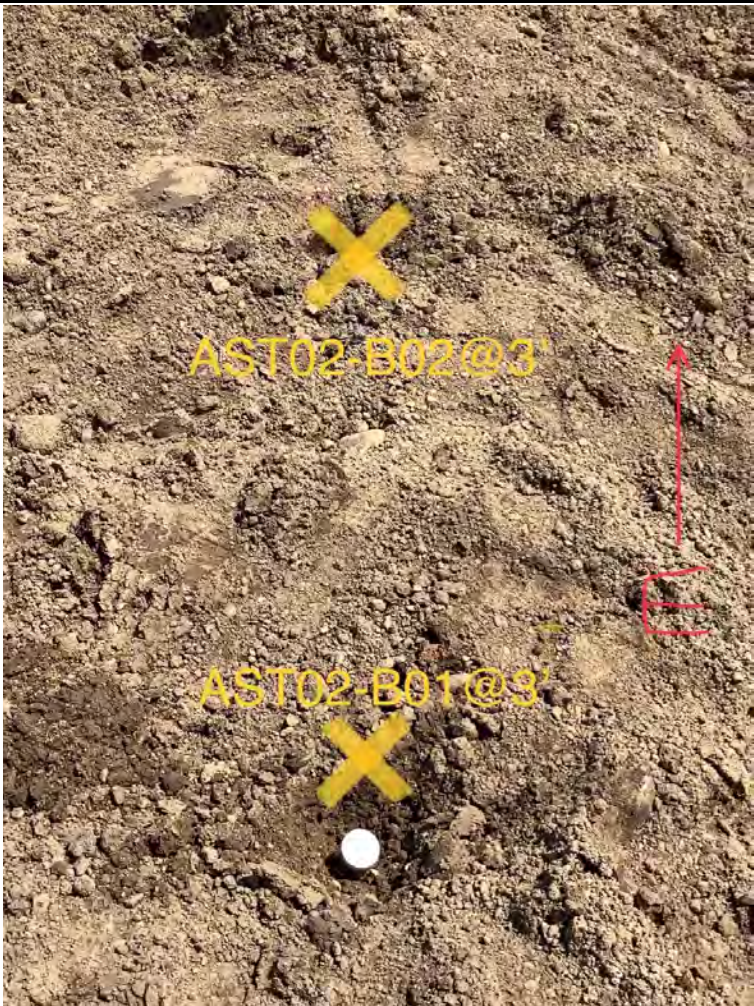
Equipment ID:		Equipment Type:		Equipment ID:		Equipment Type:	
Material:		Volume:		Material:		Volume:	
Contents:				Contents:			
<b>Notes/Conditions:</b> AST02-B01@3' and AST02-B02@3' samples collected after removal of liner #1 @1' and liner #2 @3'				<b>Notes/Conditions:</b> AST03-B01@3' and AST03-B02@3' samples collected after removal of liner #1 @1' and liner #2 @3'

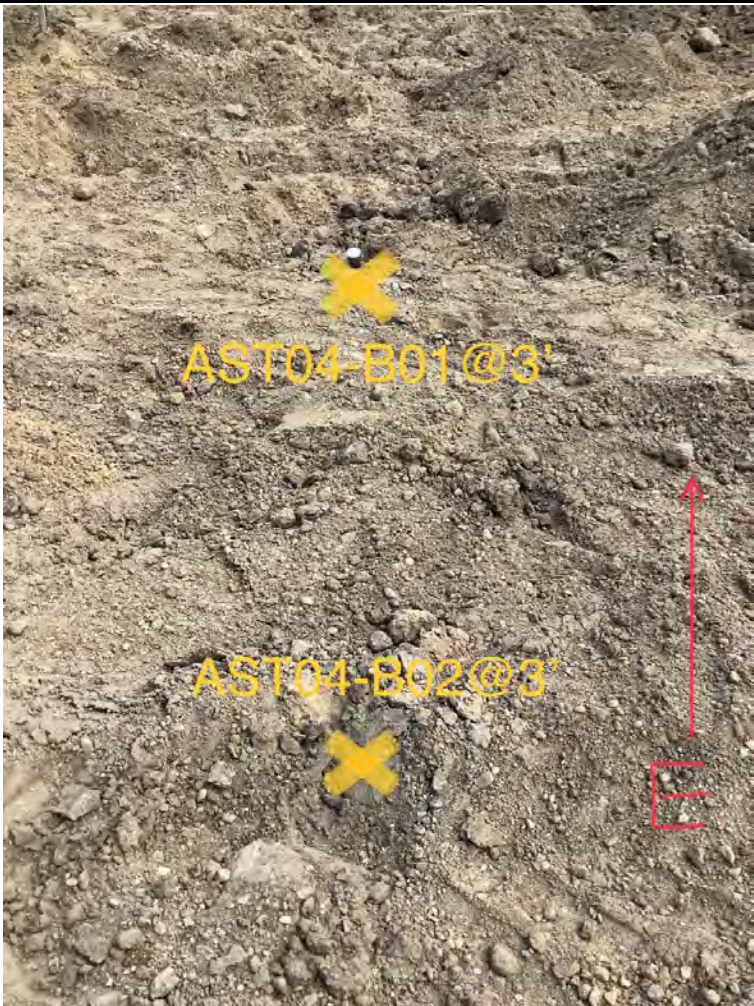
<b>Equipment ID:</b>		<b>Equipment Type:</b>		<b>Equipment ID:</b>		<b>Equipment Type:</b>	
<b>Material:</b>		<b>Volume:</b>		<b>Material:</b>		<b>Volume:</b>	
<b>Contents:</b>		<b>Contents:</b>		<b>Material:</b>		<b>Volume:</b>	
<b>Notes/Conditions:</b> AST04-B01 @3' and AST04-B02 @3' samples collected after removal of liner #1 @1' and liner #2 @3'				<b>Notes/Conditions:</b> MH-B01 @3"

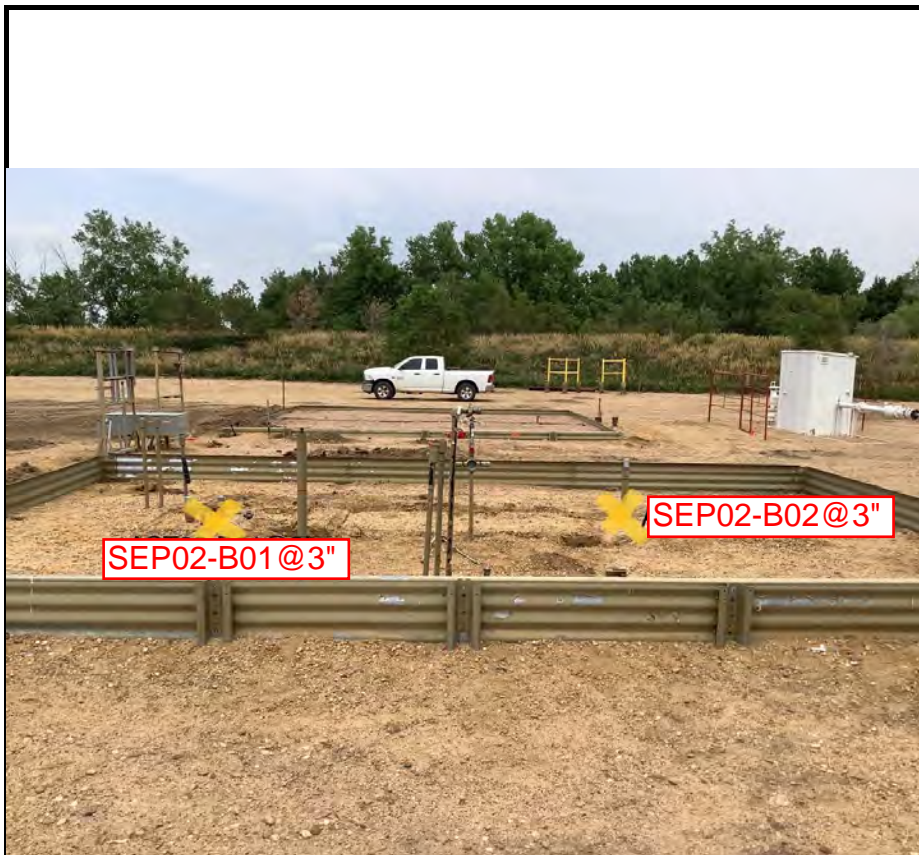
Equipment ID:		Equipment Type:		Equipment ID:		Equipment Type:	
Material:		Volume:		Material:		Volume:	
Contents:				Contents:			
Notes/Conditions: SEP02-B01@3' and SEP02-B02@3' showing area prior to excavation - Xs mark GPS of samples that were taken after excavation facing north				Notes/Conditions: DL-B01@4' Facing East

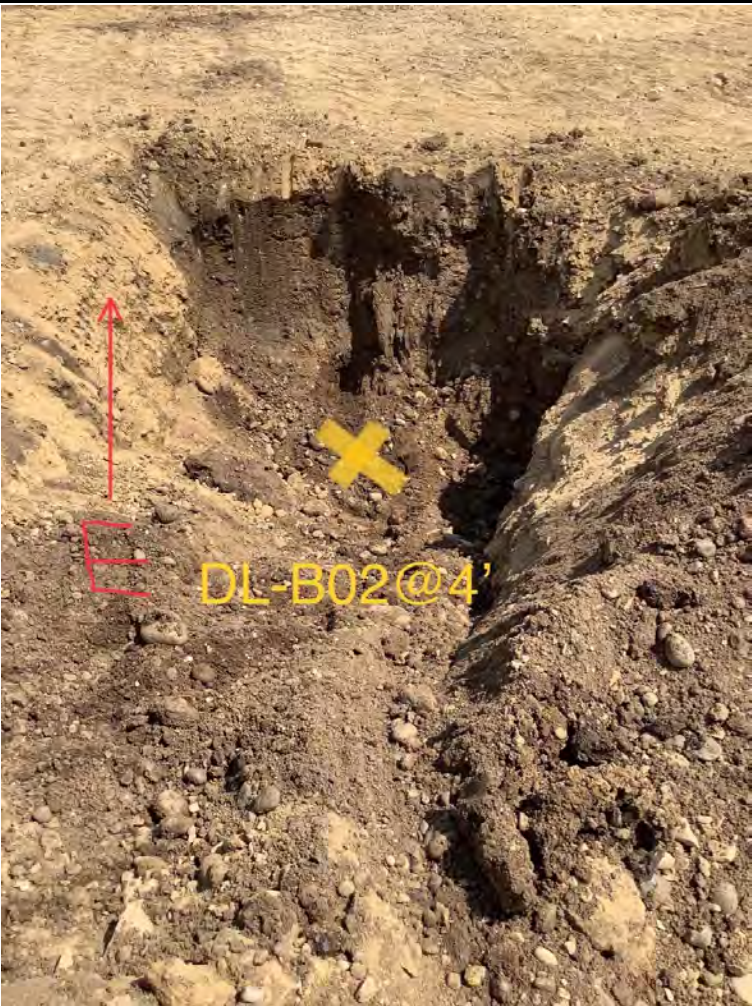
Equipment ID:		Equipment Type:		Equipment ID:	
Equipment Type:		Equipment ID:		Equipment Type:	
Material:	Volume:	Contents:	Material:	Volume:	Contents:
Notes/Conditions: DL-B02@4' Facing East			Notes/Conditions:
