Final Reclamation Inspection

Operator: KERR MCGEE OIL & GAS ONSHORE LP #47120

Location ID: 332988

Inspection Photos
Location Name: FRANK-65N67W 6SESW
Location ID: 332988

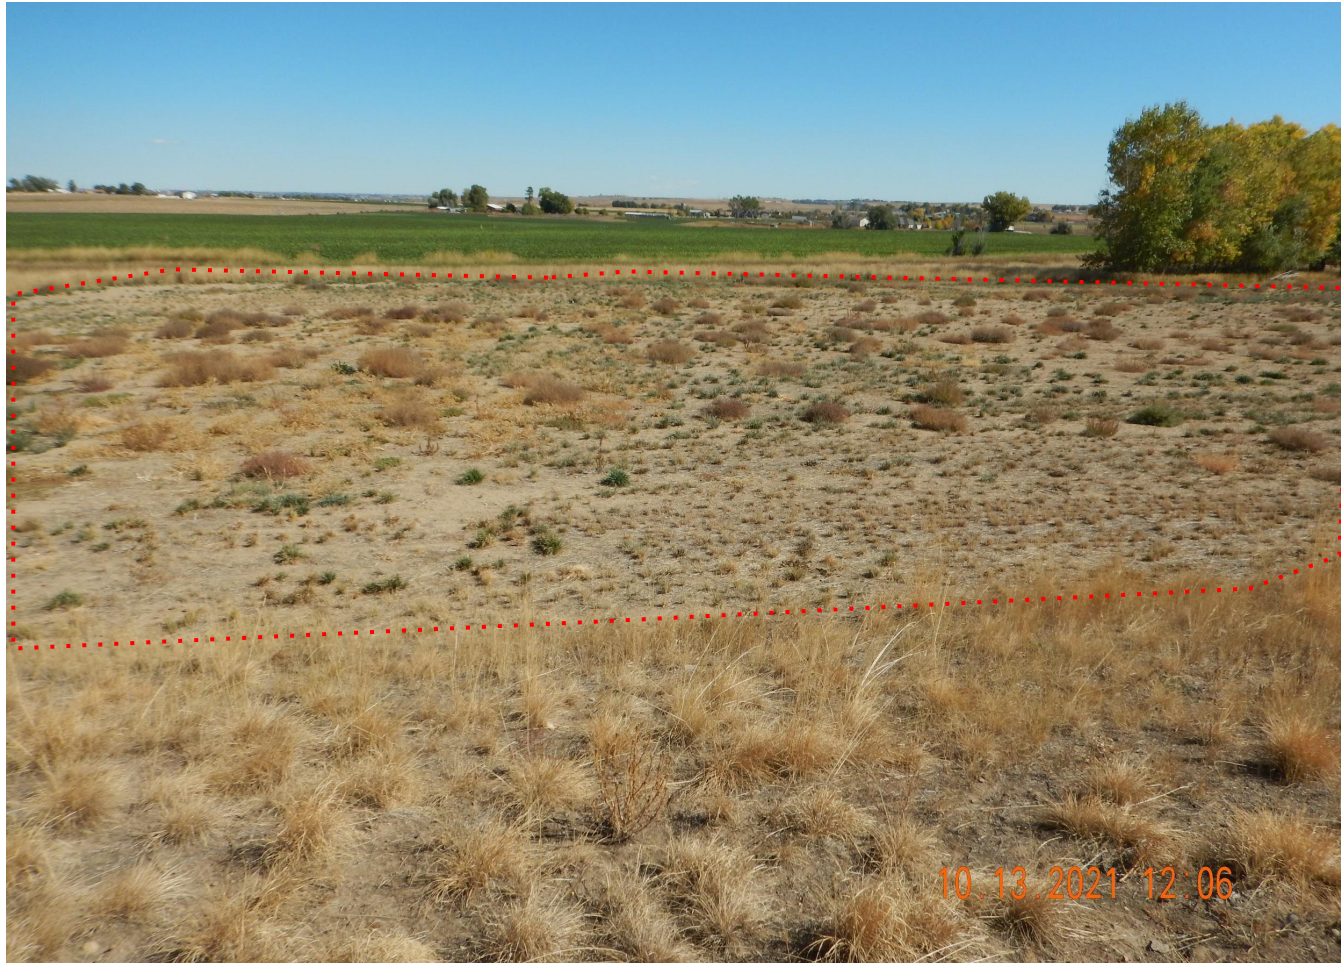
Photo 1. Photo taken west of location, facing East. Photo illustrates all equipment has been removed and final reclamation activities have been completed

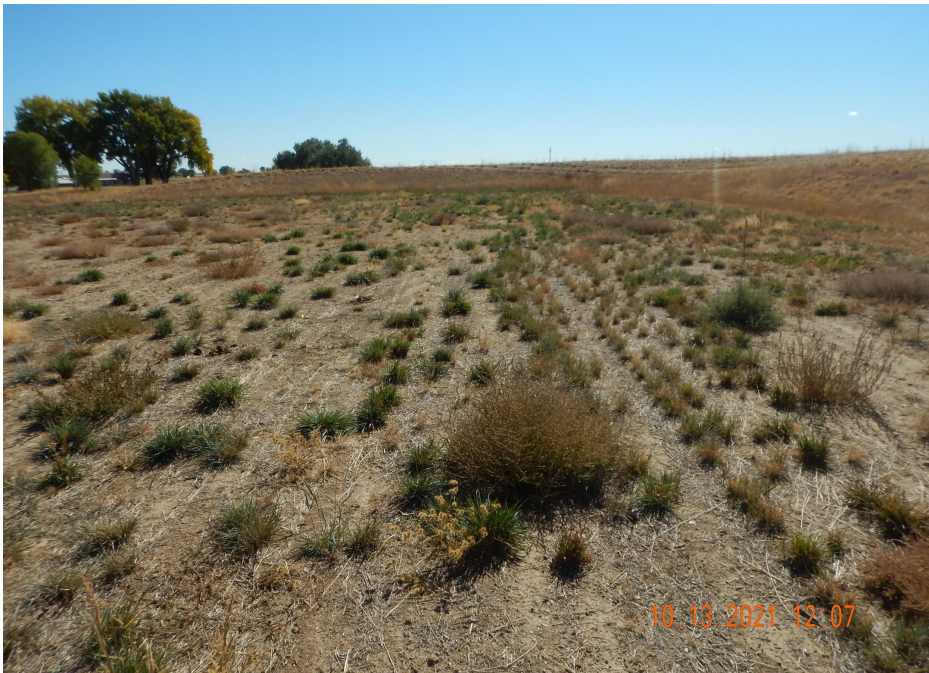
Photo 2. Photo taken from the western location, facing South. Photo illustrates the establishment of desirable plant species but bare areas were observed throughout the location. Some undesirable species, tumbleweeds, were observed and will need to be managed.

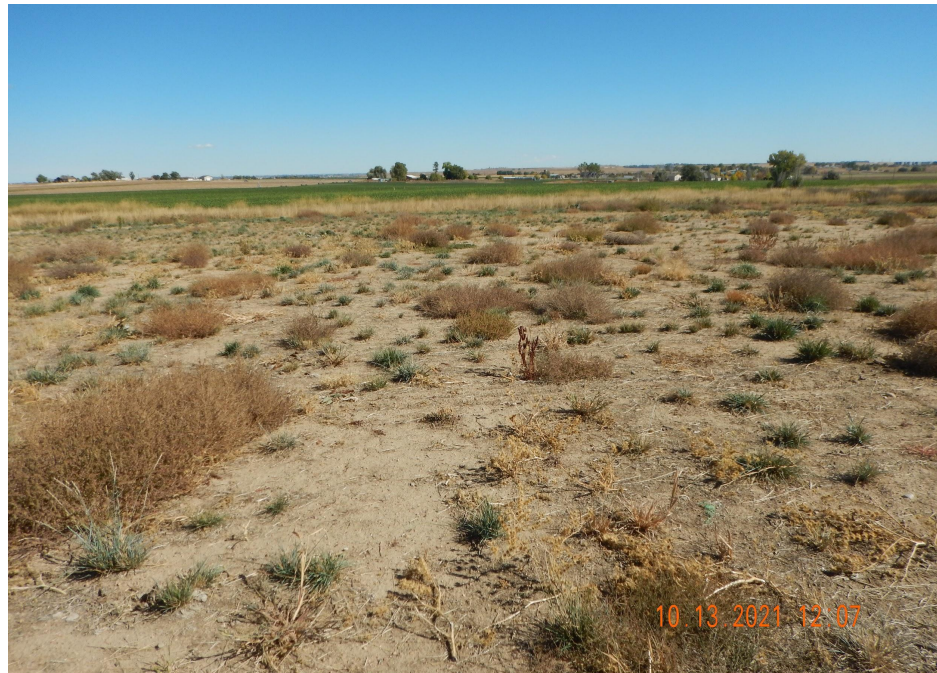
Photo 3. Photo taken from the north-central location, facing East. See comments under Photo 2.

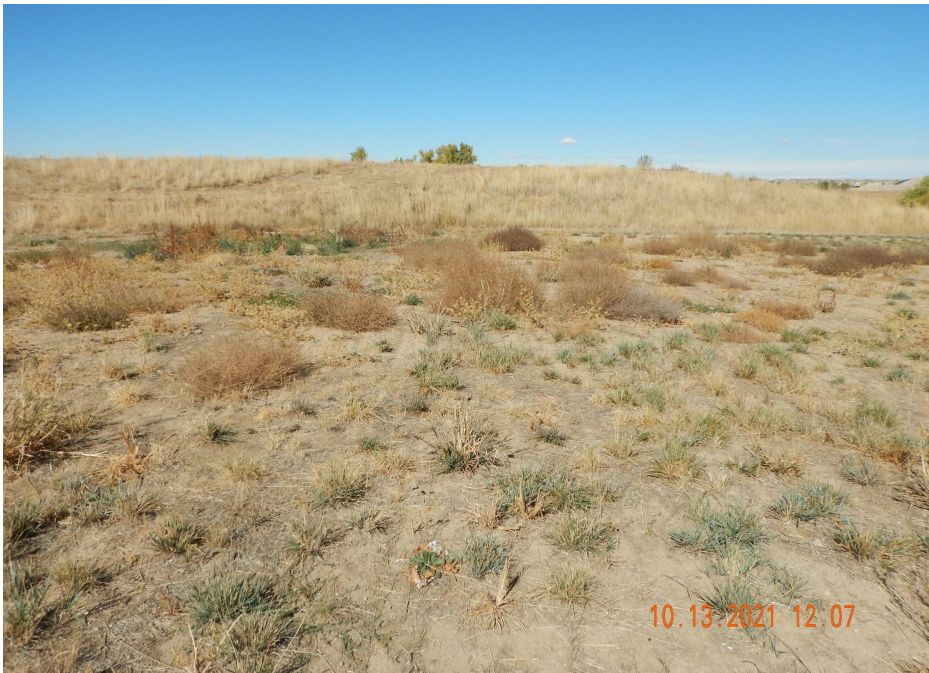
Photo 4. Photo taken from the north-central location, facing North. See comments under Photo 2.

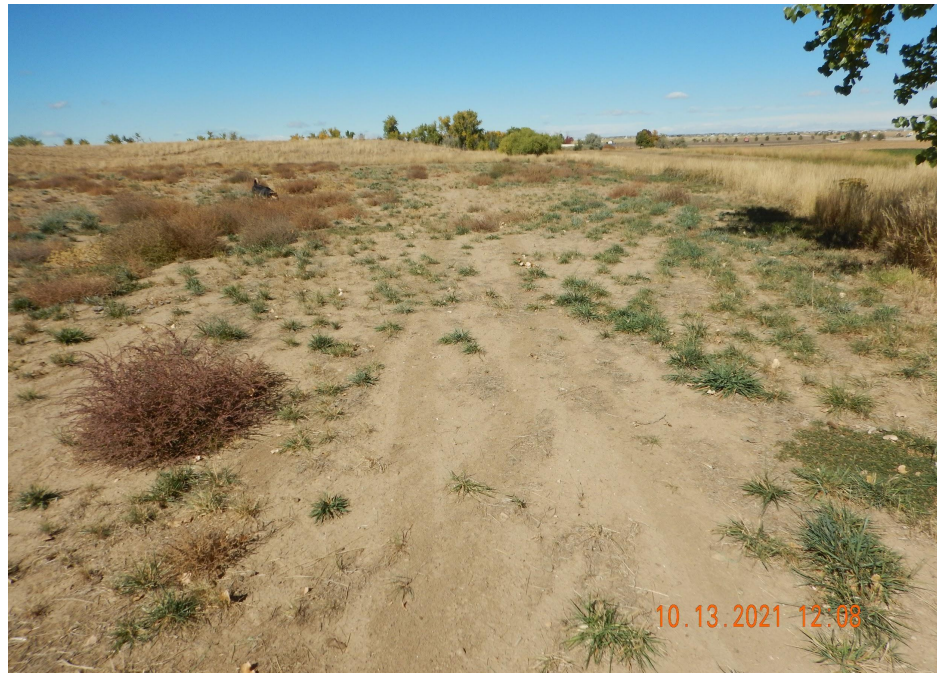
Photo 5. Photo taken from the eastern location, facing North. See comments under Photo 2.

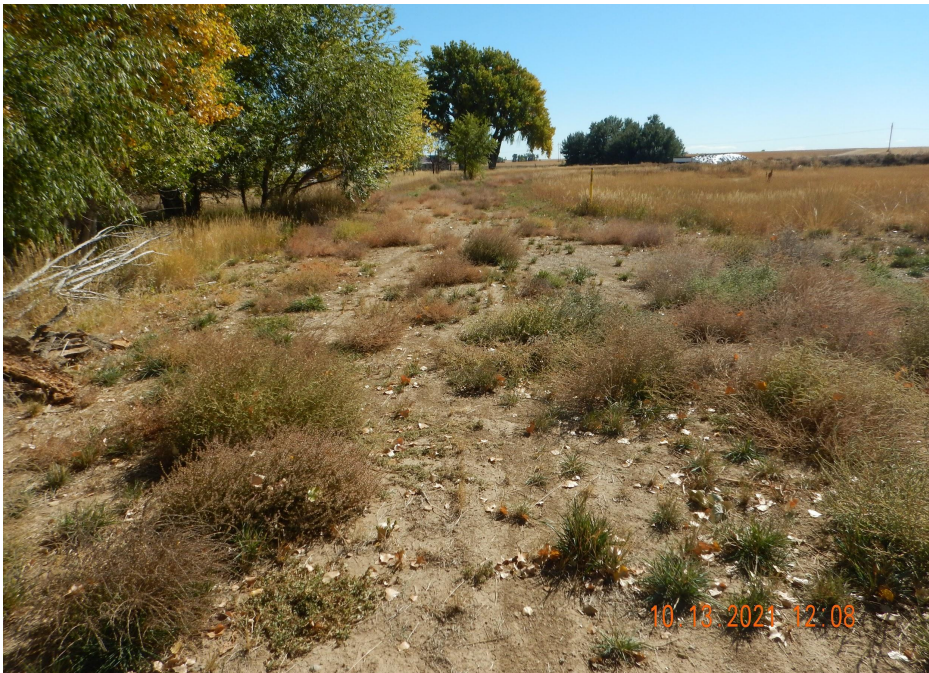
Photo 6. Photo taken from the eastern location, facing South. Photo illustrates undesirable plant establishment with some desirable species throughout most of the access road.

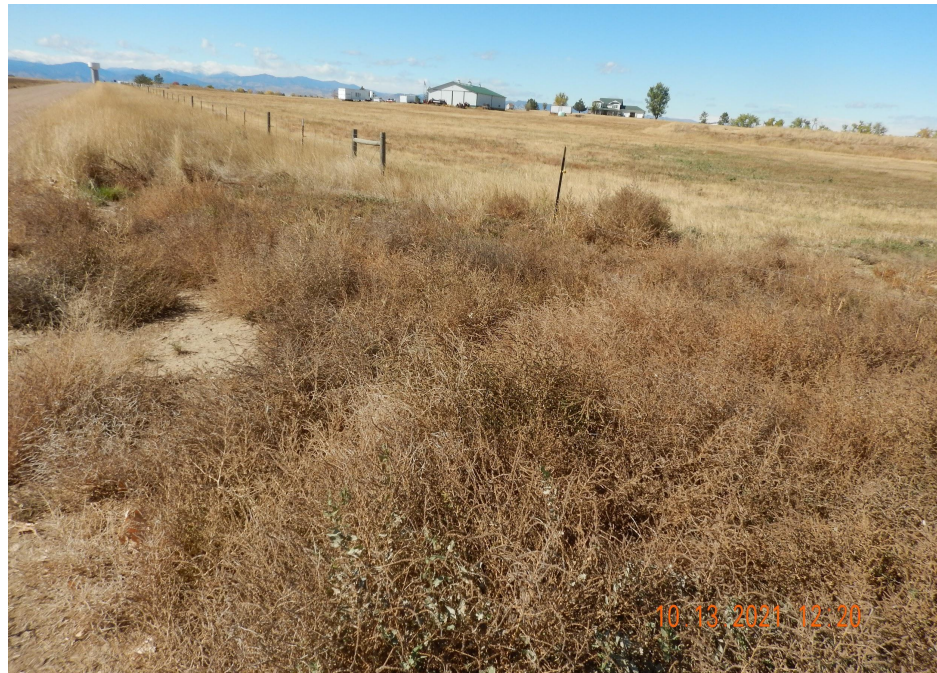
Photo 7. Photo taken from the entrance of location off CR60, facing West. Photo illustrates undesirable plant establishment with little to no establishment of desirable species.

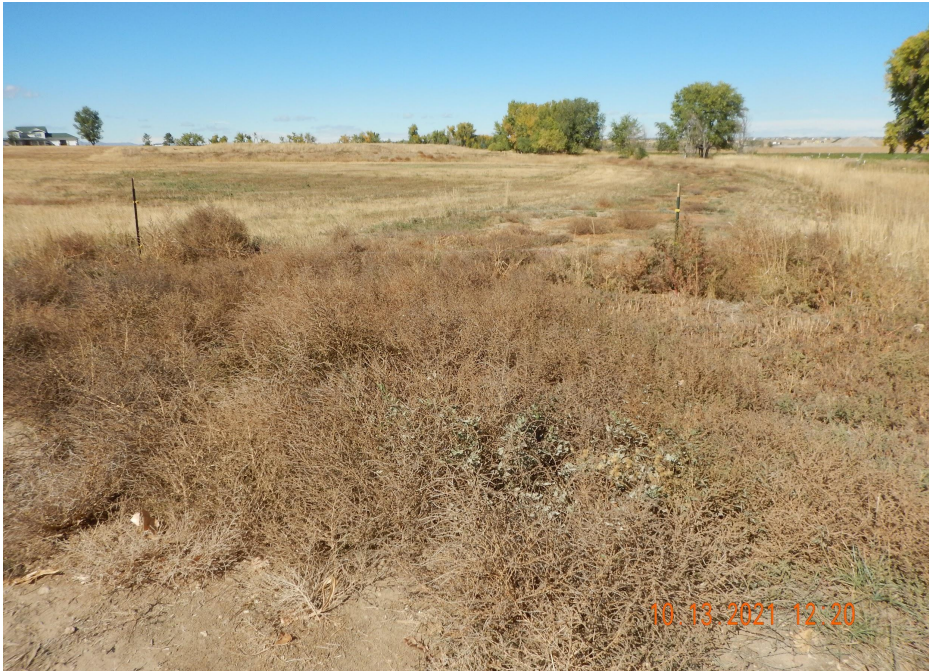
Photo 8. Photo taken from the entrance of location off CR60, facing North. See comments under Photo 7.

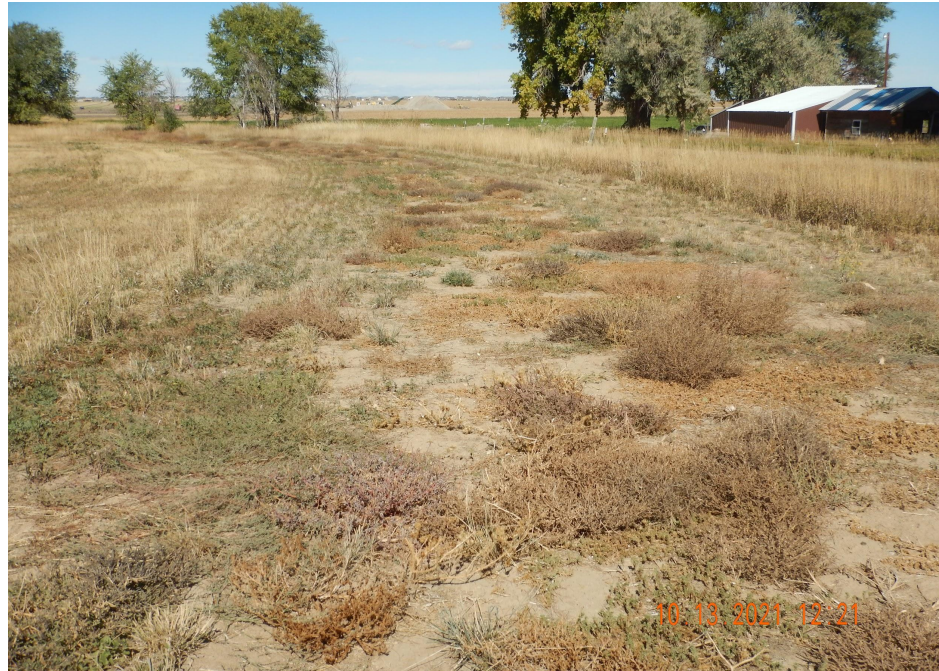
Photo 9. Photo taken from the southern access road, facing North. See comments under Photo 6.

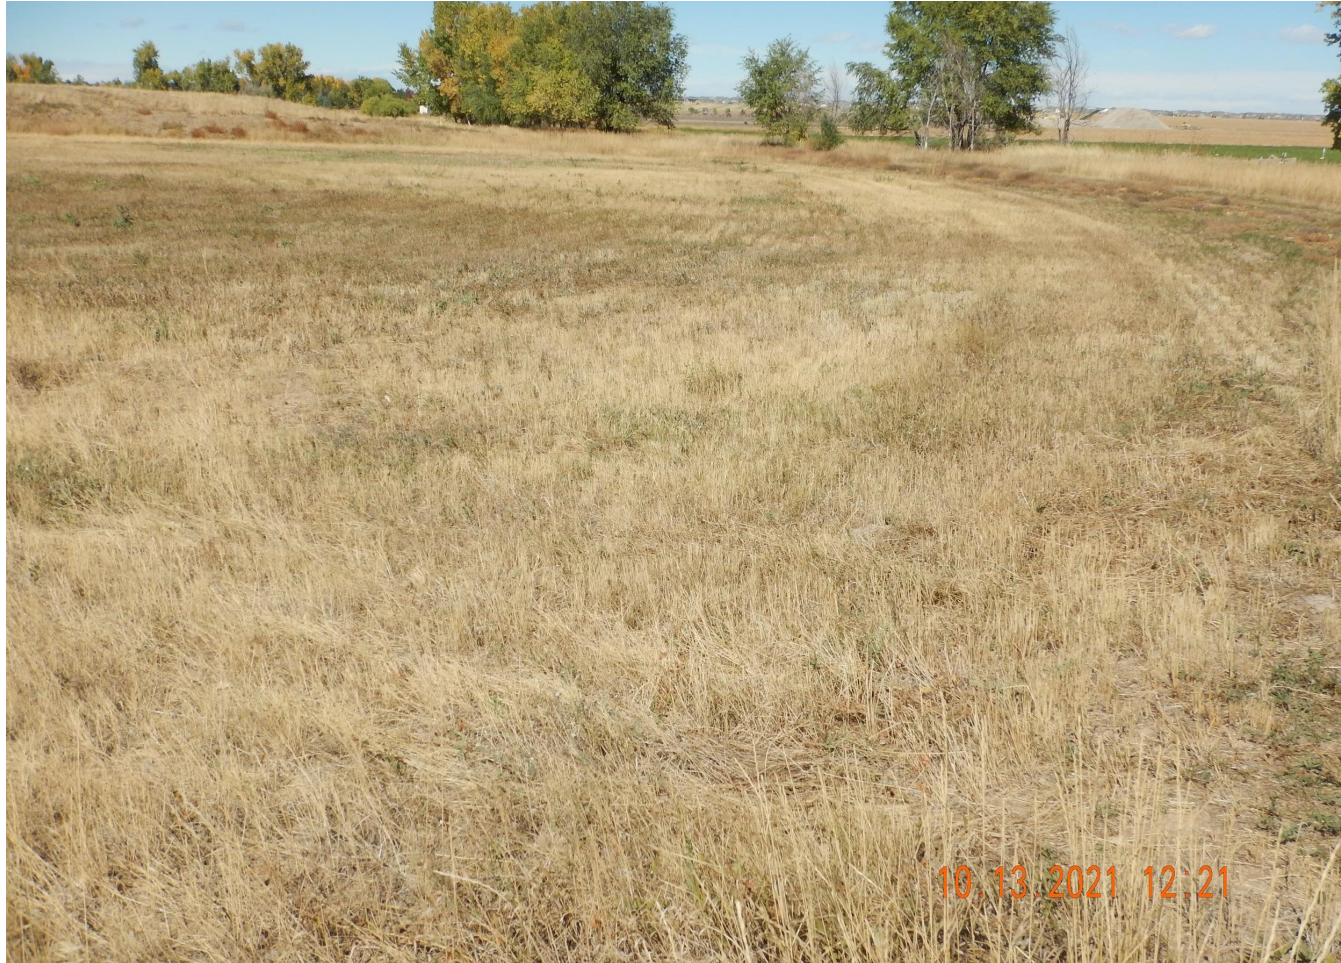
Photo 10. Reference photo taken west of the access road, facing North. Photo illustrates reference vegetative levels compared to reclamation areas.
