Inspection Photos

Operator: CAERUS PICEANCE LLC - 10456

Location ID: 334336

Garfield County, CO

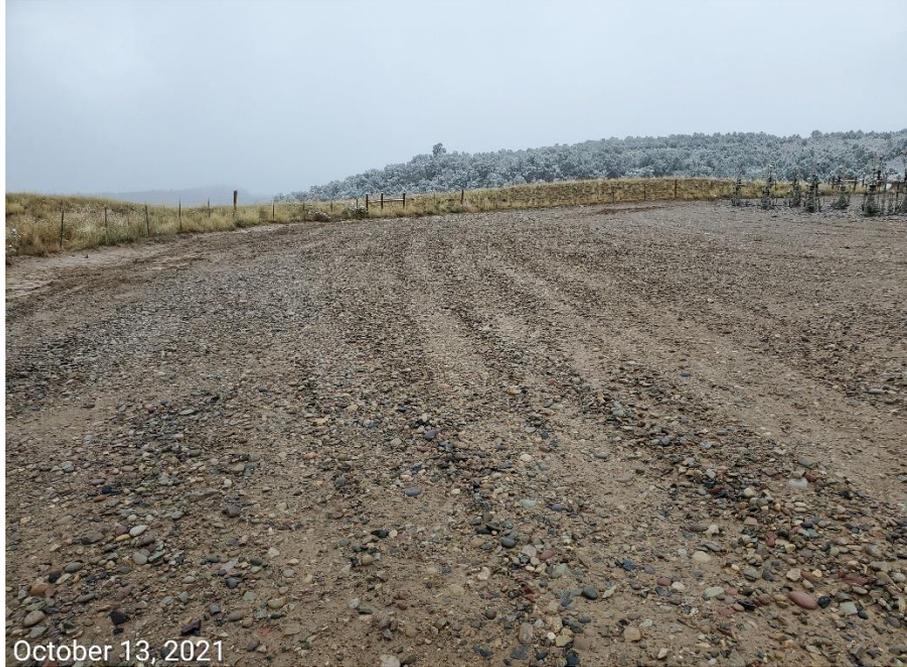
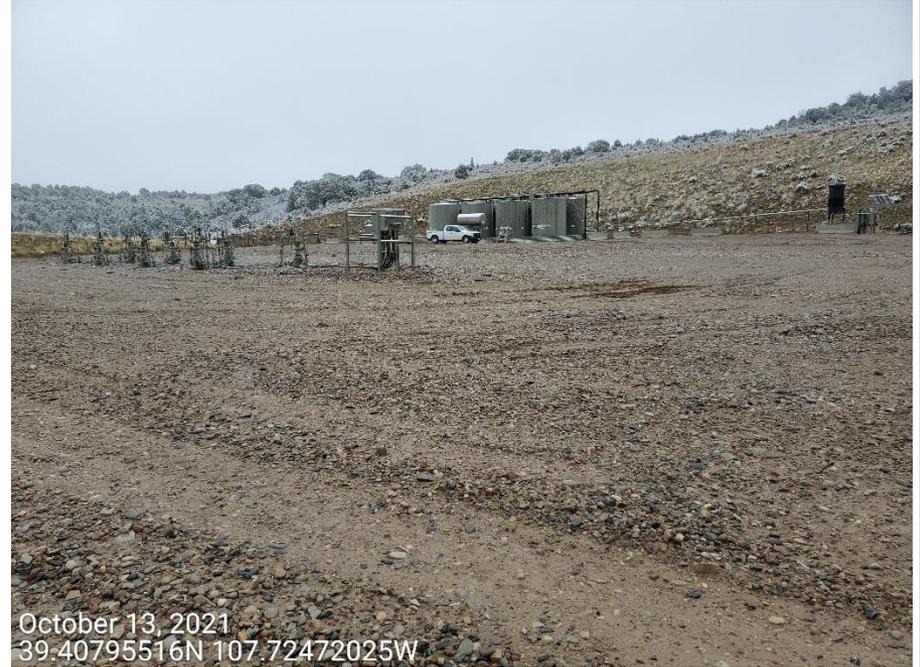
Photo 1: Photos 1-2 provide an overview from the northwest end of the Location facing northeast, east, southeast to south.

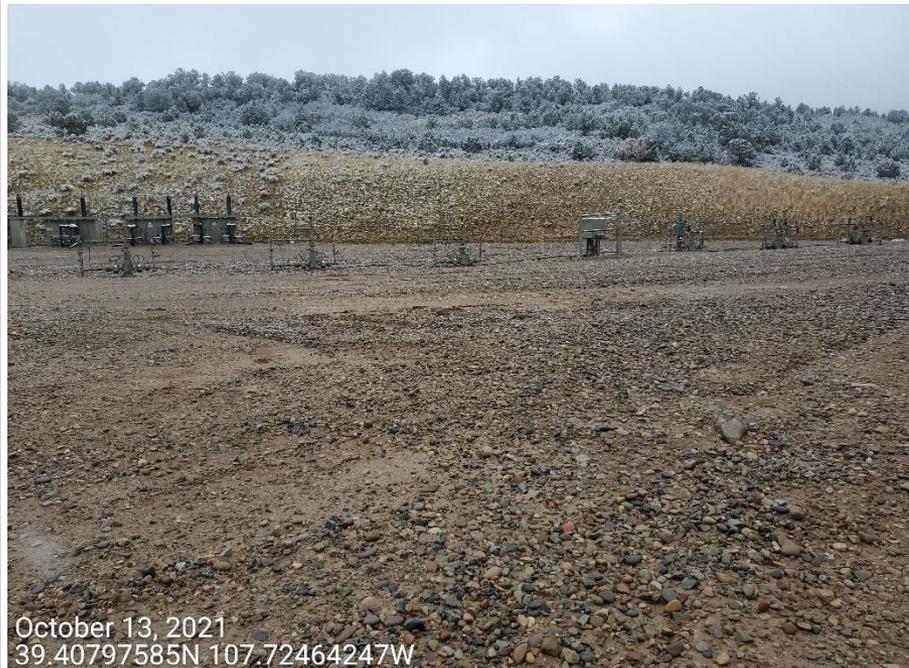
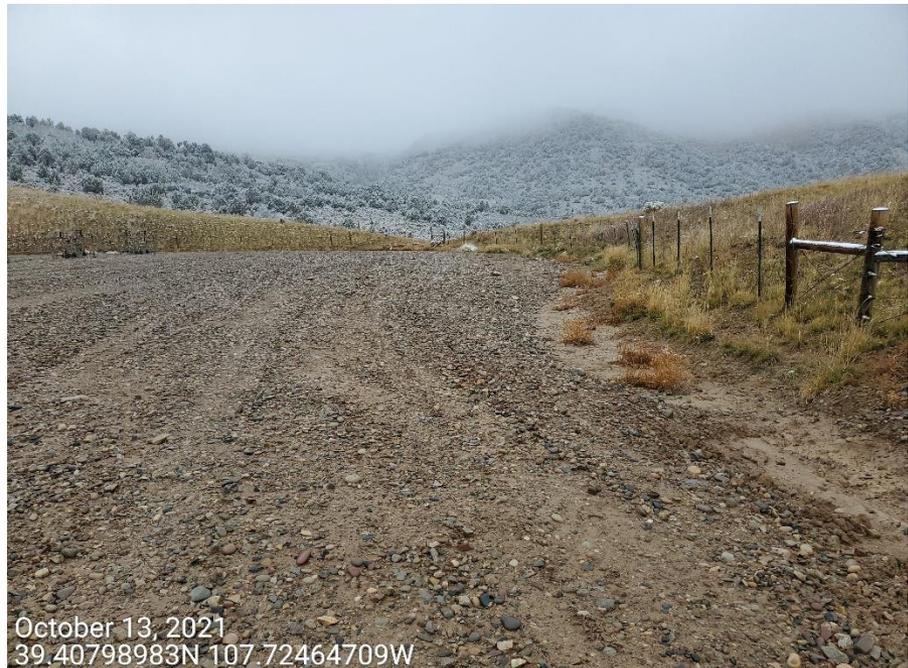
Photo 2: See comments under photo 1.

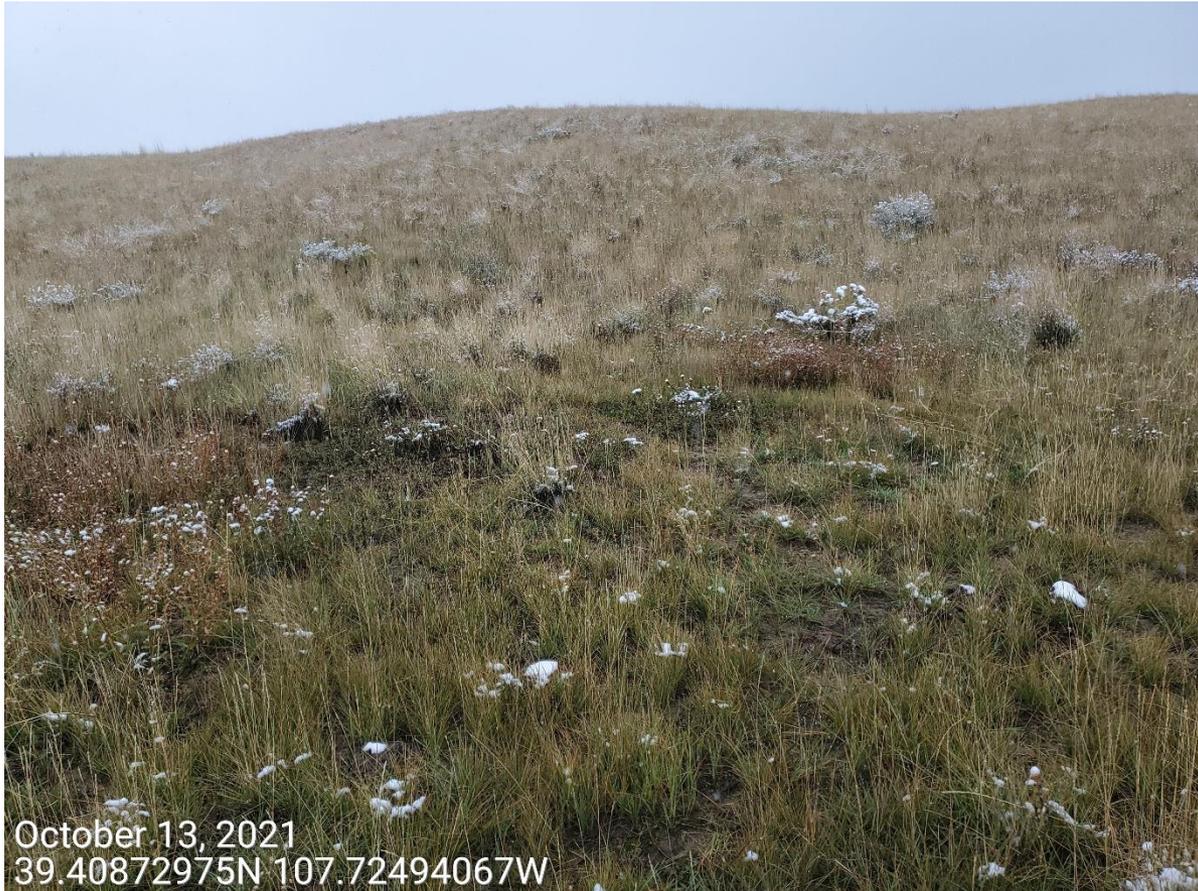
Photo 3: Photo taken from eastern interim areas of the Location; photos provide example of the observed reclamation. It is noted that though interim areas of the Location have achieved a uniform perennial vegetative establishment, species observed established on the interim areas of the Location are predominantly introduced, and not reflective of the reference area,

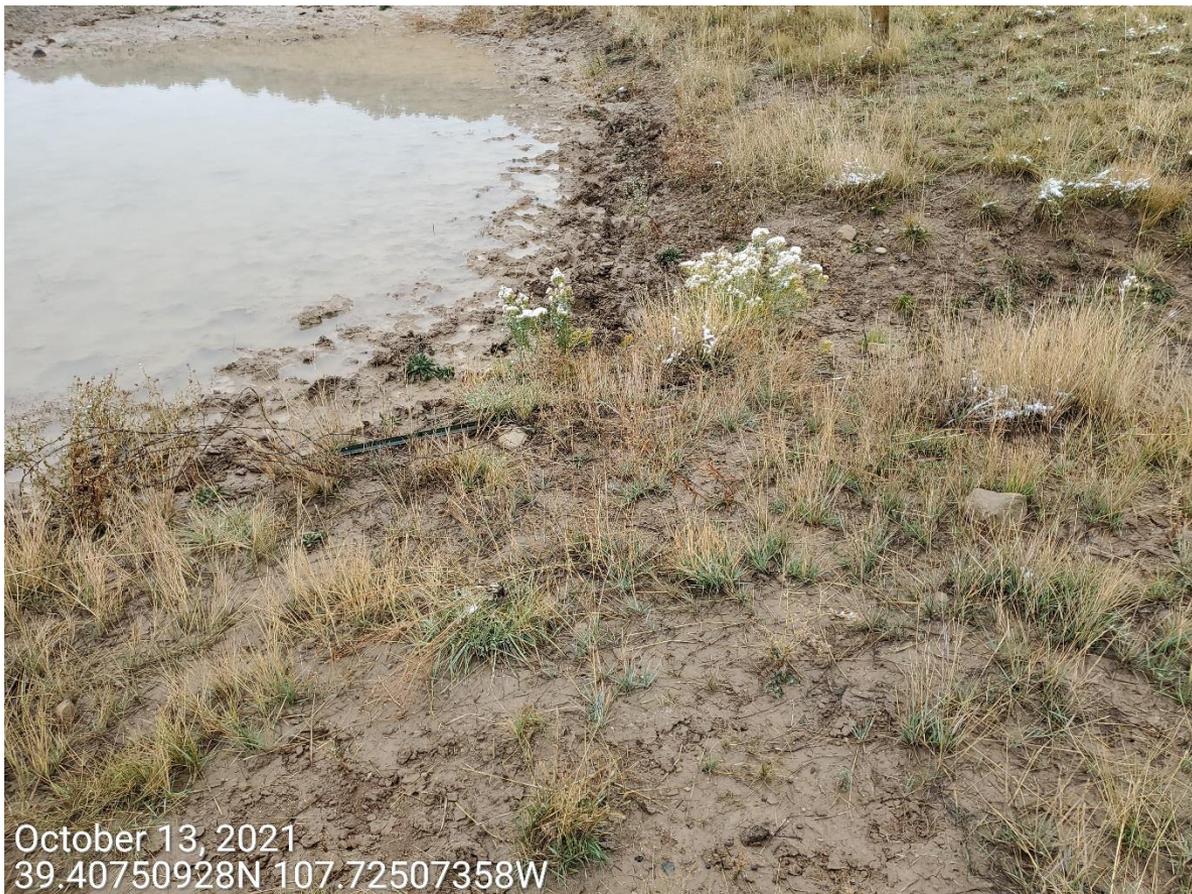
Photo 4: Photo taken from the sediment trap on the southwest end of the Location. Photo shows fence adjacent to the BMP is in disrepair. Photo also shows trap has not been constructed with an appropriate outlet to allow for sediment laden-free stormwater discharge.

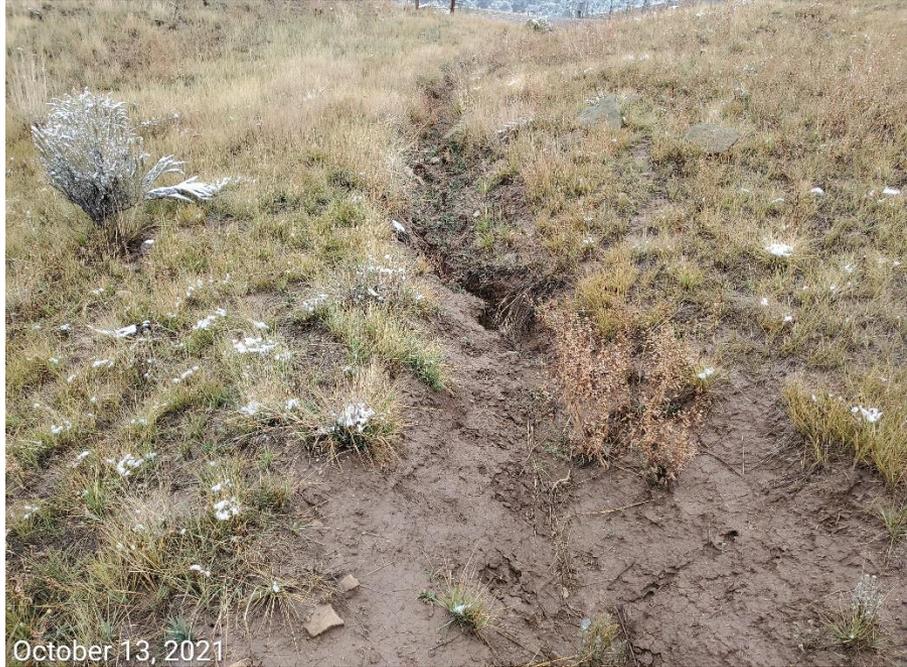
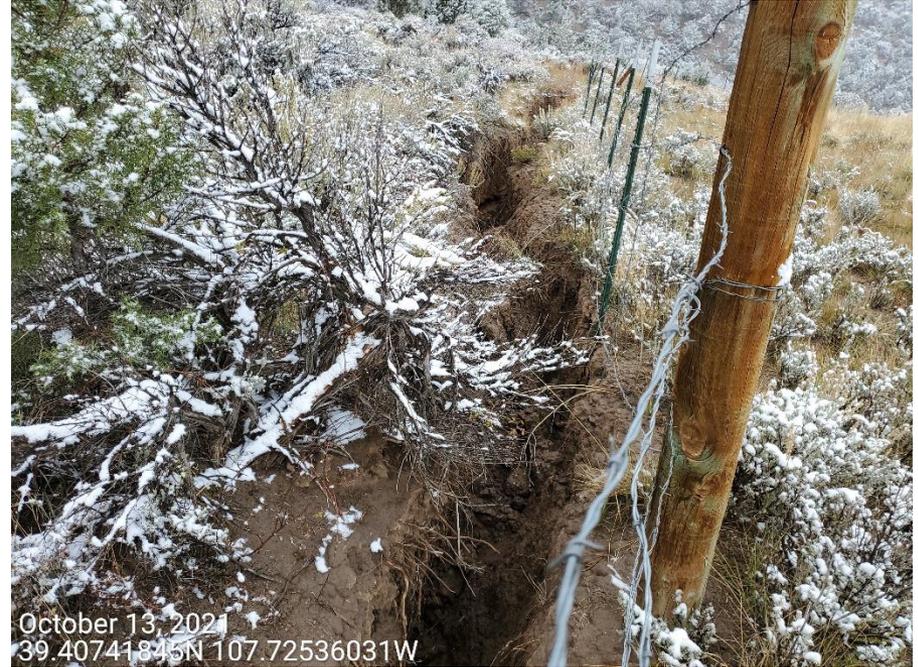
Photo 5: Photos taken from the stormwater ditch southwest of the Location; ditch travels west/southwest from the Location. At fence line, ditch appears to travel 90 degrees northwest along the fenceline. Photos shows stormwater diversion ditch has not been constructed or maintained in accordance with good engineering practices; sediment trap and ditch have not been constructed with an appropriate outlet; Photos shows stormwater runoff has resulted in degradation (incising and a gully formation) within the ditch and offsite sediment transport.

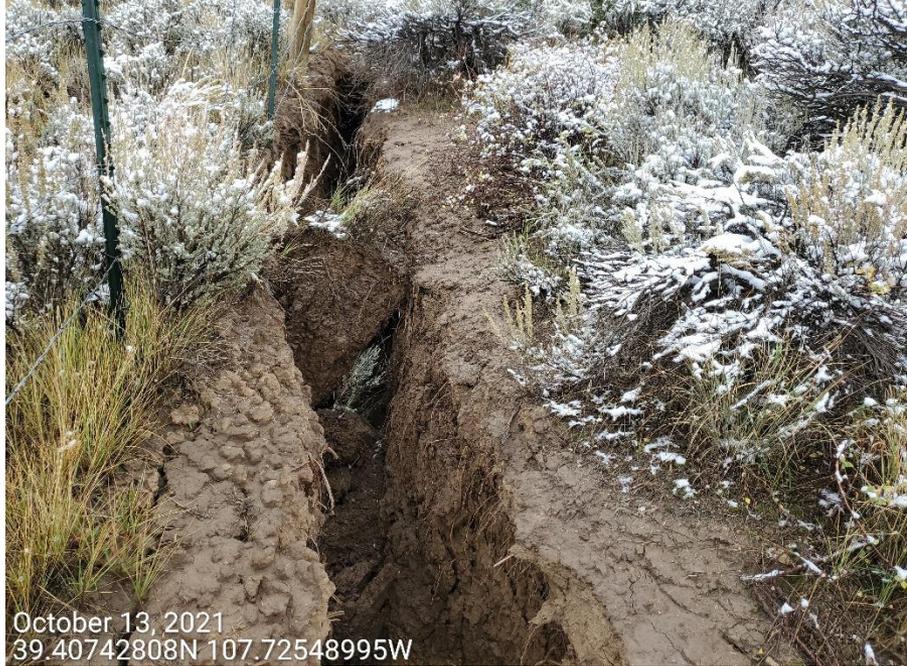
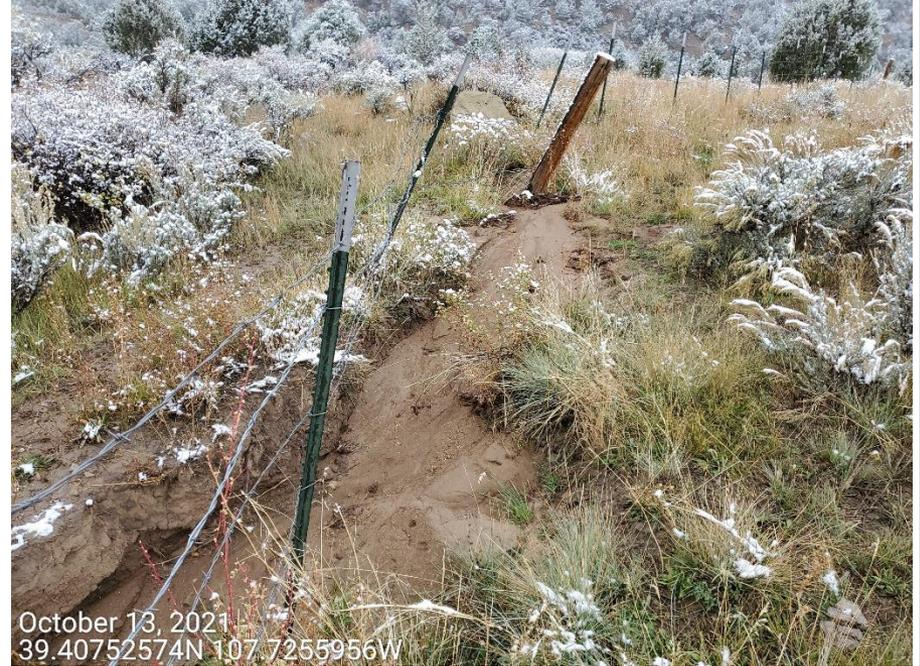
Photo 6: Continued from photo 5. Photos show gully erosion degradation within the ditch due to runoff, as well as sediment transport and deposition.

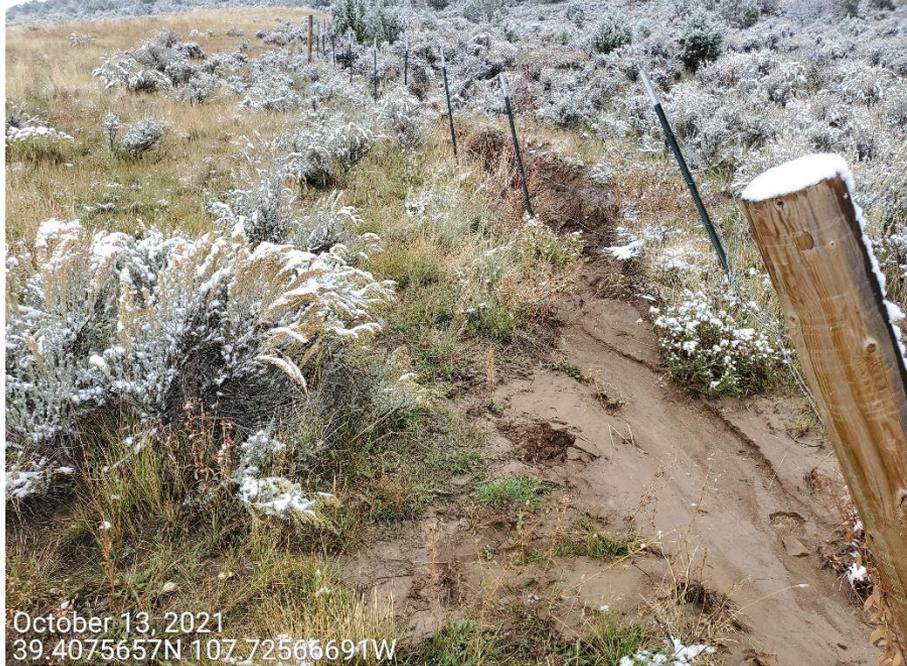
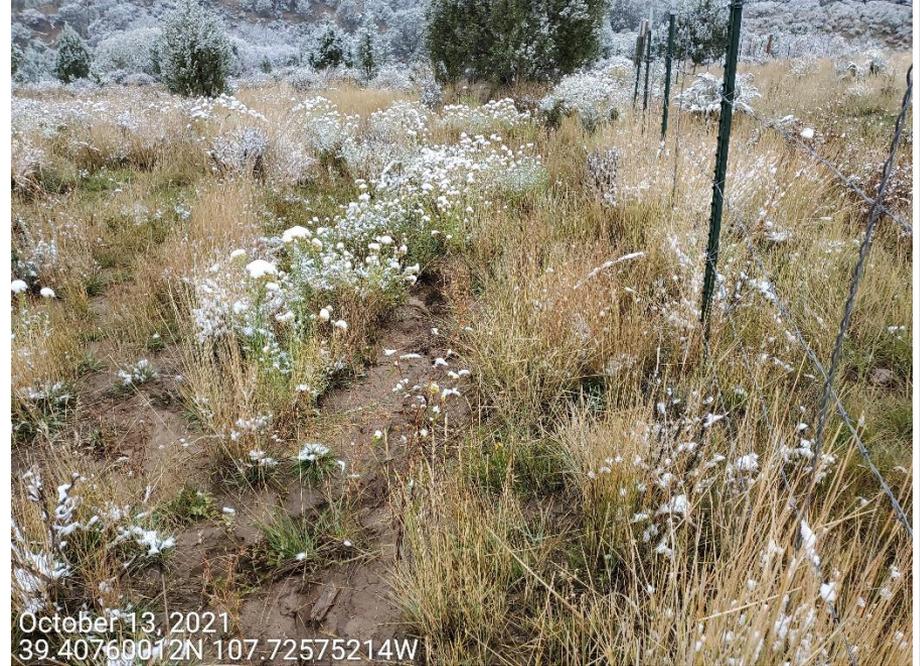
Photo 7: Continued from photo 5. Photos show gully erosion degradation within the ditch due to runoff, as well as sediment transport and deposition.
