TEP  
Broome 1  
Location # 335227

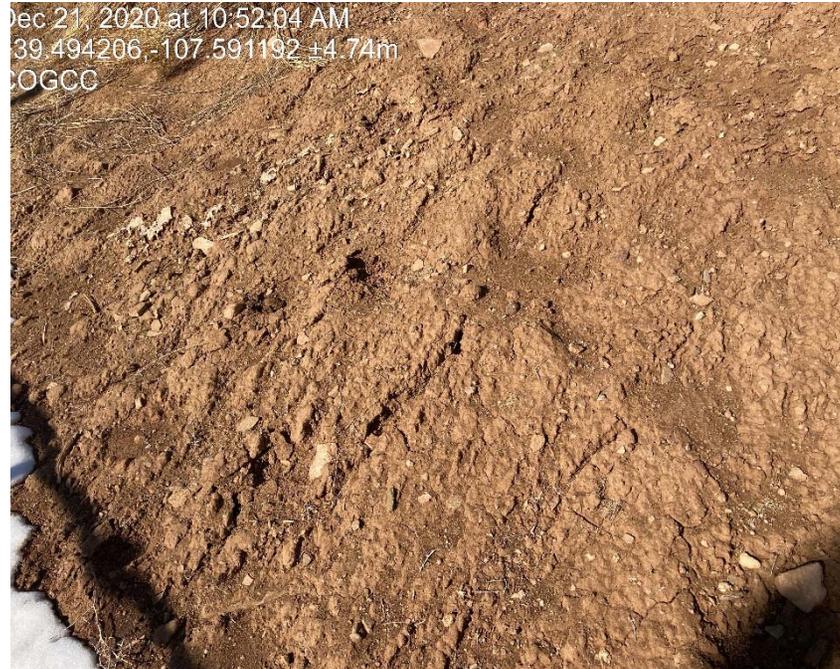
**Photo from first inspection document # 700702048  
of lack of stabilization/erosion**

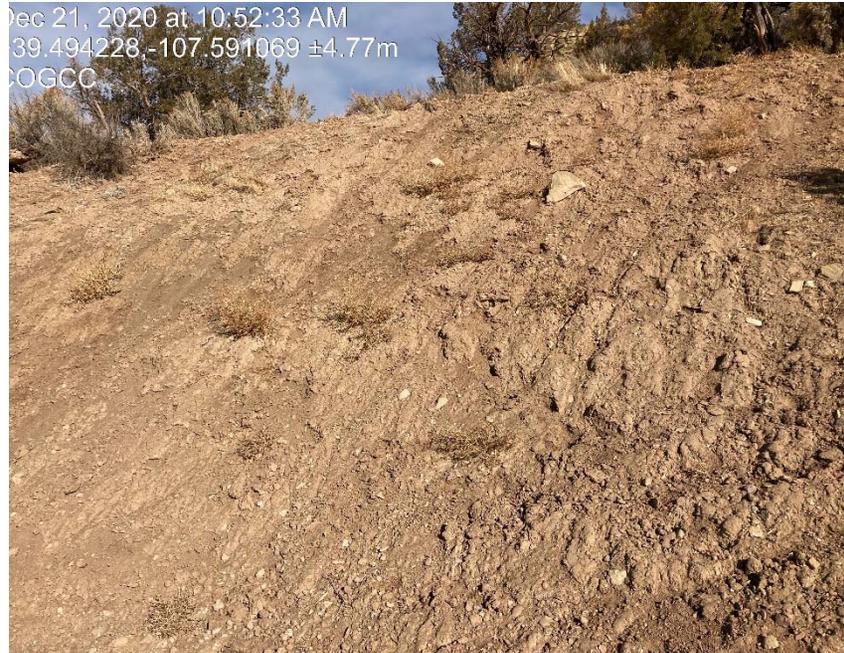
**Photo from first inspection document # 700702048  
of lack of stabilization/erosion**

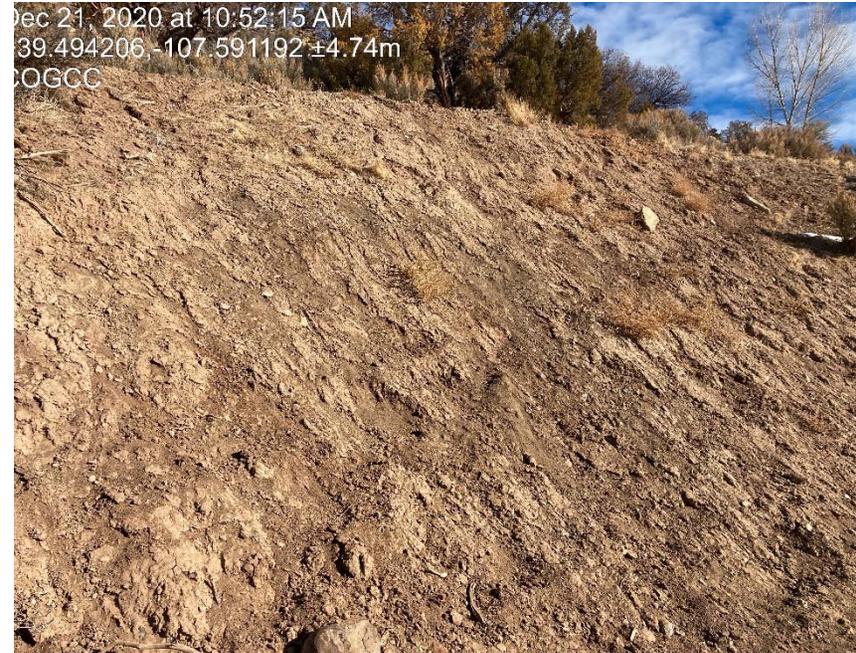
**Photo from first inspection document # 700702048  
of lack of stabilization/erosion**

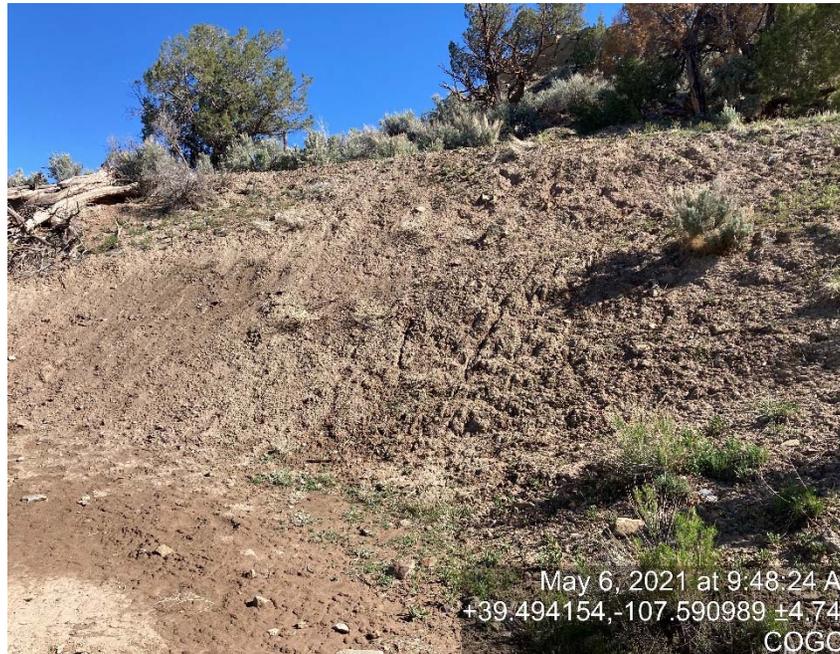
**Photo from second inspection document # 700702702  
of lack of stabilization/erosion**

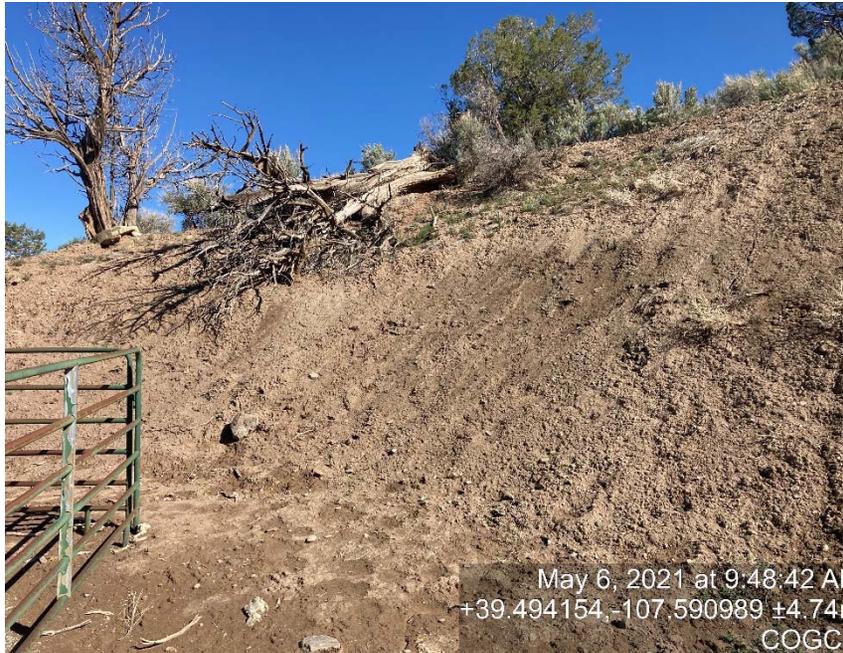
**Photo from second inspection document # 700702702 of lack of stabilization/erosion**

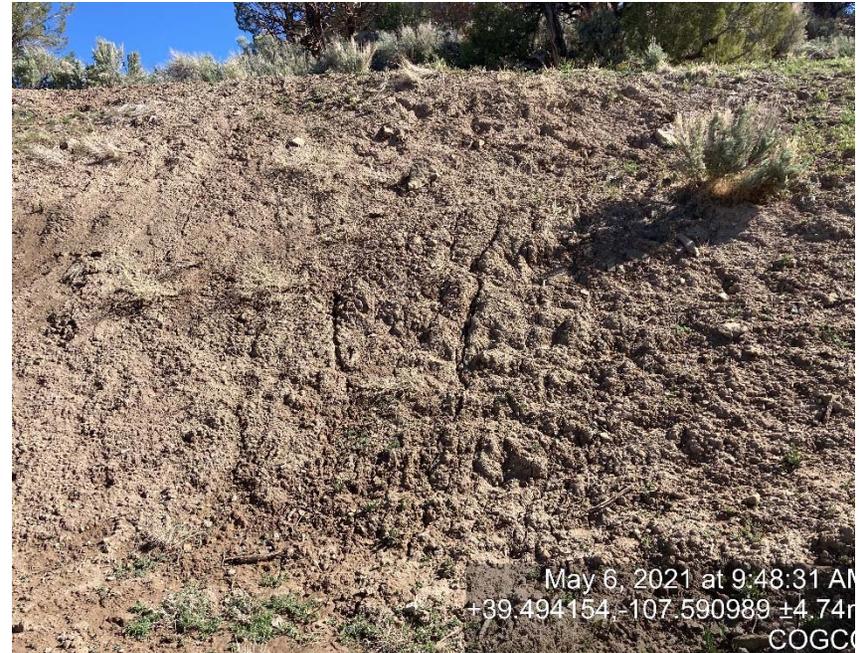
**Photo from second inspection document # 700702702 of lack of stabilization/erosion**

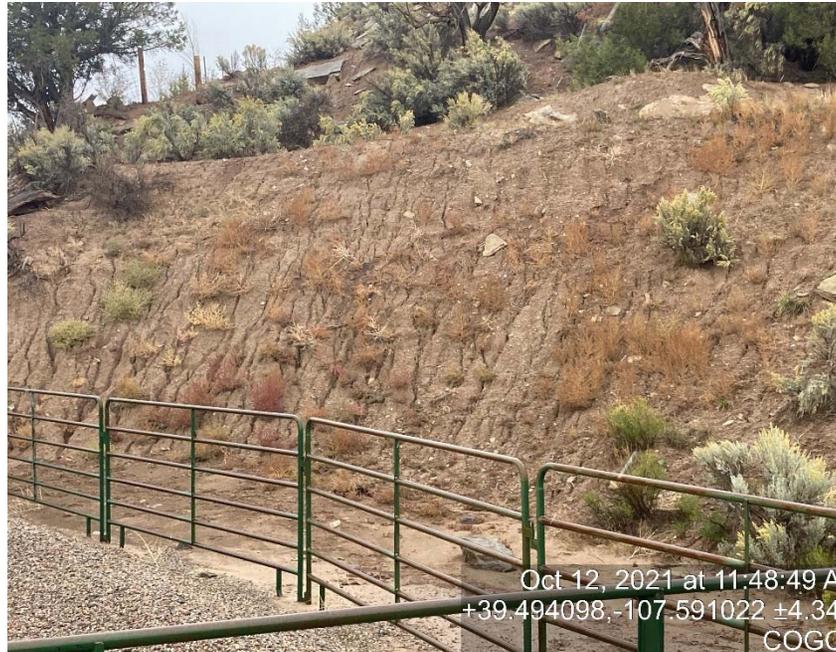
**Photo from third/this inspection document #  
700703365 of lack of stabilization/erosion**

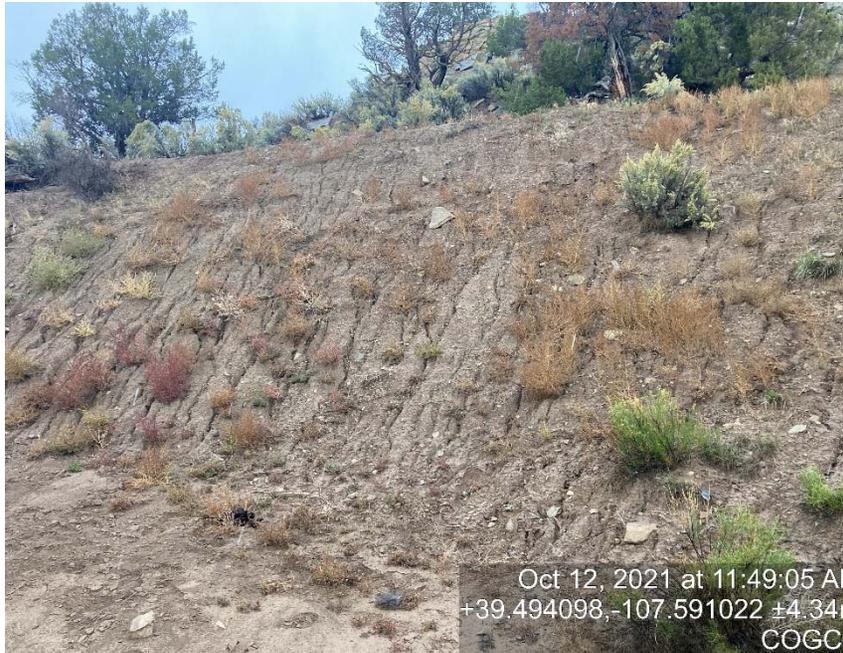
**Photo from third/this inspection document #  
700703365 of lack of stabilization/erosion**

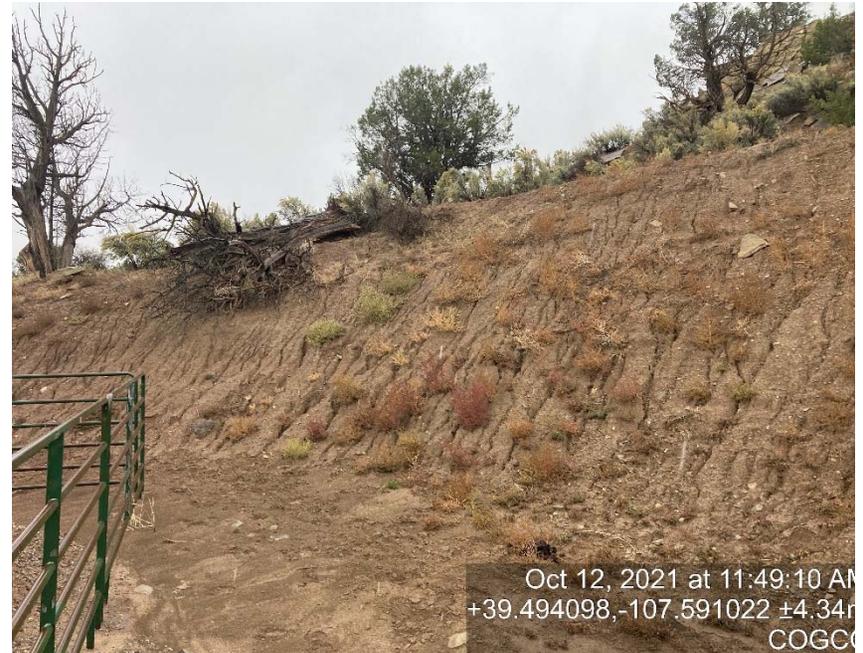
**Photo from third/this inspection document #  
700703365 of lack of stabilization/erosion**

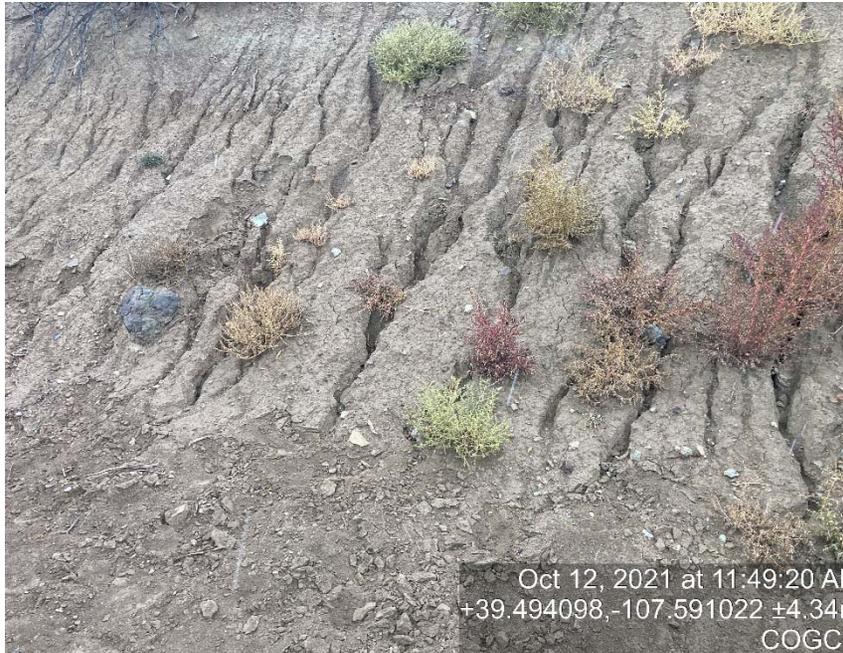
**Photo from third/this inspection document # 700703365 of lack of stabilization/erosion**

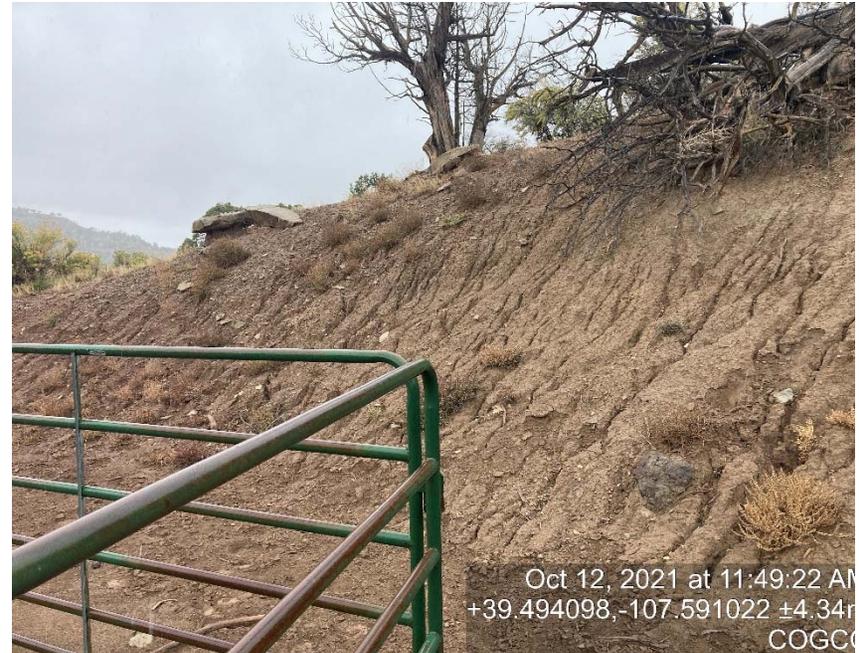
**Photo from third/this inspection document # 700703365 of lack of stabilization/erosion**
