Inspection Photos
Operator: Kinder Morgan
API: 033-06185
Date: 10/11/2021

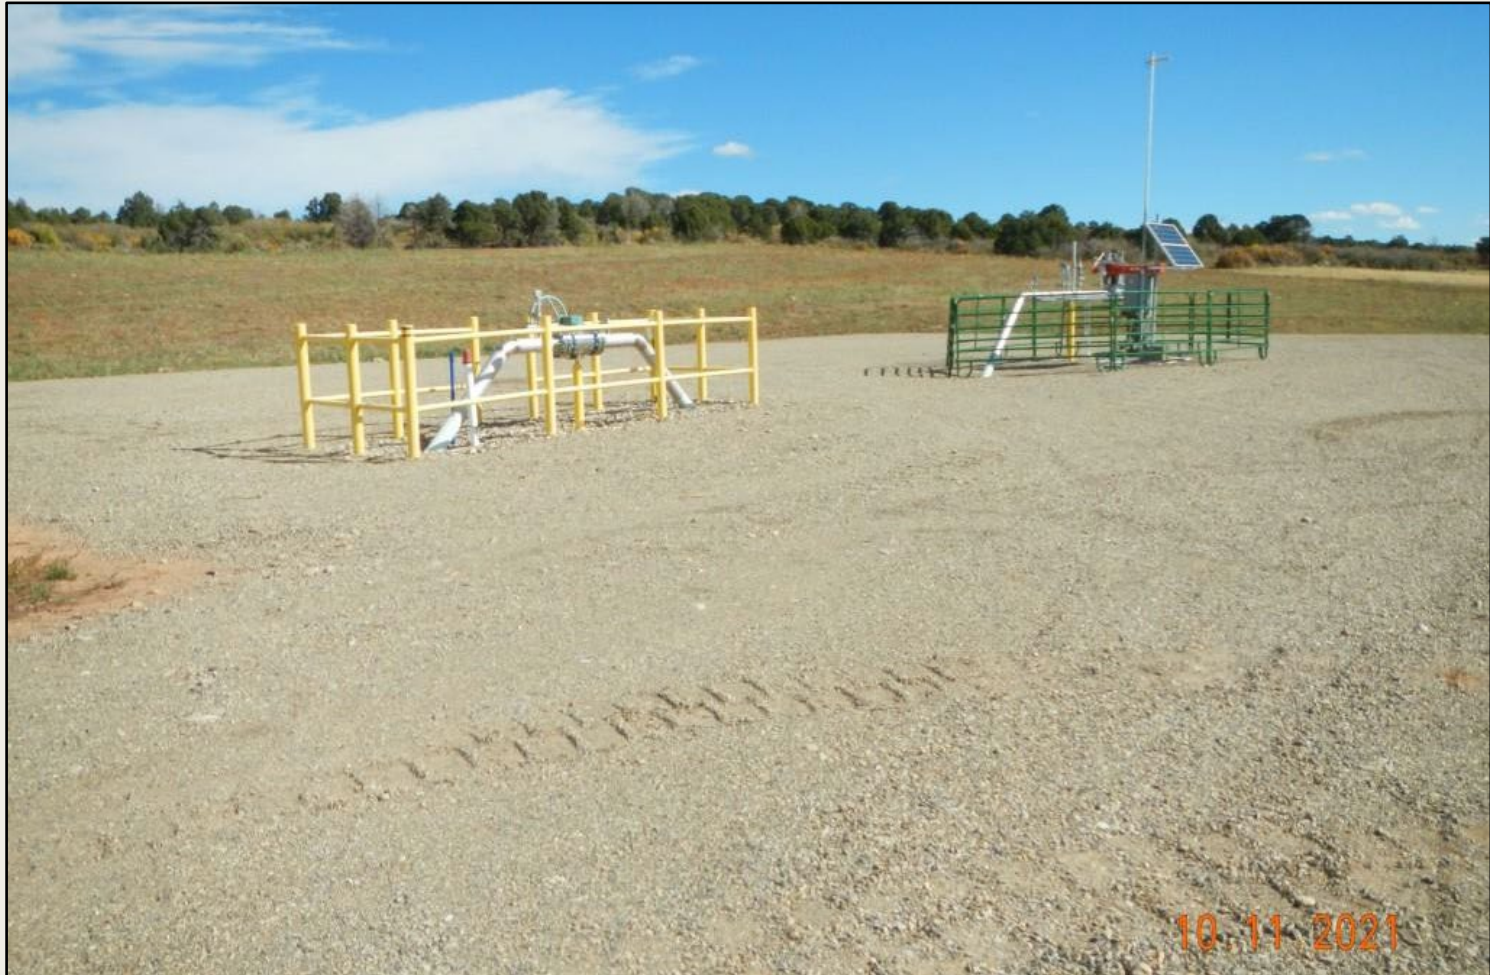
Photo 1. View of project area from the well pad entrance facing center. Well pad is reduced. Interim reclamation areas are revegetating.

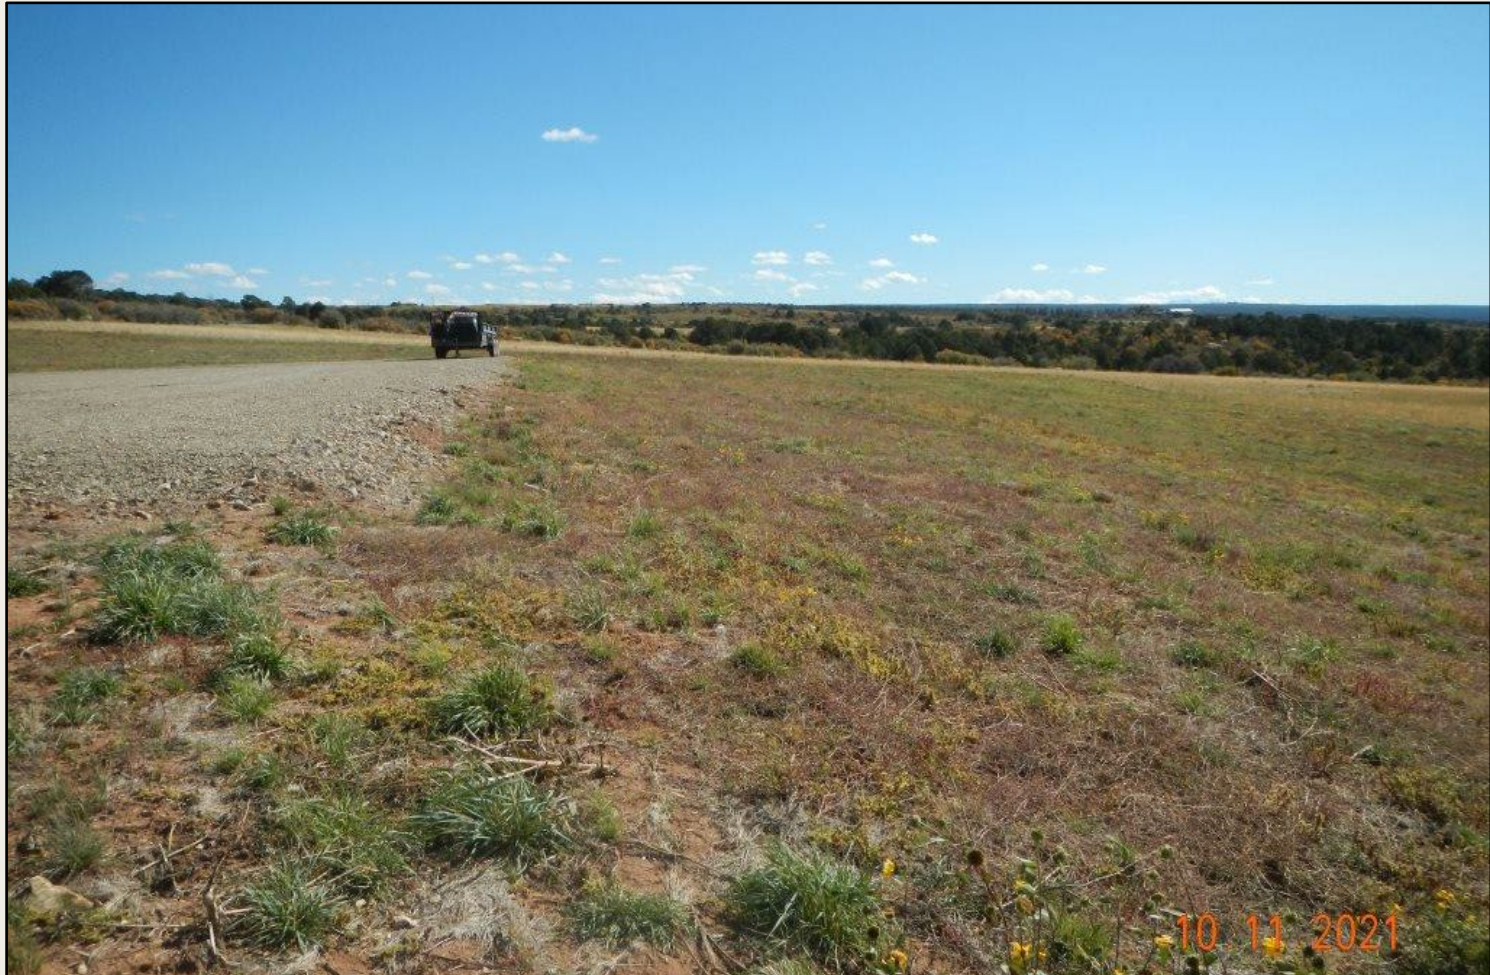
Photo 2. View of the southern fill slope from the southwestern corner facing eastward. Revegetation is progressing with grasses in an early identifiable condition that appears to be intermediate wheatgrass, blue grama, western wheatgrass, as well as forbs such as showy goldeneye, penstemon, and purple asters.

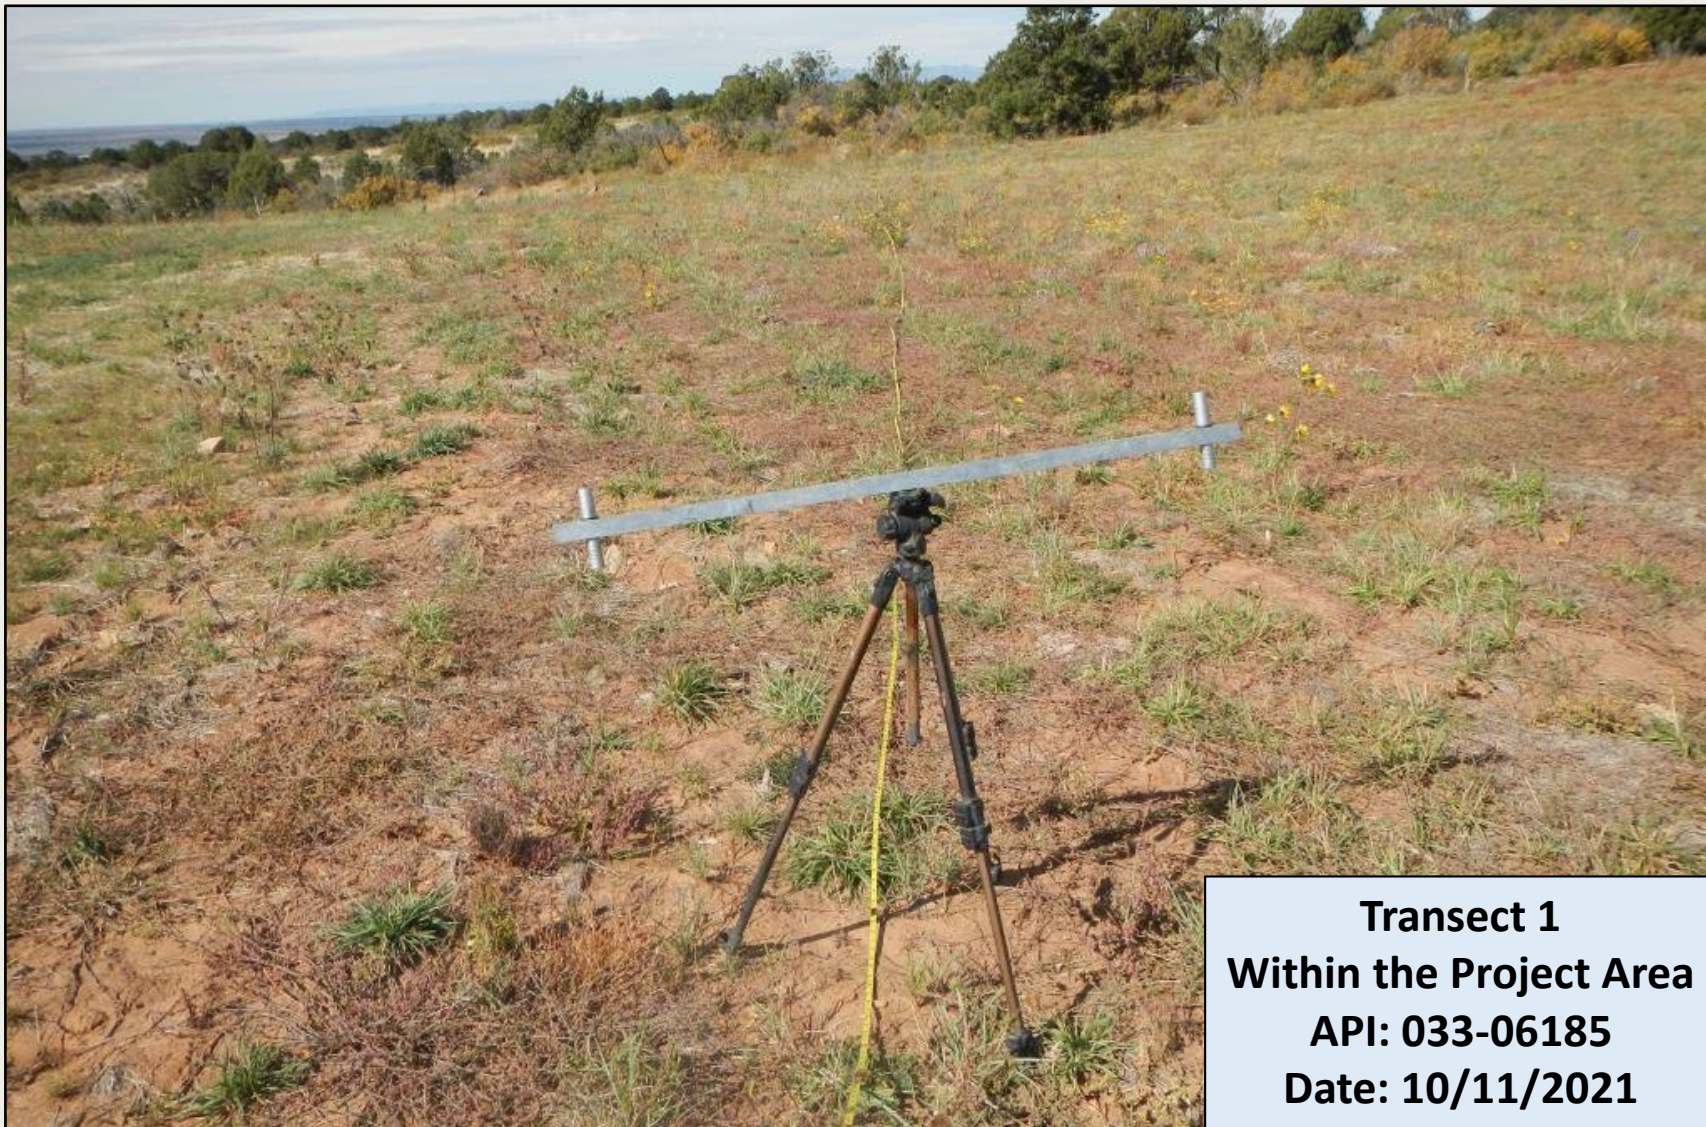
Photo 3. View of the beginning of Transect 1, facing westward.

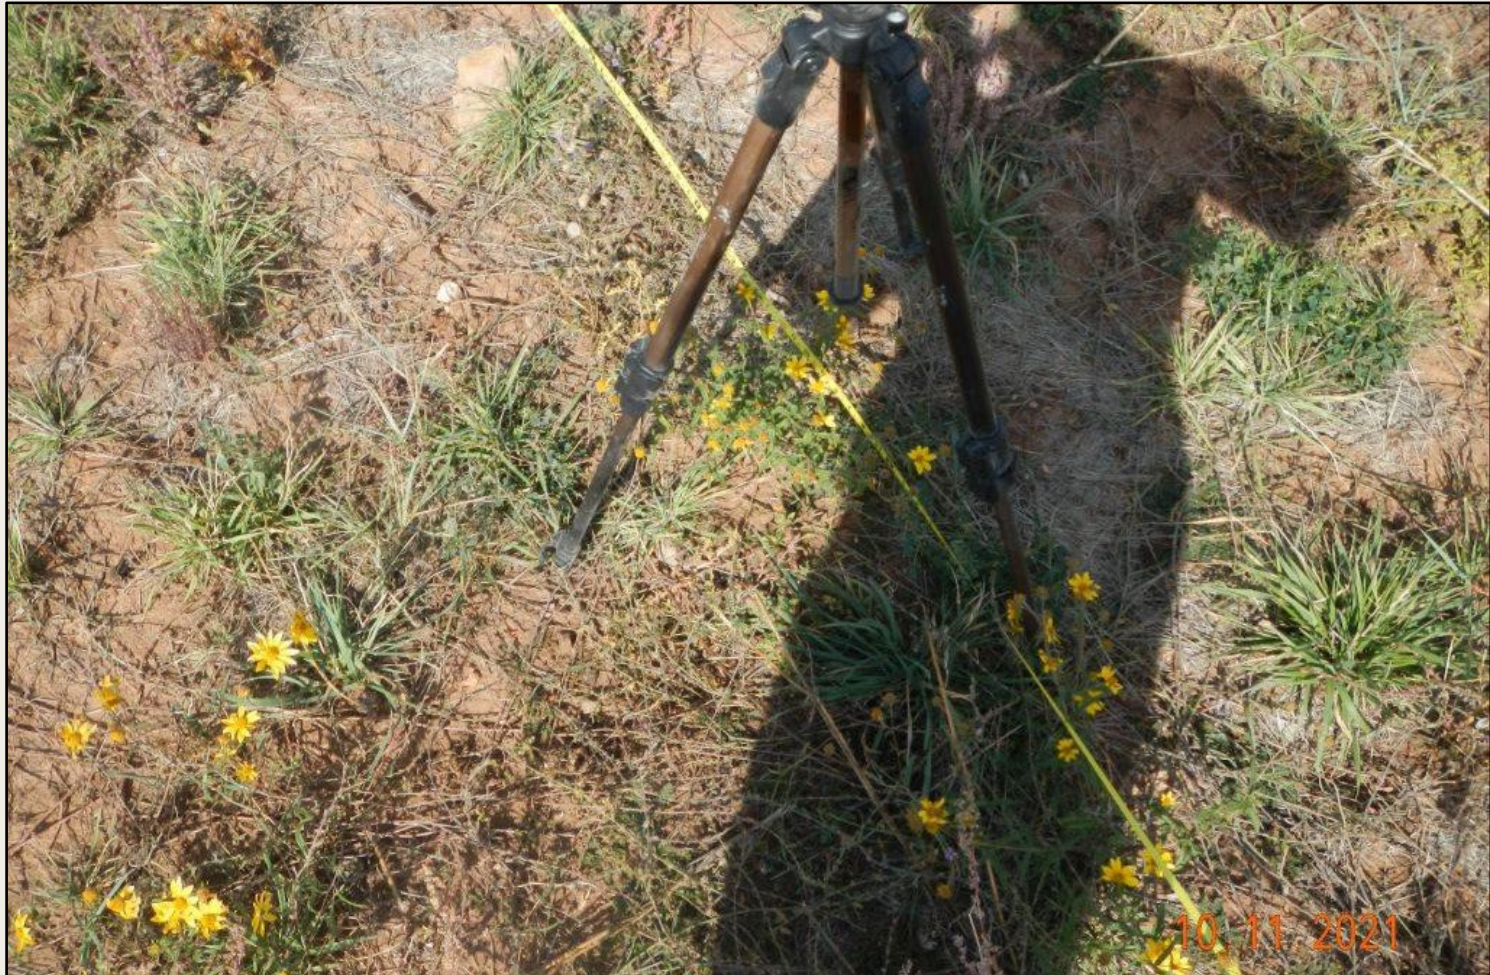
Photo 4. Birdseye view of revegetation along Transect 1, within the project area.

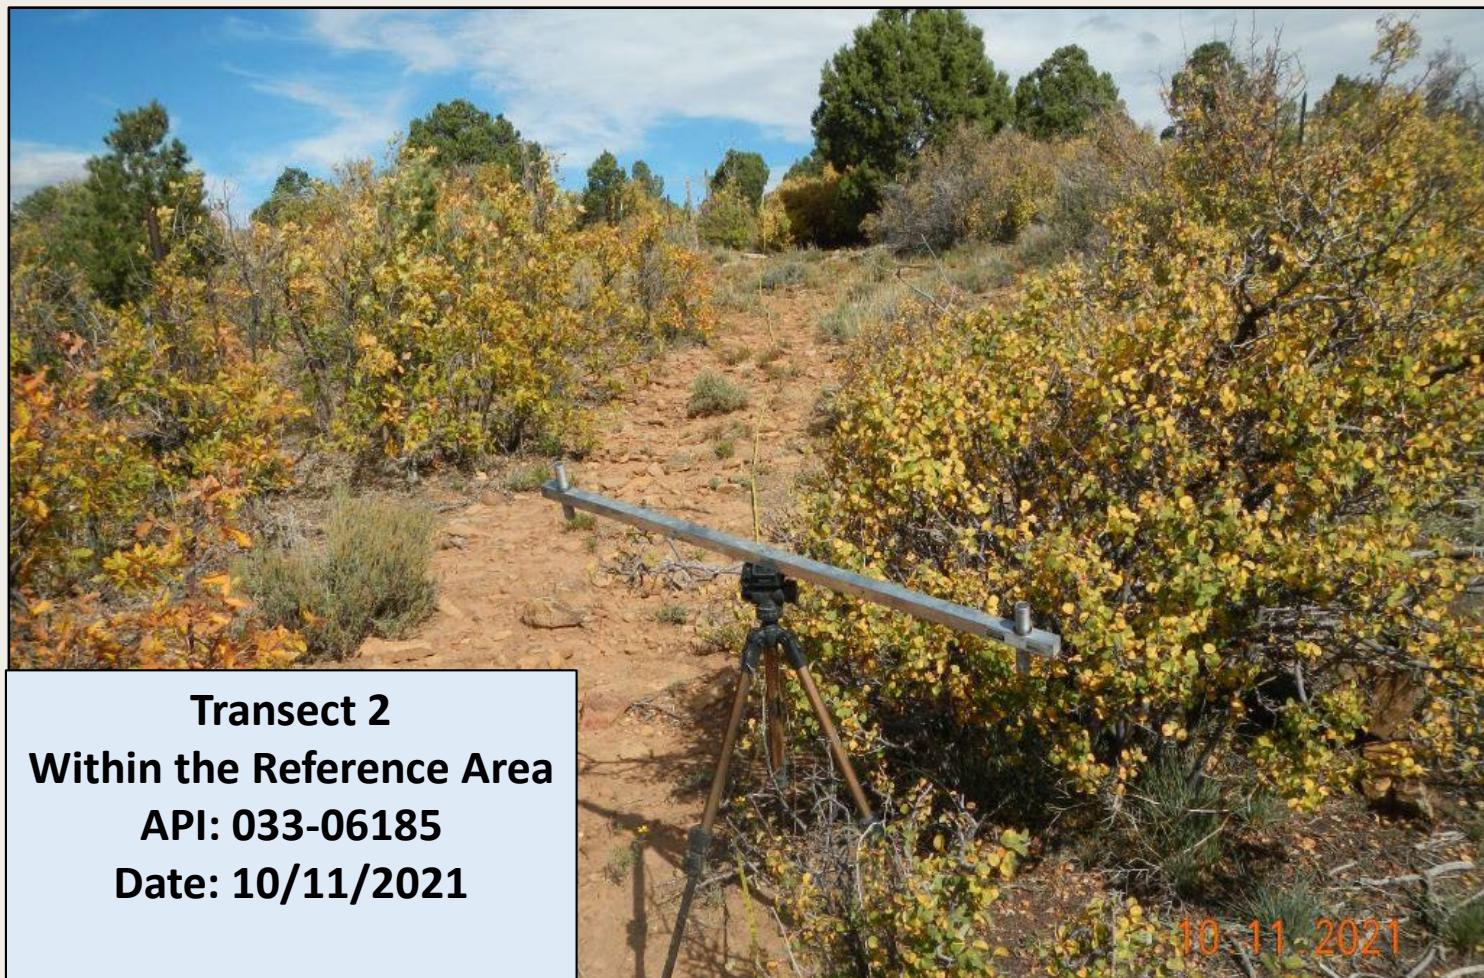
Photo 5. View of the beginning of Transect 2, within the reference area, facing northward.

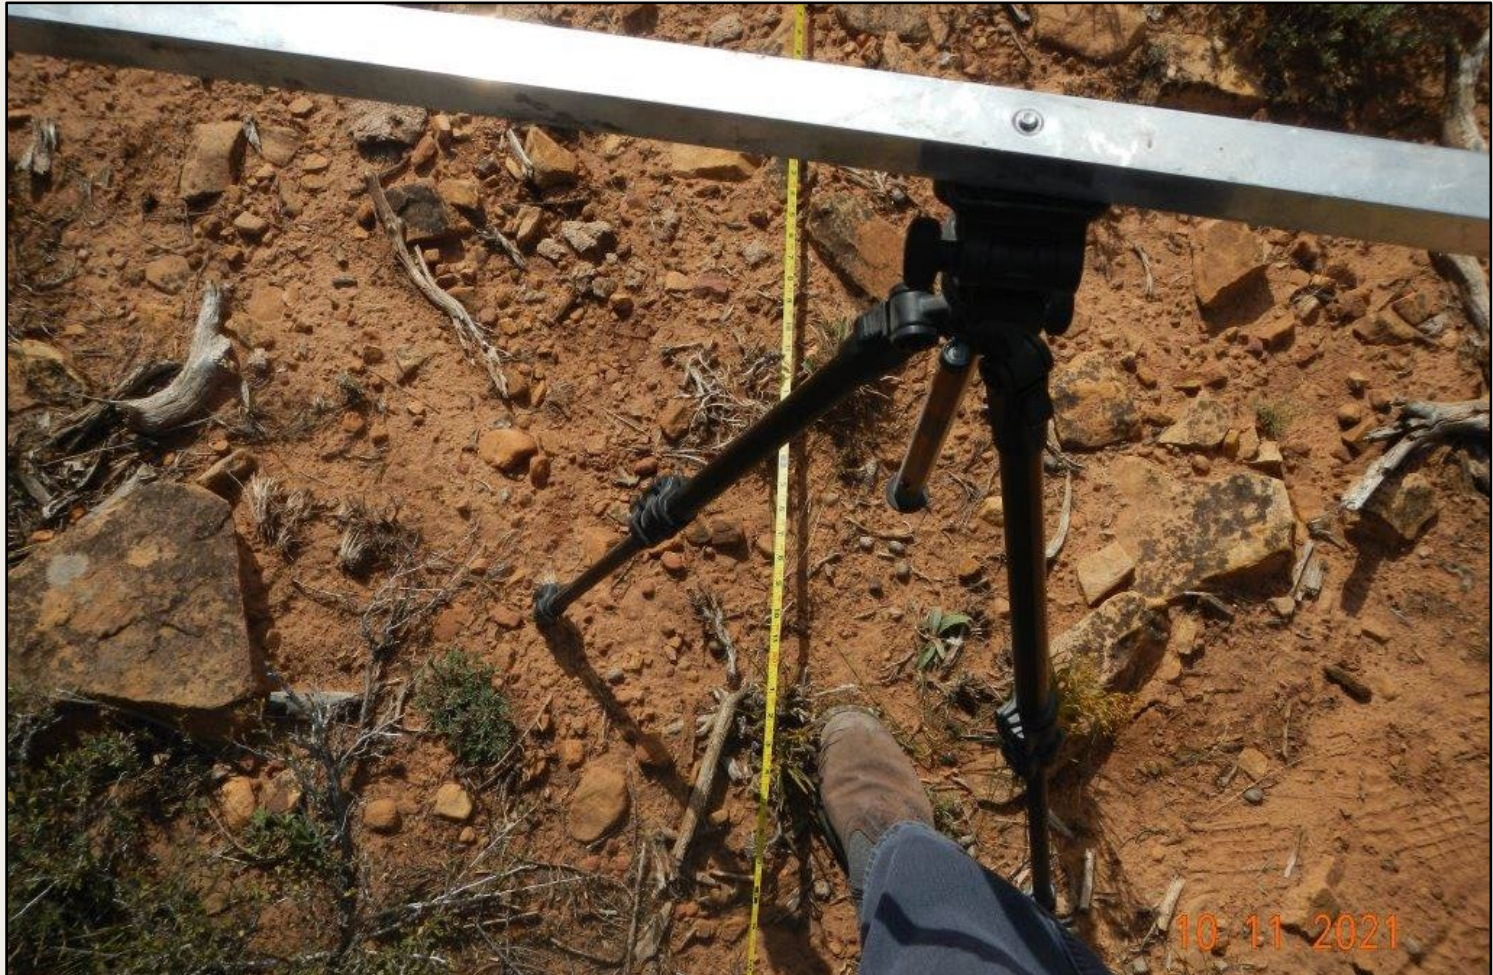
Photo 6. Birdseye view of vegetation at midpoint along vegetation Transect 2, within the reverence area.

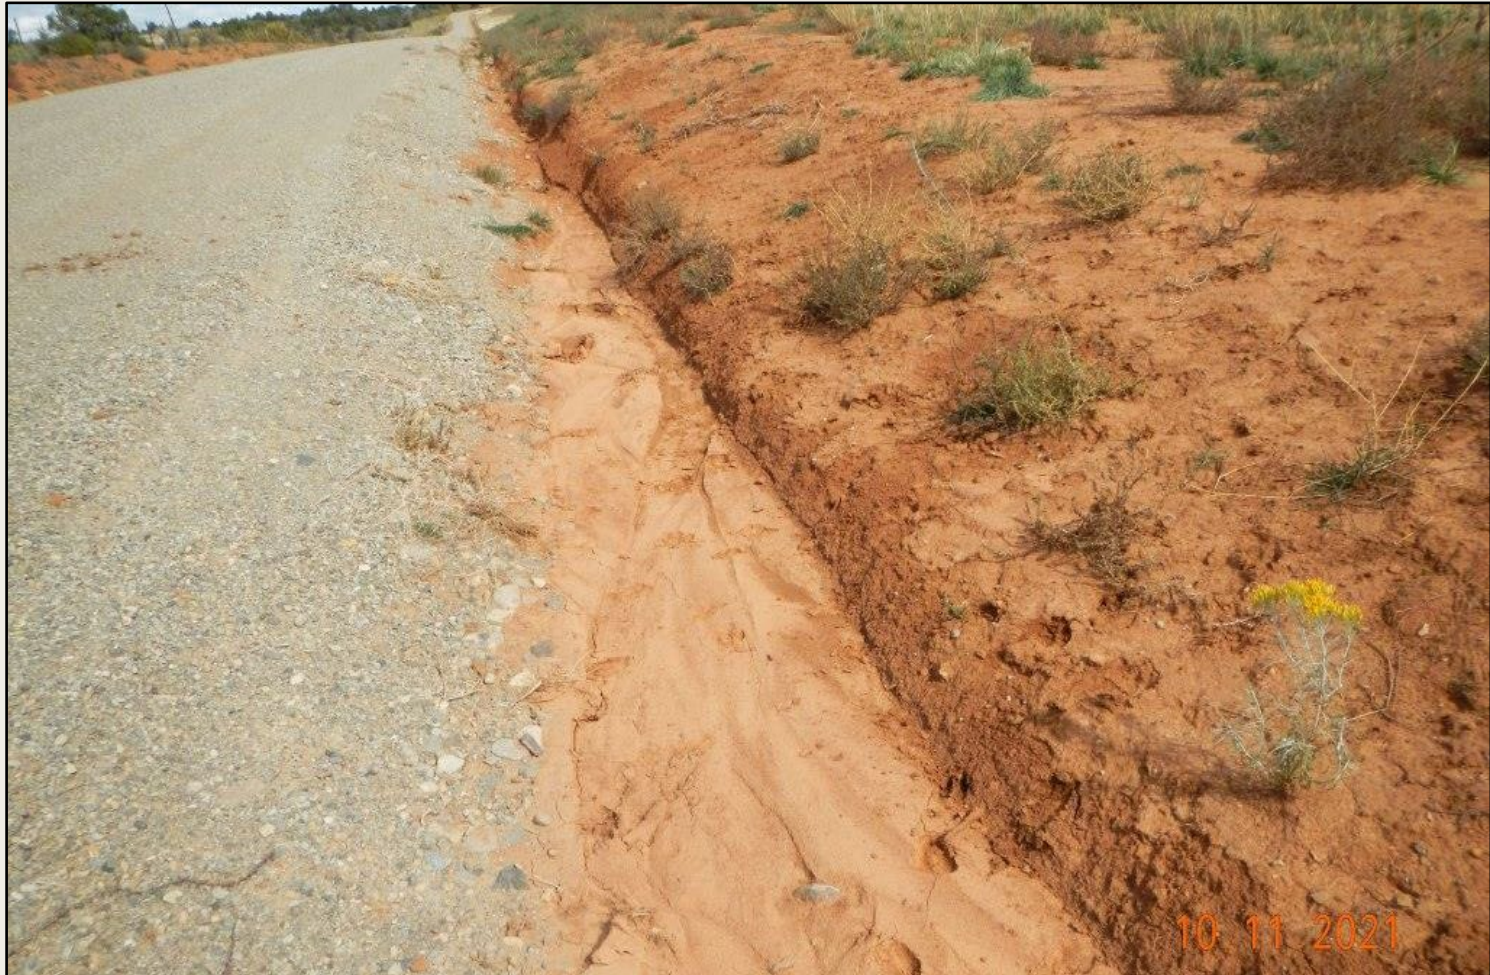
Photo 7. View of area along the access road where volumes of sediment are eroding down-slope. Additional stormwater and erosion control BMPs are needed here.

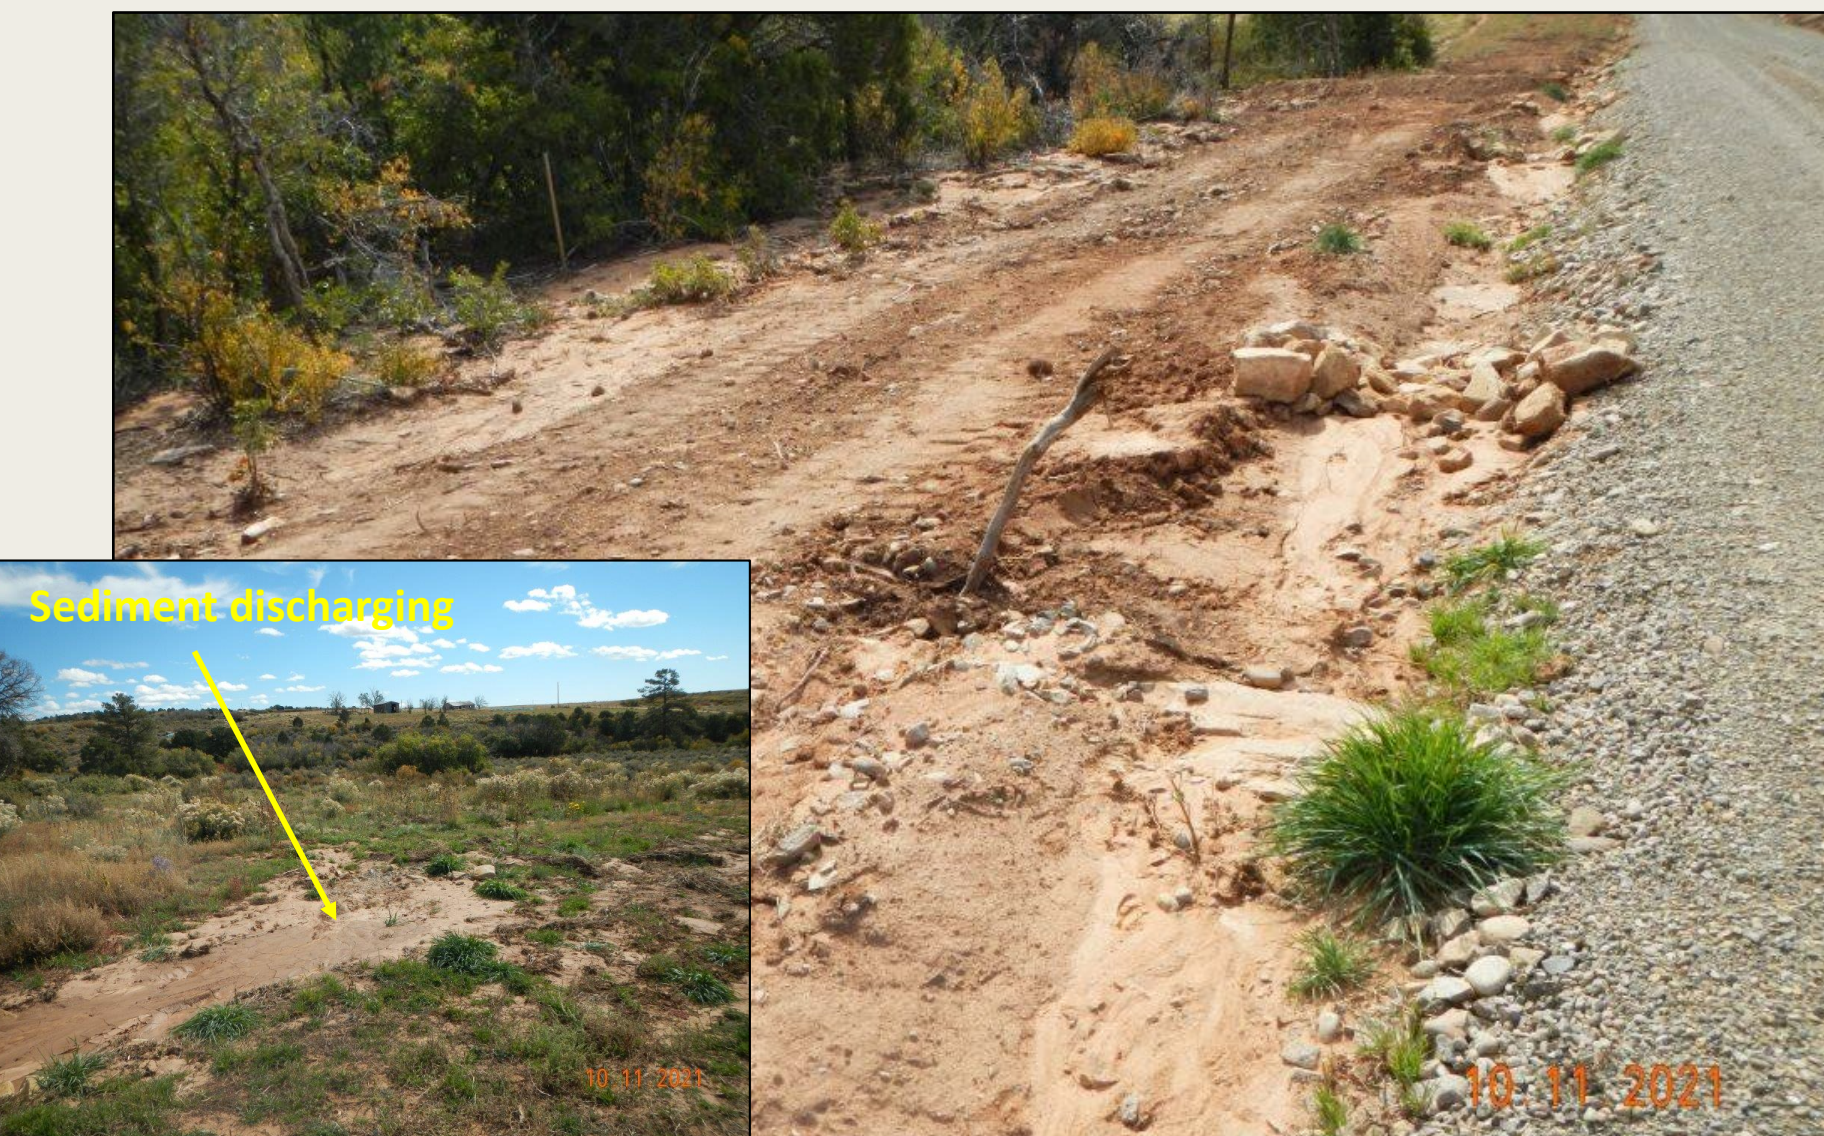
Photo 8. View of another area along the access road with evidence of sediment transport, and where existing BMPs are not adequate. Graded area adjacent to roadside ditch needs revegetation. Inset shows sediment discharge at bottom of slope.

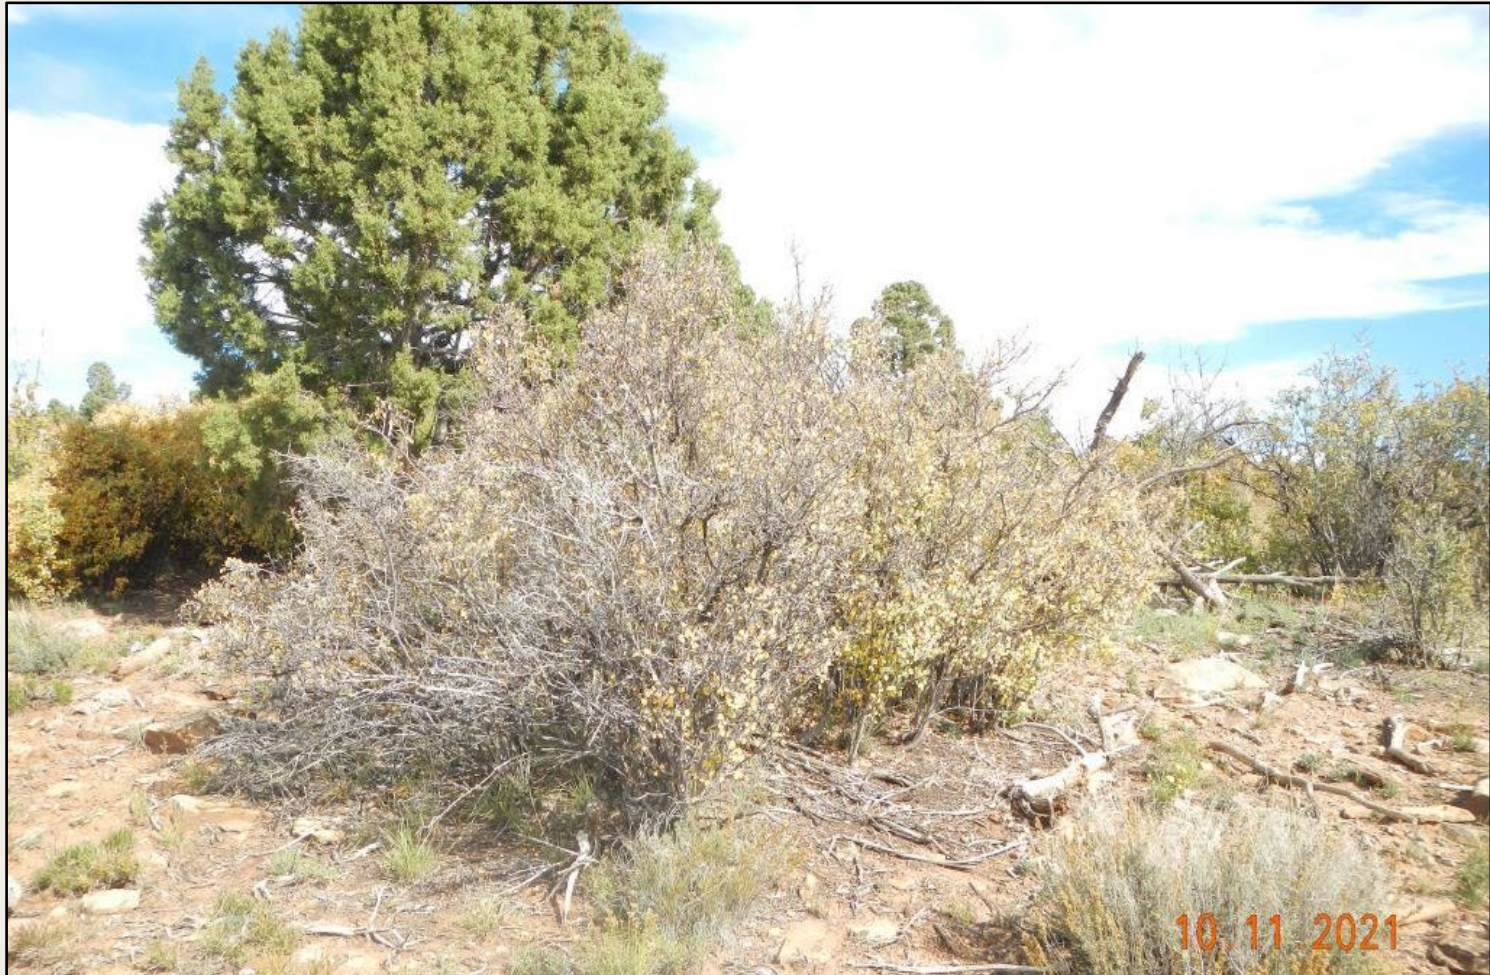
Photo 9 View of reference area comprised of mixed pinyon/juniper, serviceberry and gambel oak shrubland. With understory of prickly pear, Indian ricegrass, rock goldenrod, and James galleta.
