Inspection Photos

API: 043-06231

Operator: AUSCO PETROLEUM INC

Inspection Date: 10/15/2021

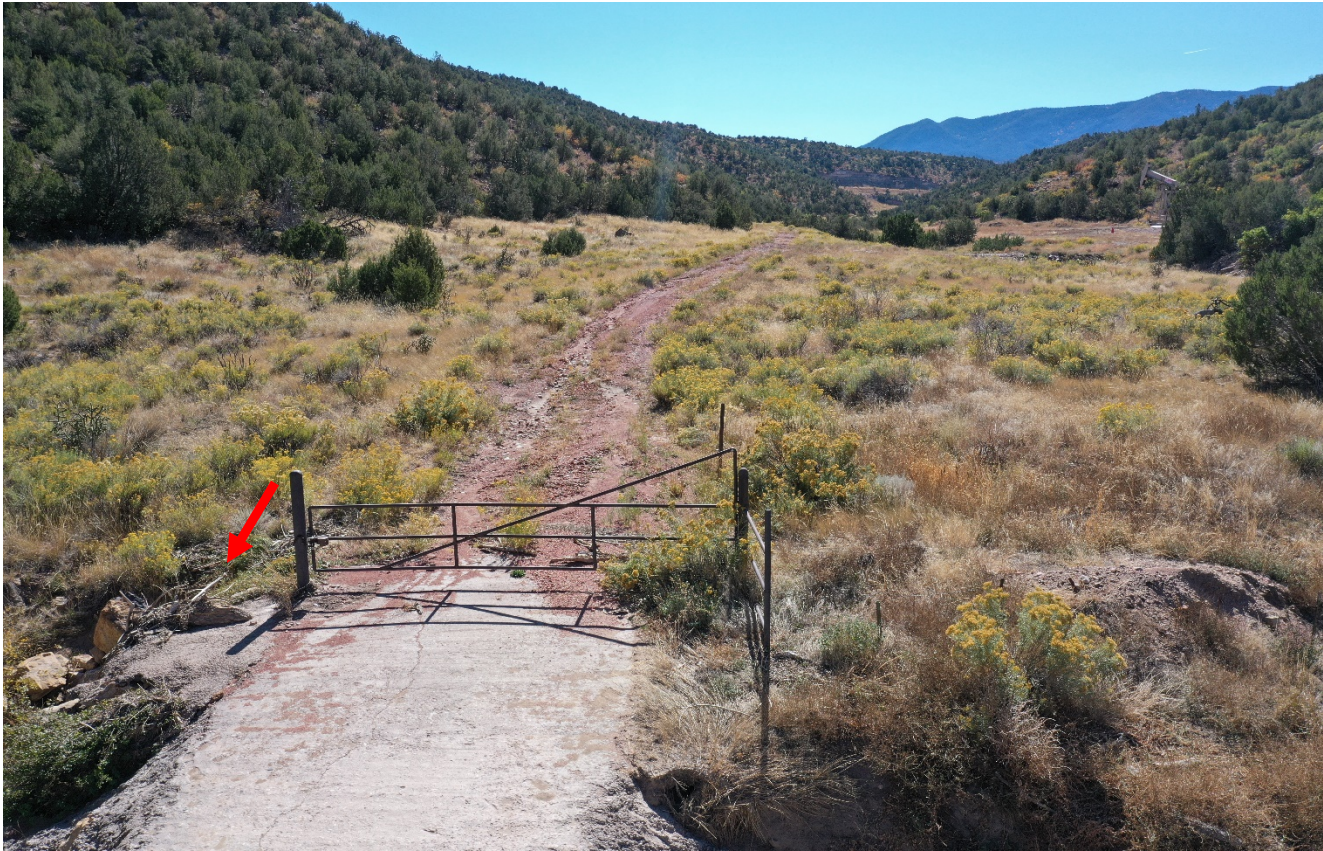
Photo 1. Drone photo facing south toward the access road. There is erosion occurring down the road which is directed toward the stream at red arrow. The erosion along the road has not been repaired or stabilized.

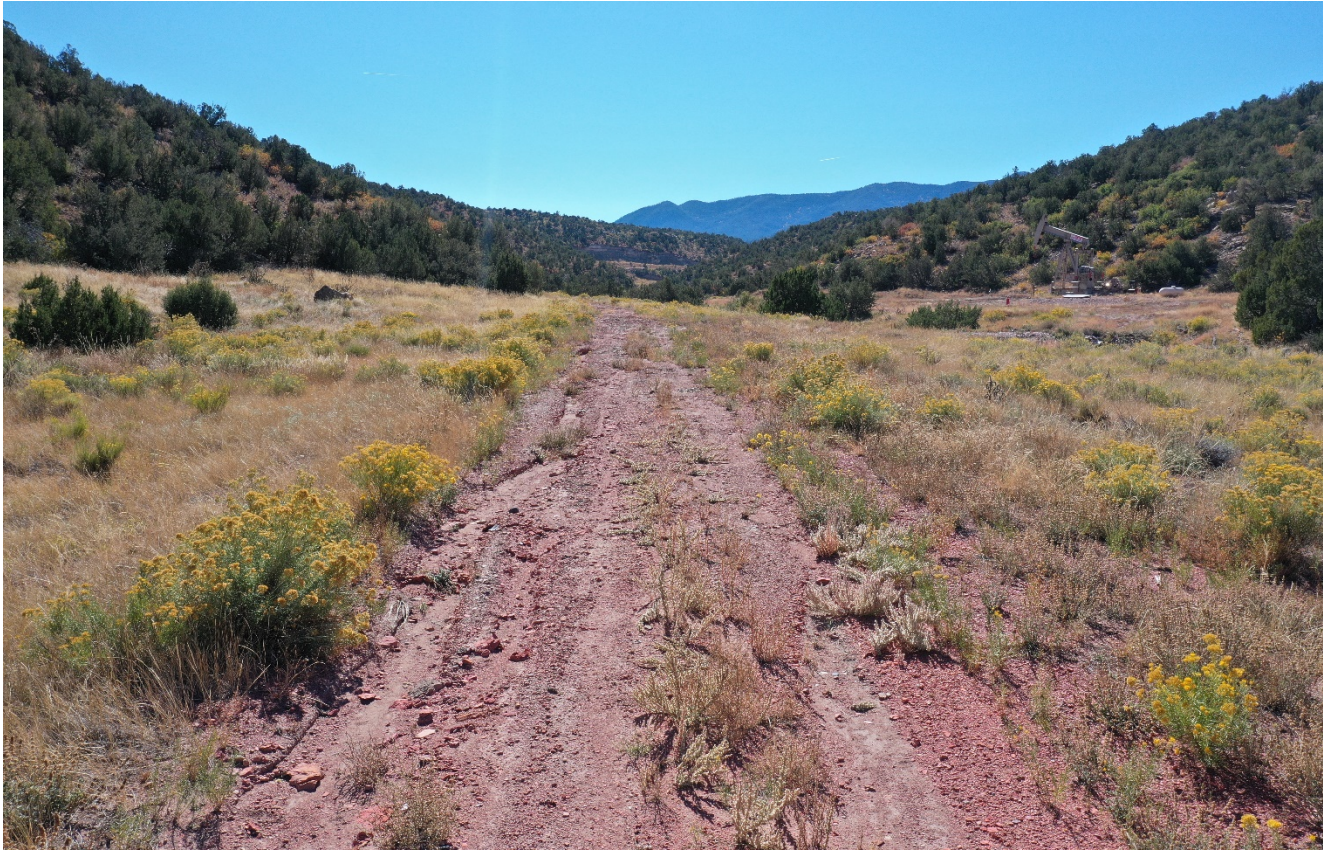
Photo 2. Facing south along the access road. Erosion along the road has gotten worse since previous inspection.

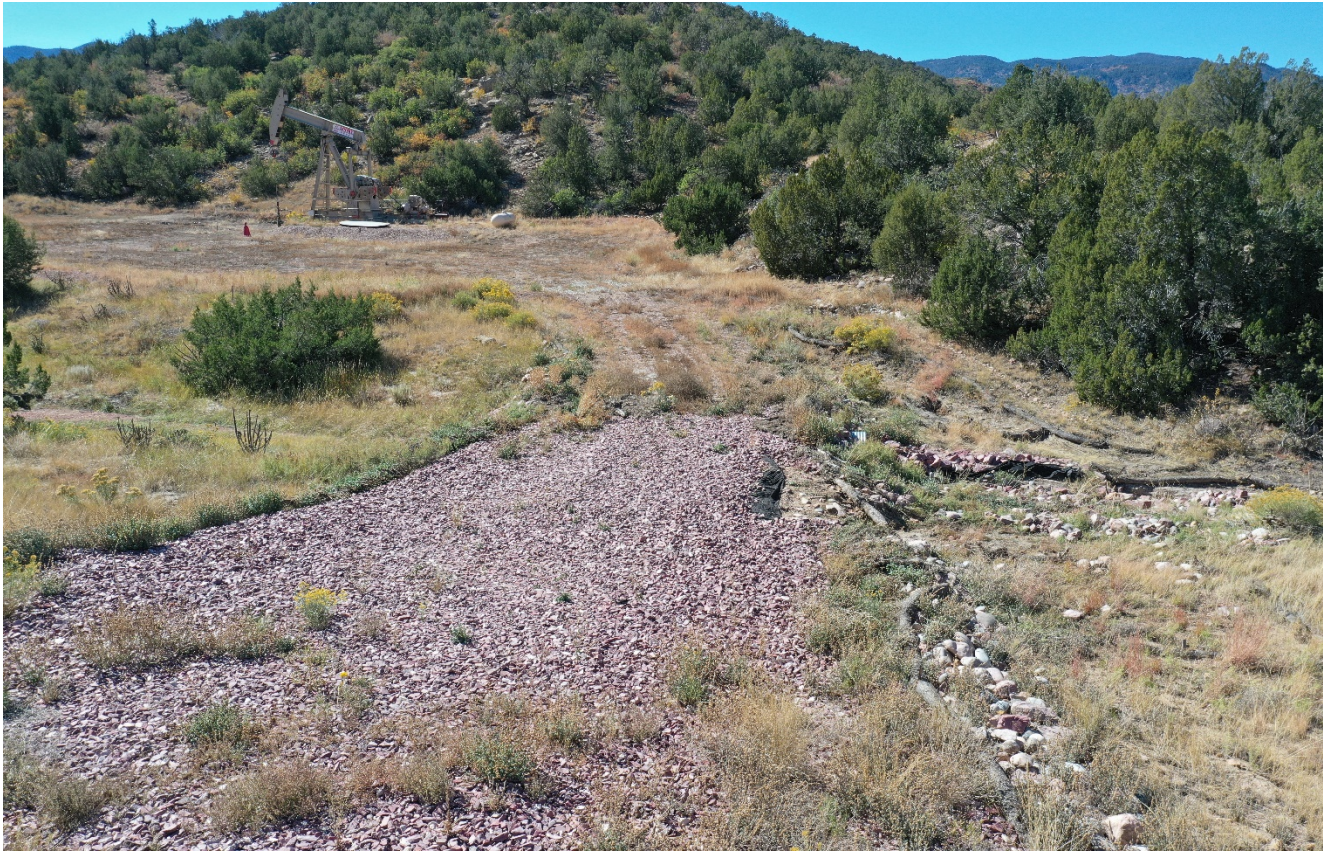
Photo 3. Facing southwest along the access road toward the location.

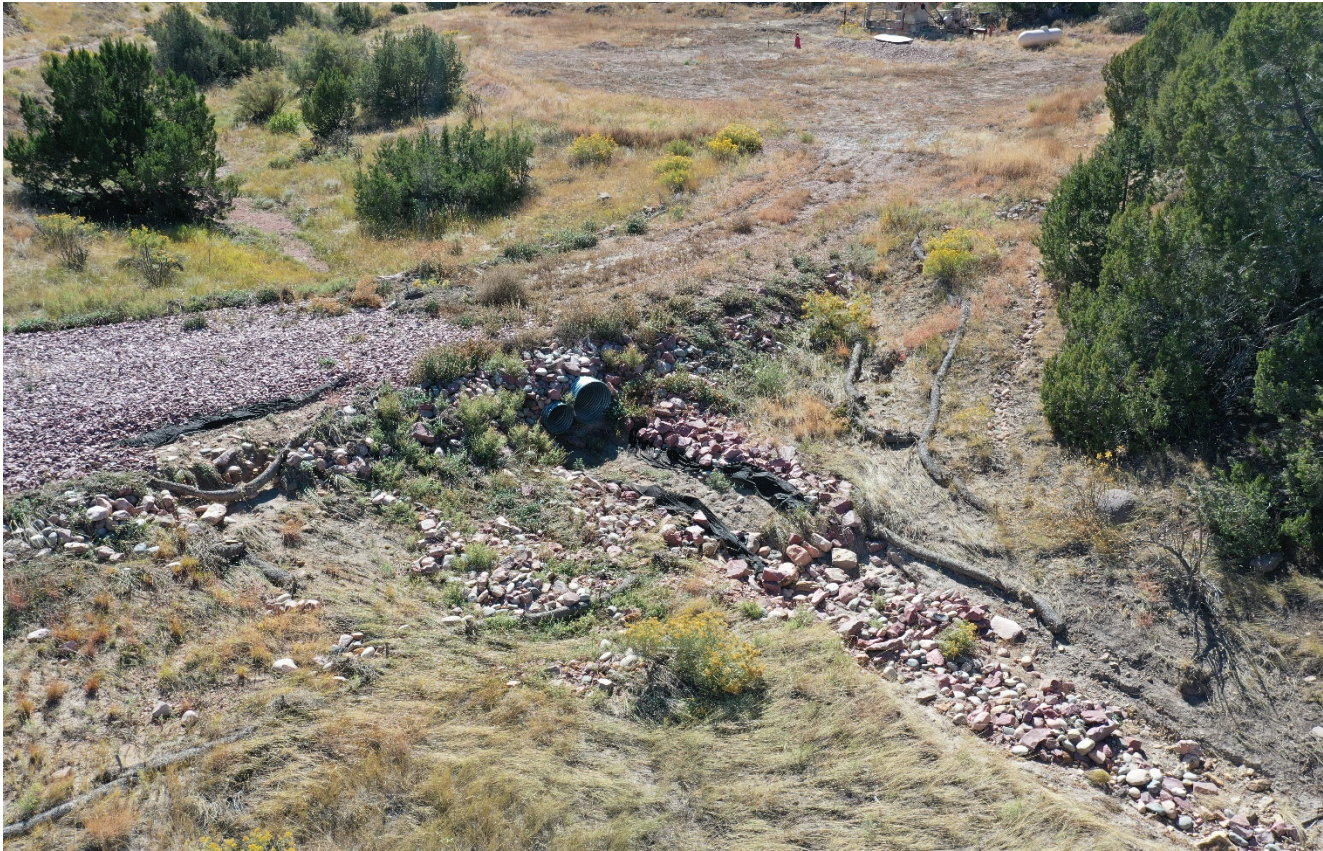
Photo 4. The outlet of the stream crossing has eroded and washed out. There are wattles, liner and rock rip/rap that are now displaced into the stream bed. This area needs to be repaired immediately.

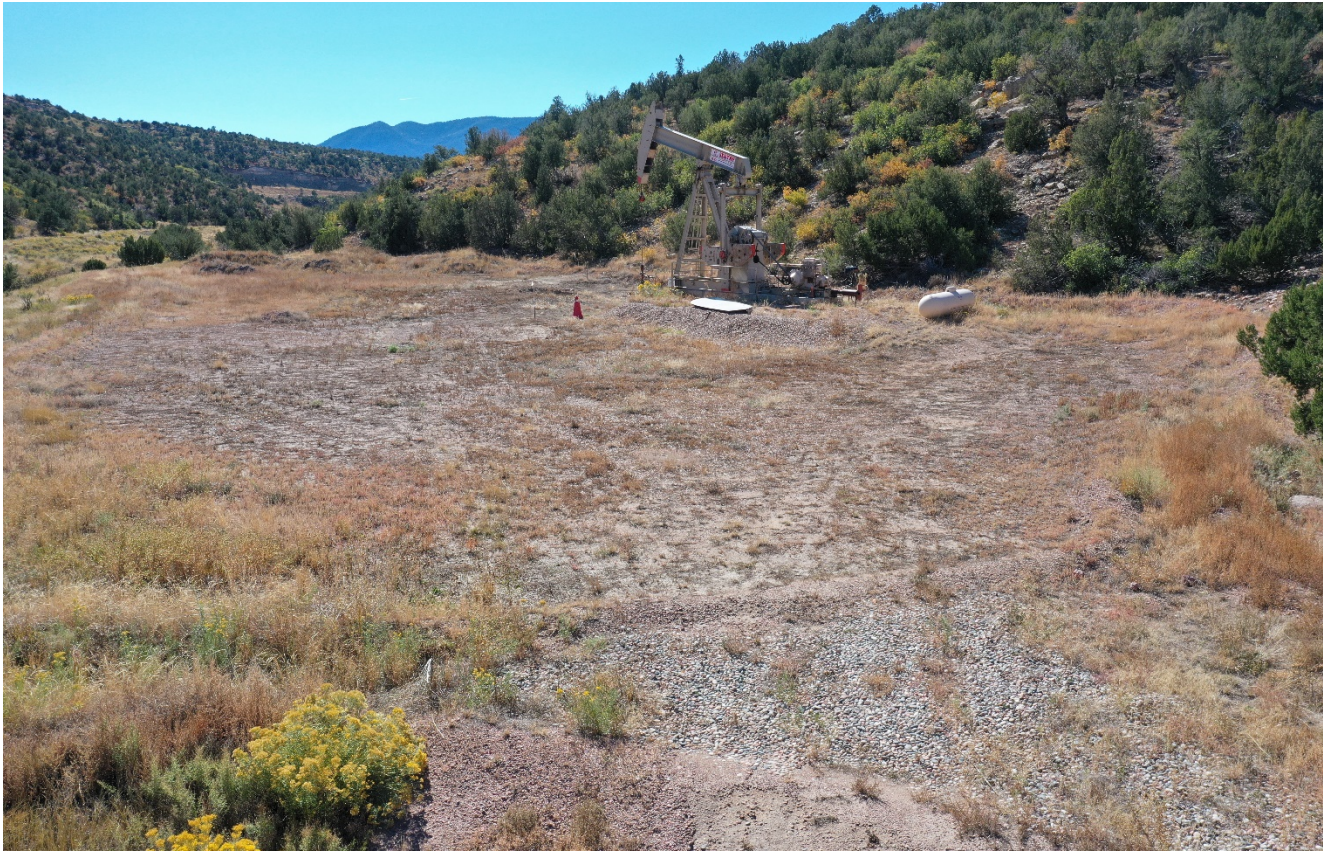
Photo 5. Facing southwest at the location. Unused areas of the location have not been reclaimed. Previous corrective action has not been performed.

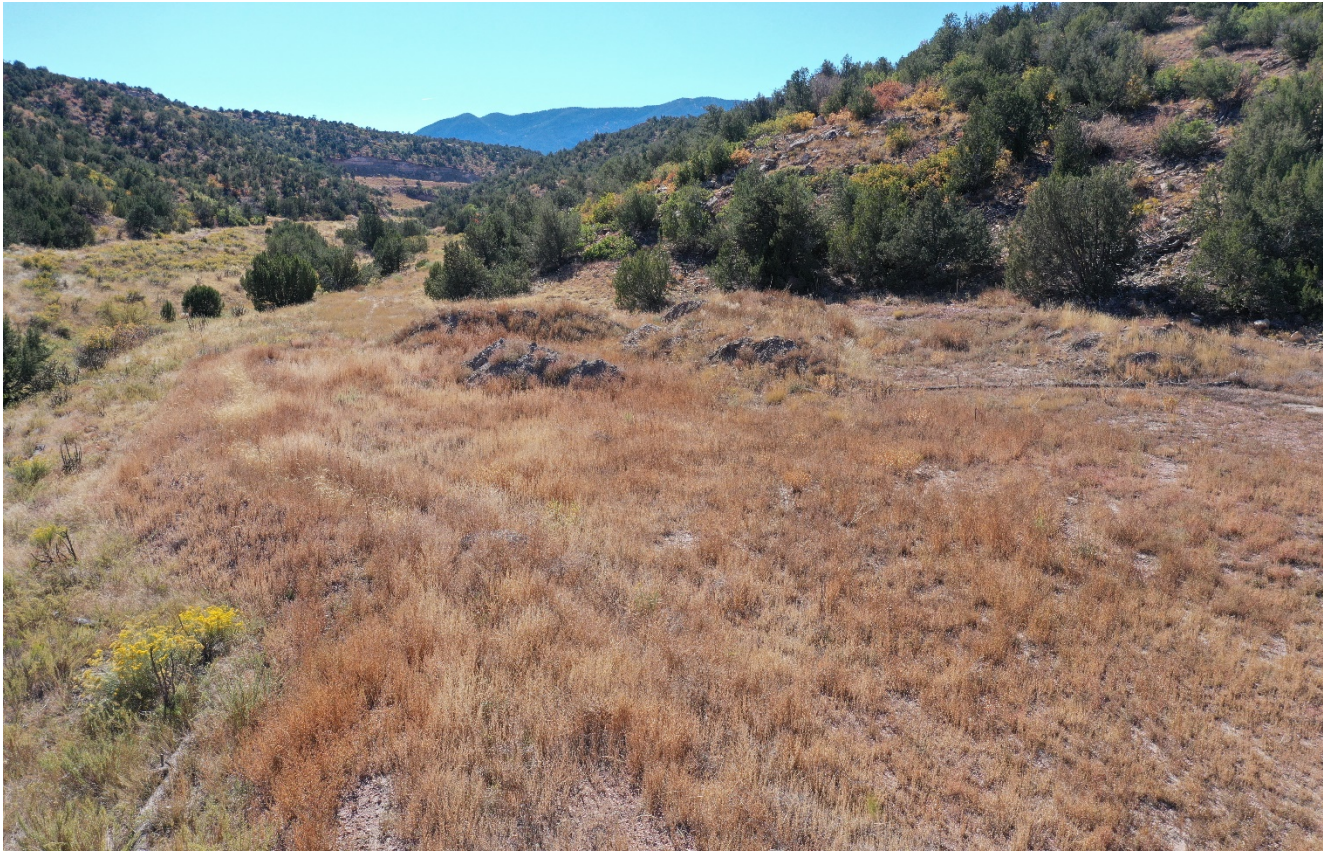
Photo 6. Facing toward the south side of the location. The soil piles are not maintained and there are undesirable weeds throughout this area. The soilpiles need to be replaced for interim reclamation. Previous corrective action has not been performed.

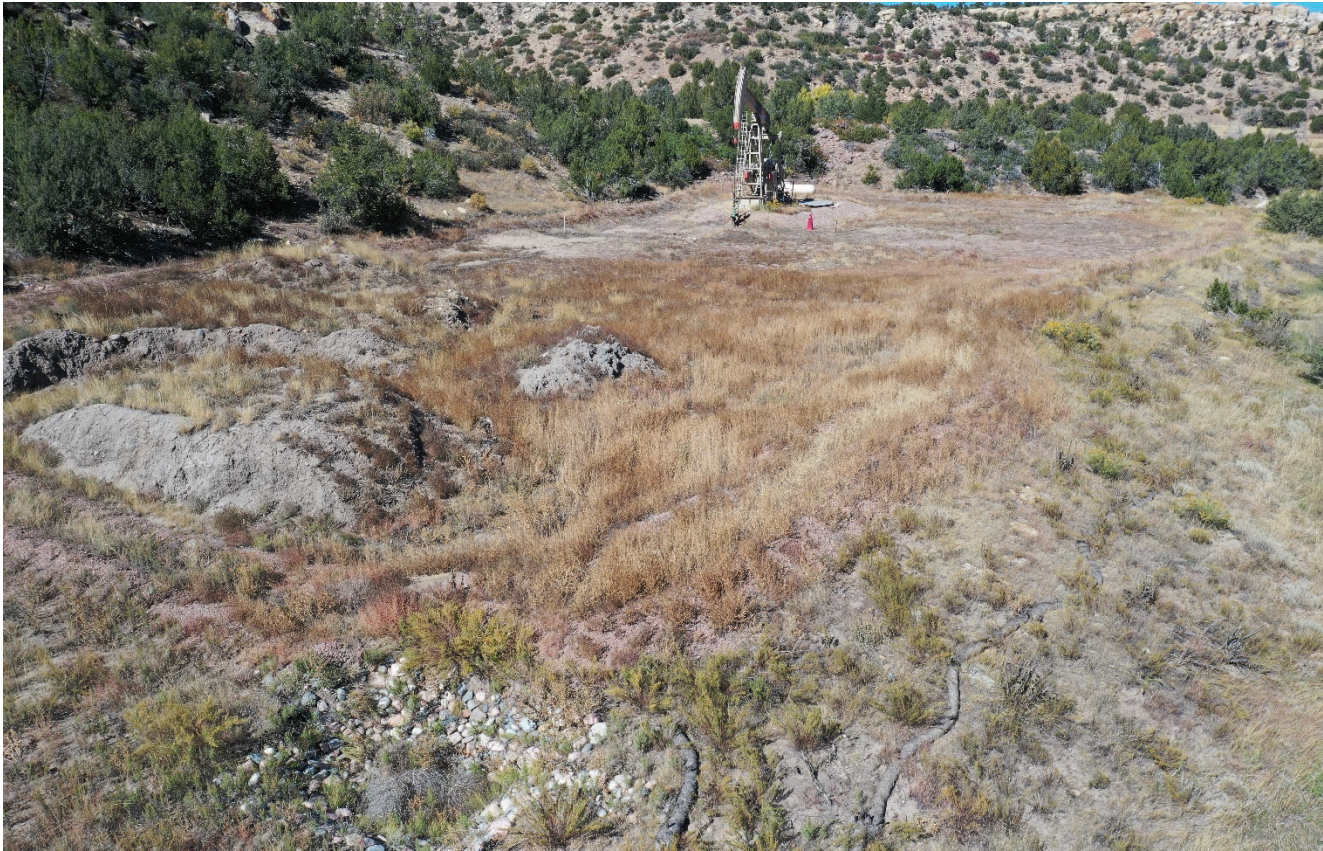
Photo 7. Facing northwest toward the location. Interim reclamation has not been performed. There are undesirable weeds throughout the location. BMP's to control erosion are not maintained.
