Inspection Photos

API: 043-06222

Operator: INCREMENTAL OIL & GAS

Inspection Date: 10/15/2021

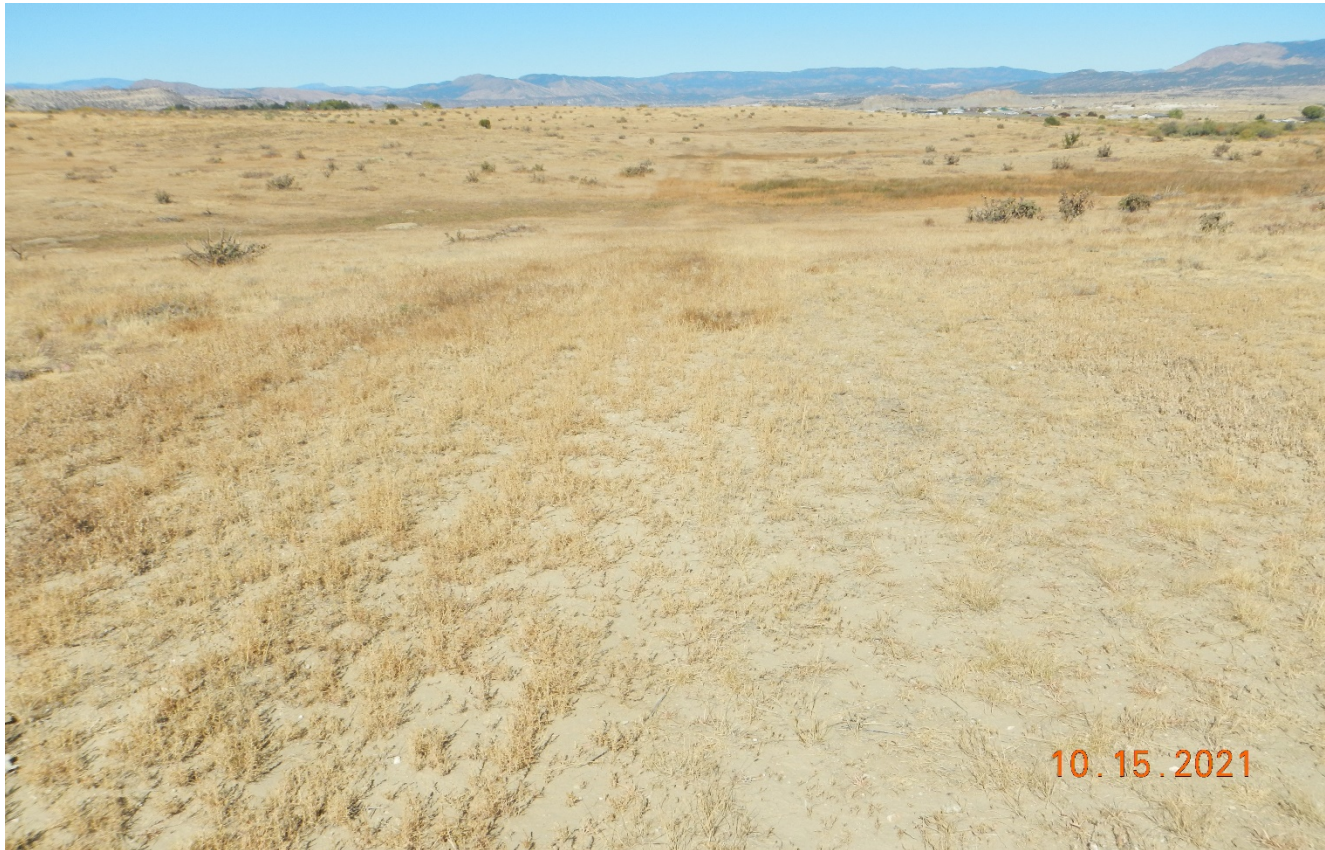
Photo 1. Facing northwest along the access road. Perennial vegetation has not re-established and there are undesirable weeds along the former road.

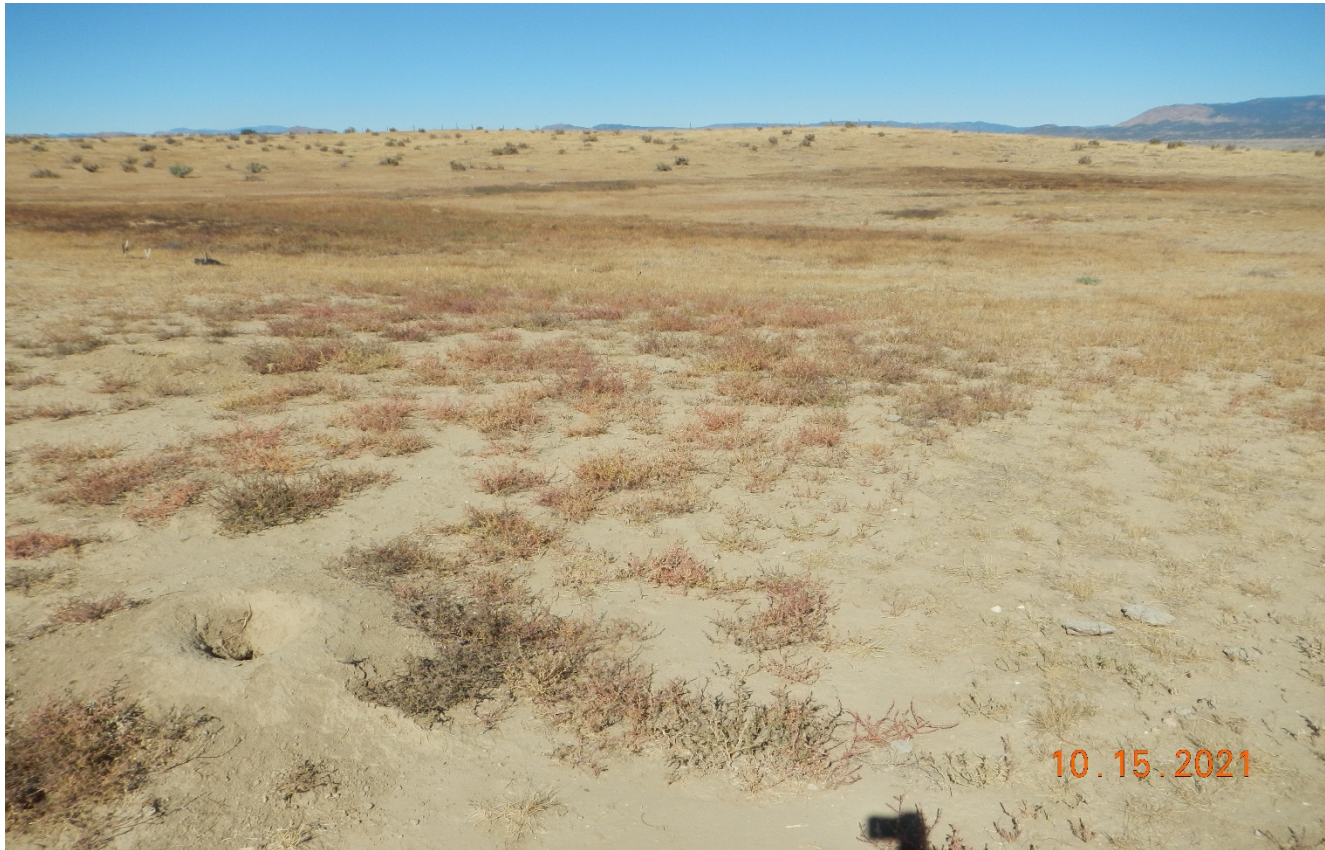
Photo 2. Facing northwest toward the location. The location consists of mostly undesirable weeds.

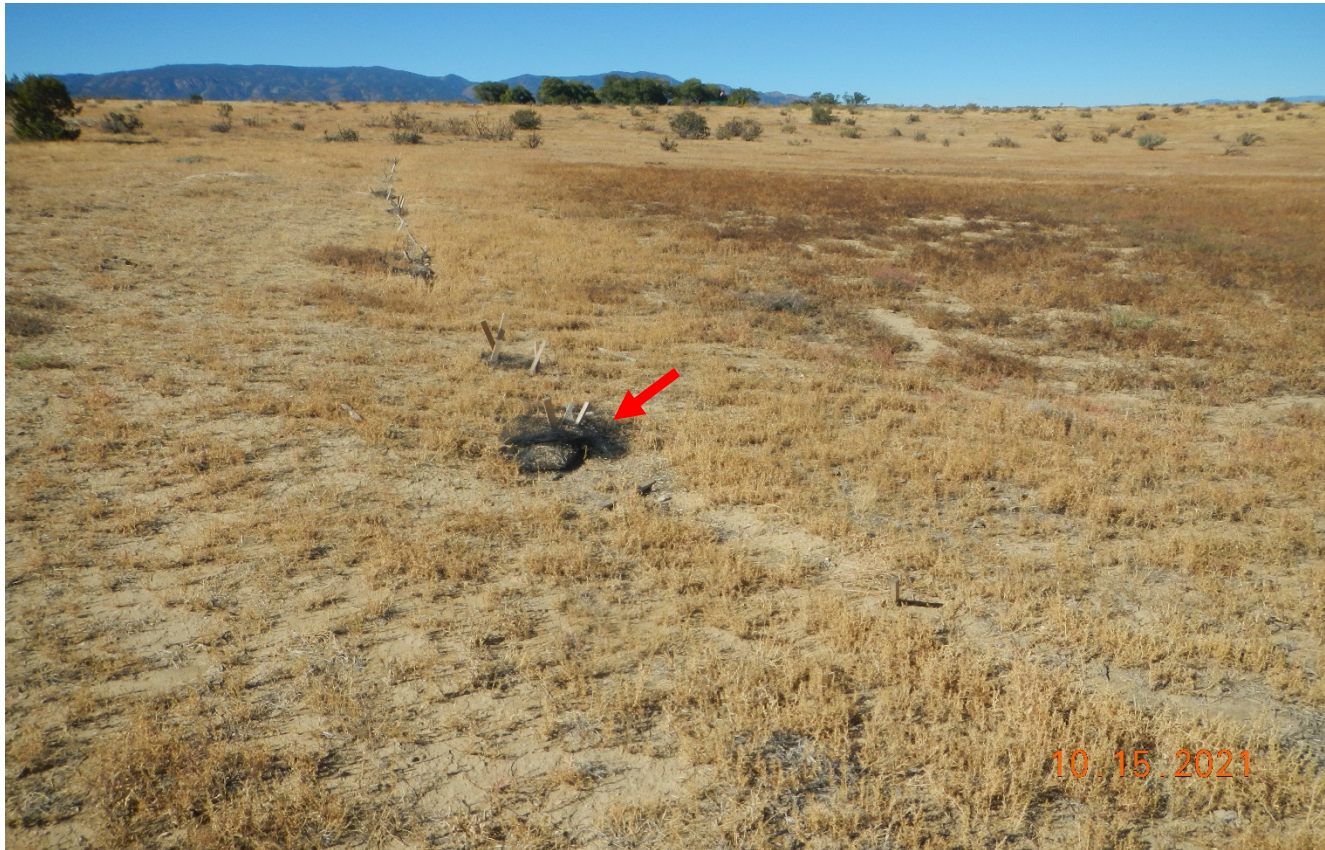
Photo 3. Facing west. The wattles around the perimeter were never repaired and removed. The stakes and netting debris still remain shown at red arrow.

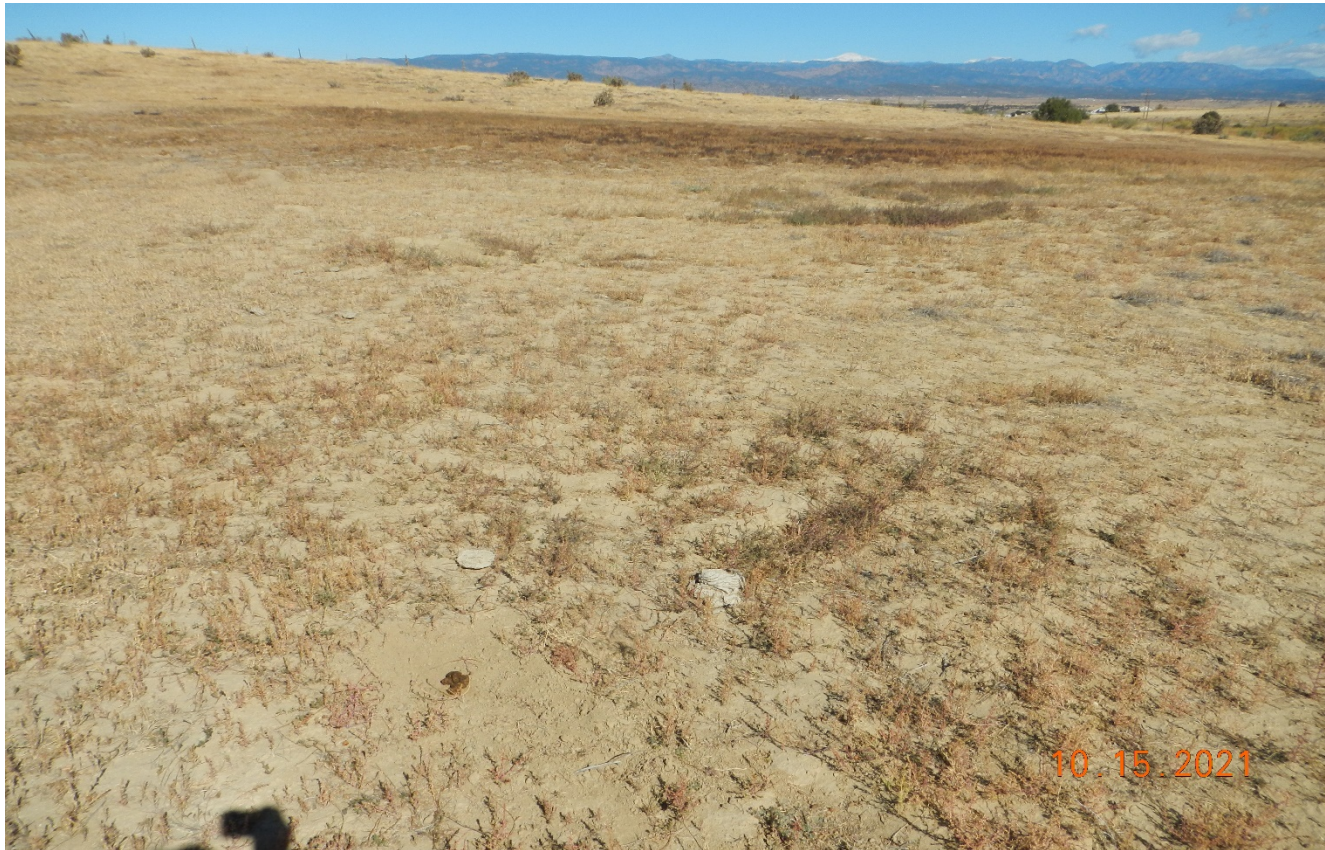
Photo 4. Center of the location facing north.

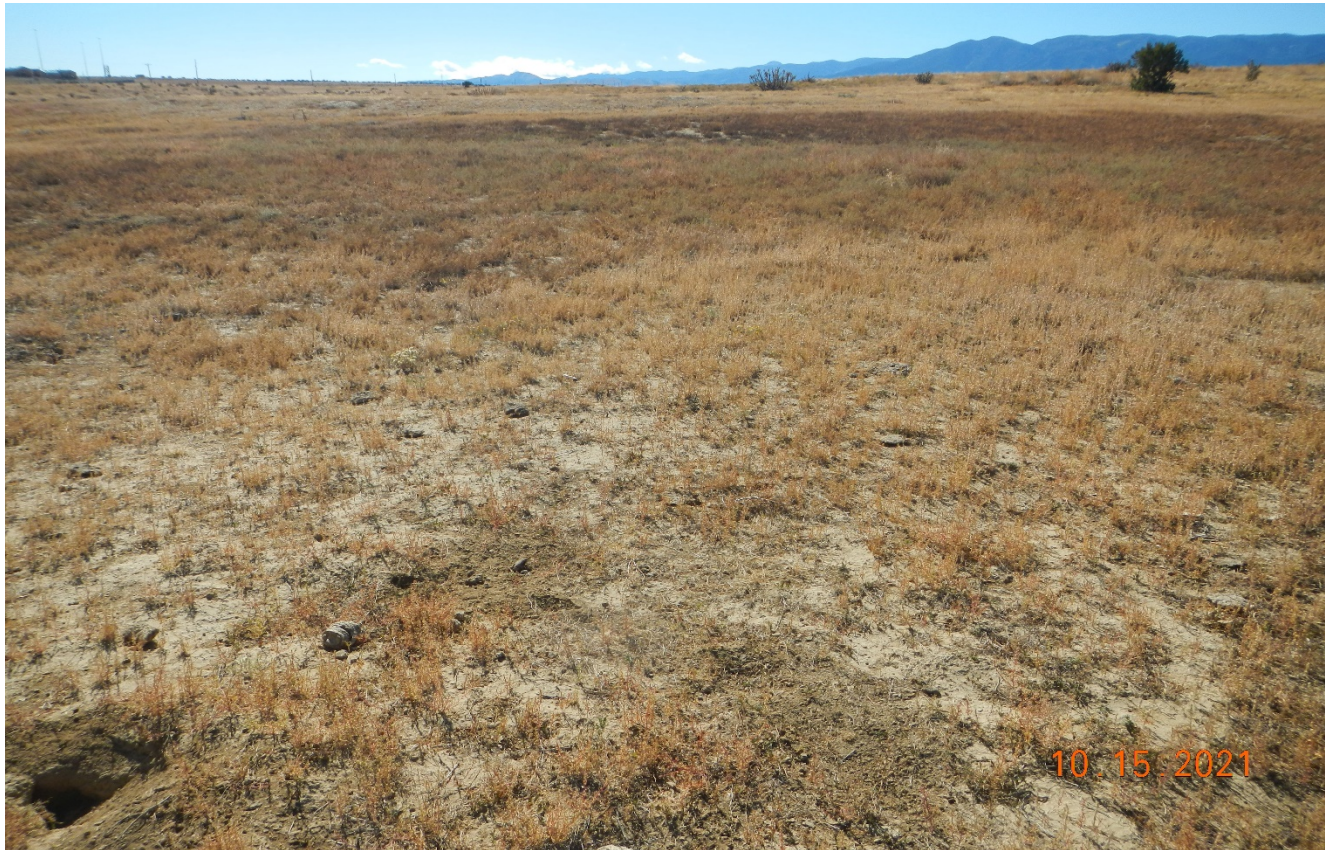
Photo 5. Center of the location facing south.

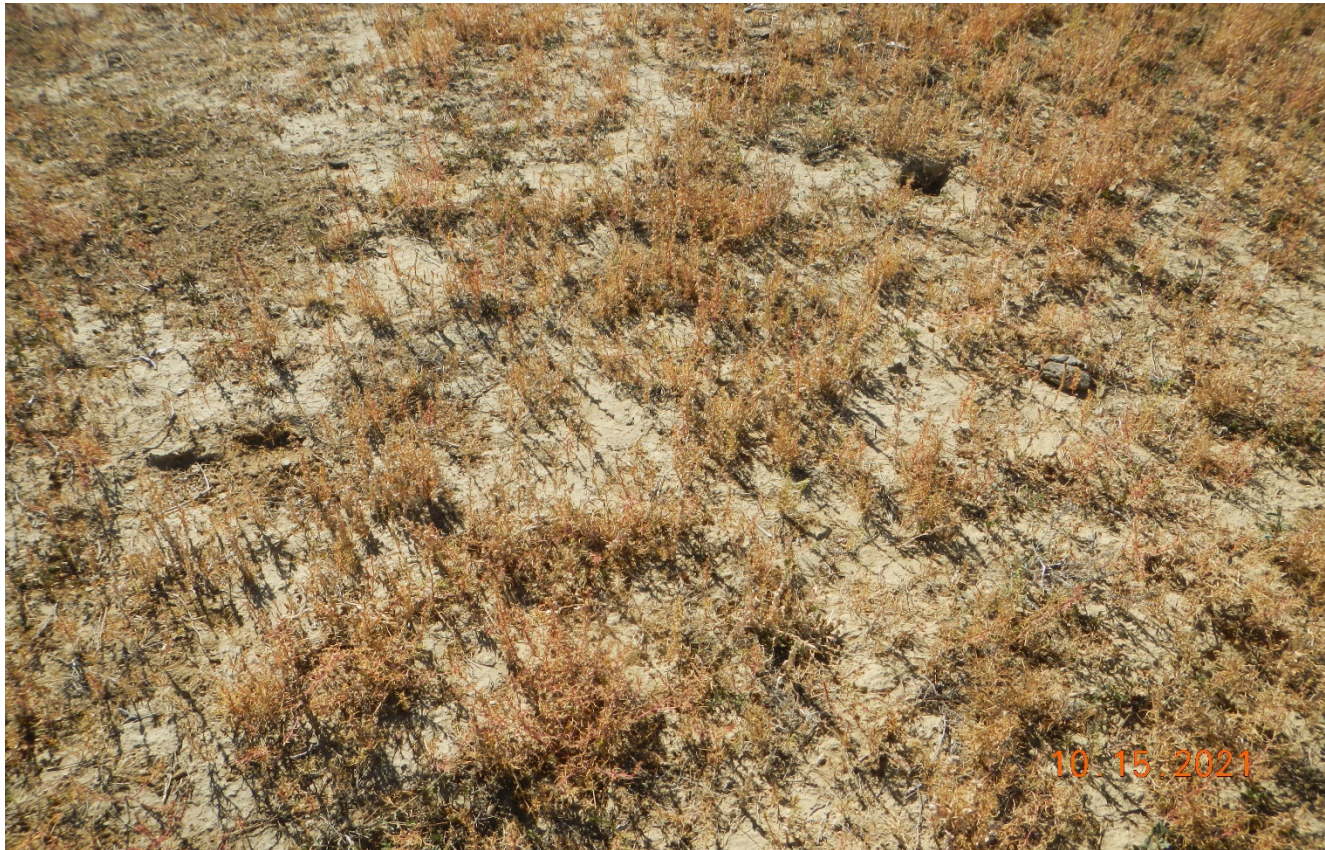
Photo 6. View of groundcover at the location shows undesirable vegetation consisting of Russian thistle.
