# Inspection Photos

10/18/2021

Operator: TEP ROCKY MOUNTAIN LLC - 96850

Location ID: 336014

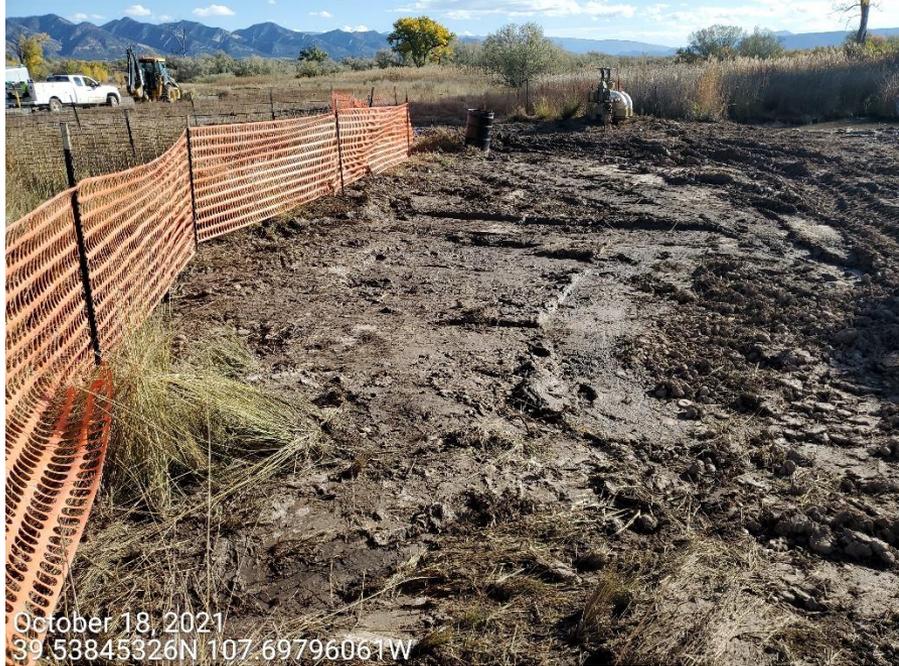
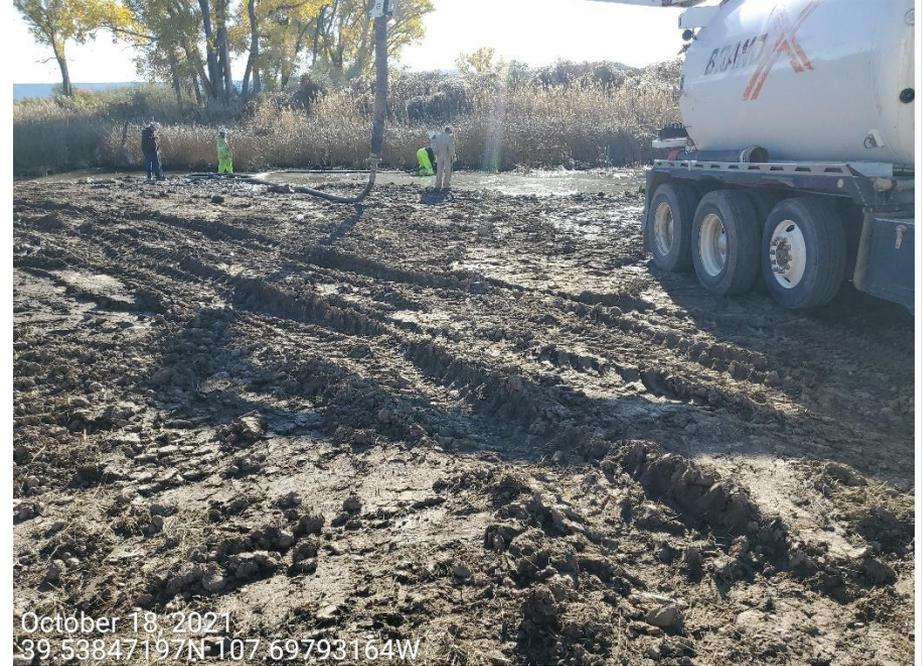
**Photo 1:** Photos taken from the spill area with impacts to both upland and wetland areas south of the Location. Areas will require reclamation upon closure of the project.

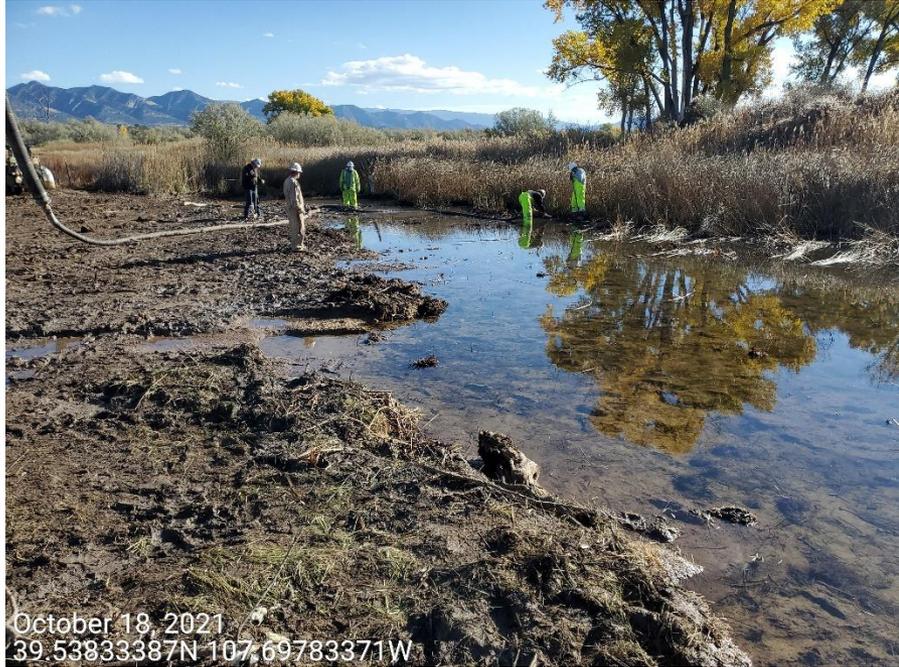
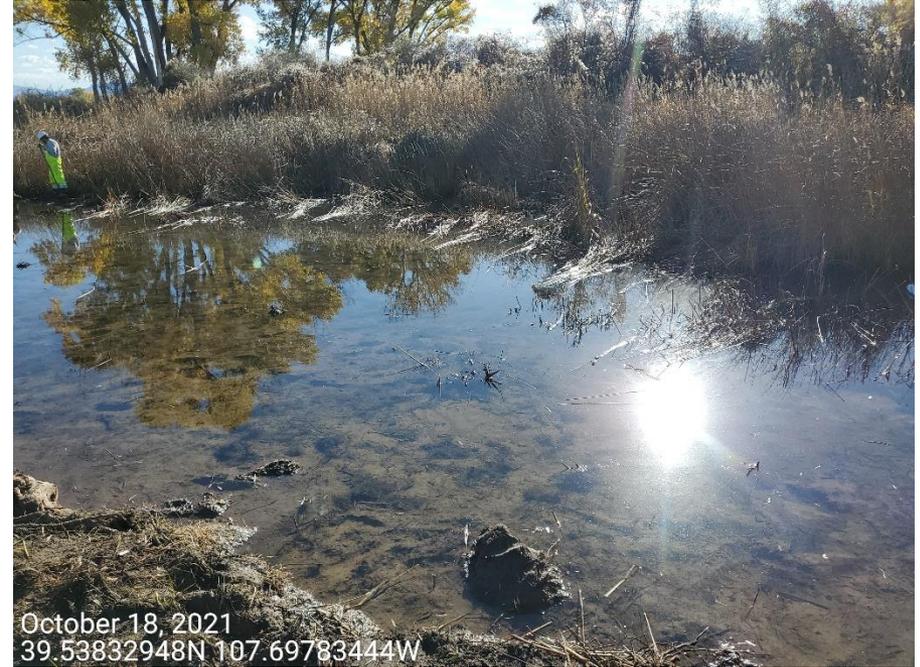
**Photo 2:** Photos taken from the spill area with impacts to both upland and wetland areas south of the Location. Areas will require reclamation upon closure of the project.

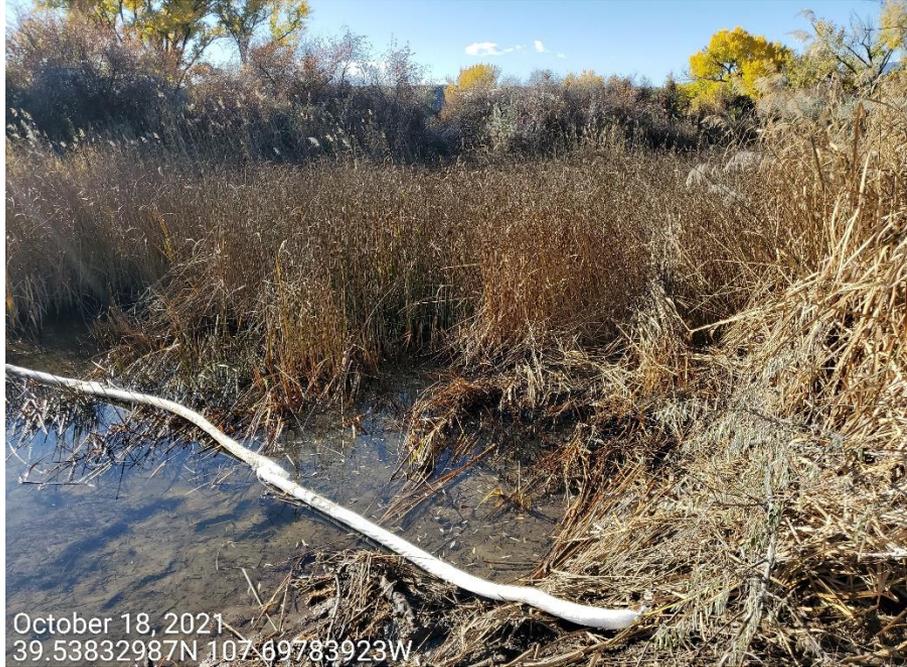
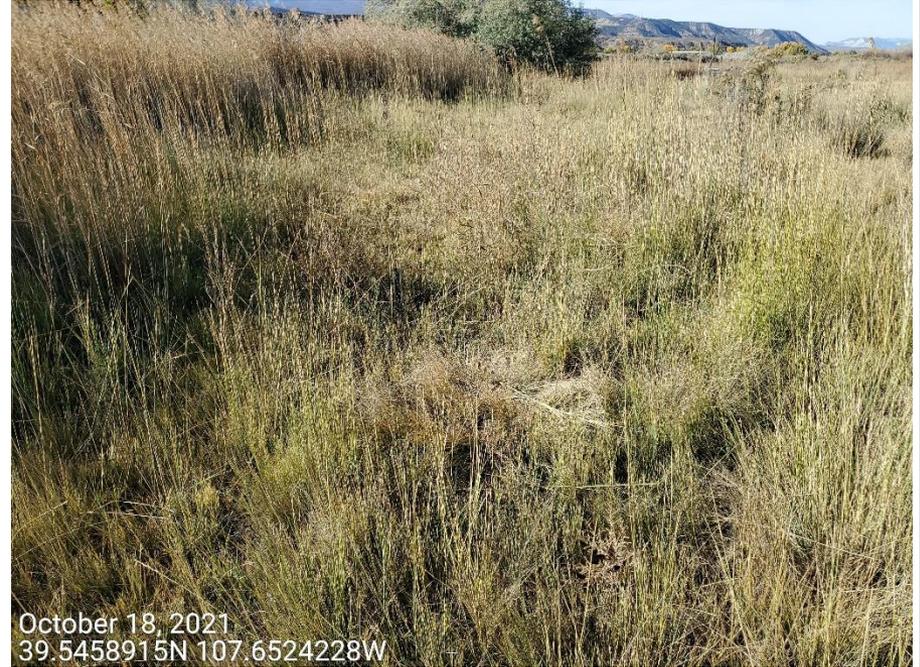
**Photo 3:** Photos show vegetation in the immediate areas adjacent to the spill area. Vegetation observed fairly consistent with wetland habitats; vegetation observed predominantly *Carex* and *Juncus* species. *Typha* was observed though in low densities; patches of dense *Phragmites*. Vegetation observed in the adjacent undisturbed upland areas predominantly consists of *Distichlis spicata*, *Chrysothamnus* sp. and various wheatgrass species.

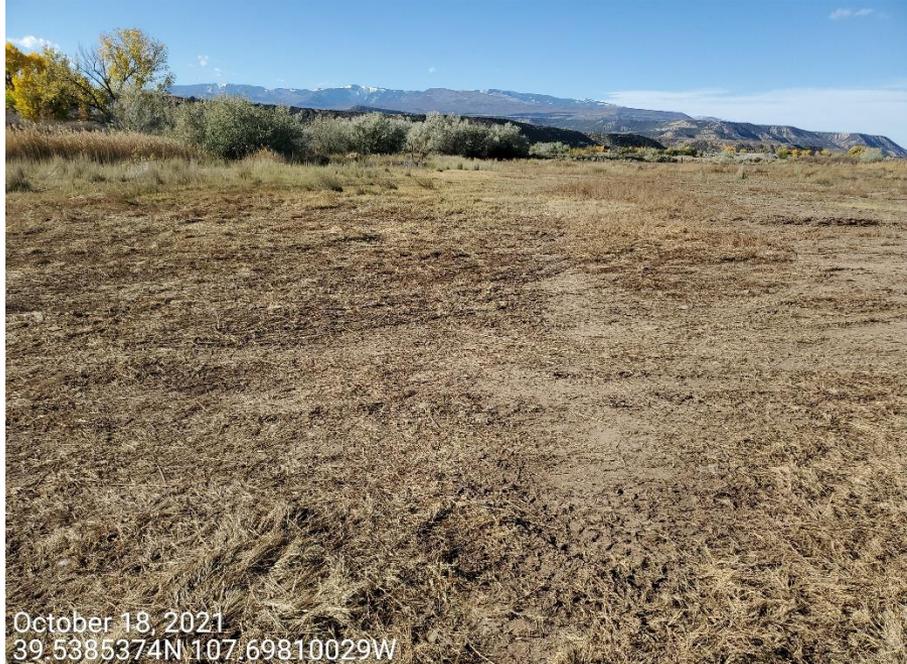
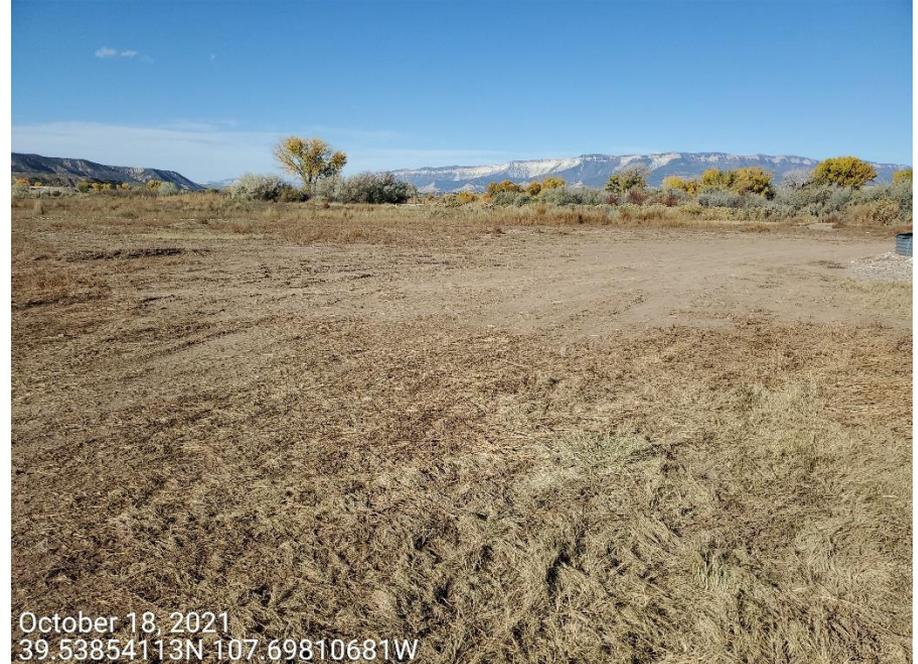
**Photo 4:** Photo taken from the interim areas west of the Location. Some areas have been disturbed during spill response. Areas will require additional reclamation.

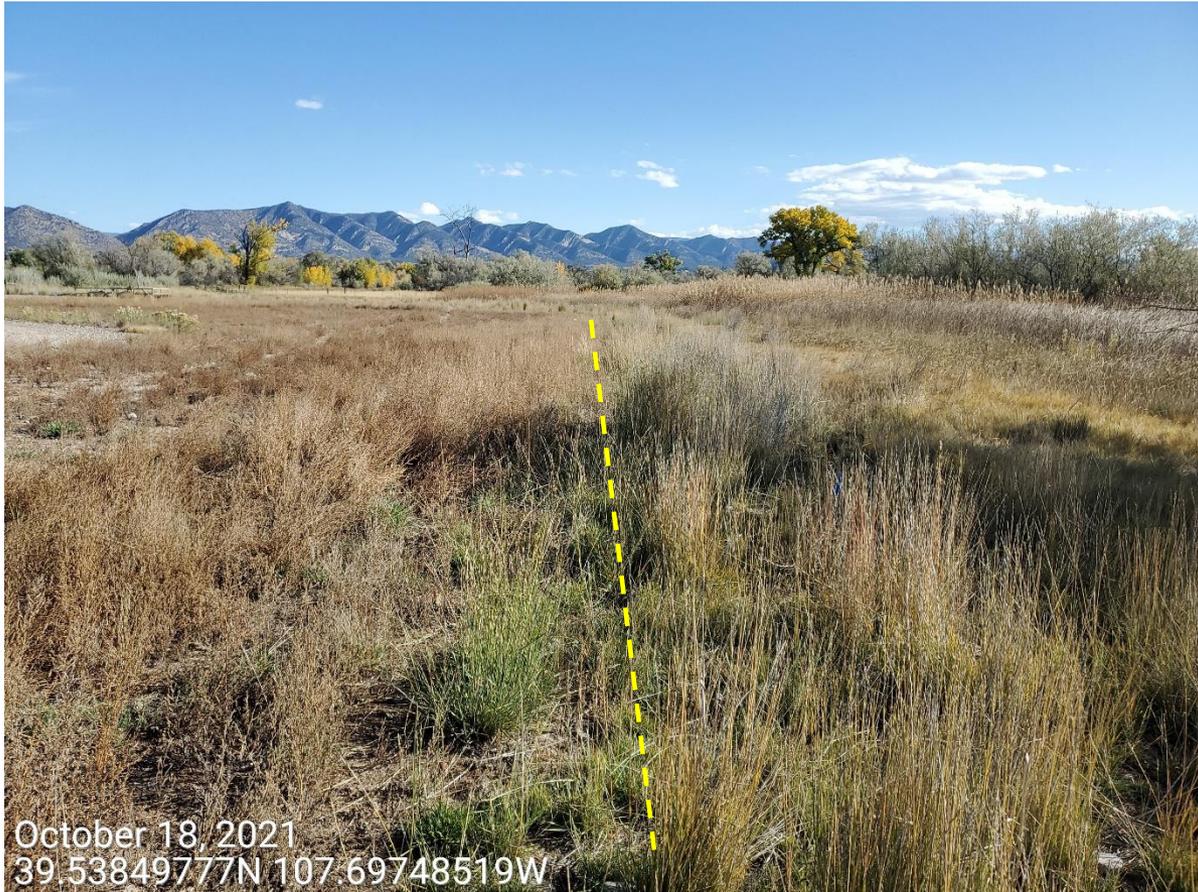
**Photo 5:** Photo taken from the southern interim areas of the Location, facing east. Photo shows interim areas (left of line) are predominately undesirable plant species such as Kochial and Salsola sp. Undisturbed upland areas (right of line) are predominantly saltgrass, wheatgrass and shrub species. Interim areas are not progressing towards 1003 standards.

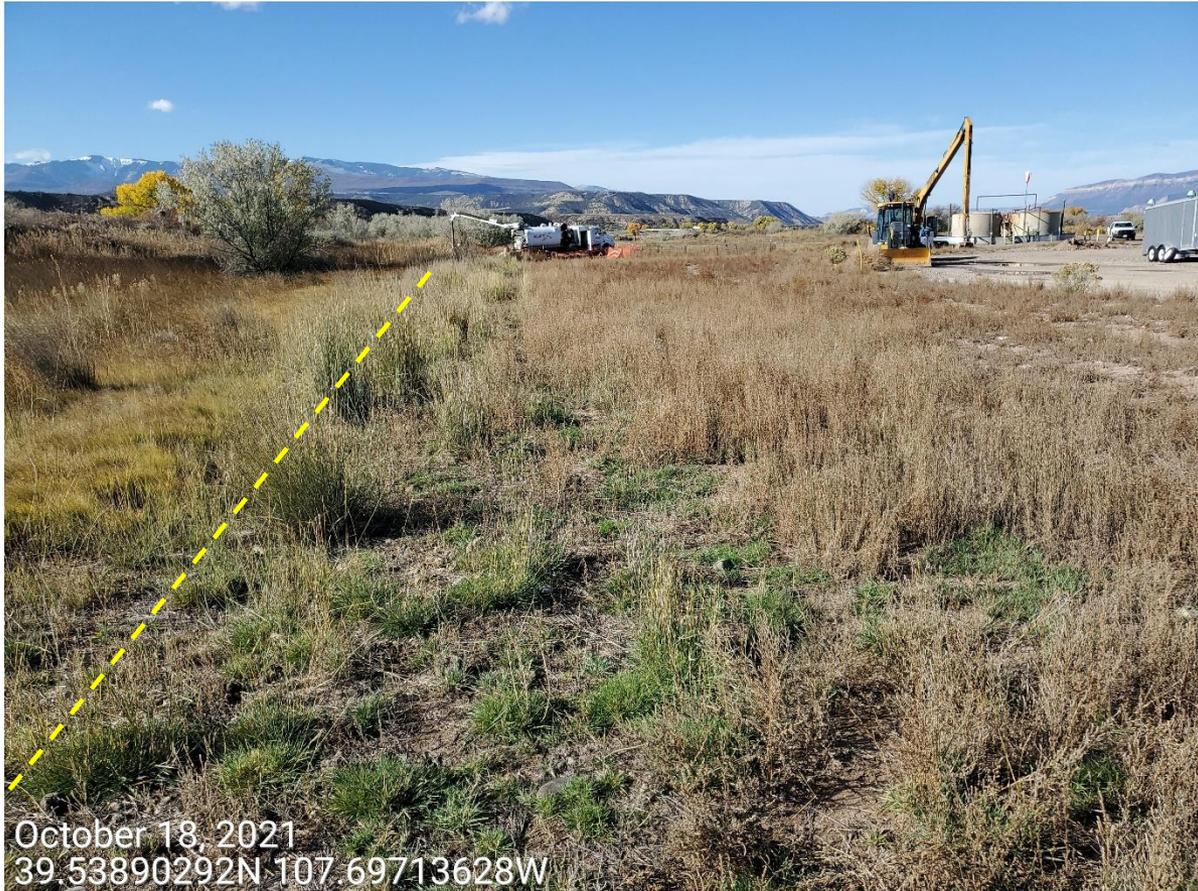
**Photo 6:** Continued from 5. Photo taken from the southeaster interim areas of the Location, facing west. Photo shows interim areas (right of line) are predominately undesirable plant species such as Kochial and Salsola sp. Undisturbed upland areas (left of line) are predominantly saltgrass, wheatgrass and shrub species. Interim areas are not progressing towards 1003 standards.

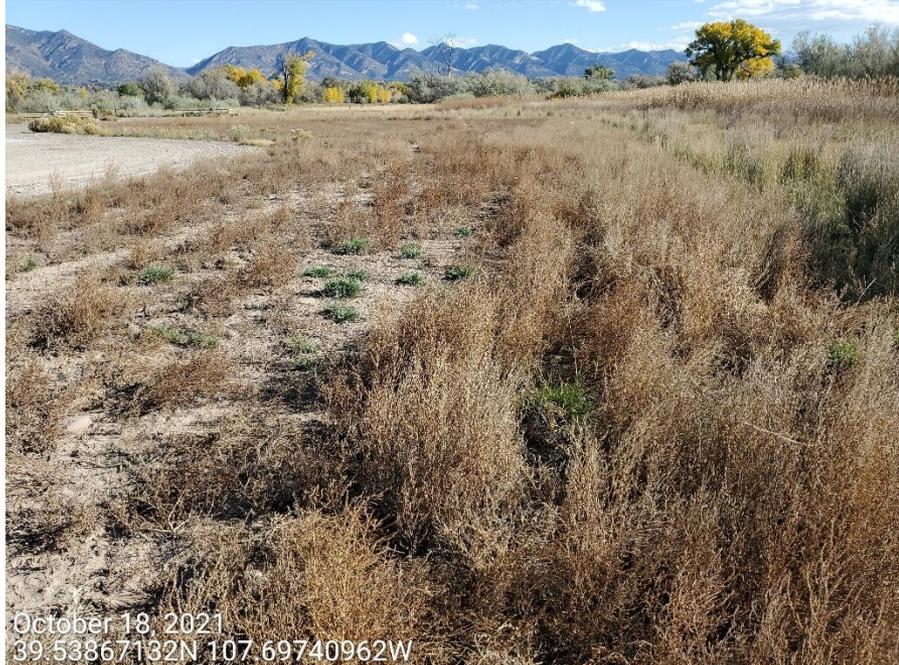
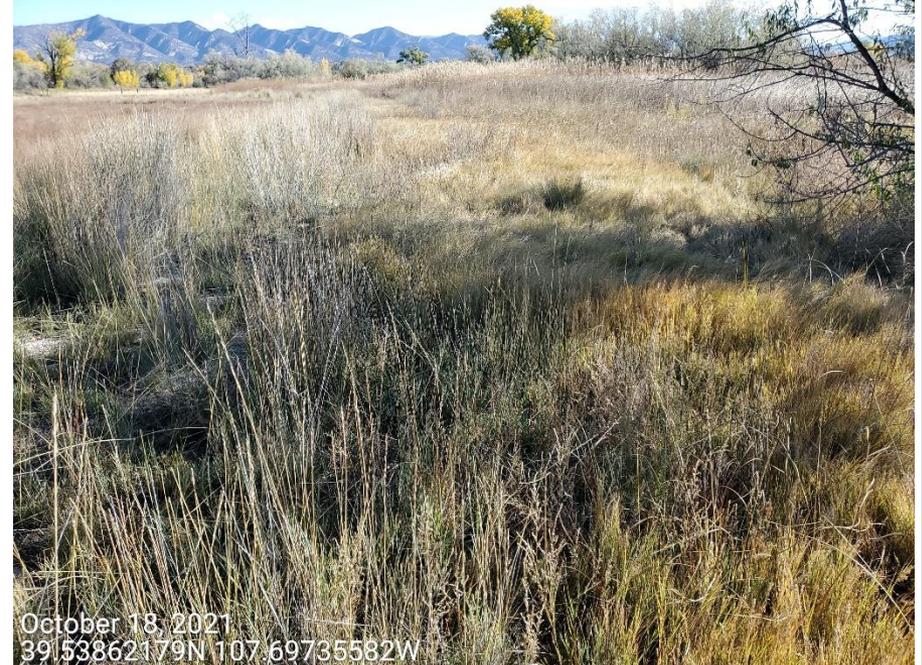
**Photo 7:** Photo shows compare/contrast of interim areas not progressing towards 1003 standards, and the adjacent reference.

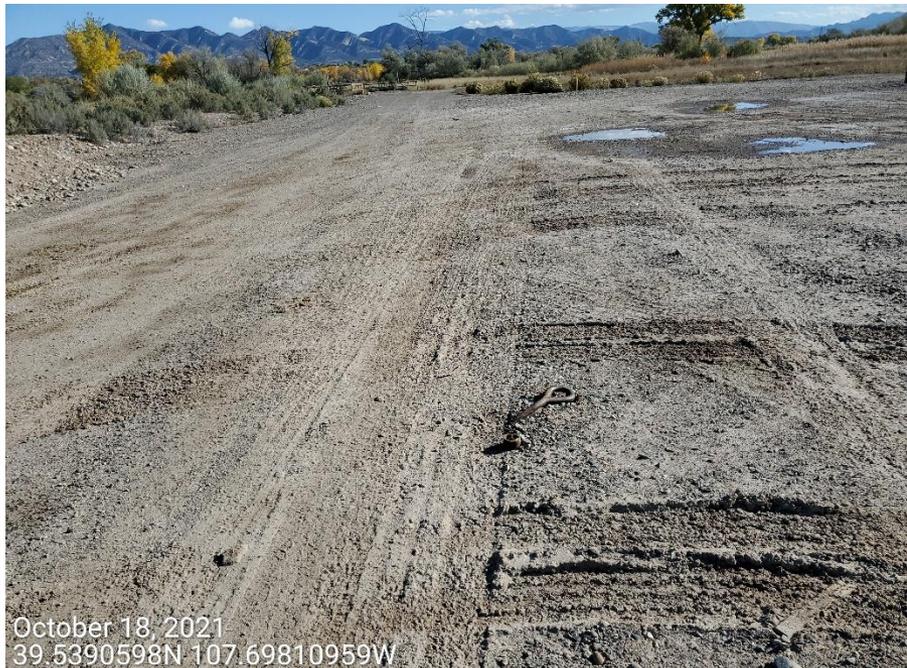
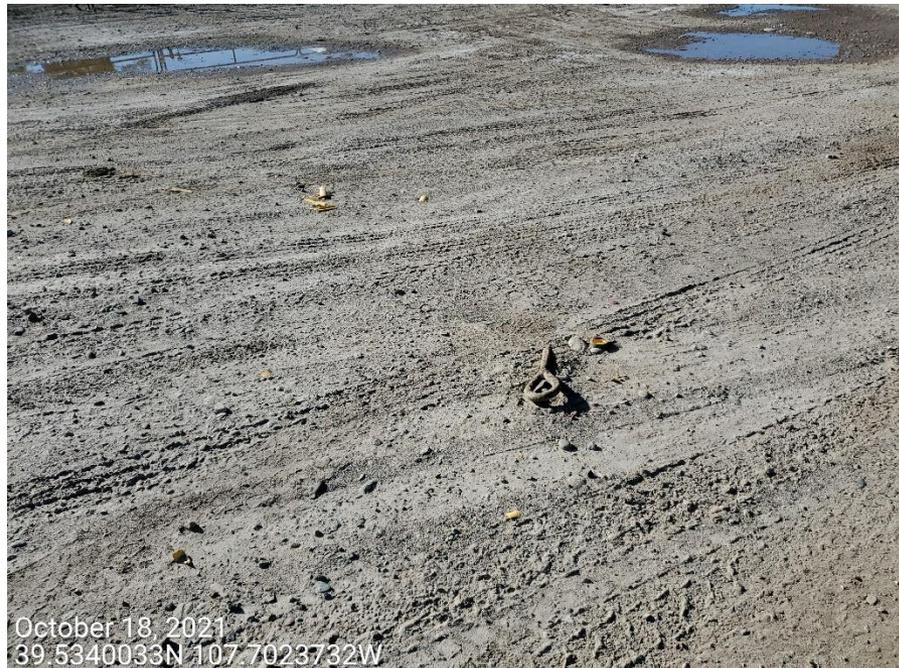
**Photo 8:** Photo shows example of anchors observed on the Location not properly marked.

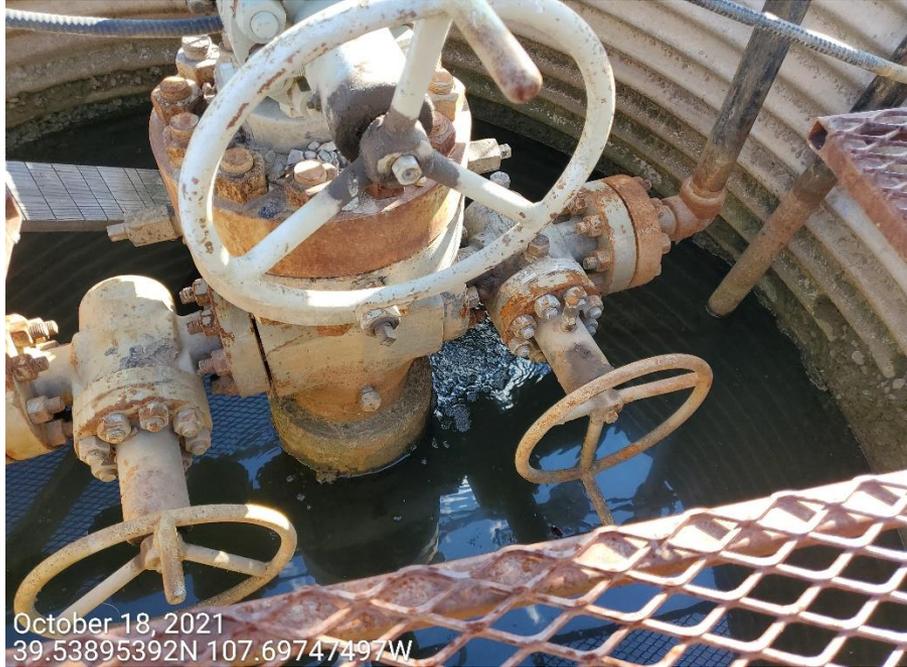
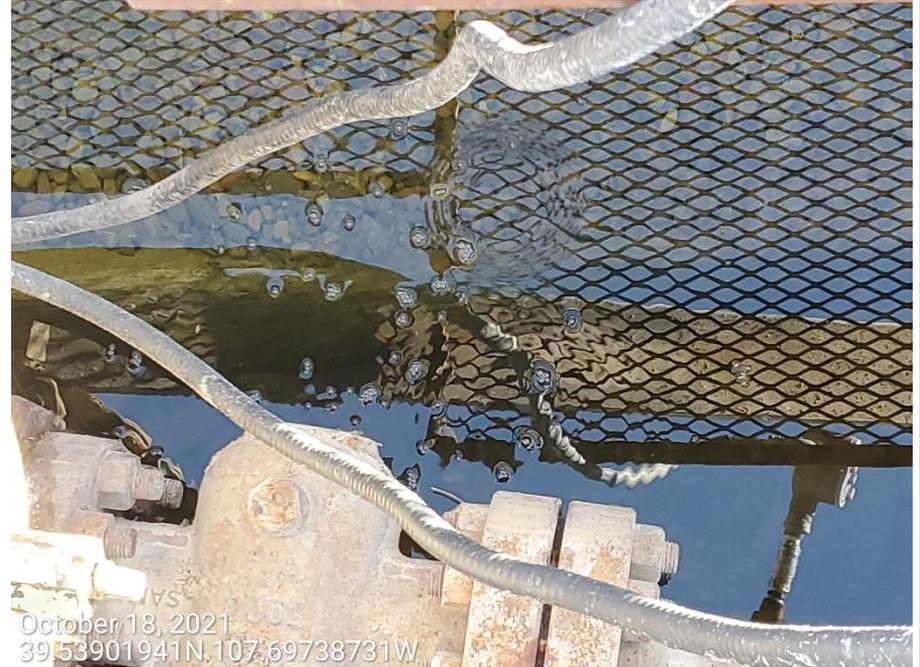
**Photo 9:** Photos show gas observed leaking from the A4 and A1 wells.
