Inspection Photos

Location Name: TEP ROCKY MOUNTAIN LLC PA-66S95W /34NWNW

Location ID: 335395

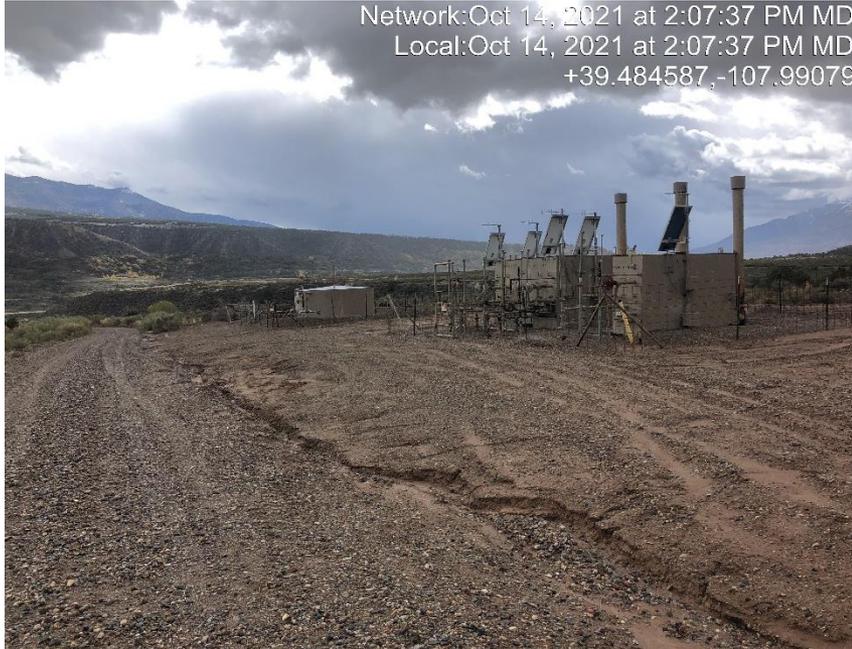
Photo #5076 from entrance to location.

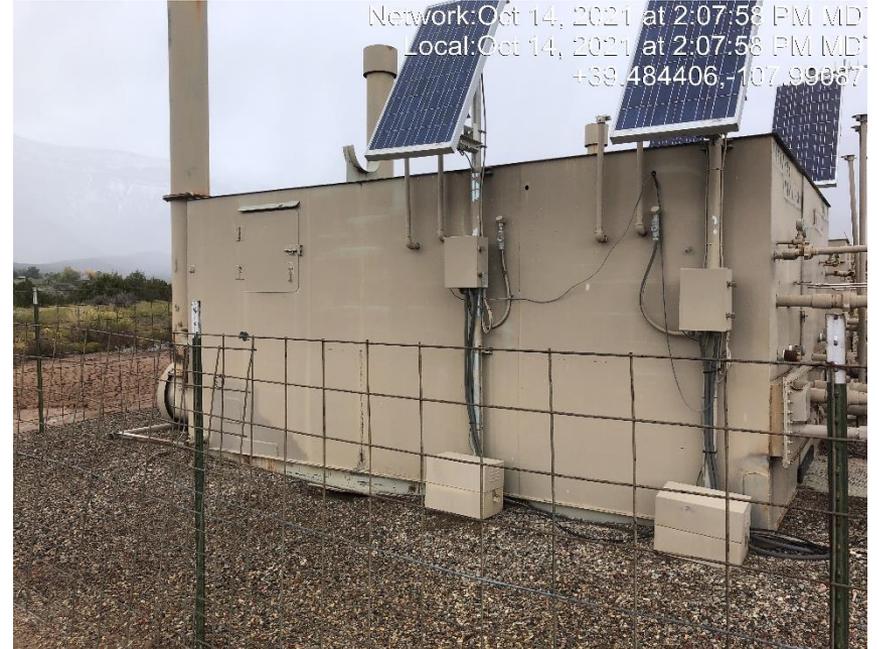
Photo #5077 Glycol storage tank missing required information.

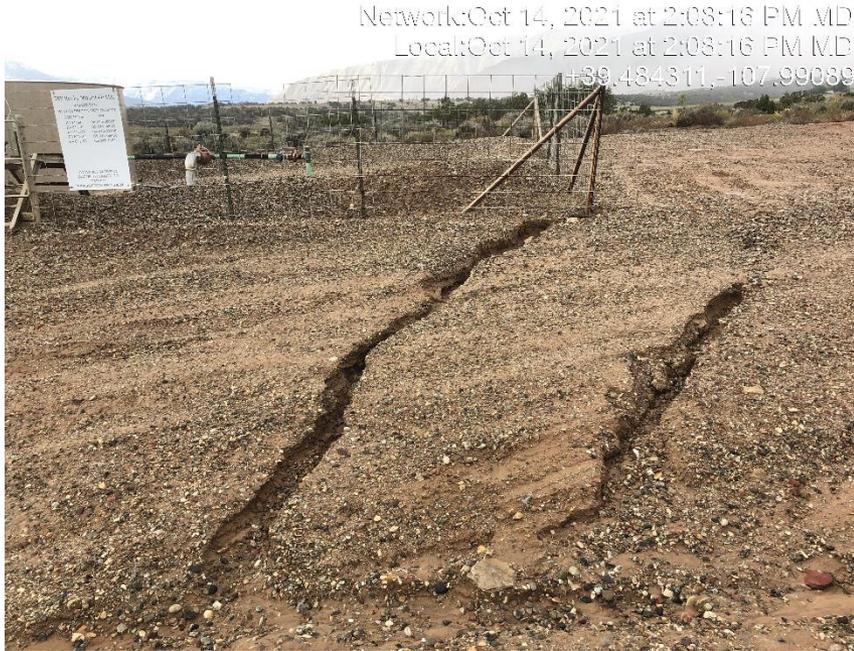
Photo #5078 Rill erosion occurring on location.

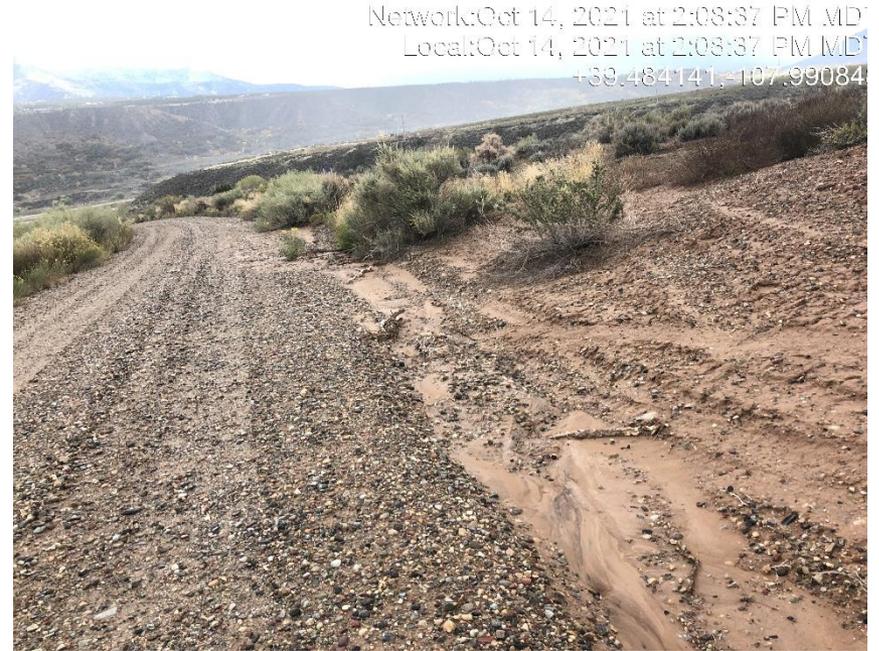
Photo #5079 insufficient velocity checks in ditch.

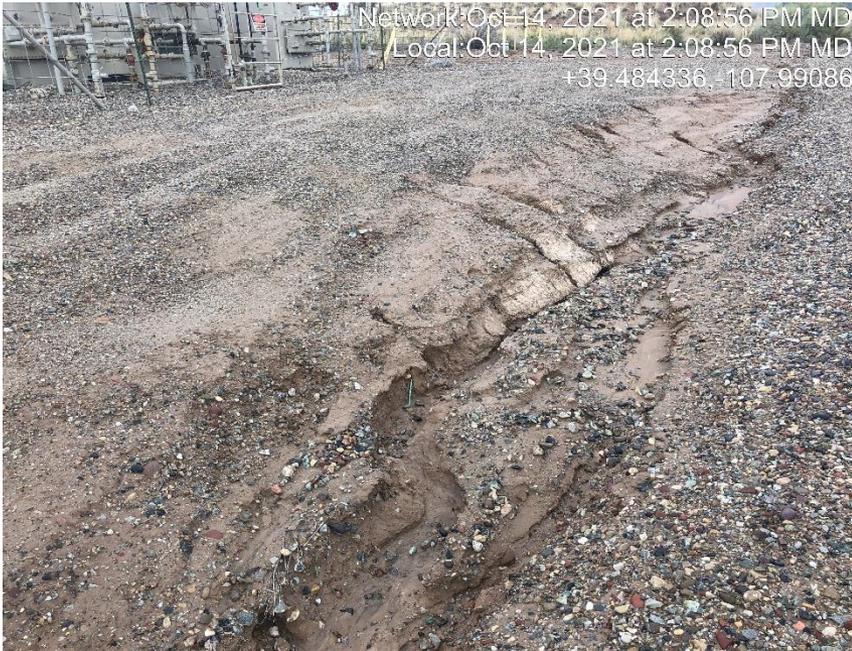
Photo #5081 Rill erosion occurring in ditch.
