Inspection Photos

Location Name: TEP ROCKY MOUNTAIN LLC MOBIL-66S95W /34SWNW

Location ID: 335254

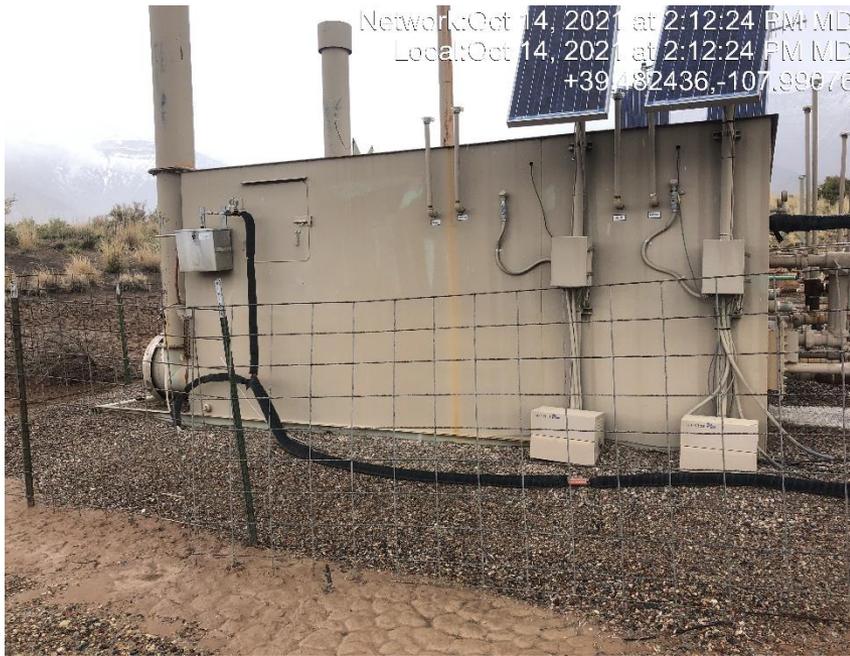
Photo #5084 Glycol storage tank missing required information.

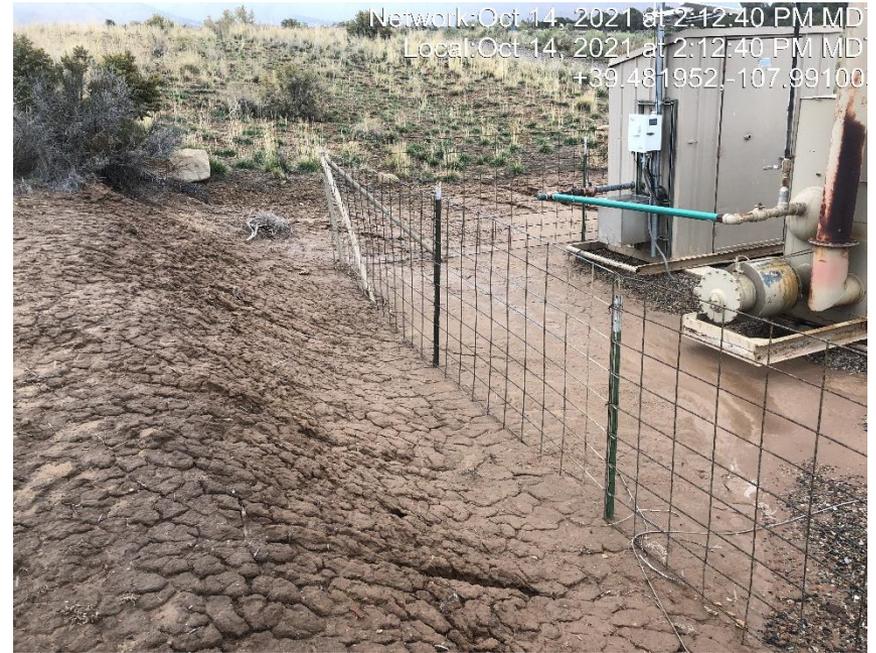
Photo #5085 Run on to location is not being controlled.

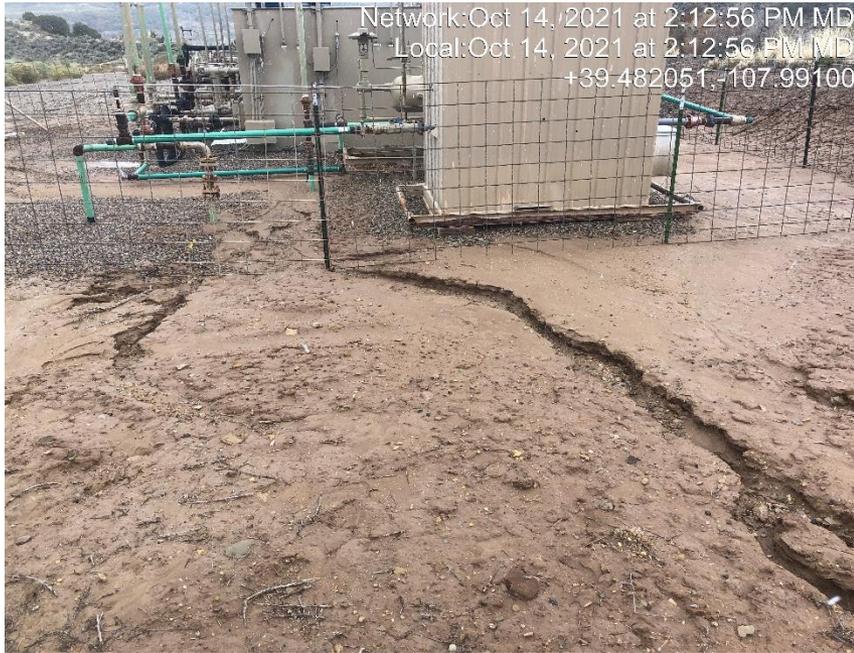
Photo #5086 Rill erosion occurring on location.

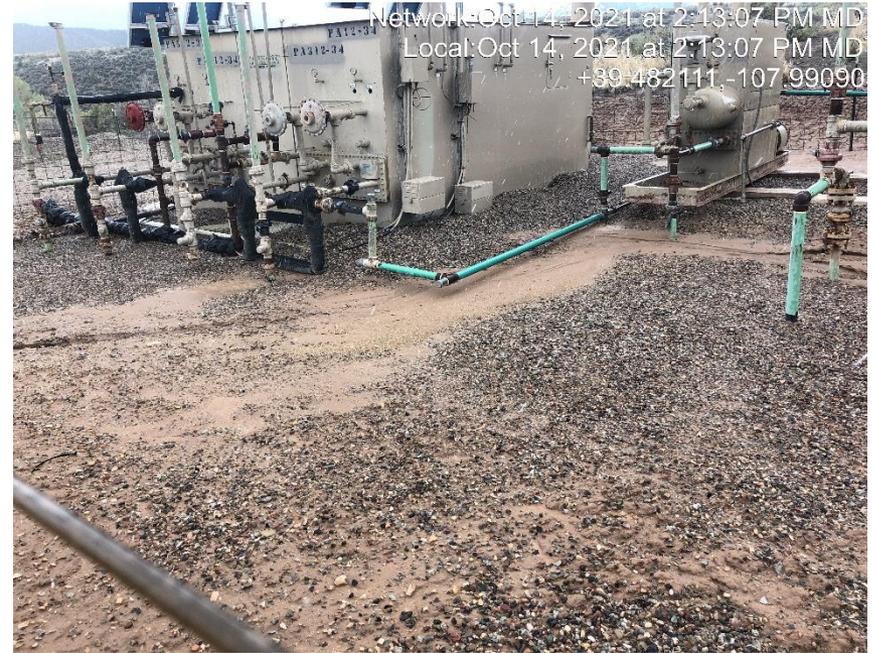
Photo #5087 Sediment encroaching on equipment.
