APACHE CANYON 20-05 API# 05-071-06191 – OGRIS OPERATING LLC
OGCC OPERATOR NUMBER 10758 - DATE: JUNE 22, 2021
CORRECTIVE ACTIONS COMPLETED REGARDING COGCC FIR DOCUMENT # 690201750

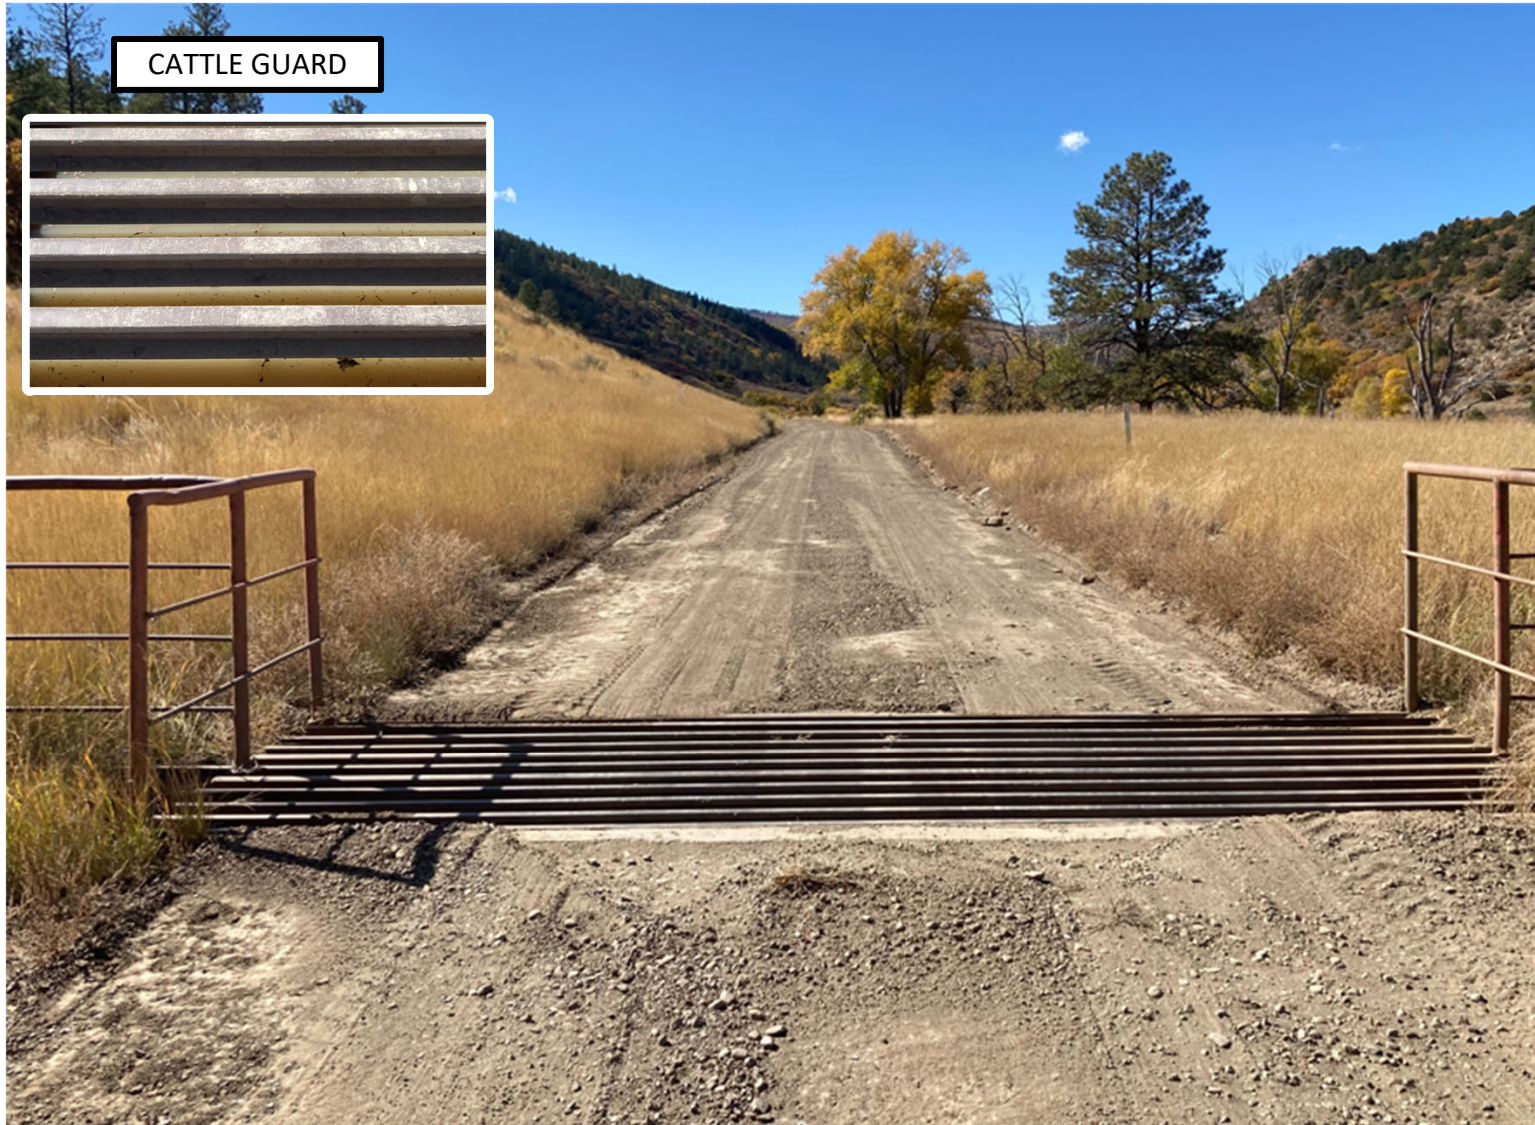
PHOTO 1: THE SEDIMENT WAS REMOVED FROM UNDERNEATH THE CATTLE GUARD.

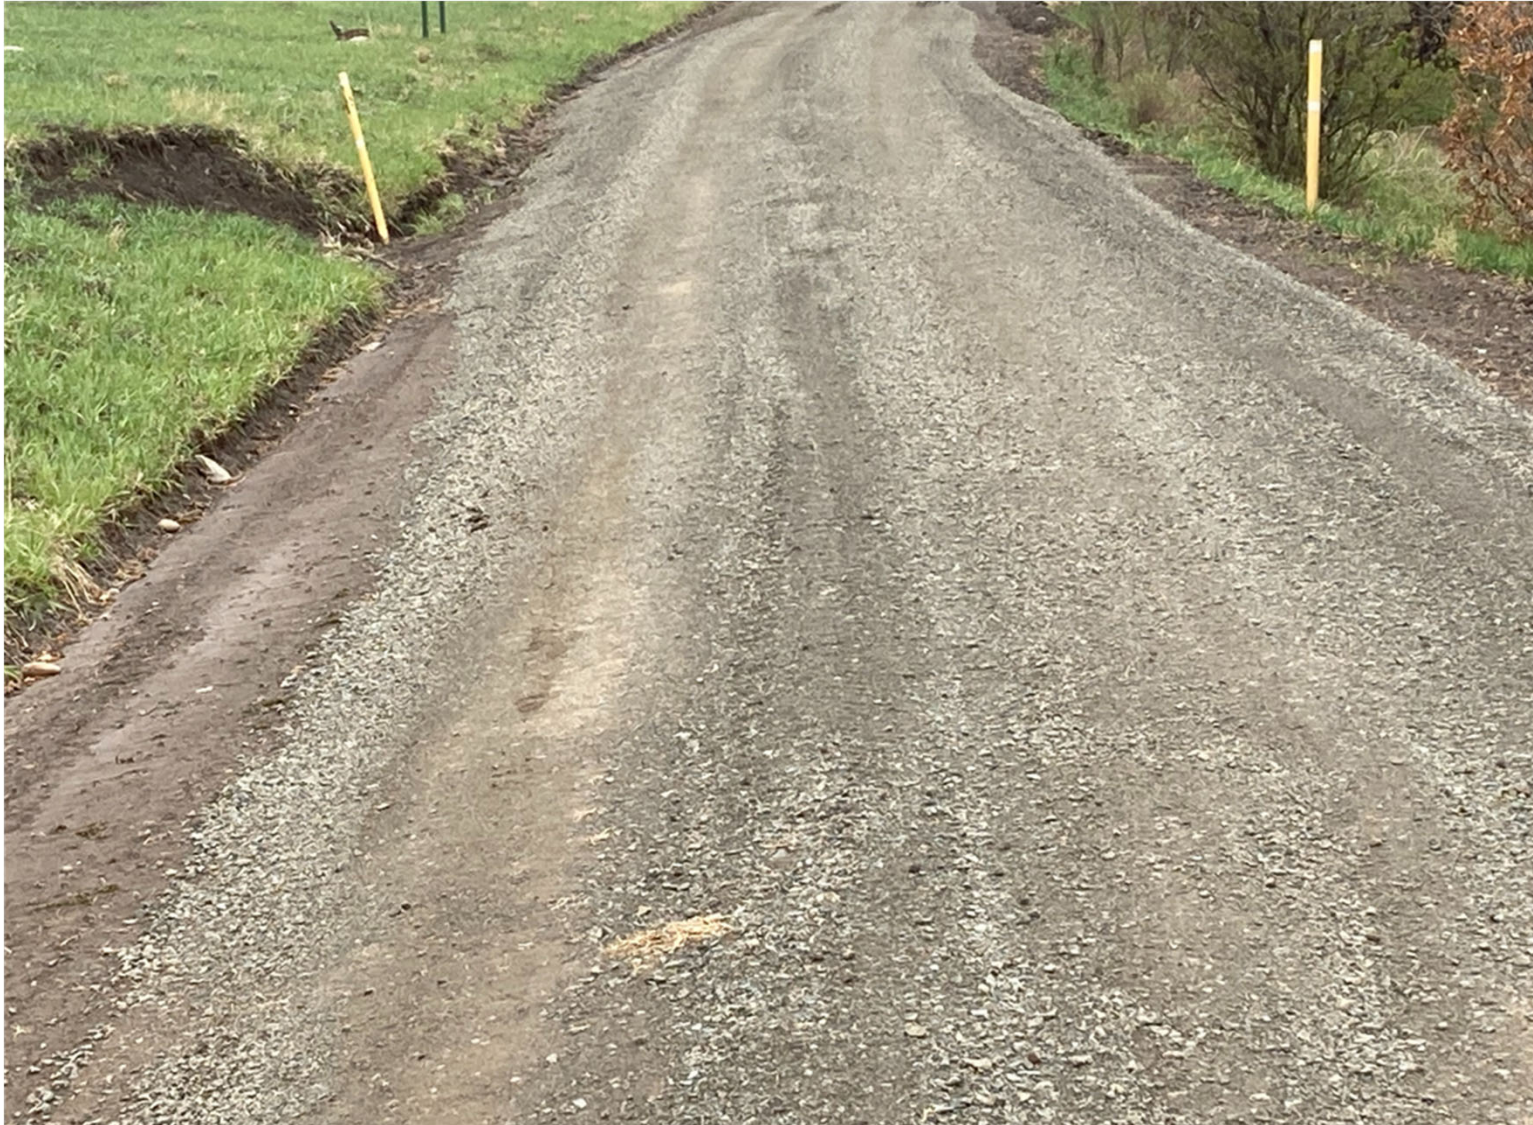
PHOTO 2: THE ROAD SURFACE WAS CROWNED TO CREATE SHEET FLOW AND ELIMINATE THE TIRE RUTS. RUN OFF IS DIVERTED TO THE CULVERT INLETS. ADDITIONAL GRAVEL WAS INSTALLED TO IMPROVE STABILIZATION.

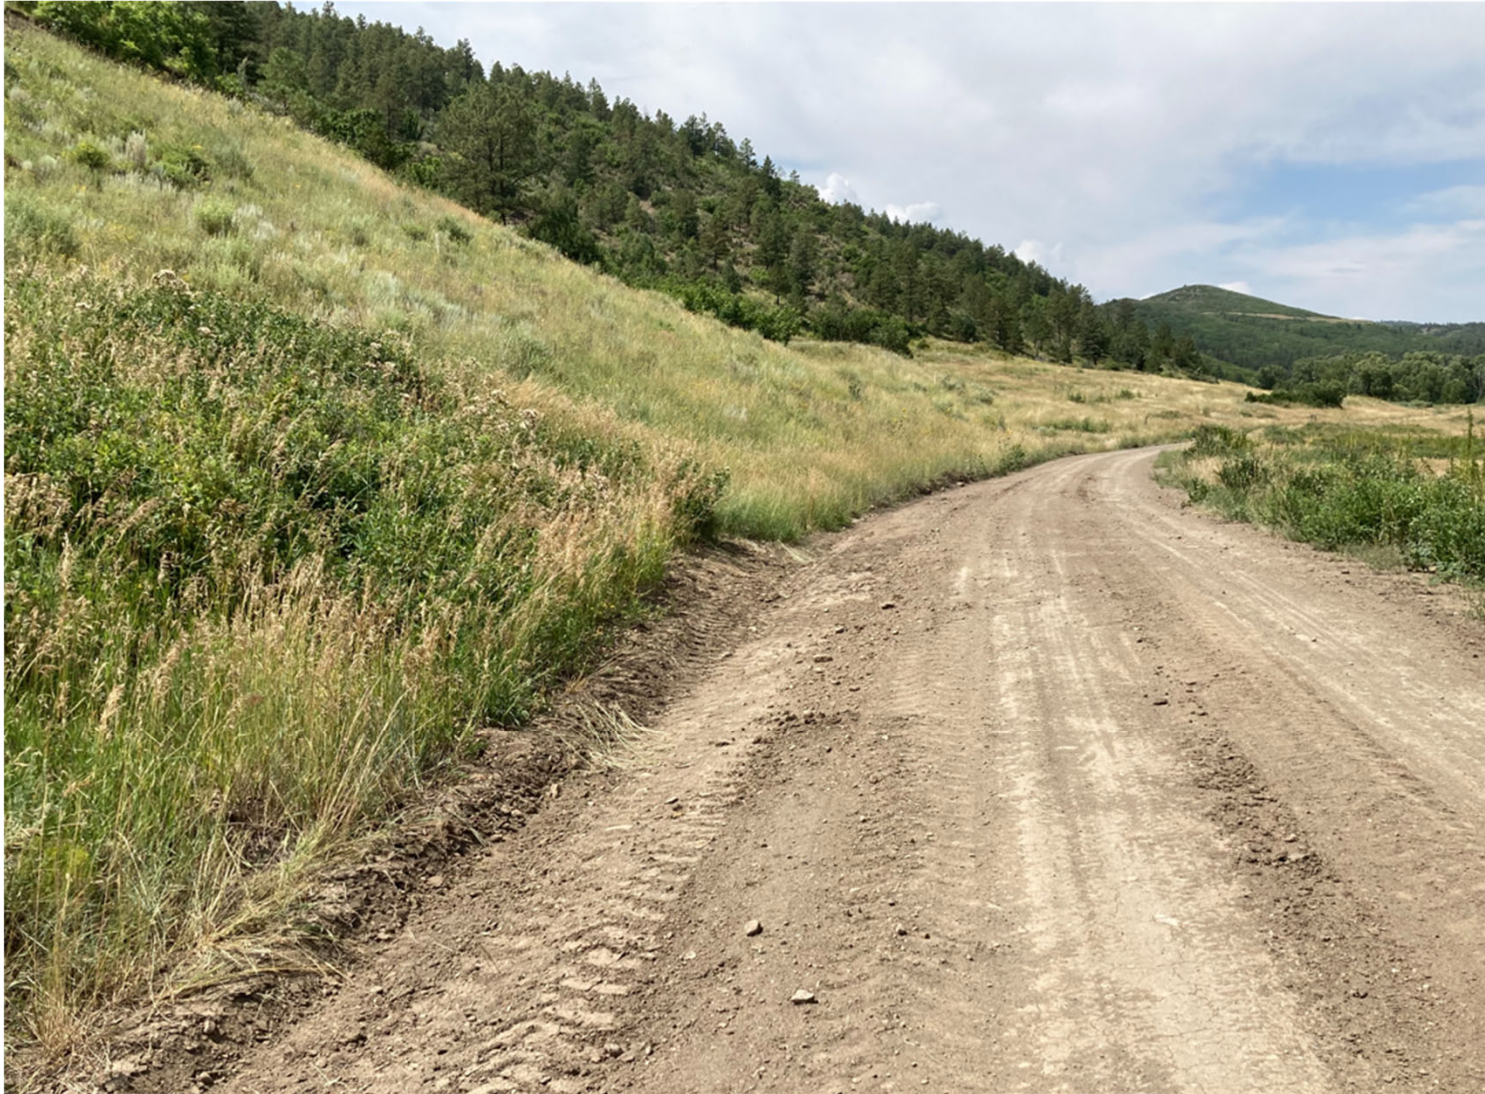
PHOTO 3: THE BAR DITCH WAS DOMINATED TO RECEIVE STORMWATER RUN OFF FROM THE ACCESS ROAD. THE ROAD SURFACE WAS CROWNED TO CREATE SHEET FLOW AND ELIMINATE THE TIRE RUTS.

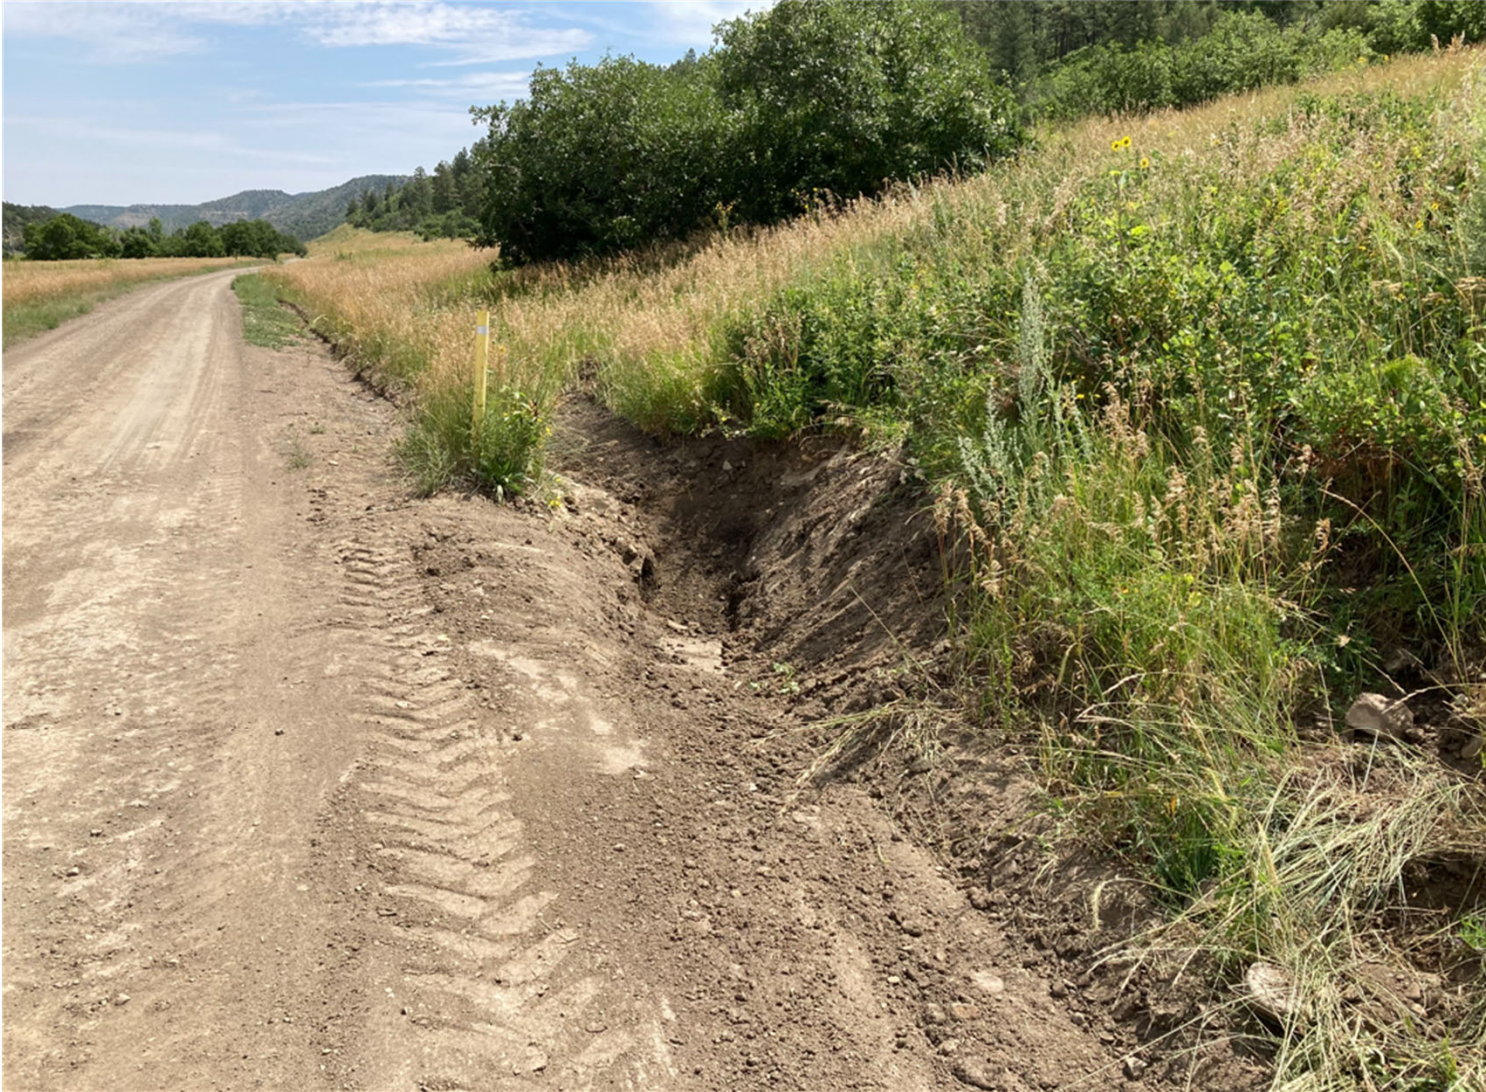
PHOTO 4: THE SEDIMENT ACCUMULATION WAS REMOVED FROM THE BAR DITCH. THE BAR DITCH WAS DOMINATED TO RECEIVE STORMWATER RUN OFF FROM THE ACCESS ROAD. THE ROAD SURFACE WAS CROWNED TO CREATE SHEET FLOW AND ELIMINATE THE TIRE RUTS.

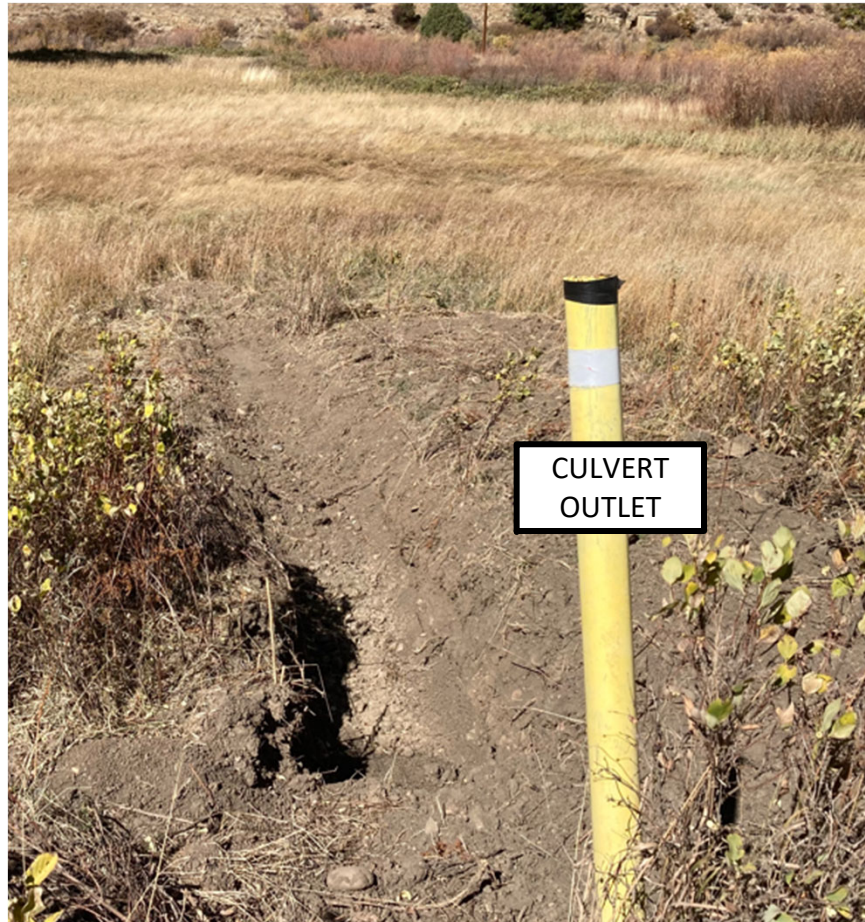
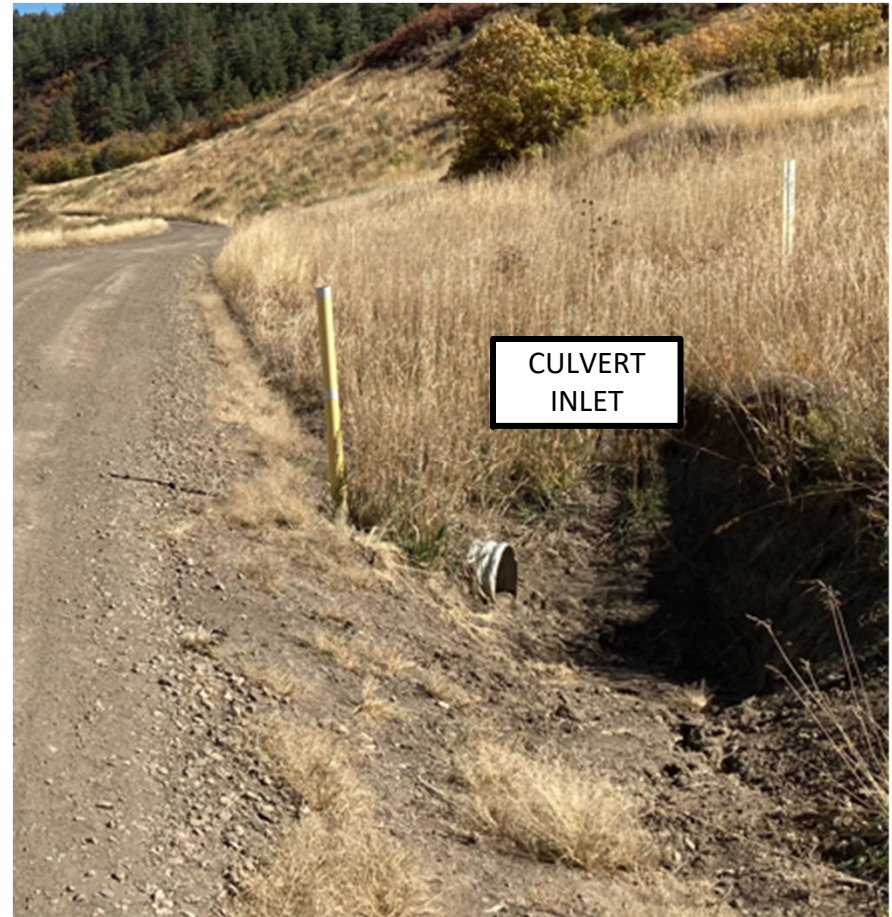
PHOTO 5: SOME OF THE CULVERT OUTLETS ALONG THE MAIN SOUTH FORK LEASE ROAD WERE BELOW GRADE AND WOULD NOT DRAIN PROPERLY. DRAINAGE WAS ESTABLISHED FOR THE OUTLETS. THE CULVERTS WERE CLEANED OUT WITH THE HYDRO-VAC EQUIPMENT AND THE SEDIMENT ACCUMULATION WAS REMOVED FROM THE CULVERT INLETS.

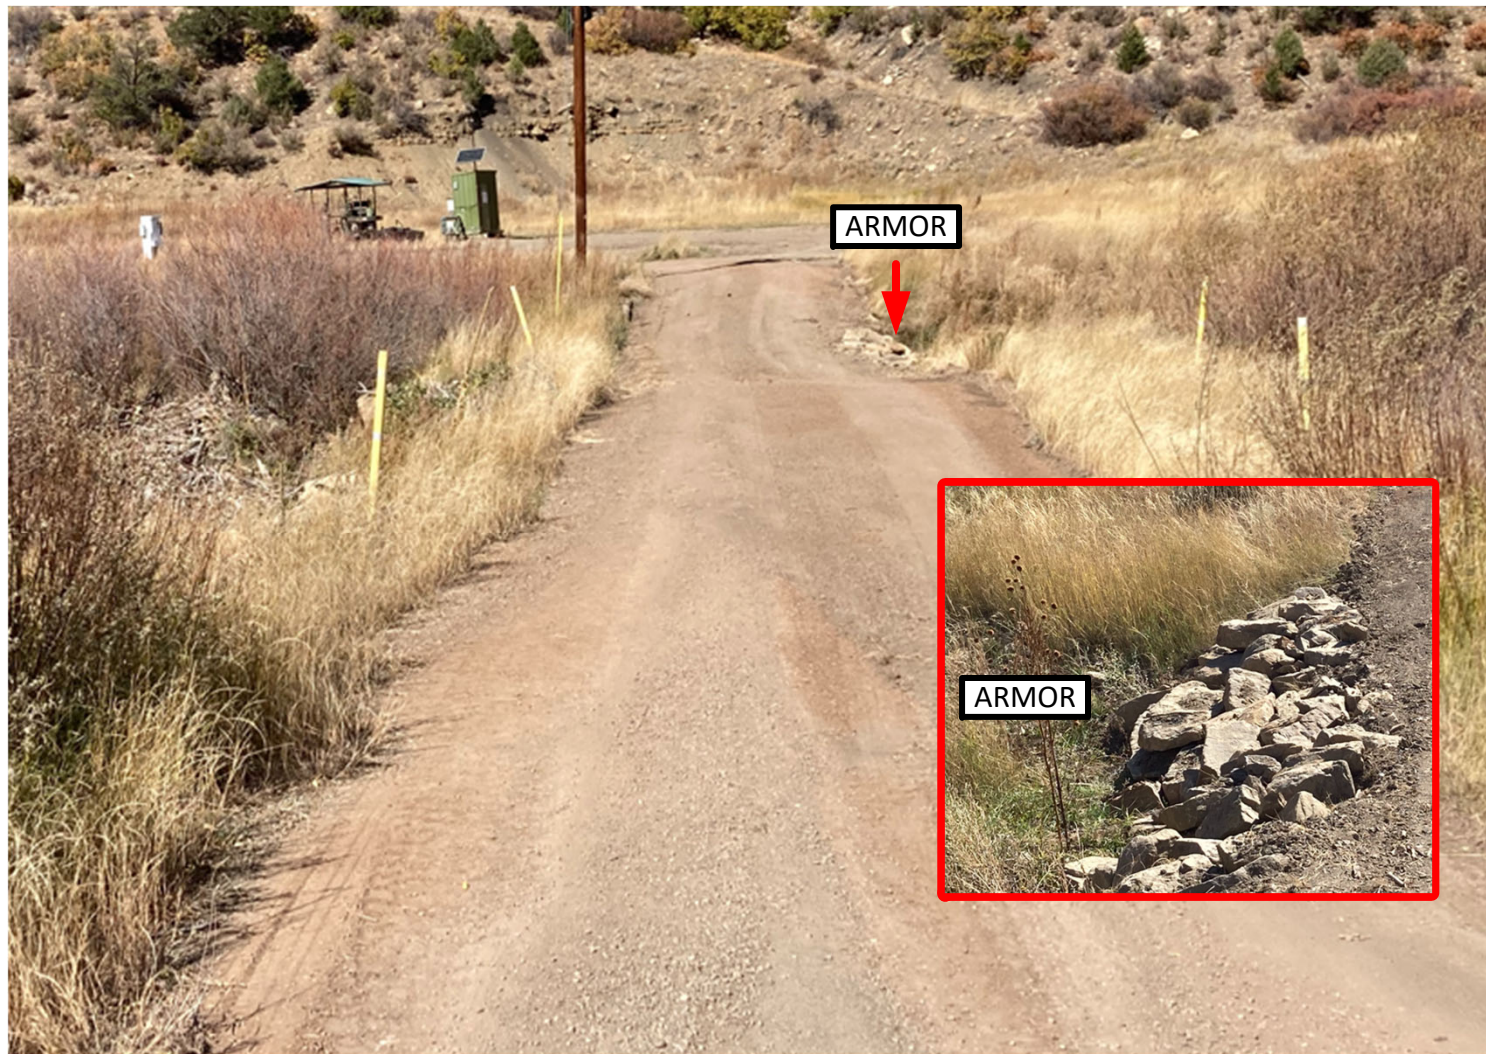
PHOTO 6: THE ACCESS ROAD TO LOCATION WAS REPAIRED WHERE WATER HAD SCOURED THE FILL PORTION OF THE ROADWAY. ARMOR WAS PLACED ON THE FILL FOR STABILIZATION. ADDITIONAL GRAVEL WAS INSTALLED ON THE ACCESS ROAD SURFACE.

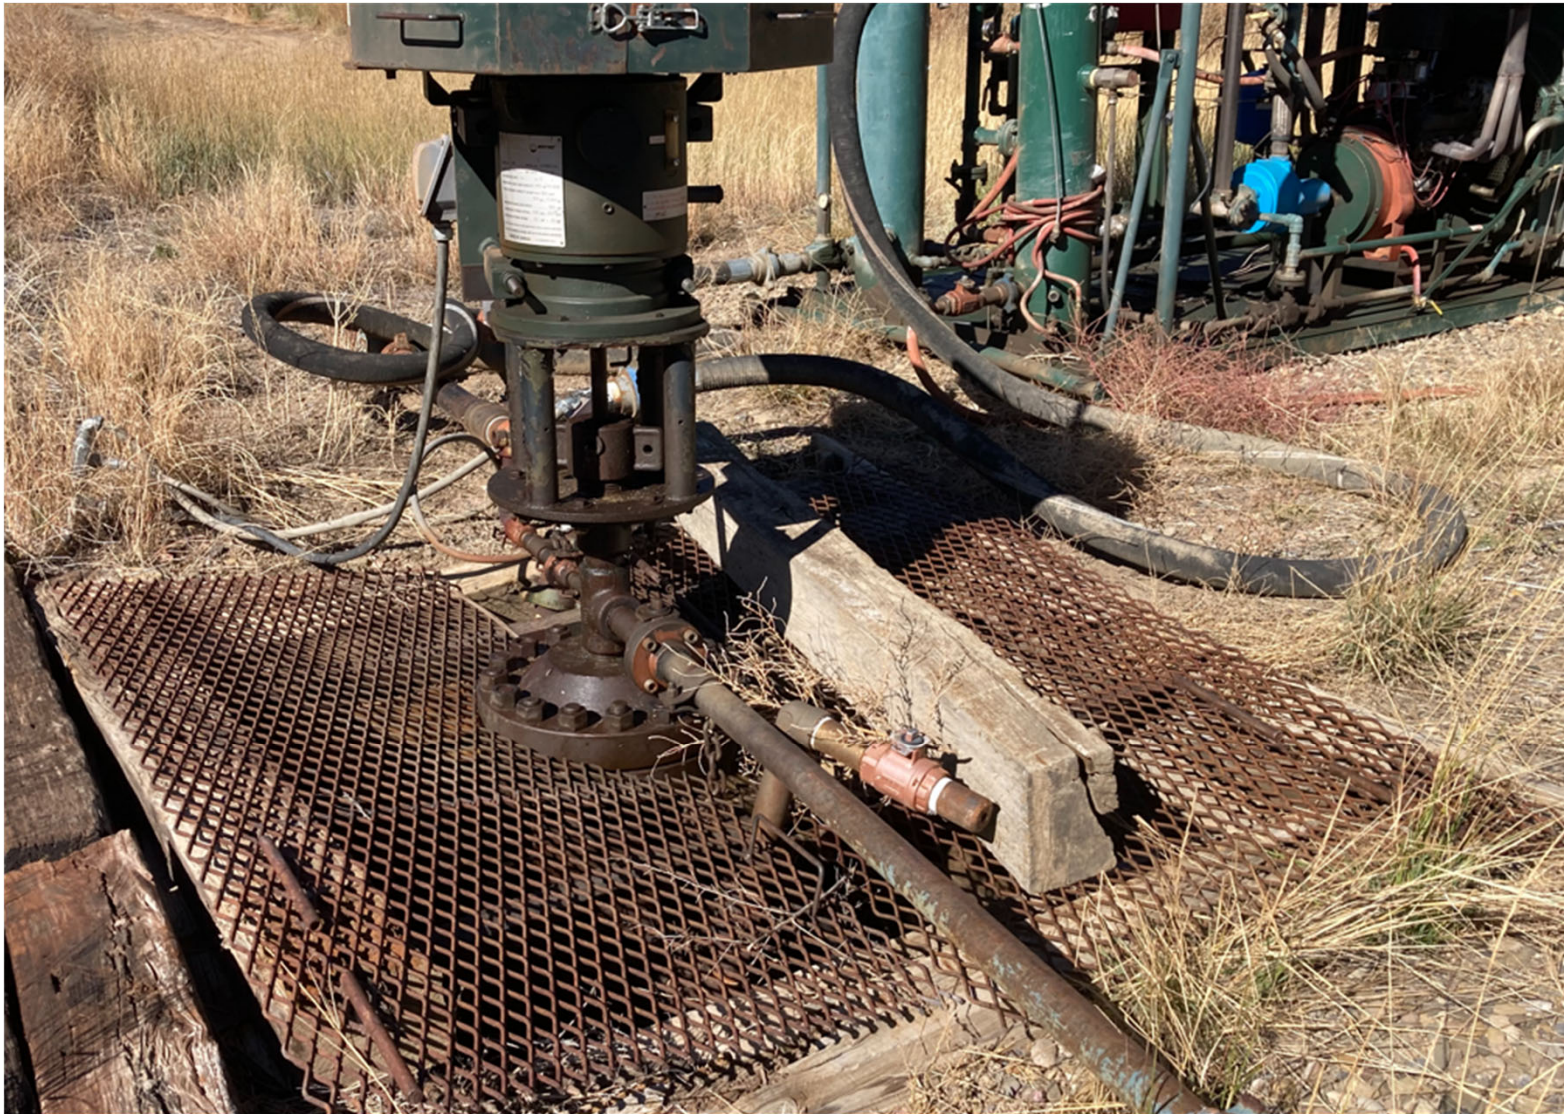
PHOTO 7: THE METAL GRATE WAS RECONFIGURED TO COVER THE CELLAR OPENING.

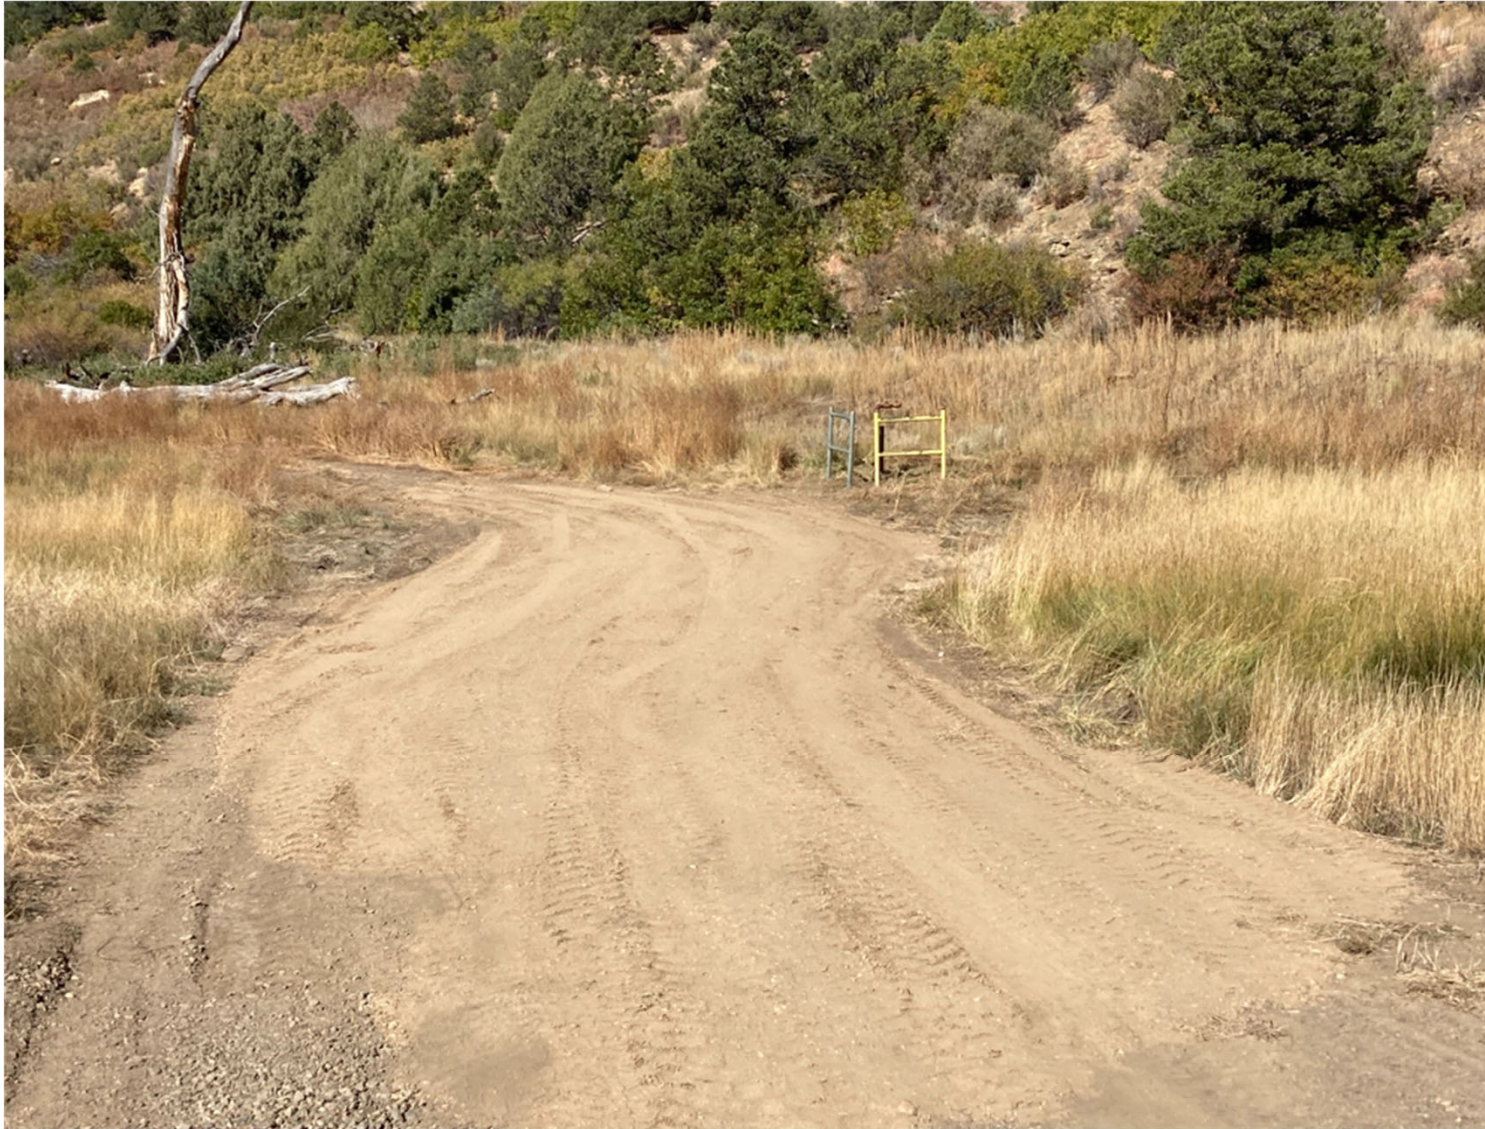
PHOTO 8: THE VEHICLE ACCESS TO THE DRIPS WERE STABILIZED WITH ROAD BASE.
